DISCUSSION ITEM

Agenda Item # 6

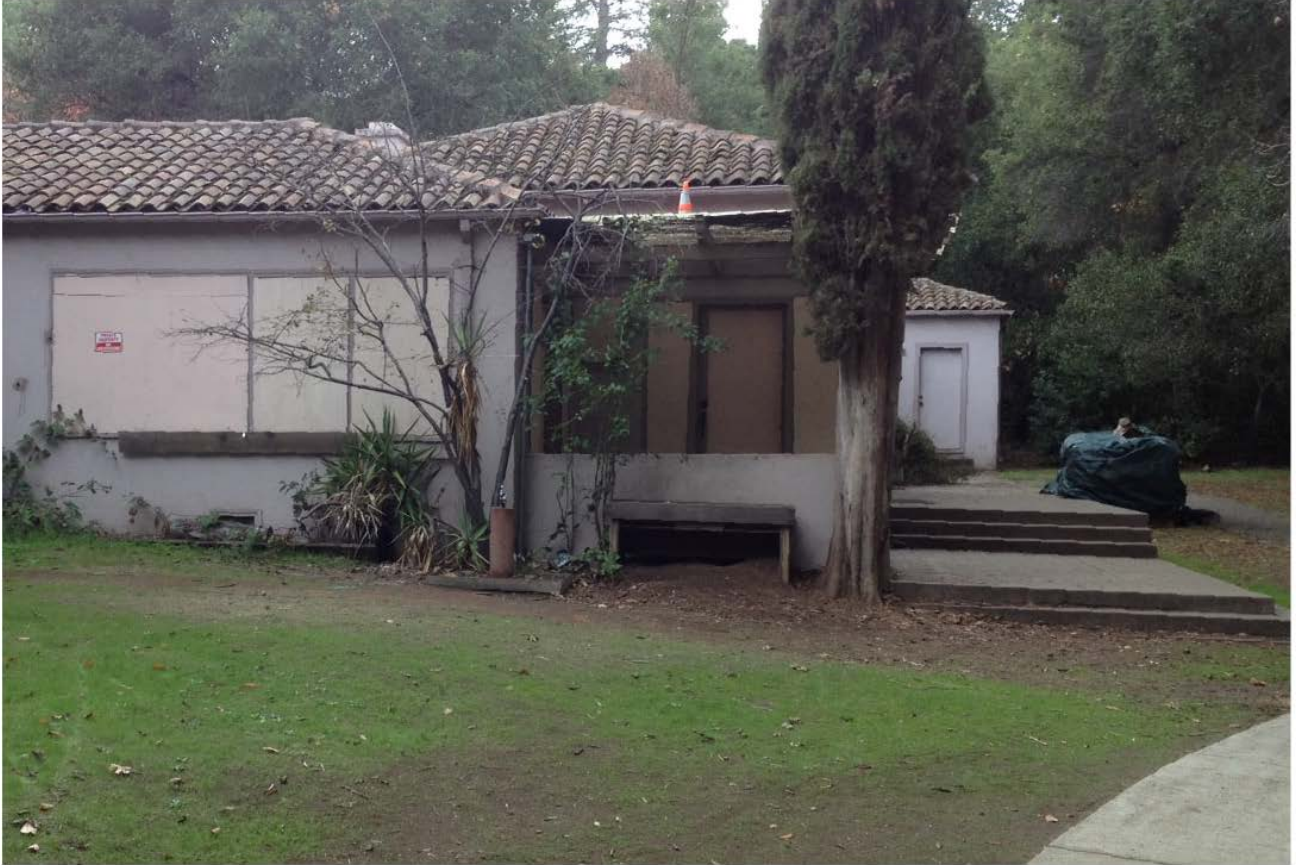
Feasibility Study for the Adaptive
Reuse of the Historic Halsey House
or Demolition and Construction of a
New Nature Center at Redwood Grove Park
482 University Avenue, Los Altos, California

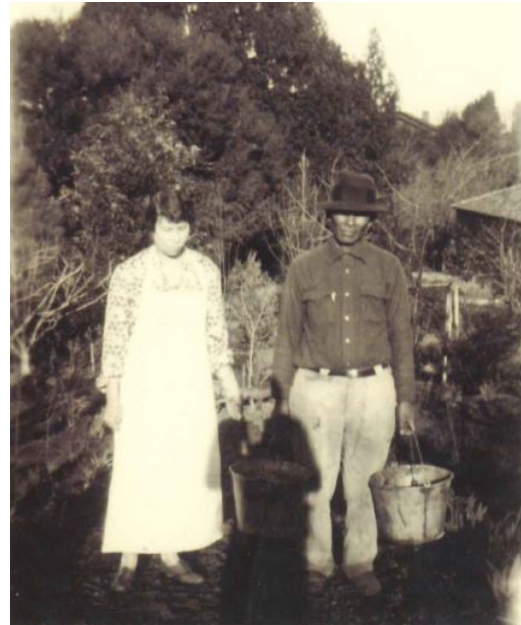
Emma Halsey and Omori, c.1920s (Los Altos History Museum).

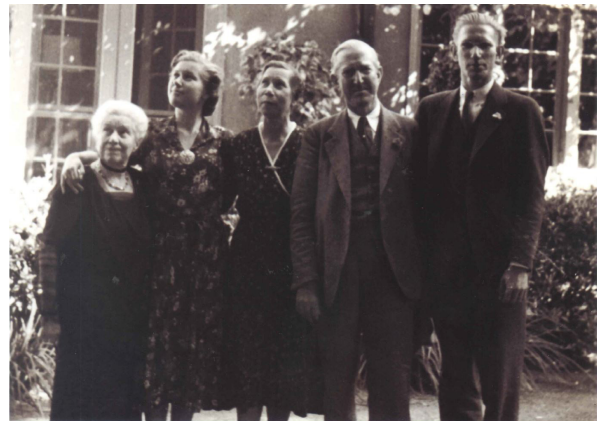
(L to R) Emma E. Wright, Myra Eugenia Halsey, Emma Halsey, T.V. Halsey, and T.V. Halsey Jr., c.1930 (Los Altos History Museum).

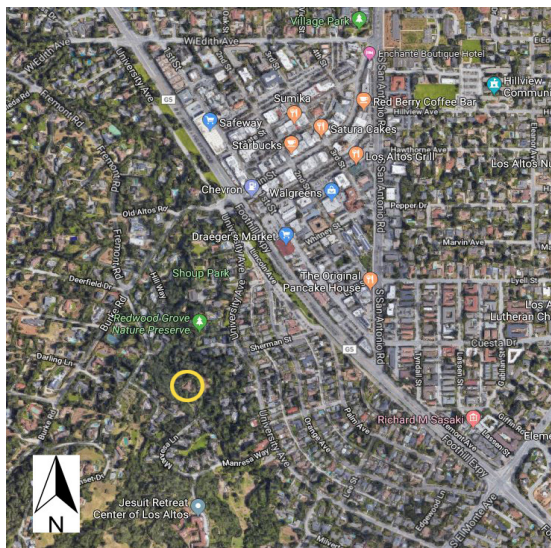
Figure 1. Aerial view of central Los Altos, location of Halsey house indicated with yellow circle (Google maps, amended by author).

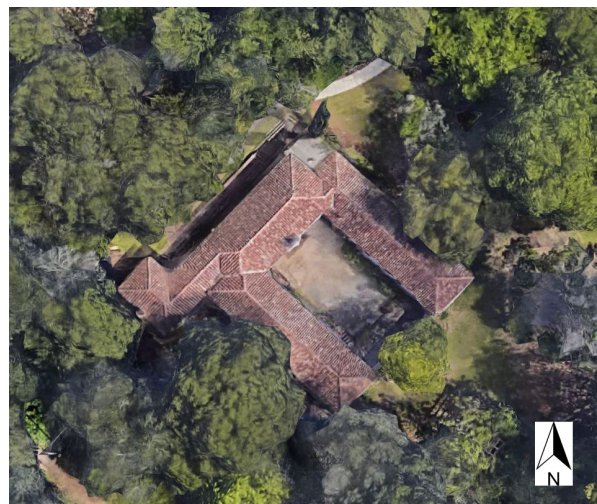
Figure 2. Aerial detail of Halsey House (Google maps, amended by author).

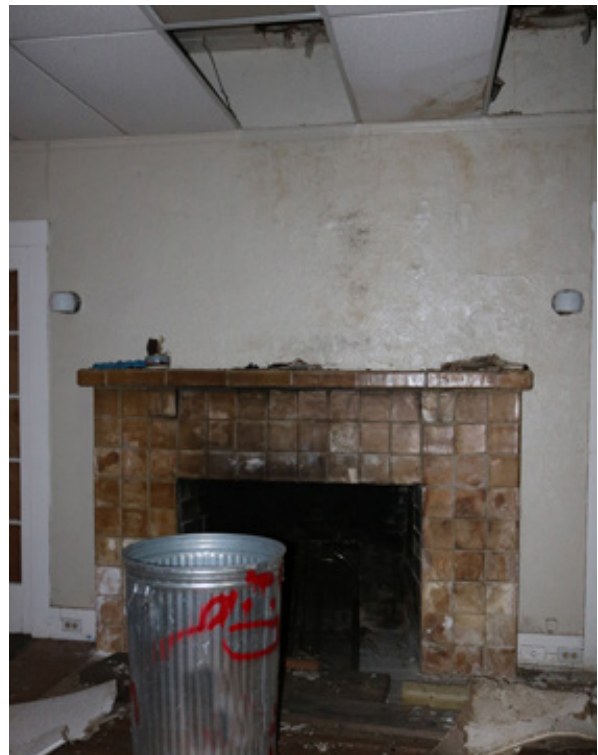
Figure 8. Tiled fireplace in former living room (photo: ARG, May 2019).

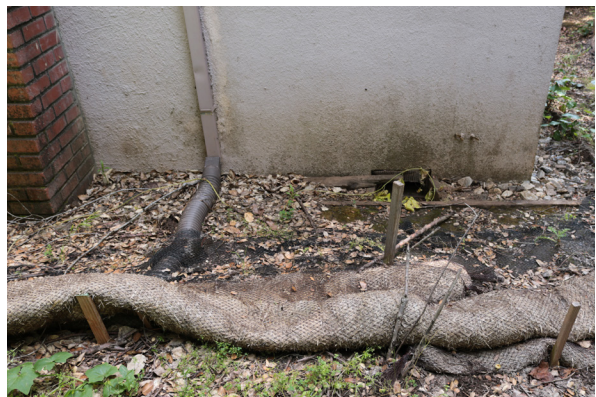
Coir rolls along west elevation (ARG, 2019).

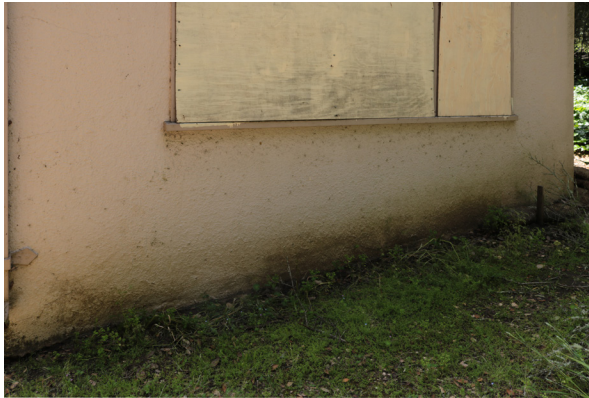
Biological growth along base of exterior wall at east elevation (ARG, 2019).

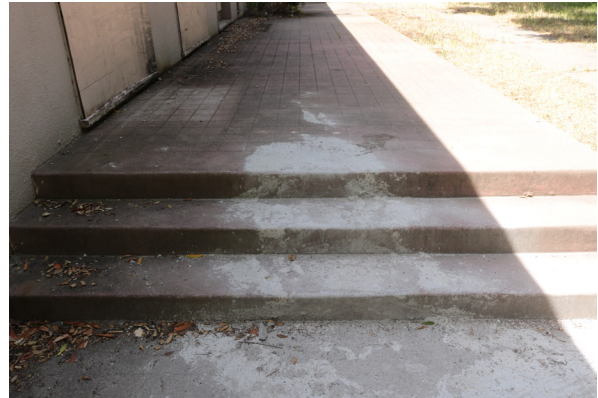
Paint stain at the north terrace stairs (ARG, 2019).

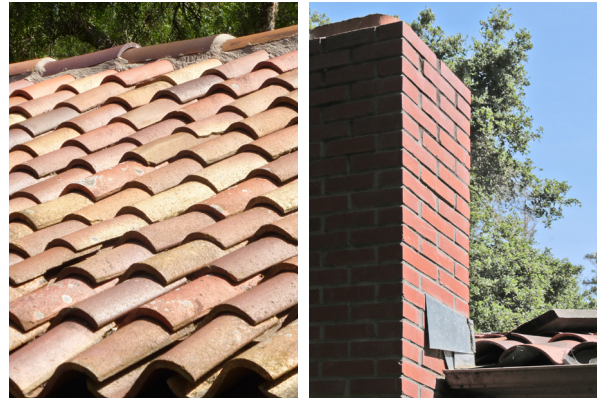
Clay tile roof (left); metal flashing at west chimney (right); (ARG, 2019).

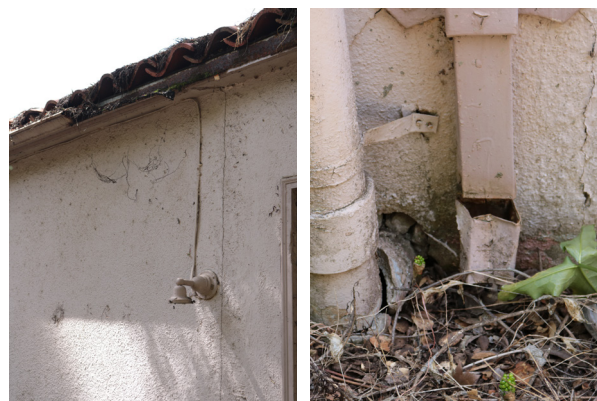
Missing segment of roof gutter (left); damaged rain leader (right); (ARG, 2019).

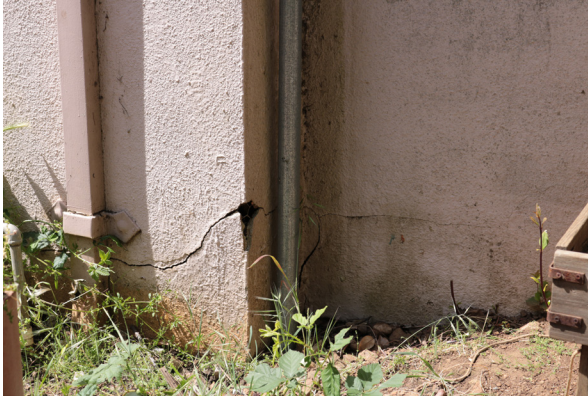
Major stucco spall at the base of the northeast corner (ARG, 2019).

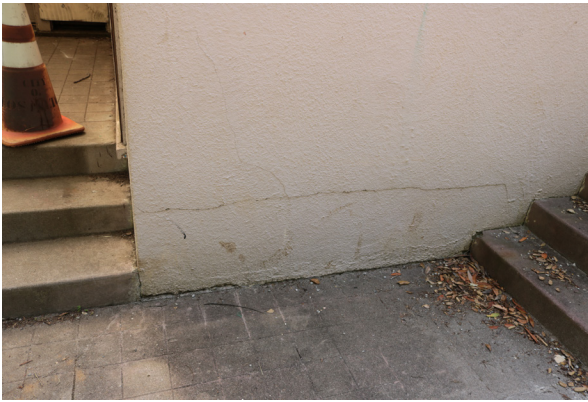
Crack along the base of the north elevation at the Main Entry (ARG, 2019).

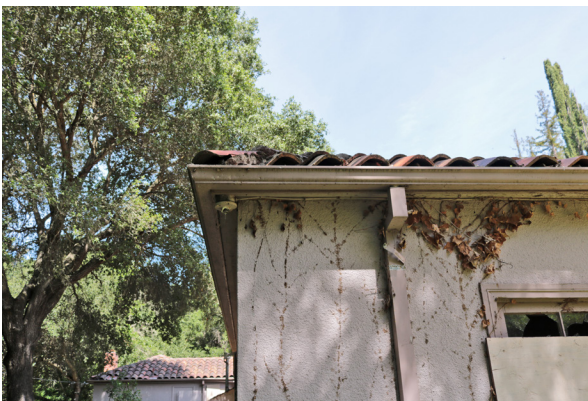
Remains of ivy growth along the south elevation (ARG, 2019).

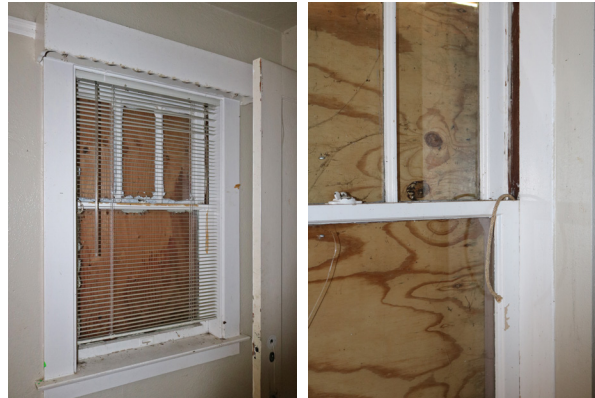
Typical original double-hung window in the Animal Room (left); damaged sash cord at Entry (right); (ARG, 2019).

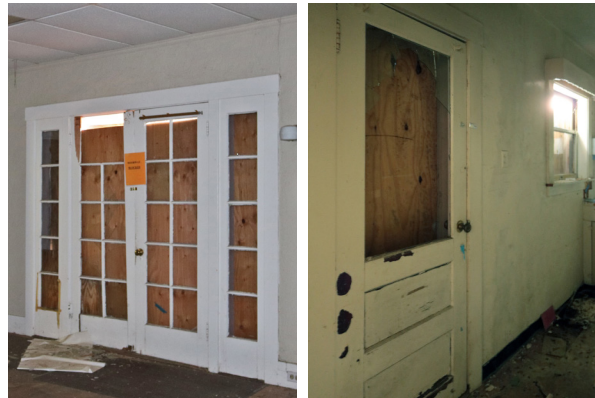
Typical original French doors in the Main Room (left); damaged exterior door at the East Kitchen (right); (ARG, 2019).

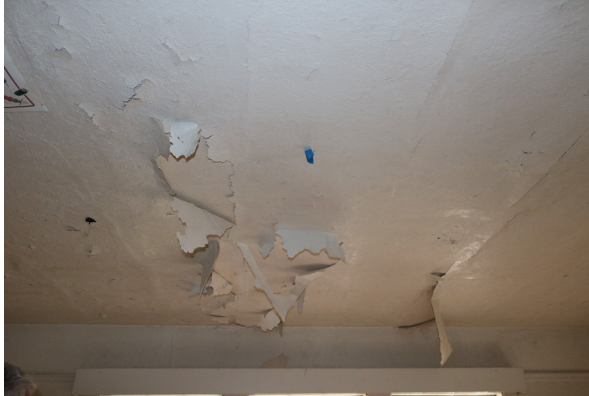
Delamination of plaster at the Discovery Lab (ARG, 2019).

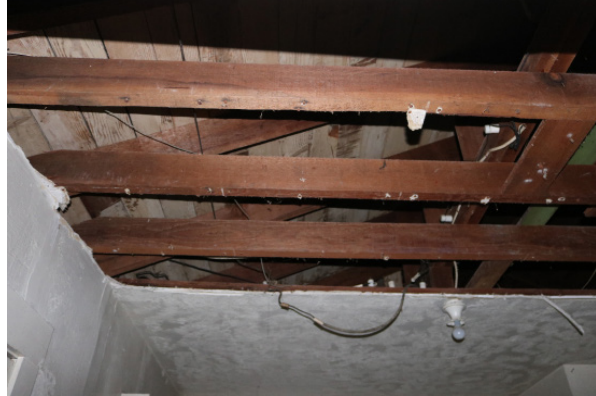
Missing drywall in the East Kitchen (ARG, 2019).

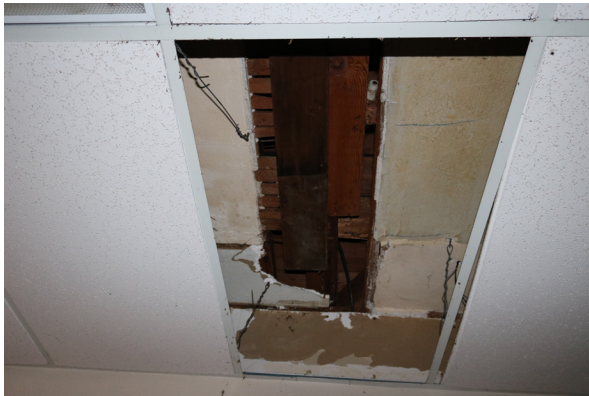
Missing section of acoustic tile with underlying damaged plaster and lath in the Main Room (ARG, 2019).

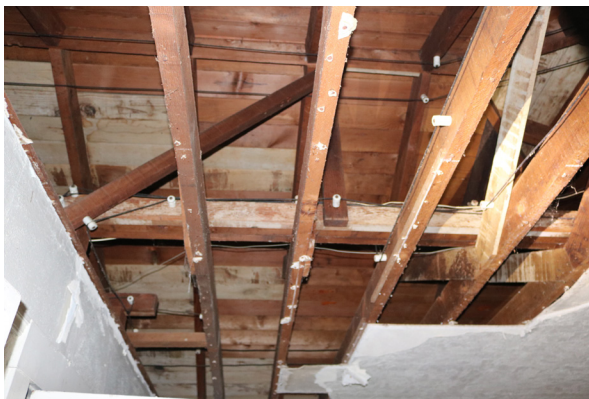
Missing drywall in the Craft Room (ARG, 2019).

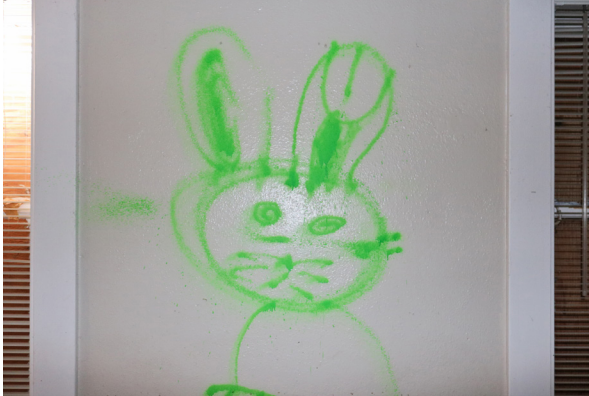
Graffiti on the east wall of the Animal Room (ARG, 2019).

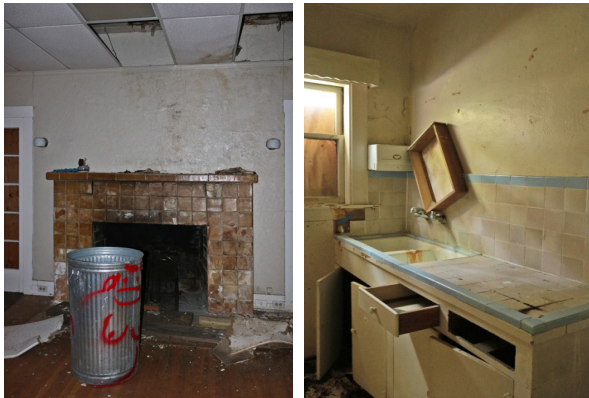
Water damage above fireplace in the Main Room (left); damaged casework and tile of the West Kitchen (right); (ARG, 2019).

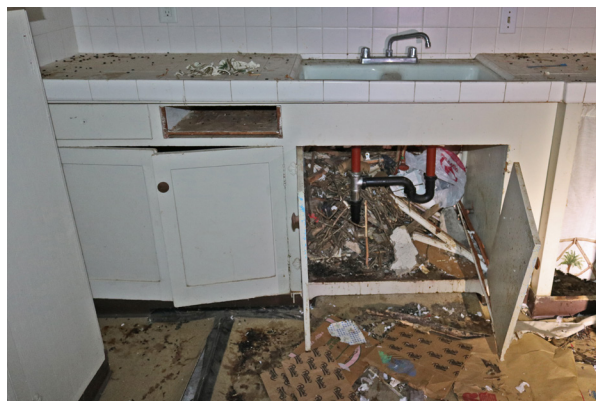
Large rodent nest at the sink base cabinet in the East Kitchen. Note the missing drawer and missing hardware (ARG, 2019).

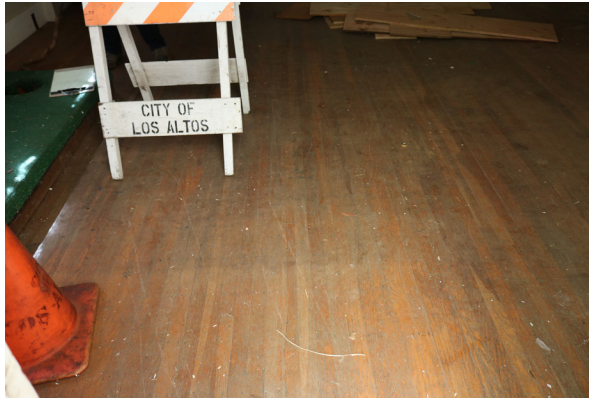
Original wood flooring in the Entry (ARG, 2019).

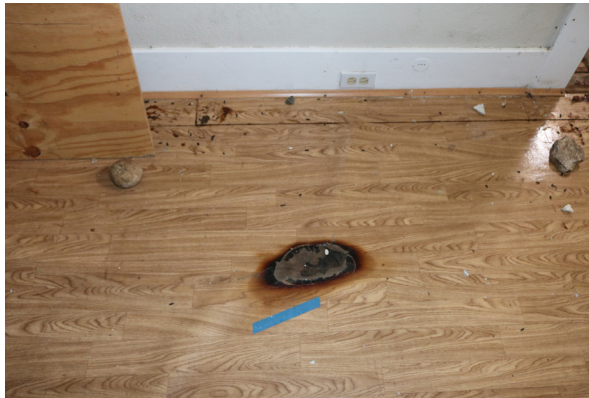
Burn damage at the floor of the Animal Room (ARG, 2019).

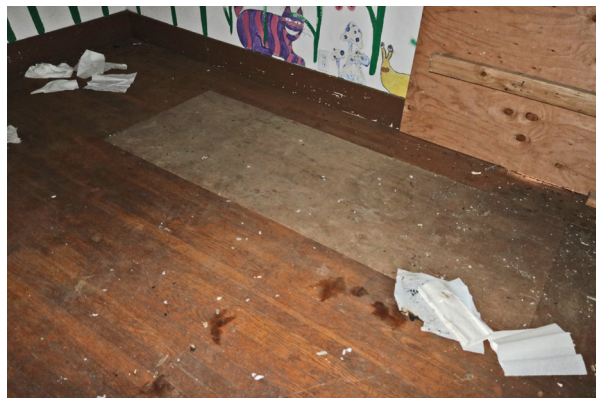
Plywood patch at the wood floor in the Kid's Room (ARG, 2019).

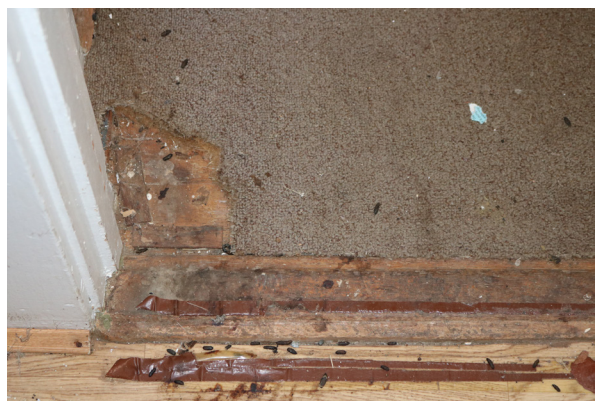
Section of missing carpet revealing the original wood flooring beneath in the West Hall (ARG, 2019).

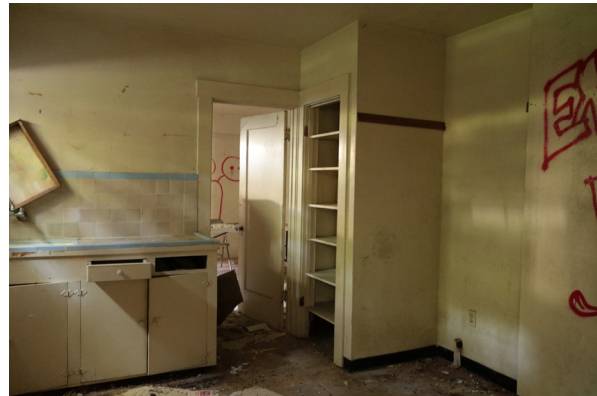
Note the missing door at the pantry of the West Kitchen (ARG, 2019).

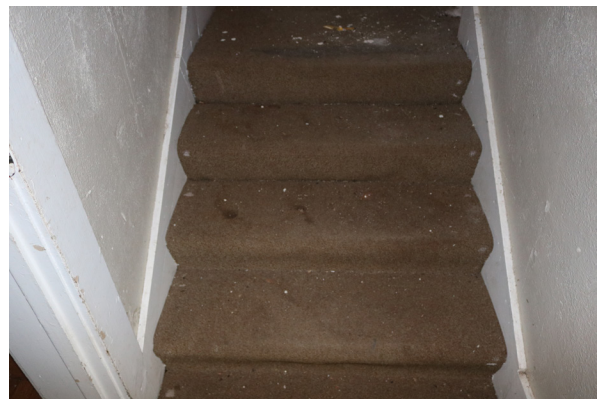
Carpeted stairs at the West Hall (ARG, 2019).

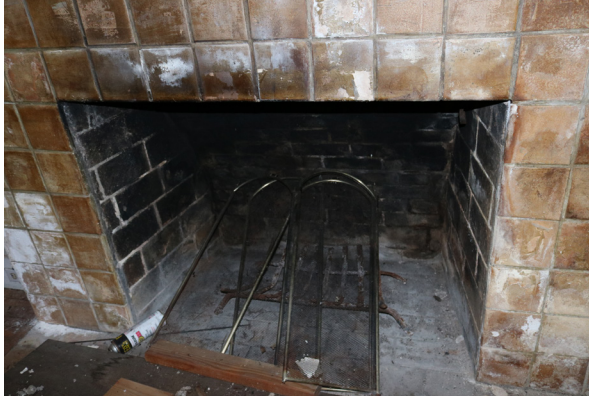
Firebox and ceramic tile surround at the fireplace in the Main Room (ARG, 2019).

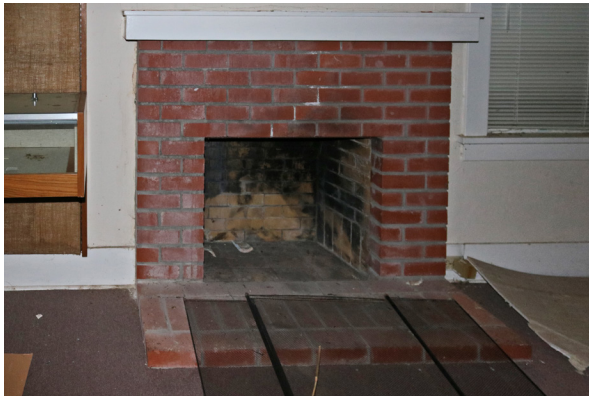
Fireplace in the Ohlone Room. Note the soot damage at the firebox (ARG, 2019).

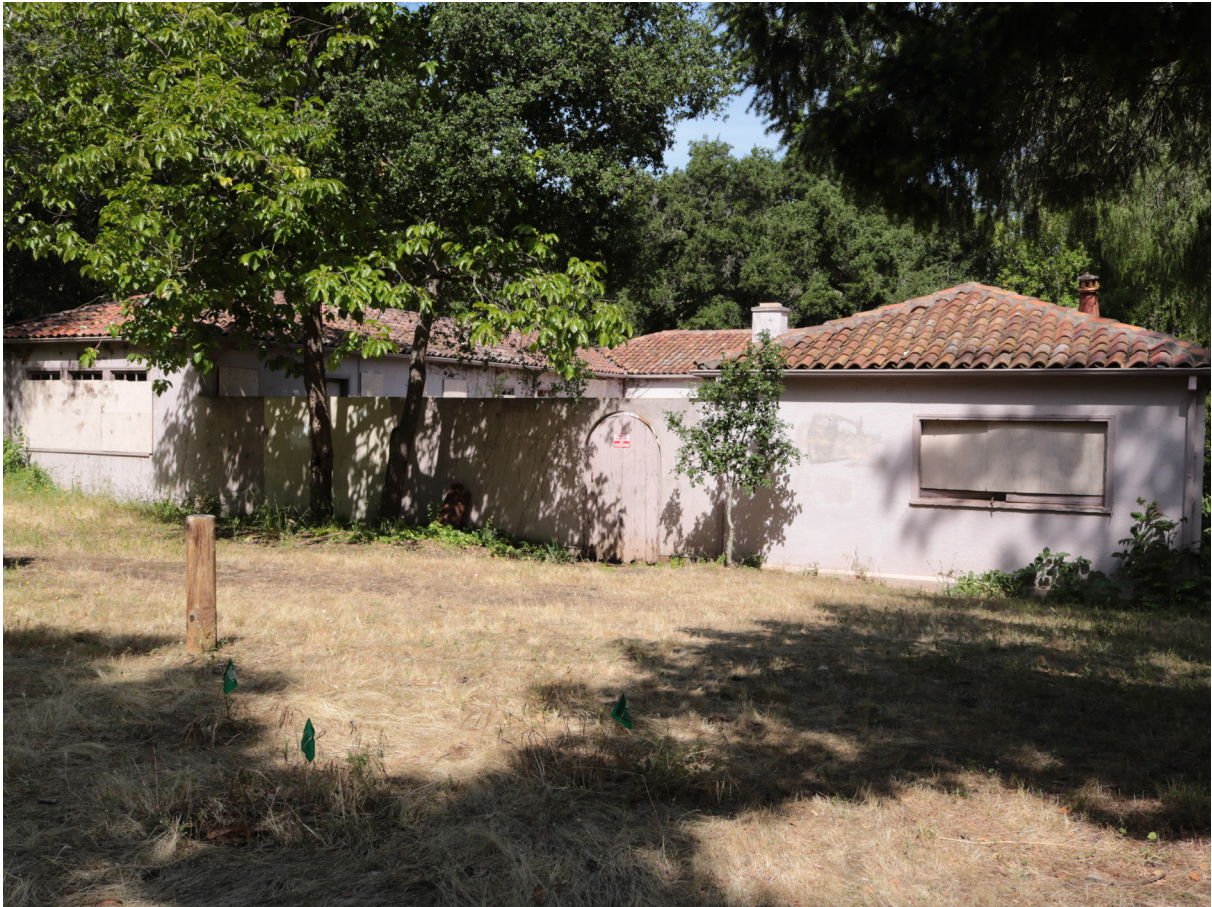
View of the south elevation.

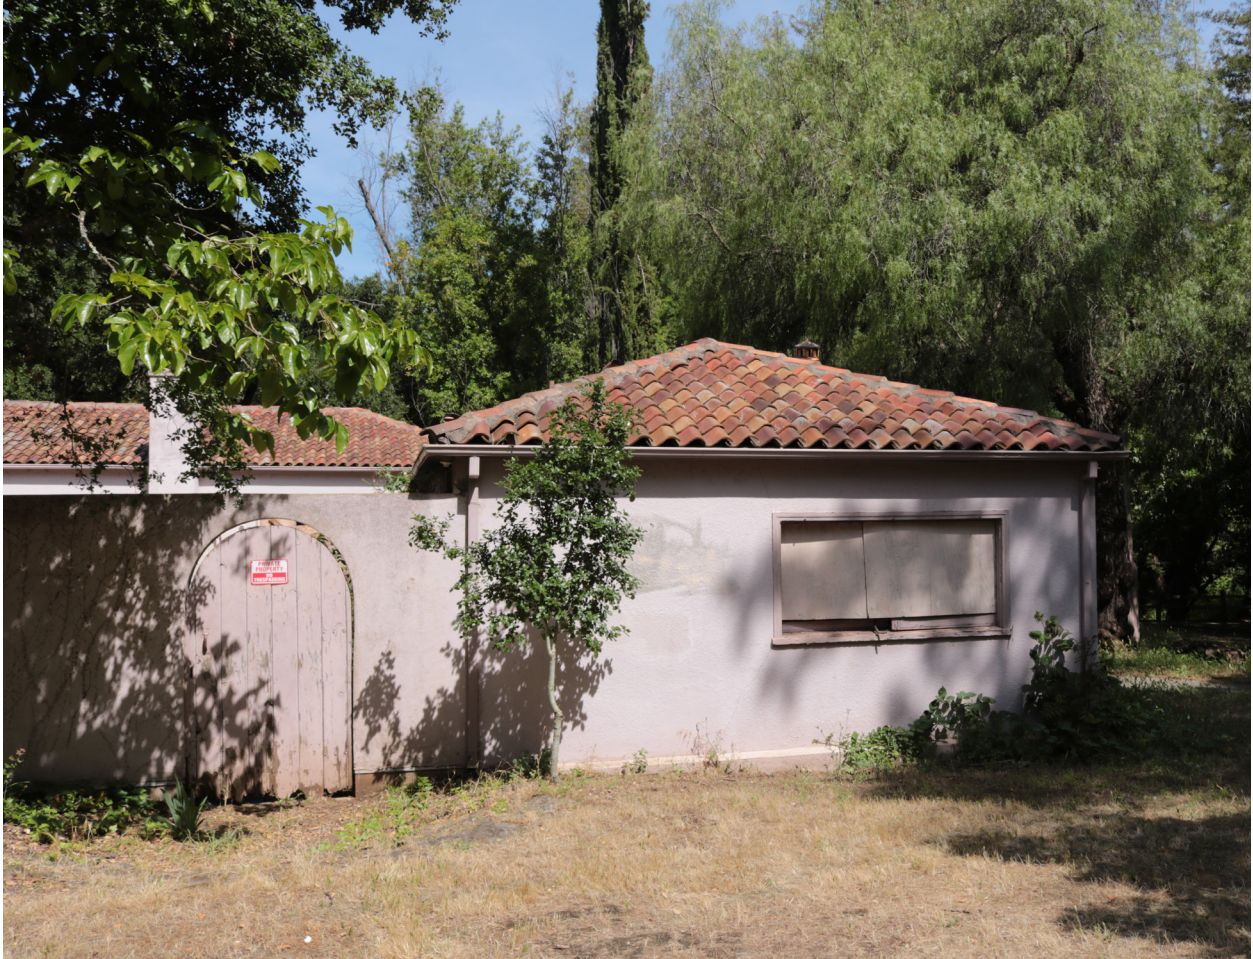
View of east half of the south elevation. The arched opening on the left side of the image leads into the enclosed courtyard.

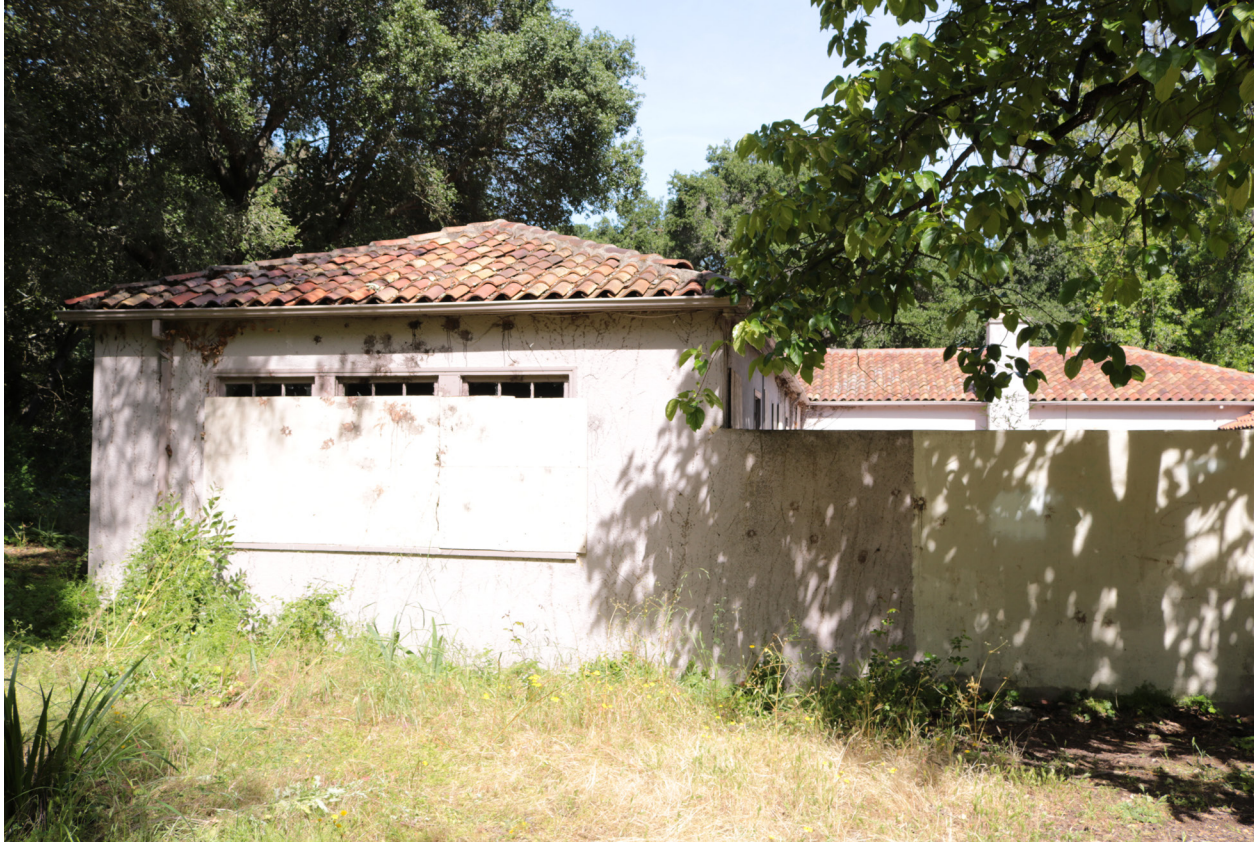
Existing Condition Photographs

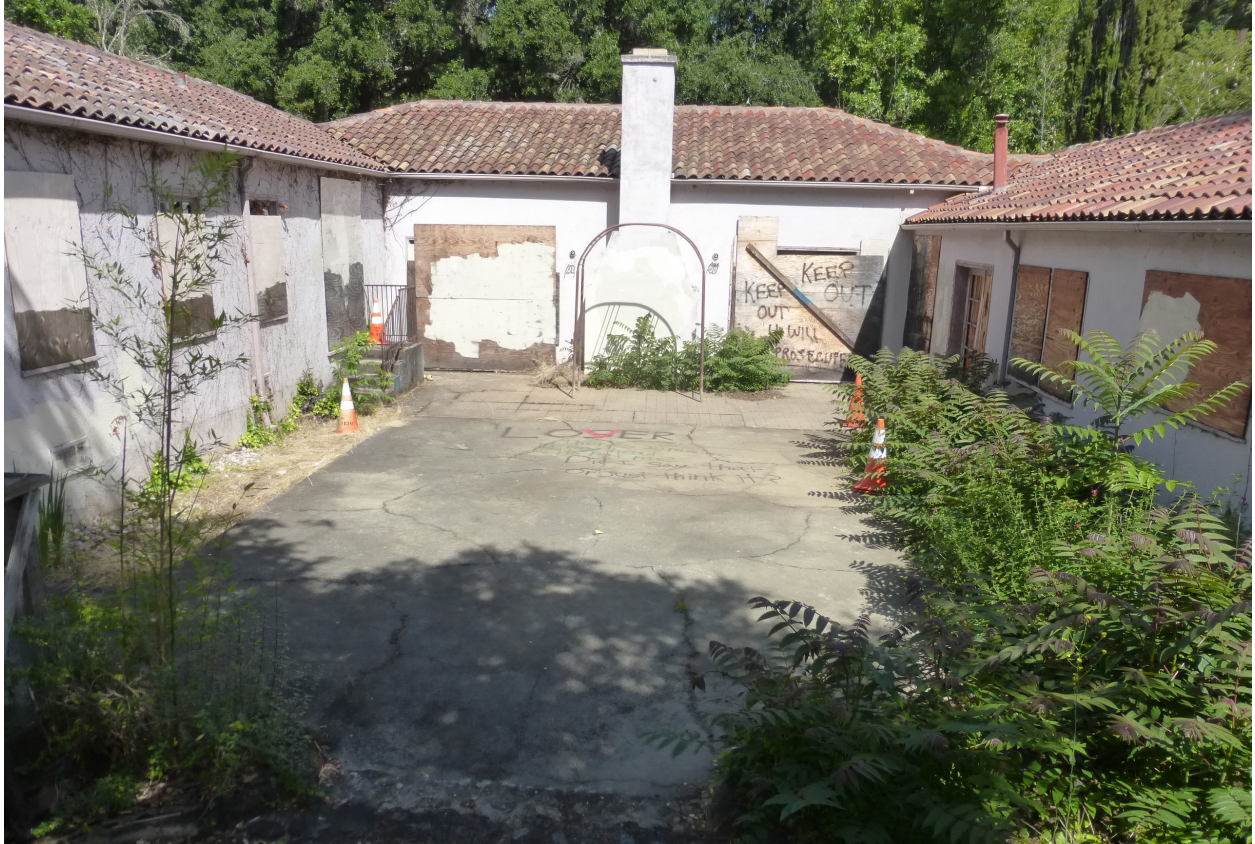
View looking north into enclosed courtyard.

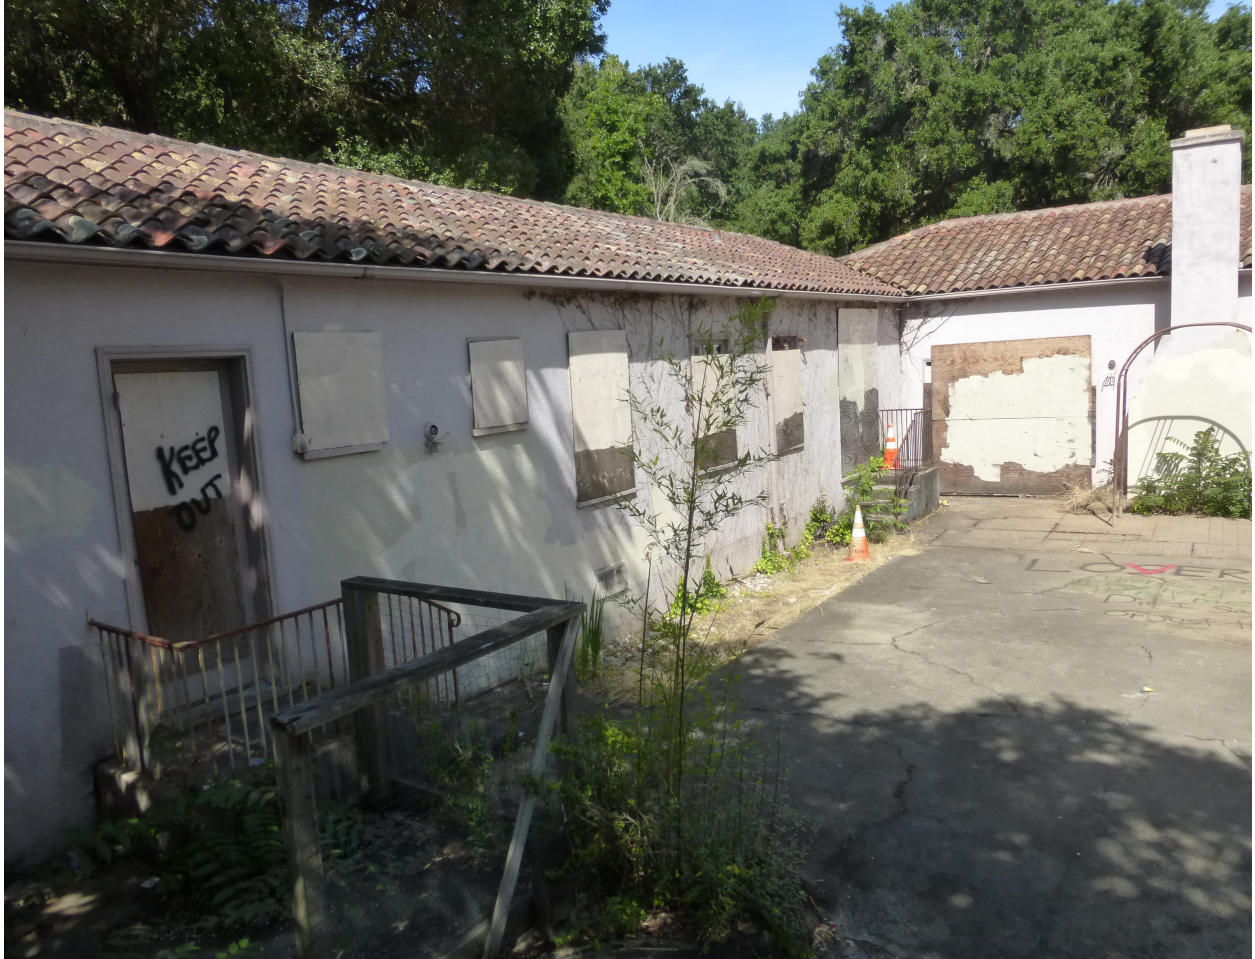
Looking west inside the enclosed courtyard.

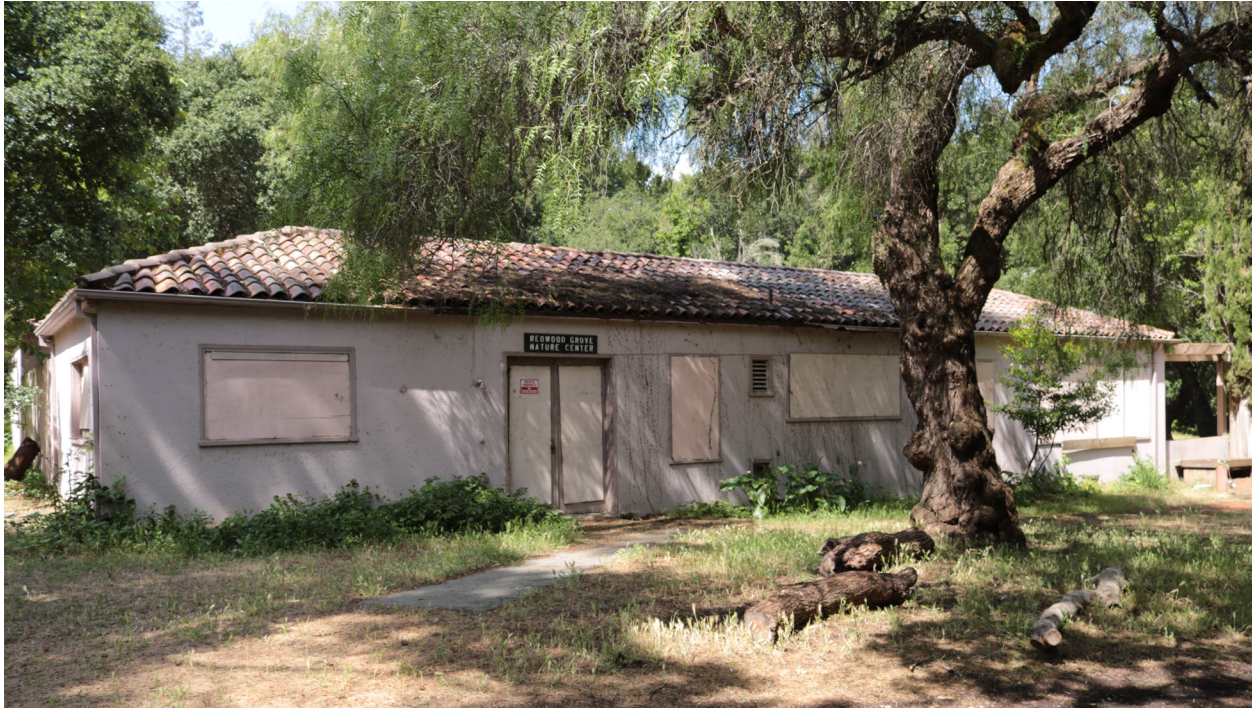
Overall view of east elevation.

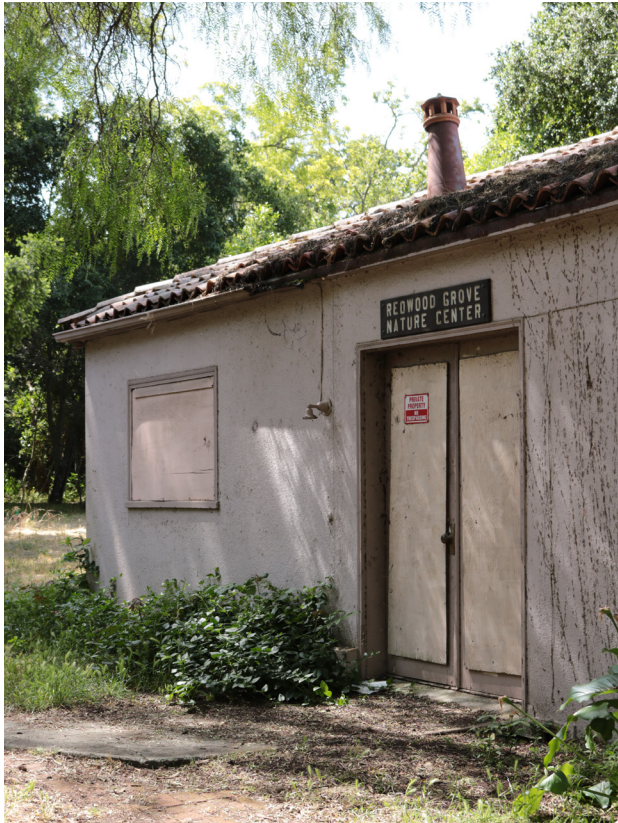
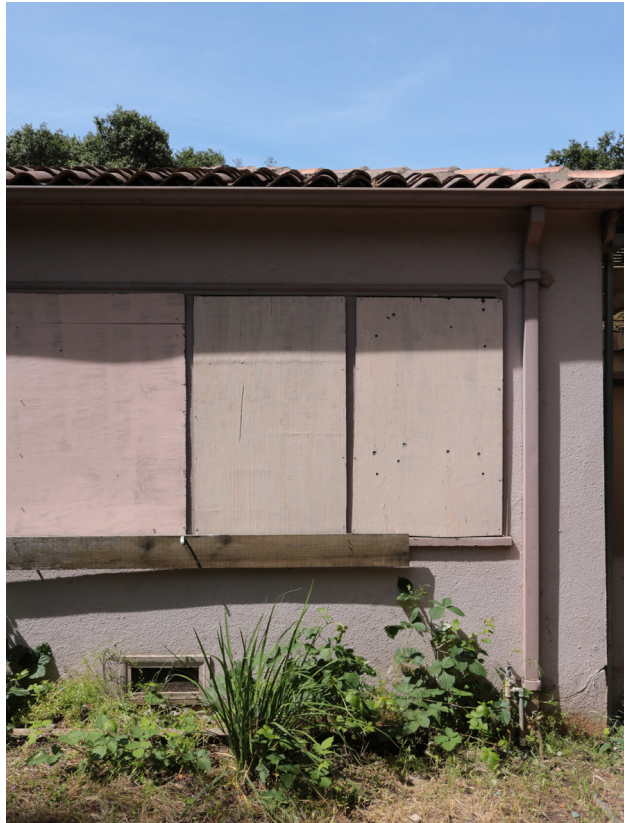
Views of the east elevation. Above left is the southeast corner; above right the northeast corner.

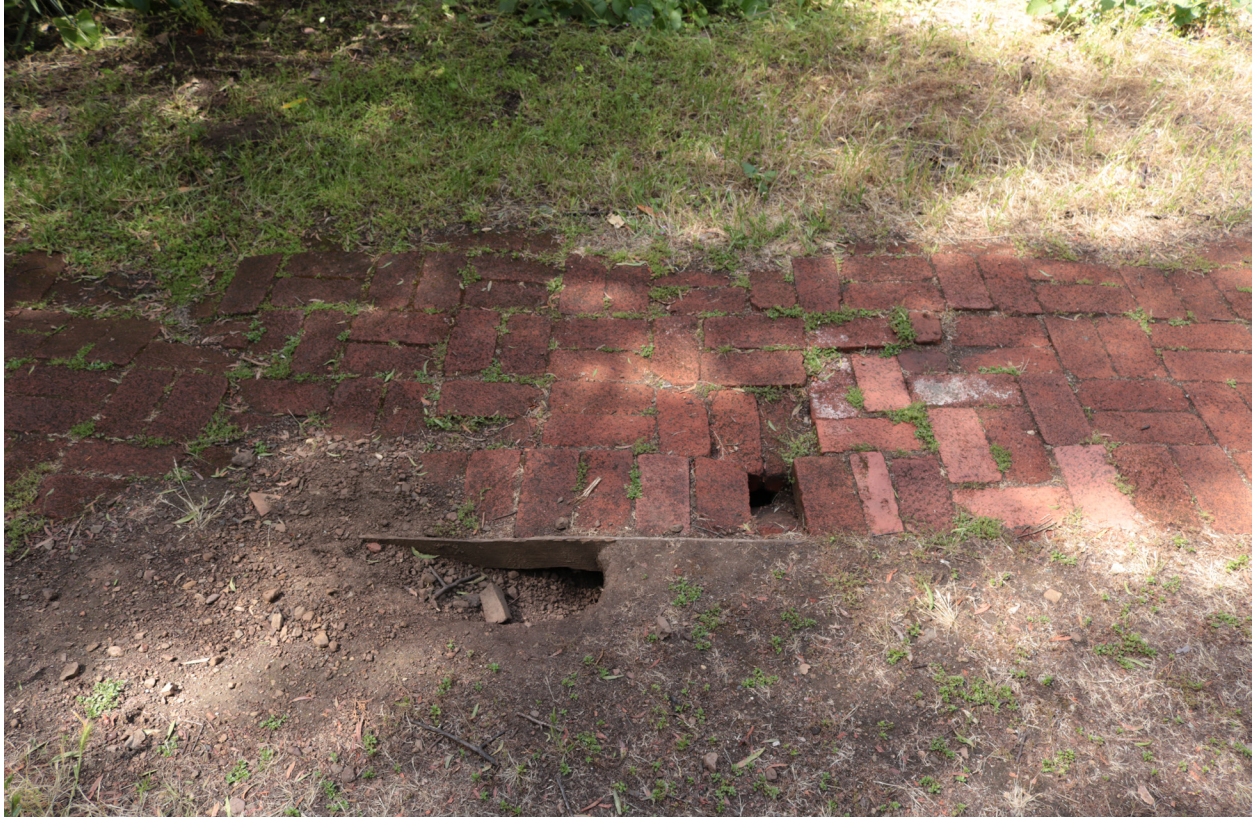
View of walkway paving along east elevation.

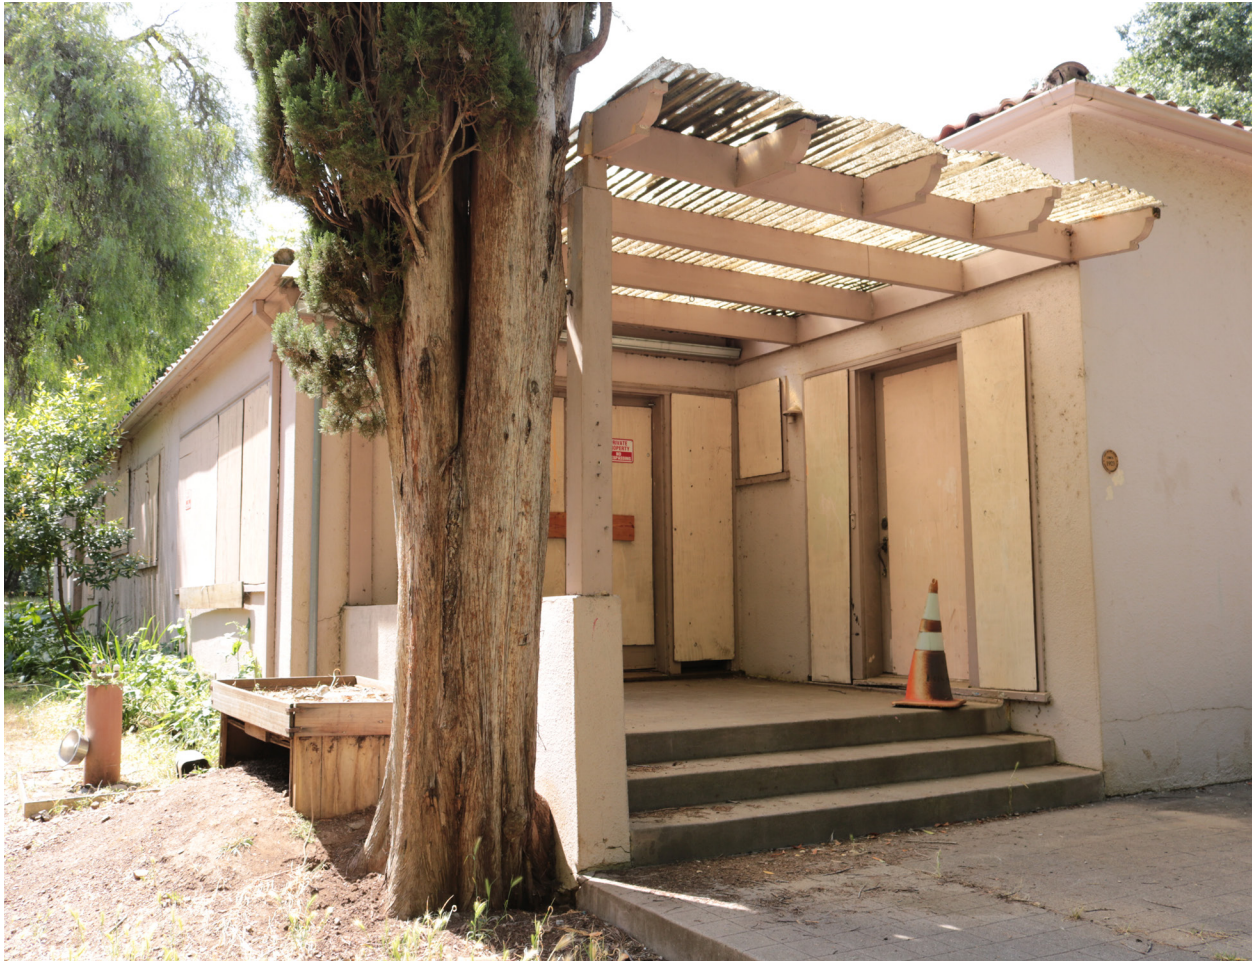
View of northeast corner of Halsey House, including main entrance.

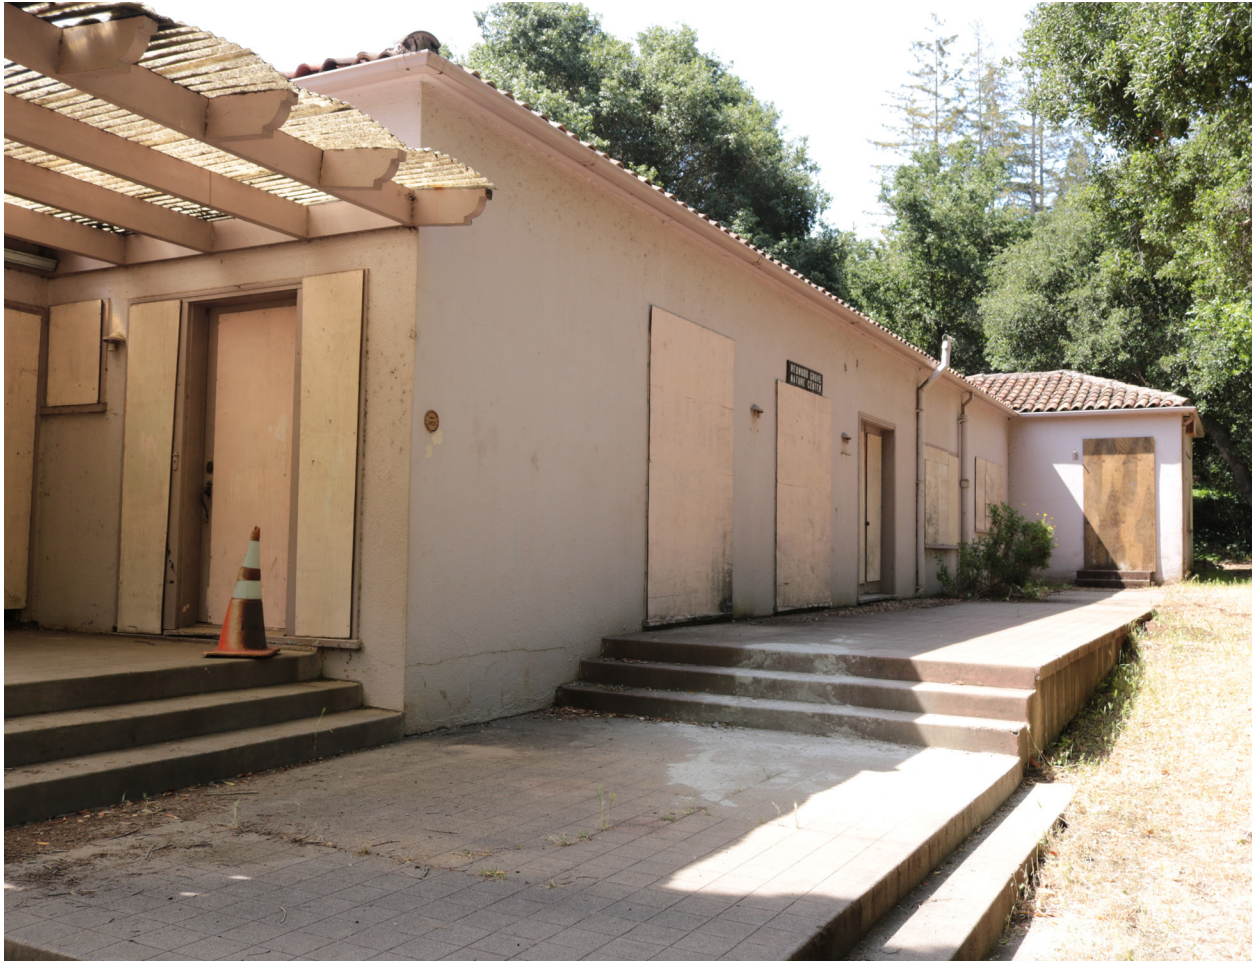
North elevation and patio adjacent to north wall.

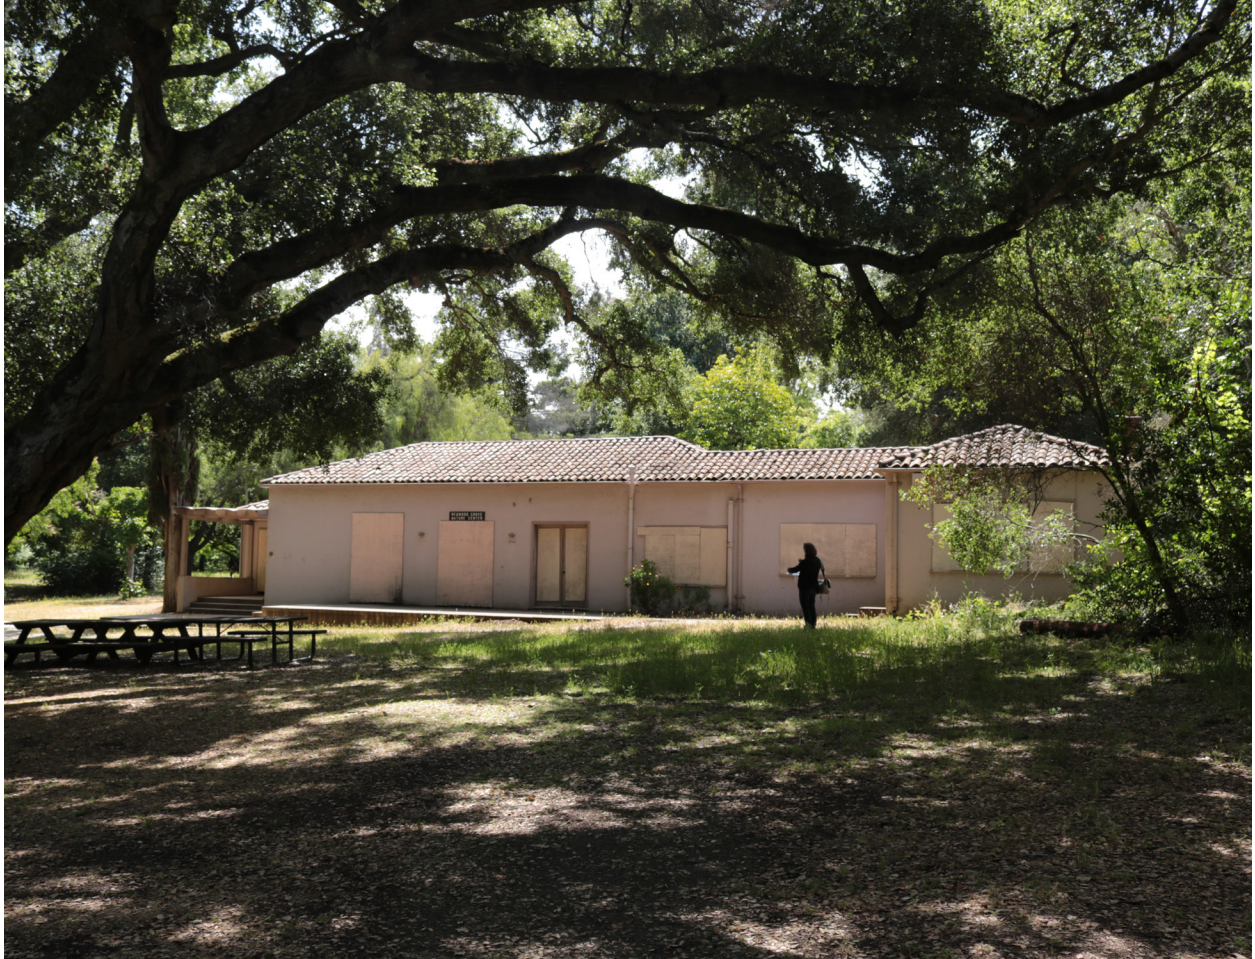
Overall view of north elevation from edge of redwood grove.

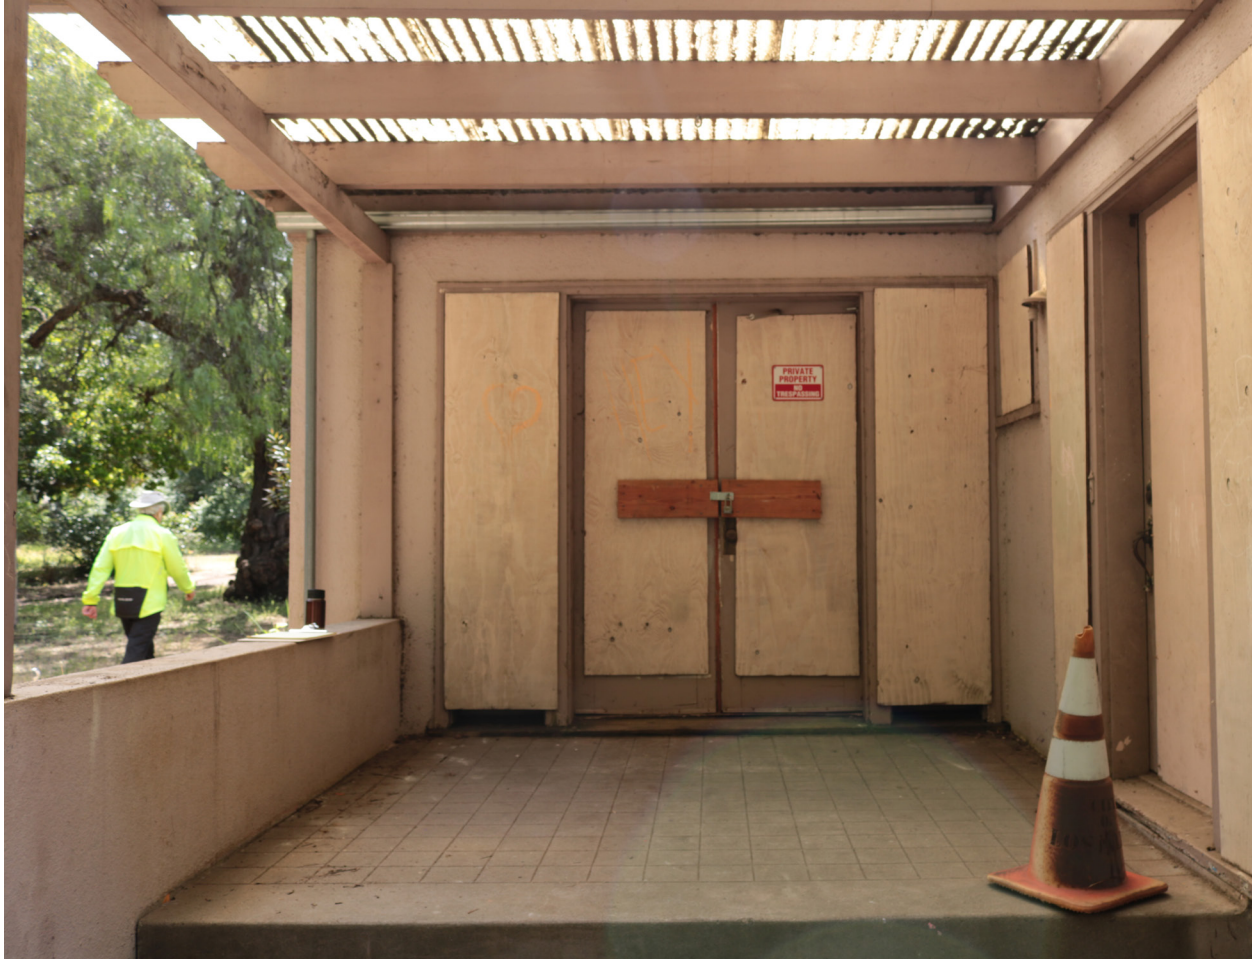
Main entrance to Halsey House, at northeast corner of building.
