DISCUSSION ITEM

Agenda Item # 6

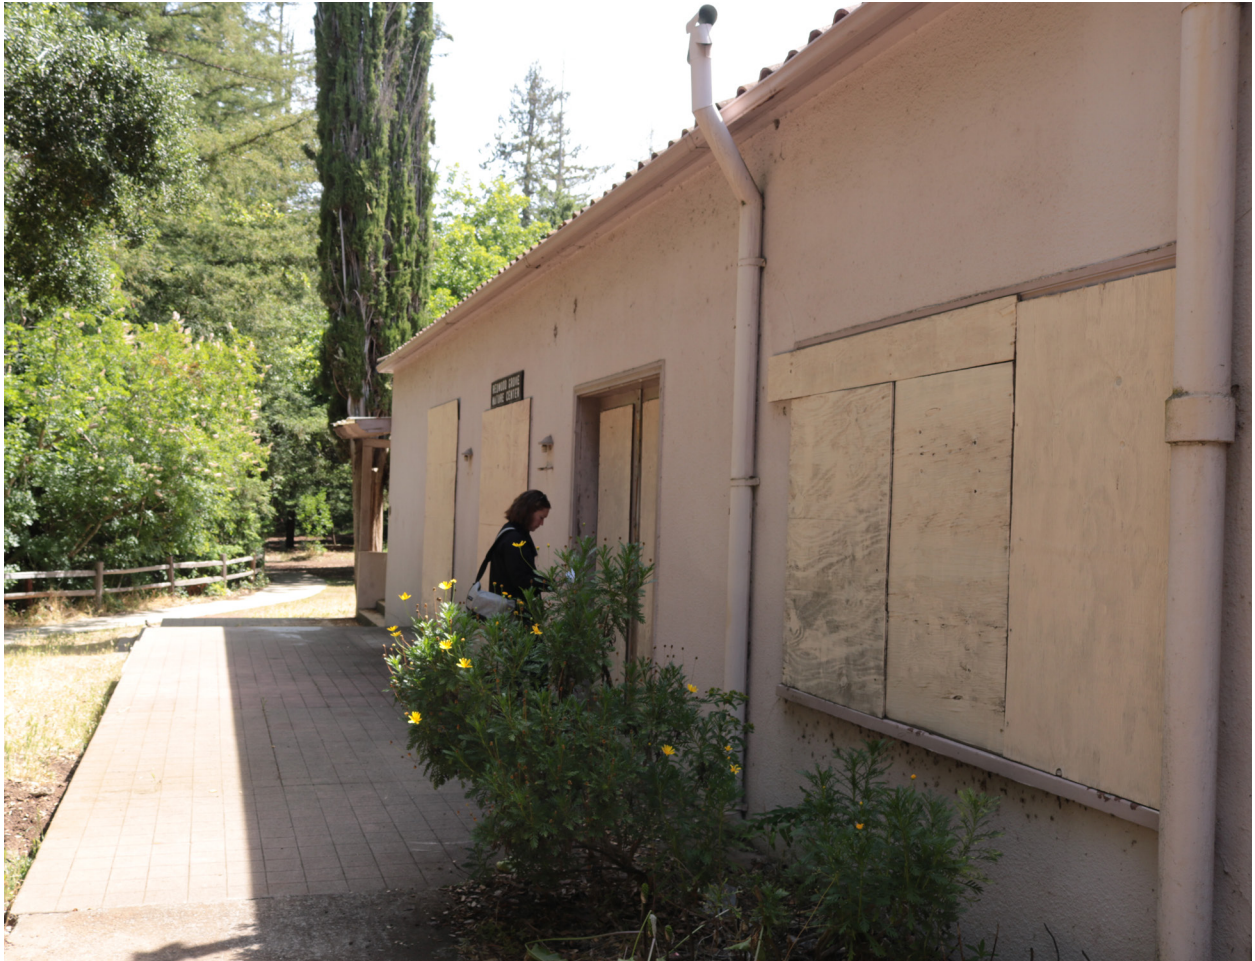
View of north elevation looking east.

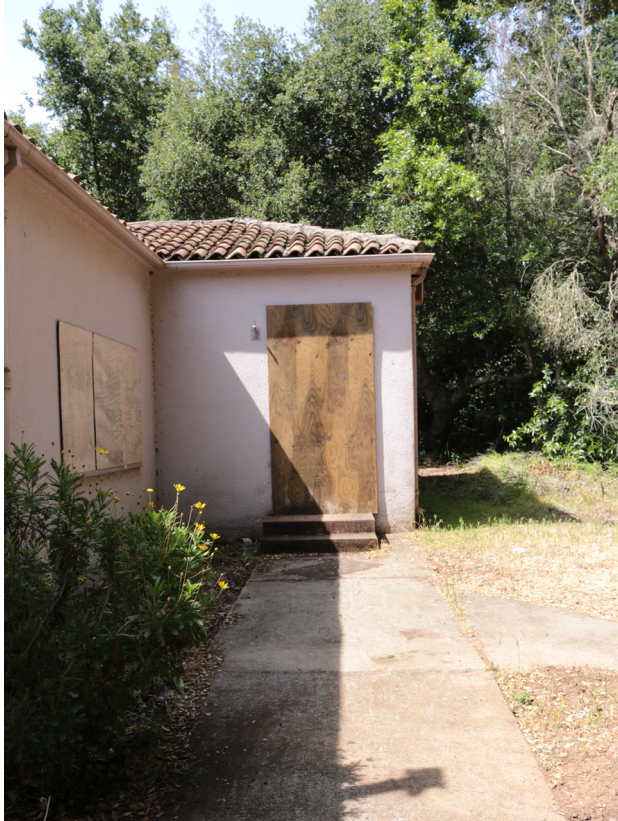
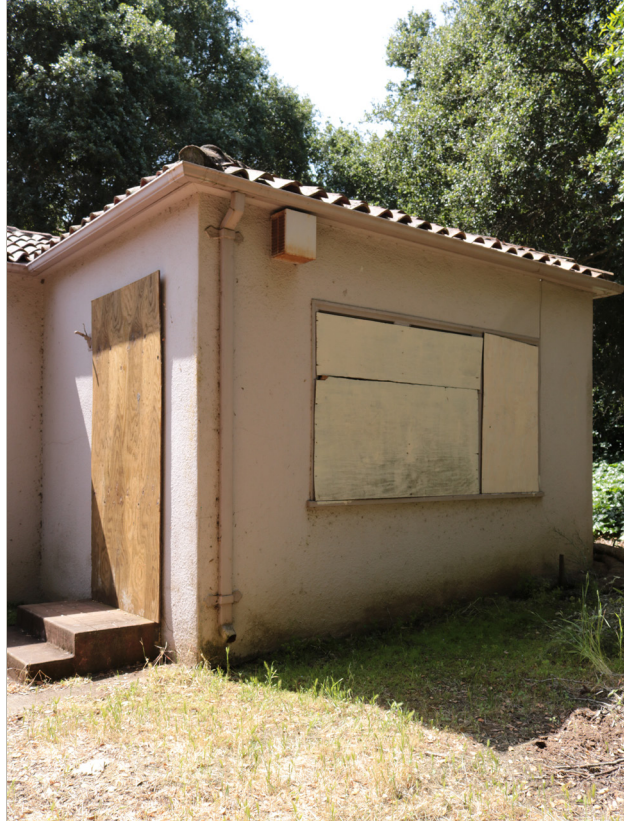
Views of entrance at northwest corner of building.

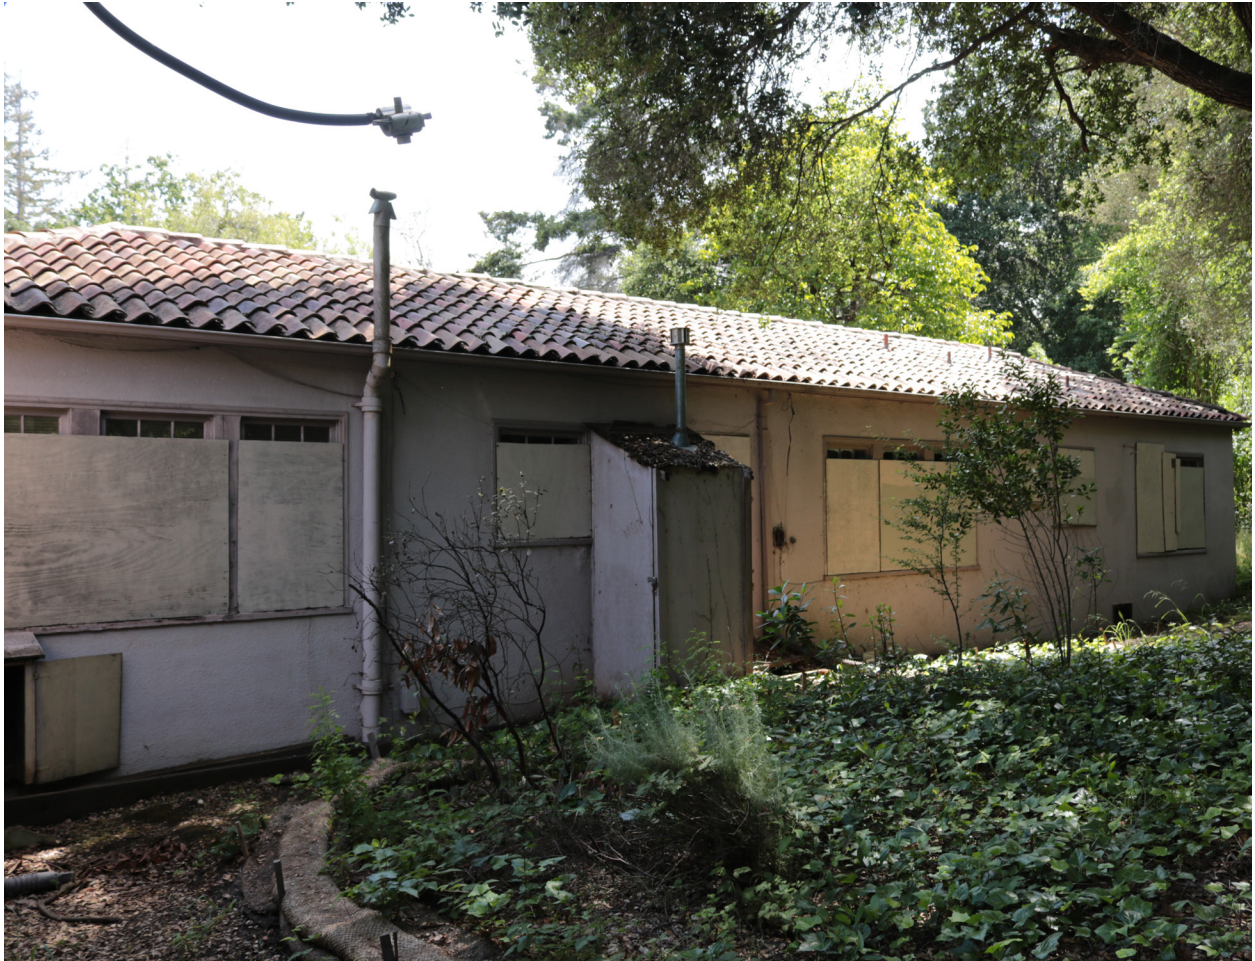
Overall view at center of west elevation, looking southeast.

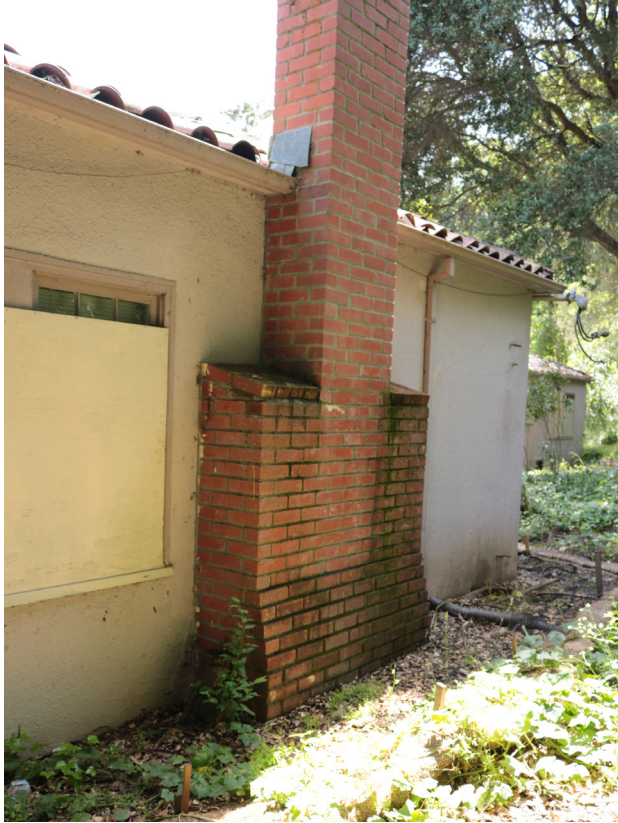
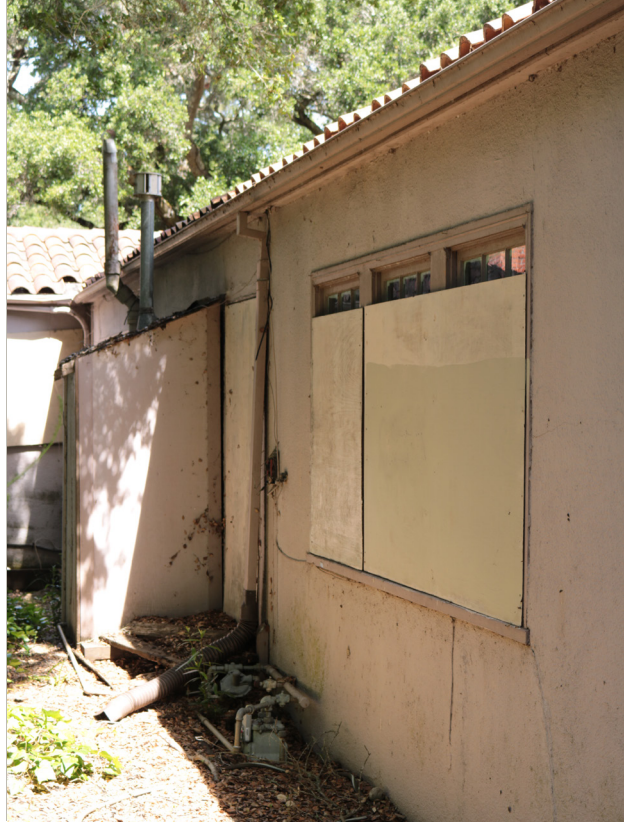
Detail views from west elevation.

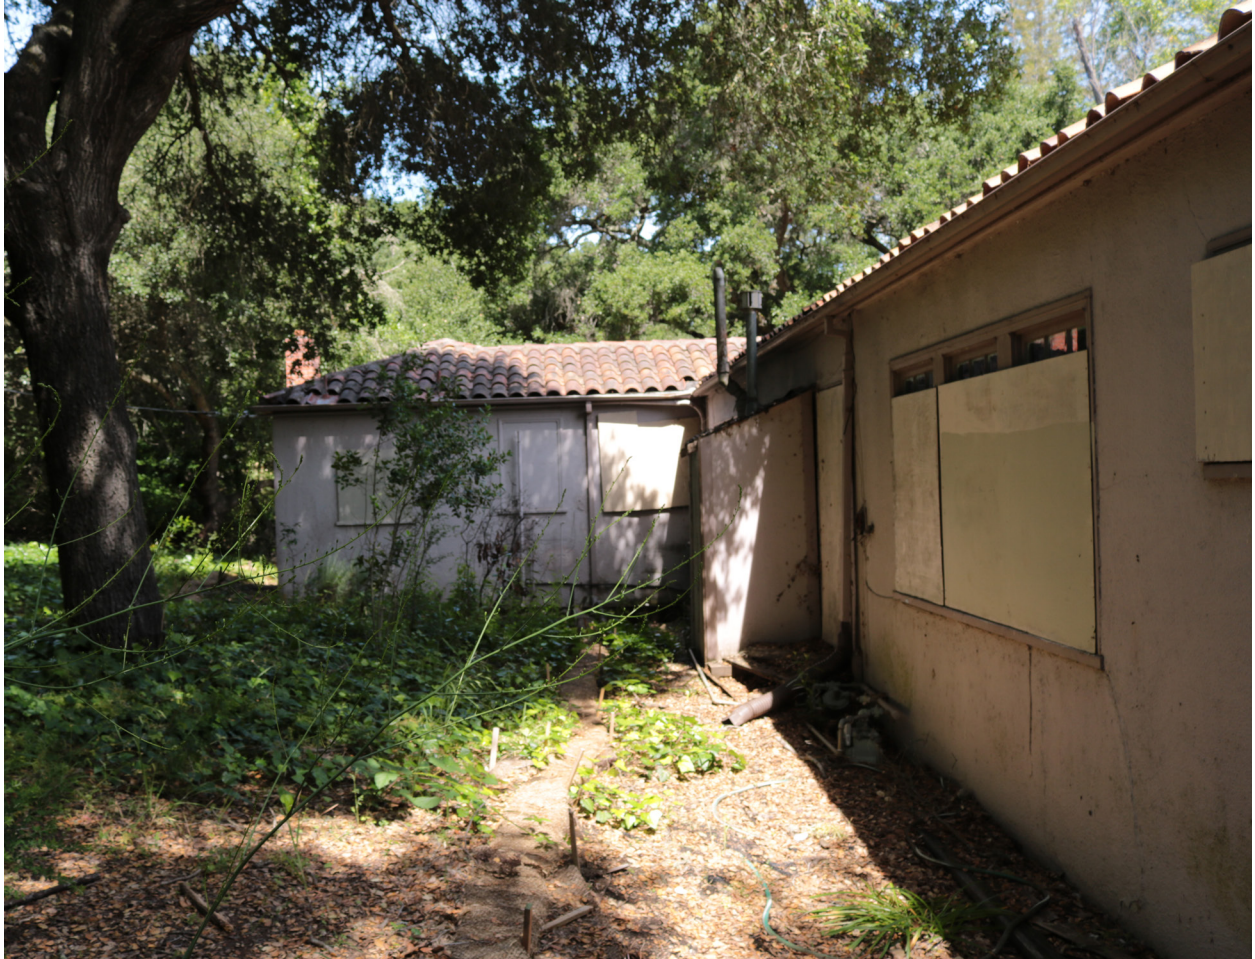
Looking north along the west elevation.

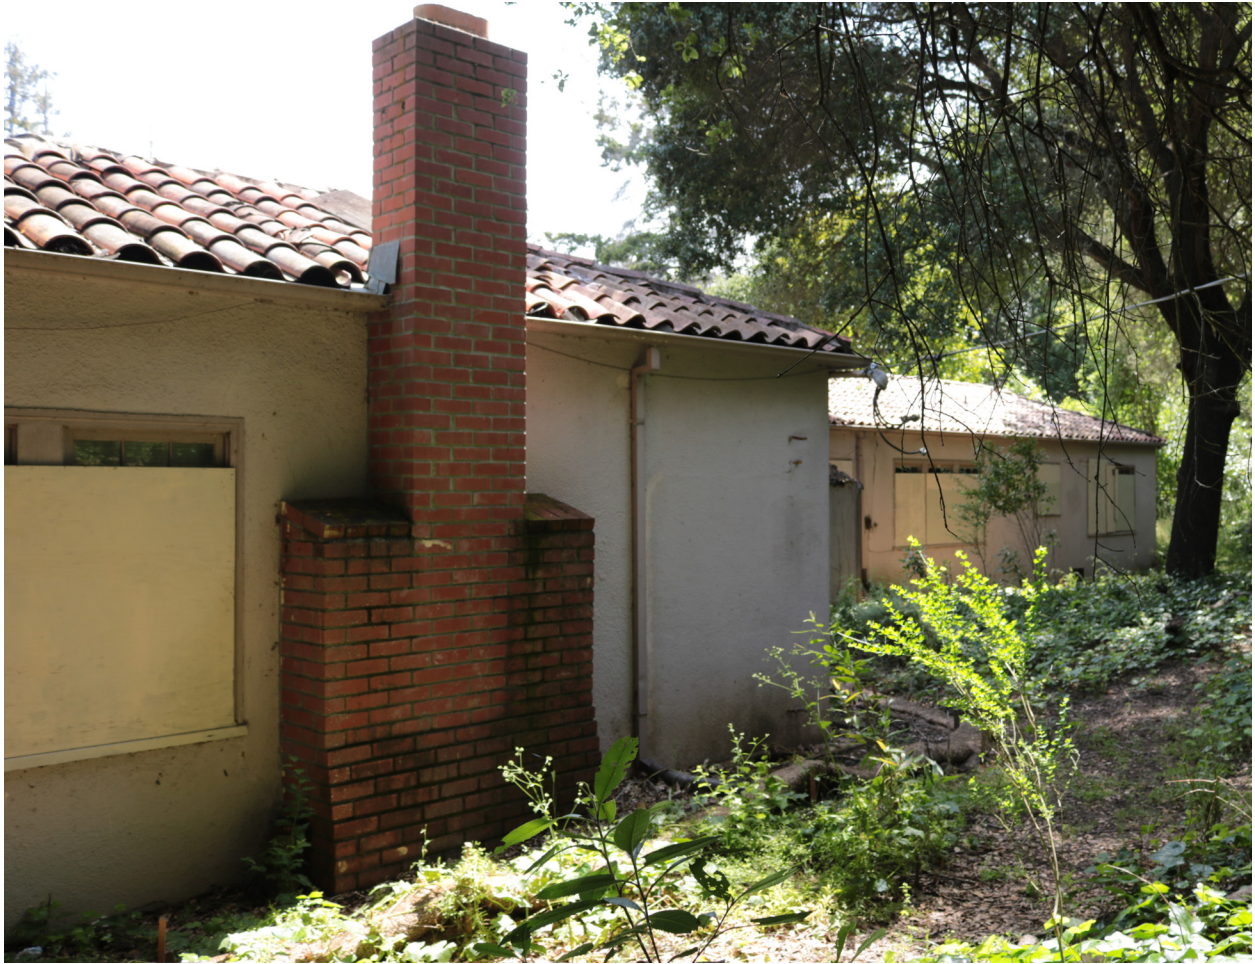
Looking south along the west elevation.

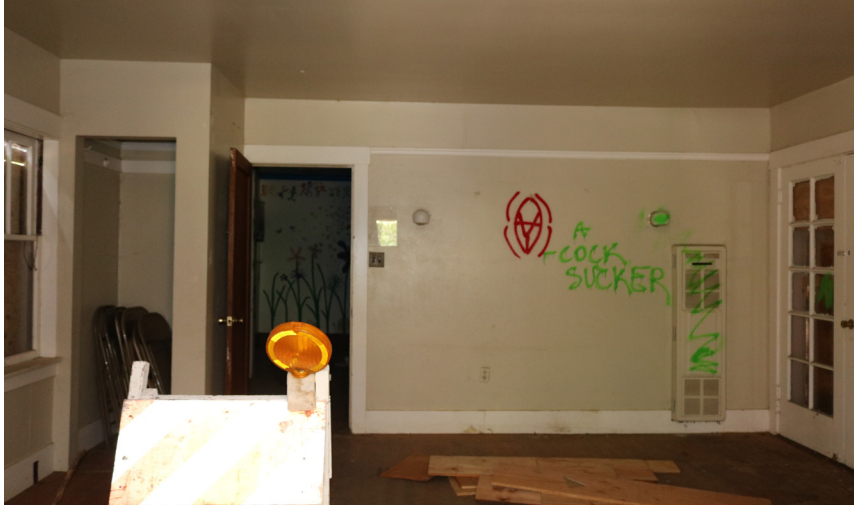
View looking south inside main entrance.

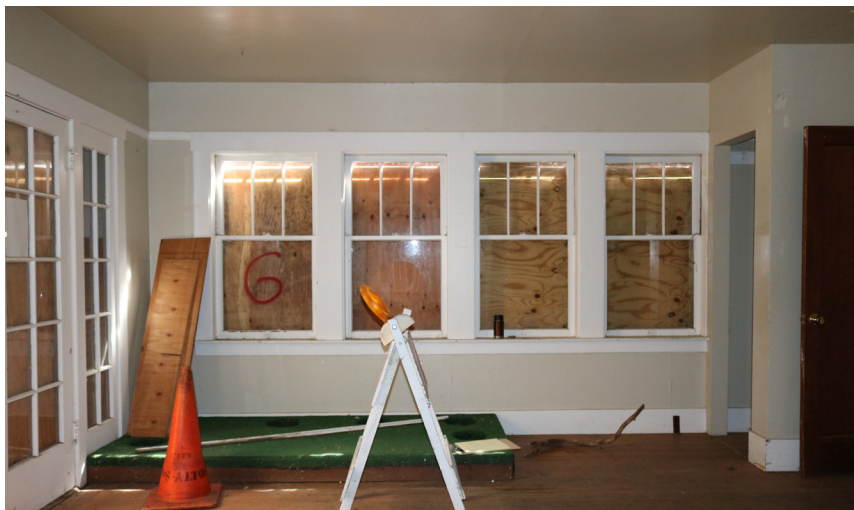
Looking north east inside the entry.

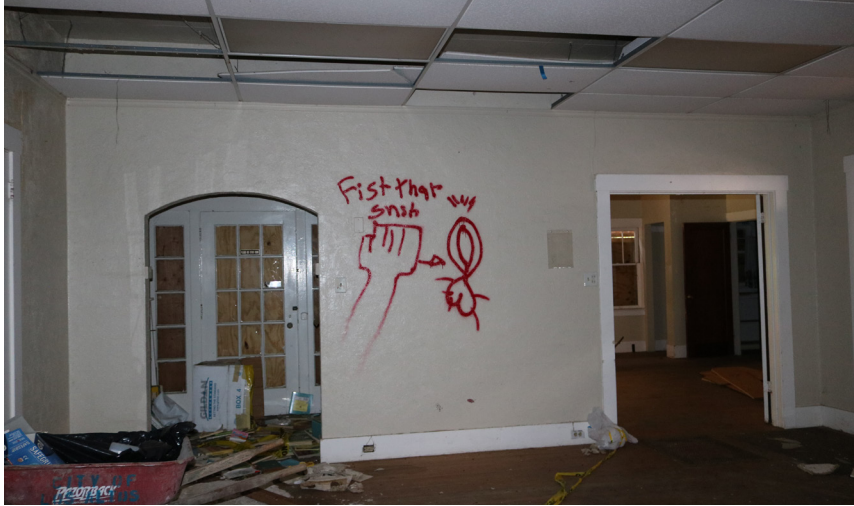
View inside main room looking east toward entry.

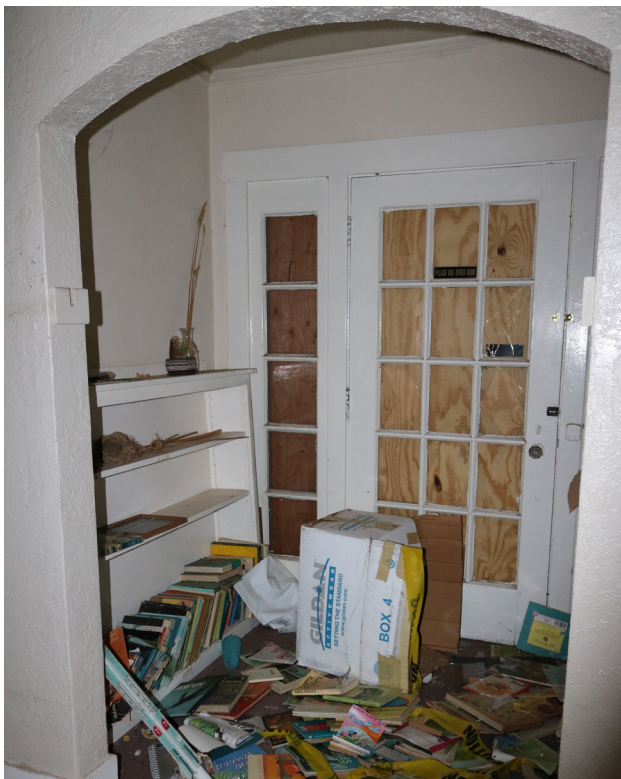
View inside niche at east wall of main room, looking east toward entry.

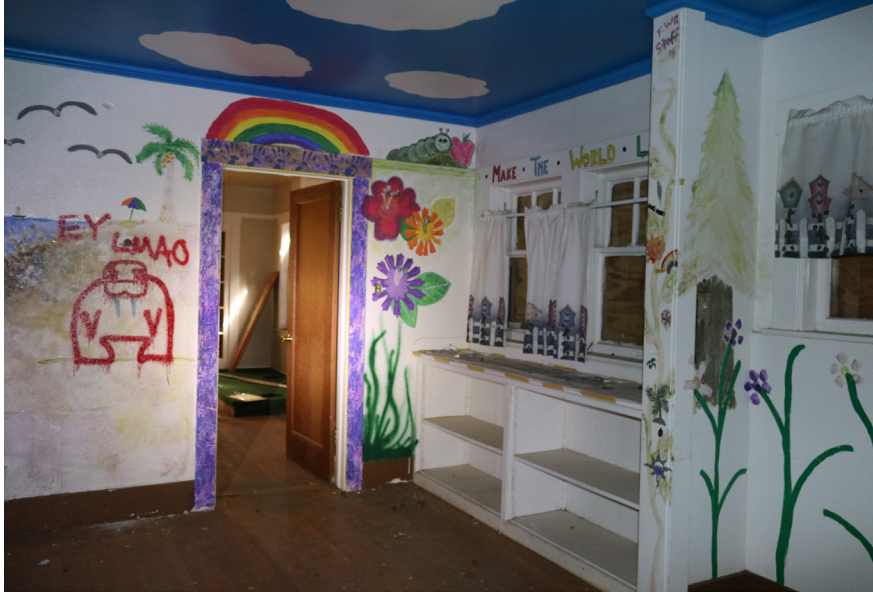
Overall view looking west inside main room.

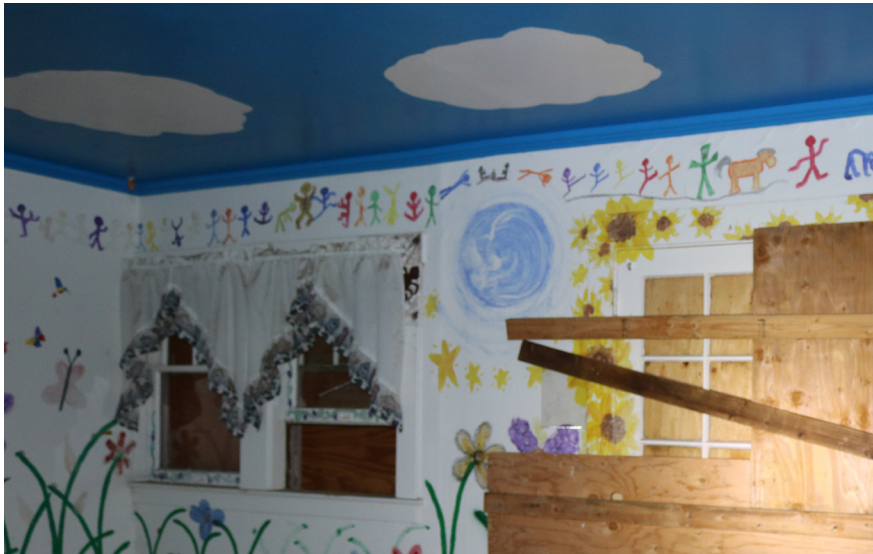
Interior view of preschool room.

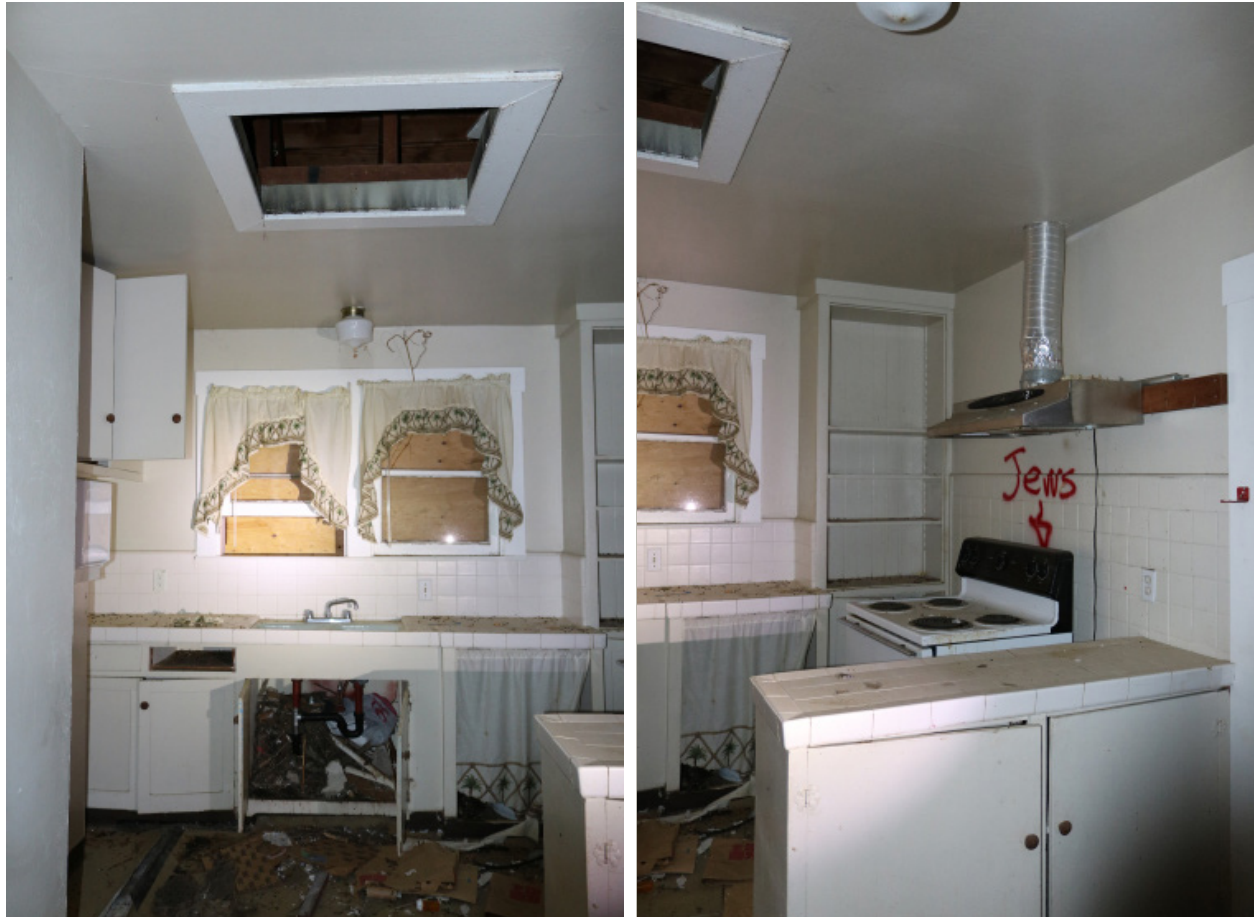
Interior views of kitchen inside east wing.

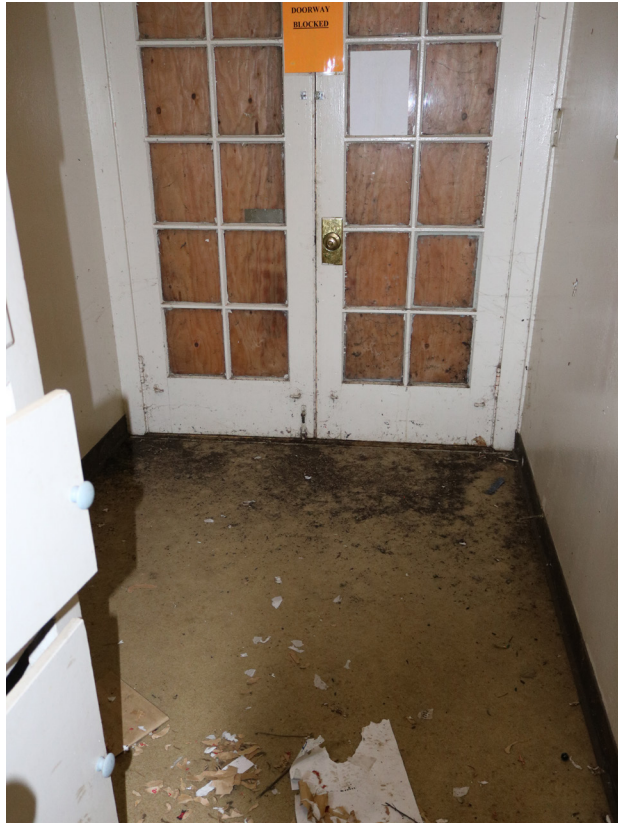
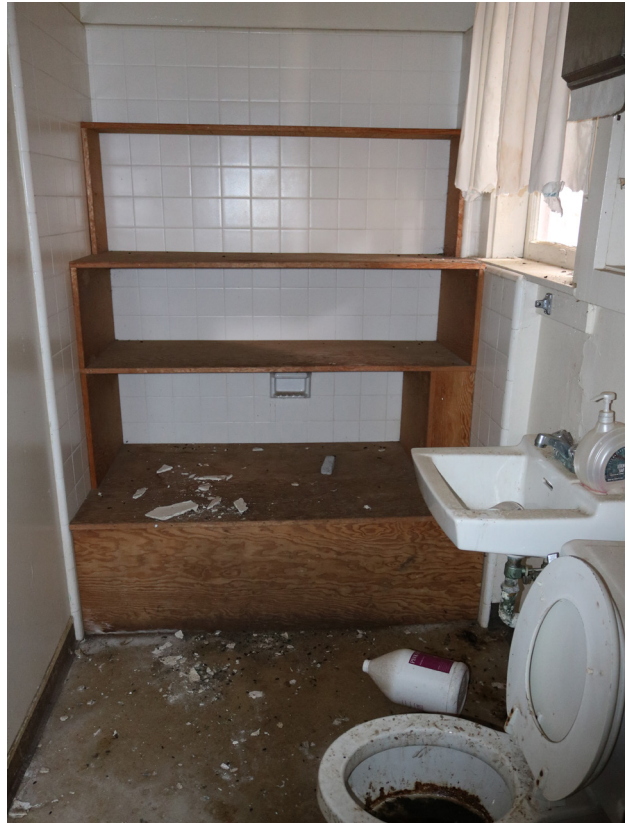
Above left: interior of hall in east wing. Above right: restroom in east wing.

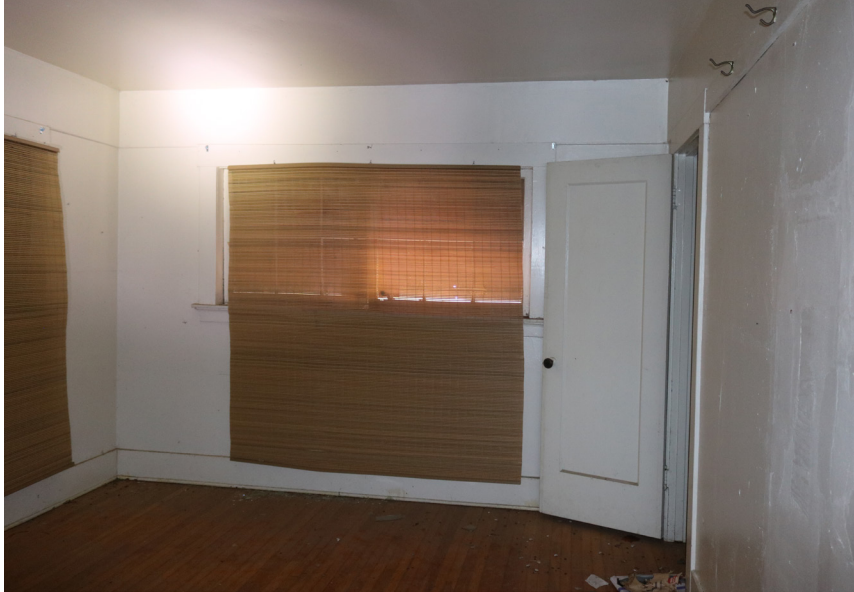
*View looking south inside bedroom/
office at end of east wing.*

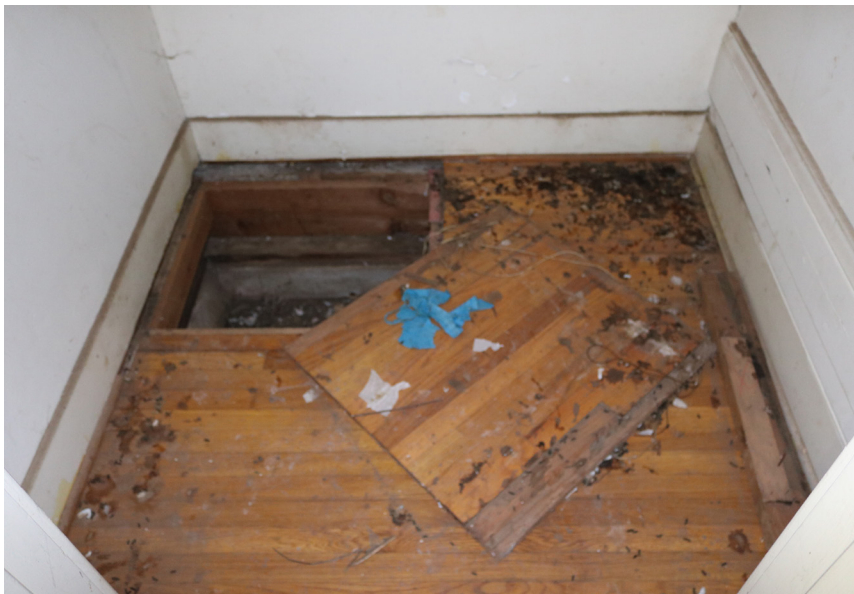
*View of access panel at floor inside
closet at south end of east wing.*

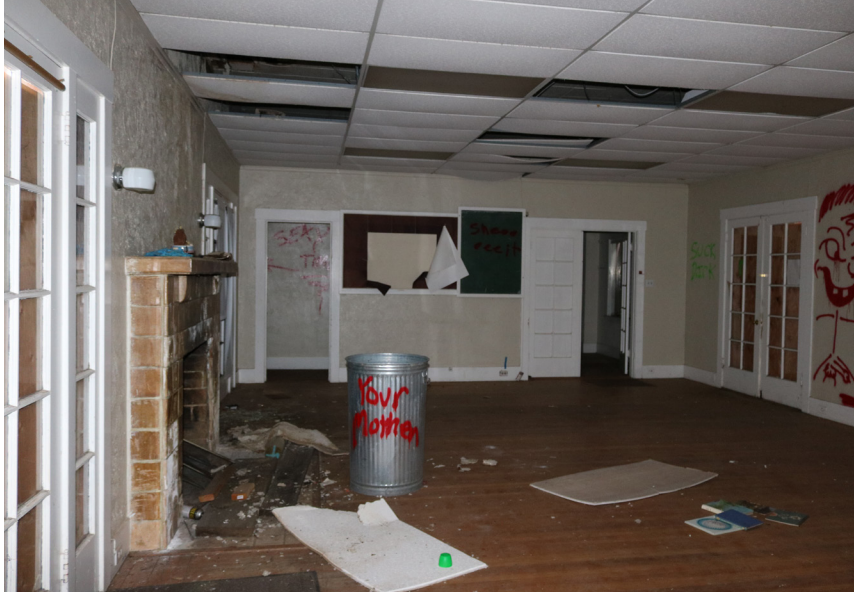
Overall view looking west inside main room.

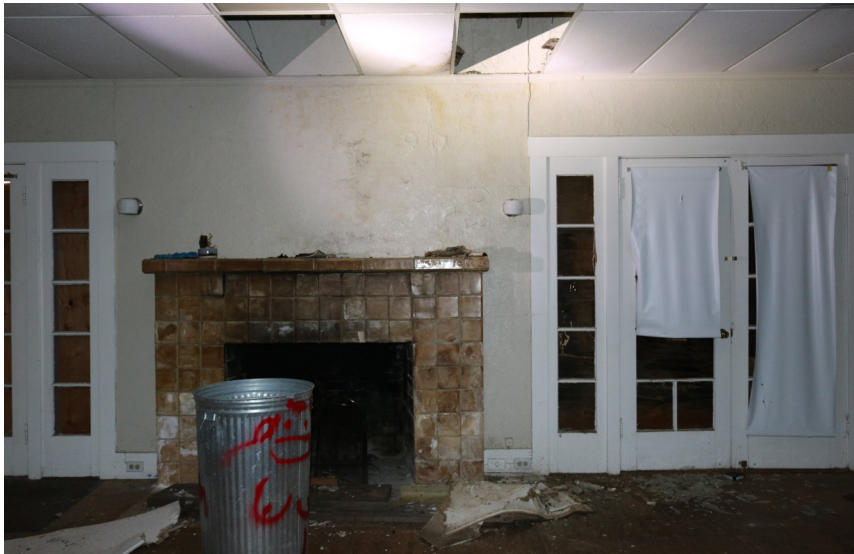
Looking south, including view of fireplace, inside main room.

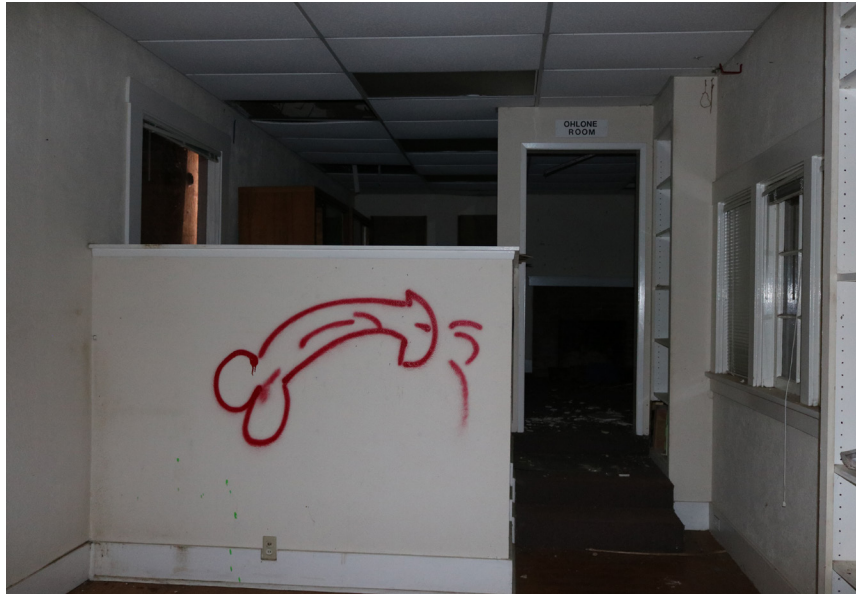
Overall view, looking west, of kitchen adjacent to main room and entrance to Ohlone room.

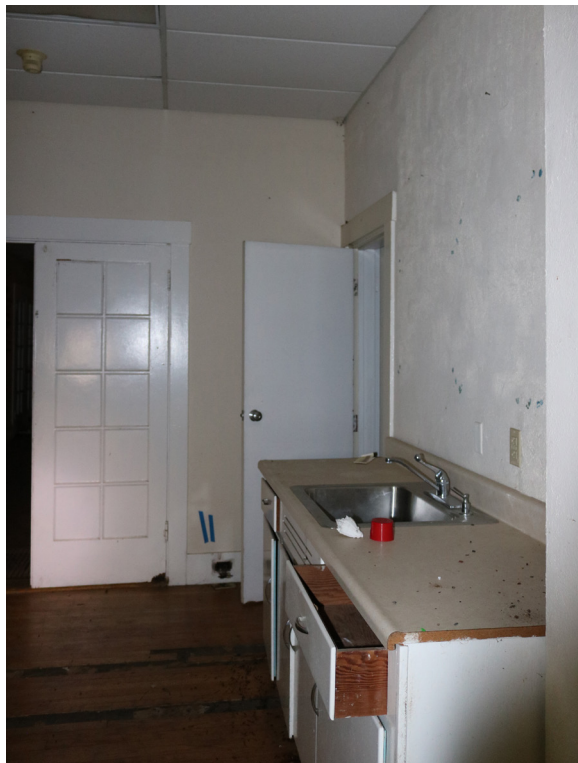
View of small kitchen adjacent to main room and Ohlone room.

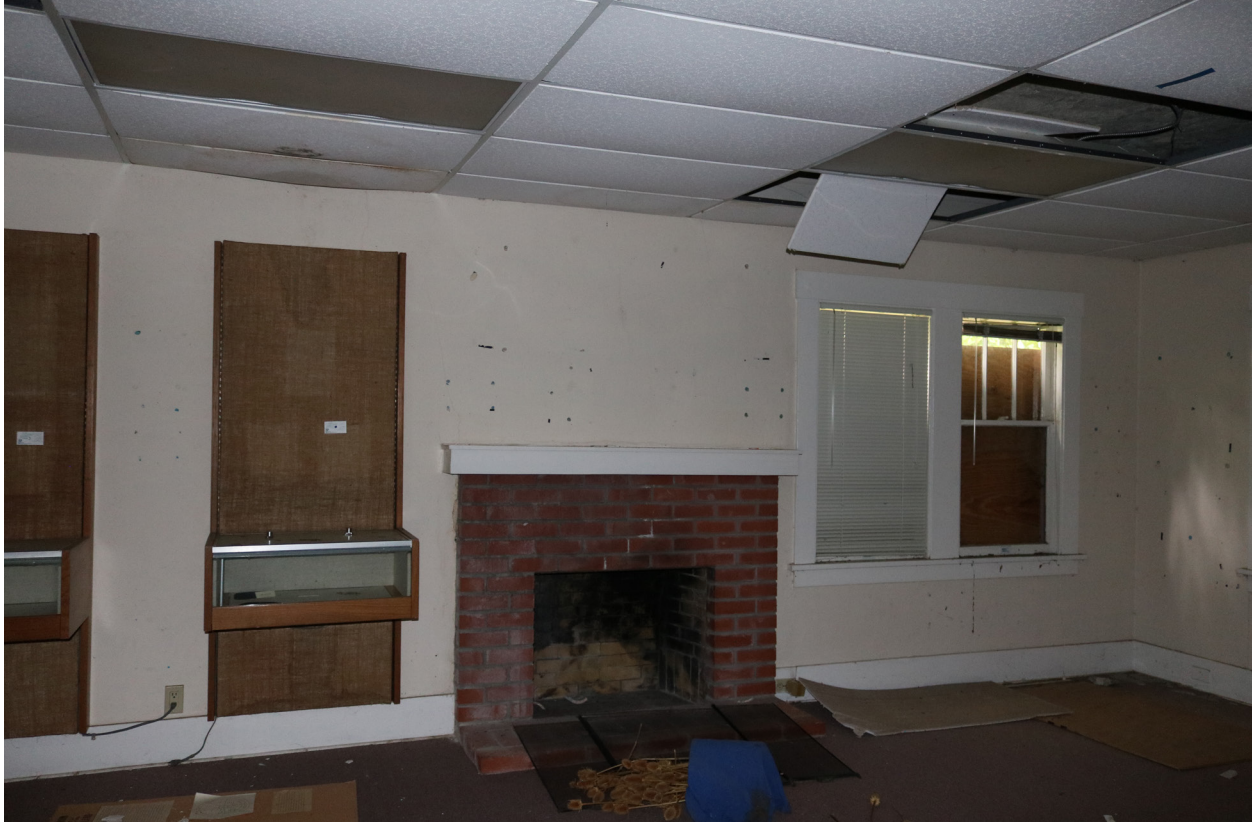
Overall view inside Ohlone room.

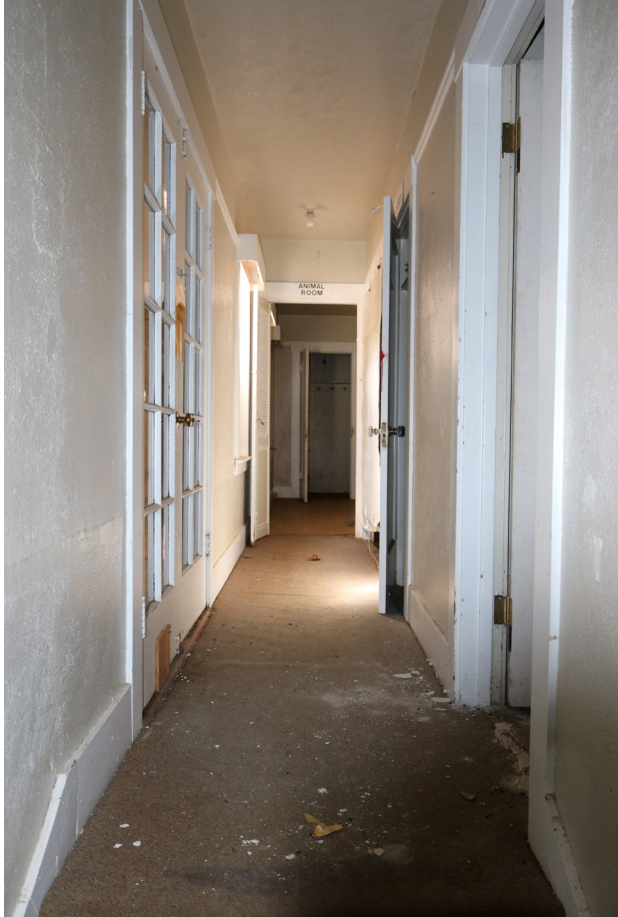
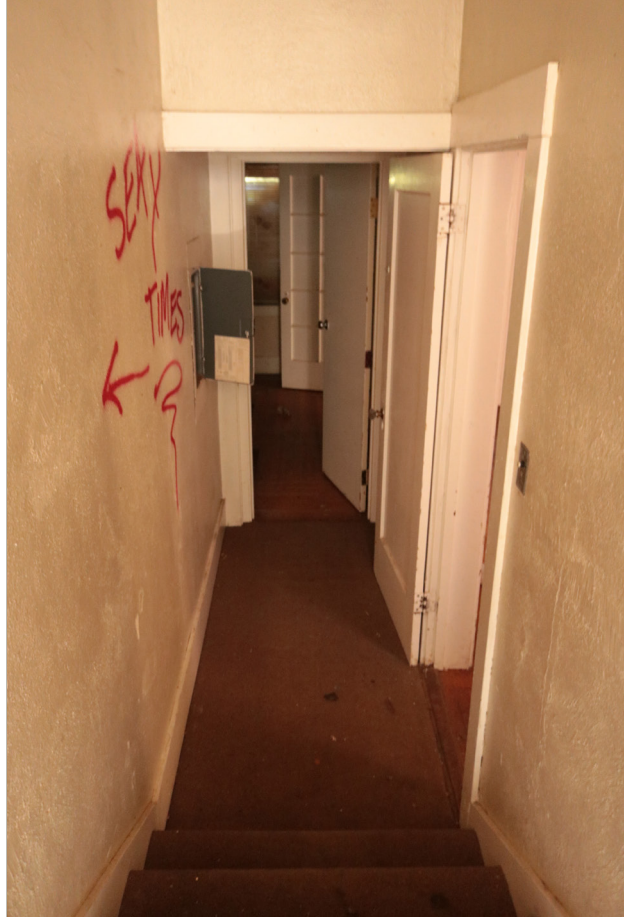
Above left: view looking south down hallway in west wing. Above right: view looking north inside west wing hallway, into Ohlone room entrance area.

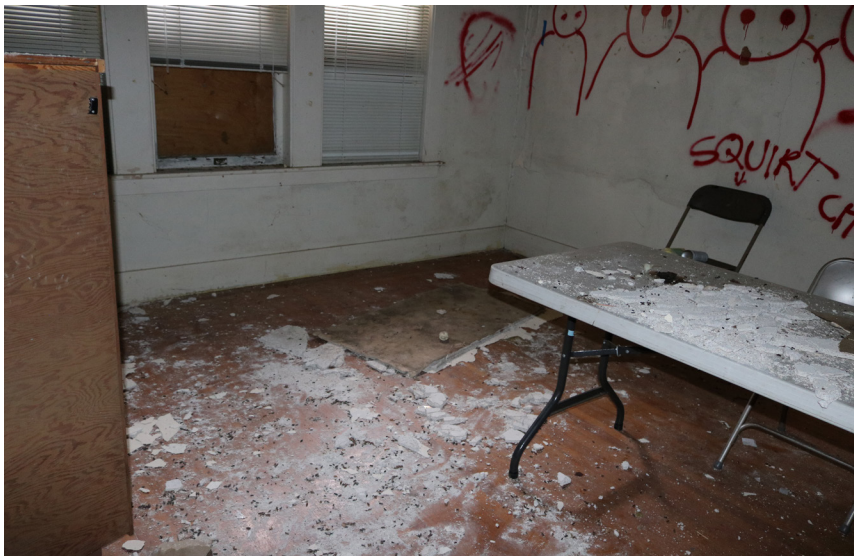
Craft room, view of floor and walls.

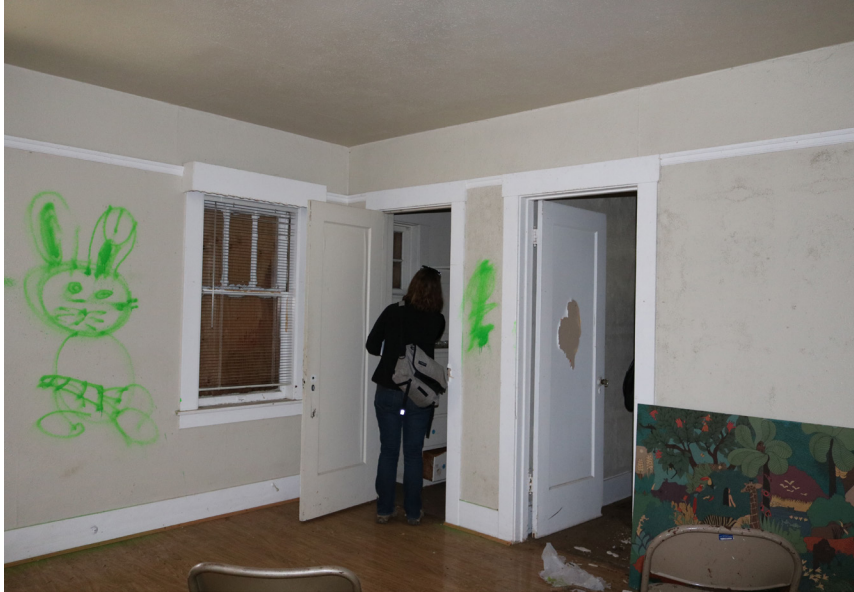
Animal room, overall view.

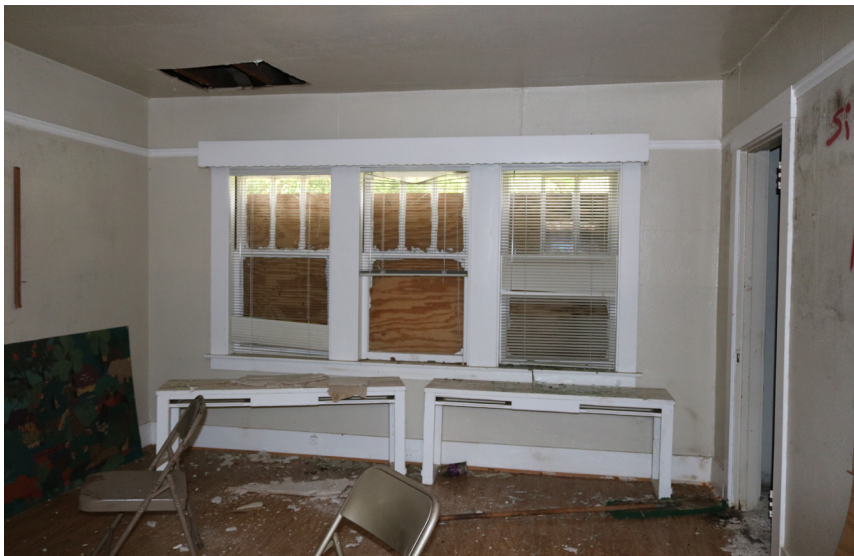
Animal room, view looking west.

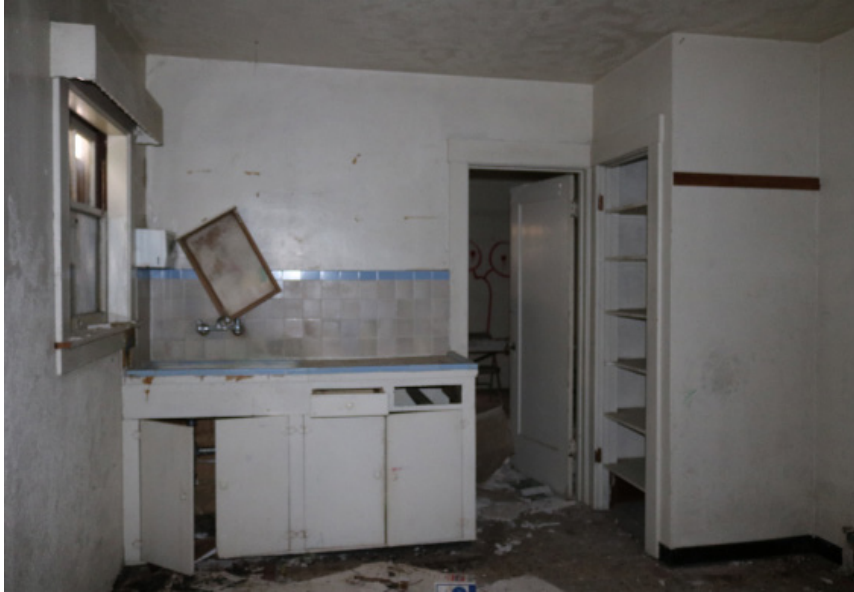
Kitchen in west wing.

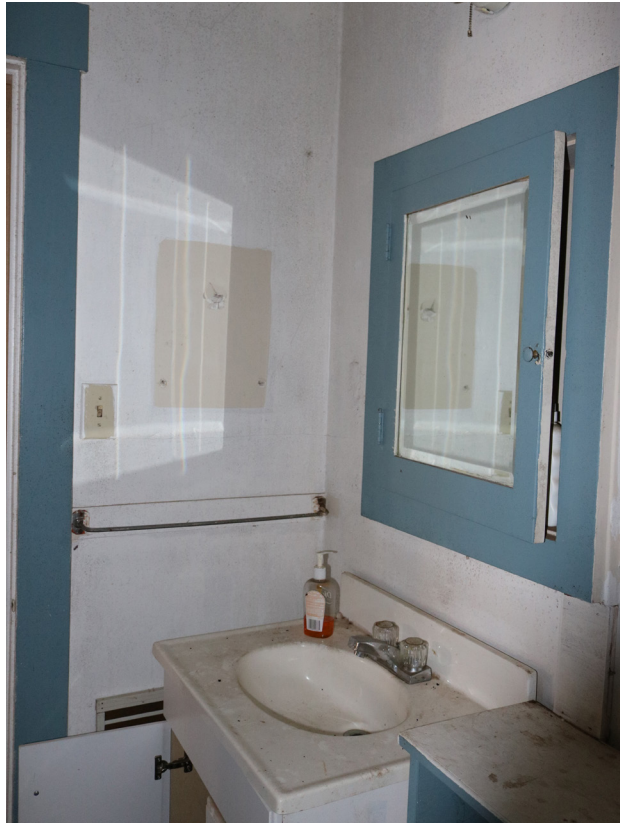
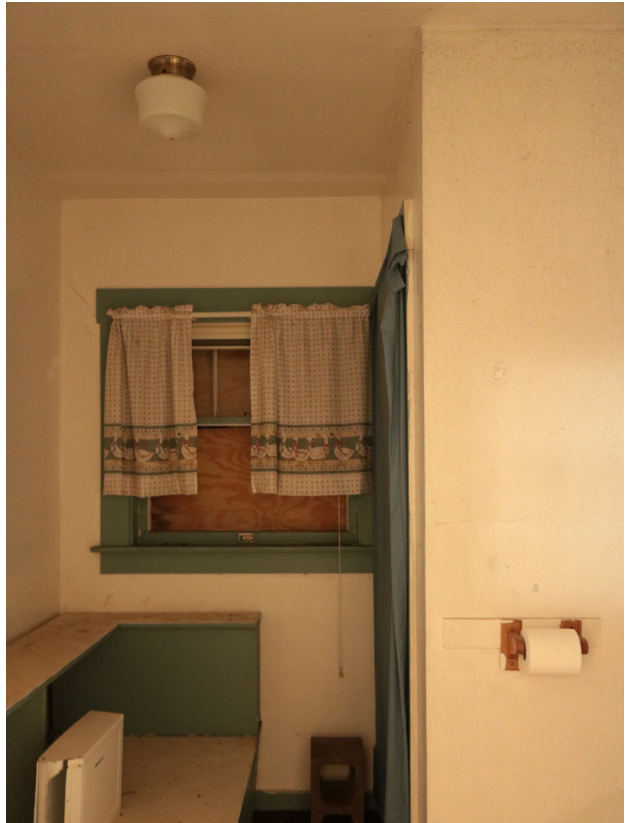
Interior views of restroom near the southern end of the west wing.

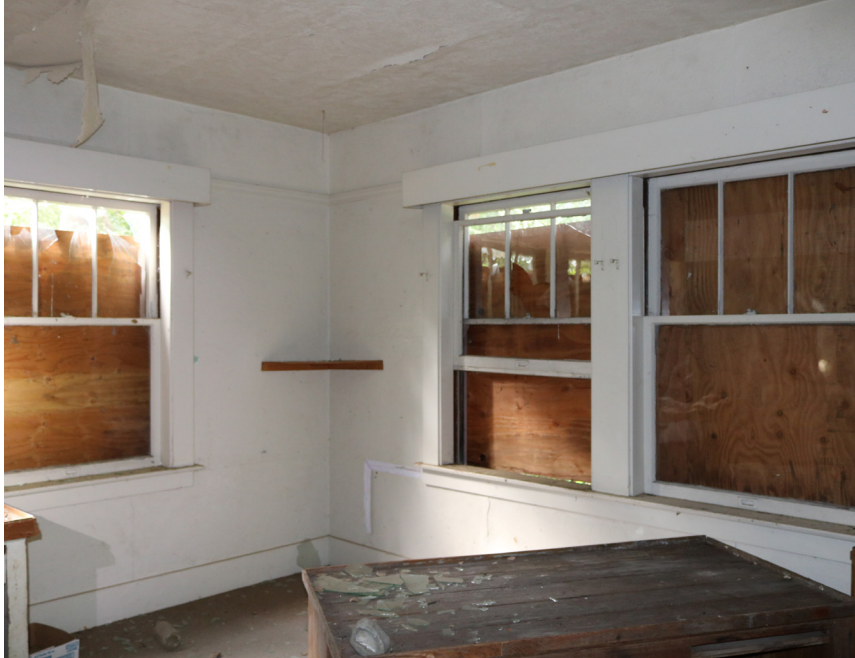
View looking south inside Discovery Lab.

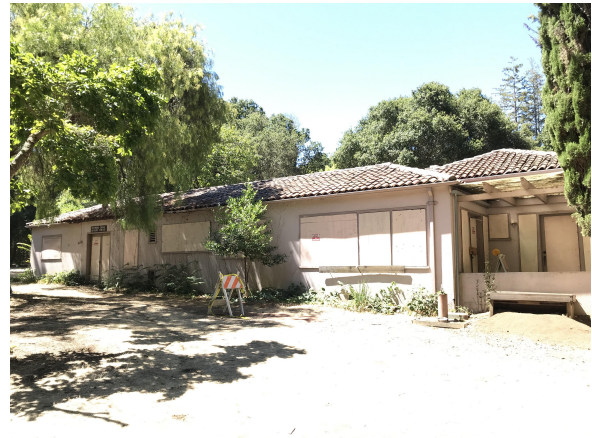
Photo #10 - East Elevation of the East Wing of the Building

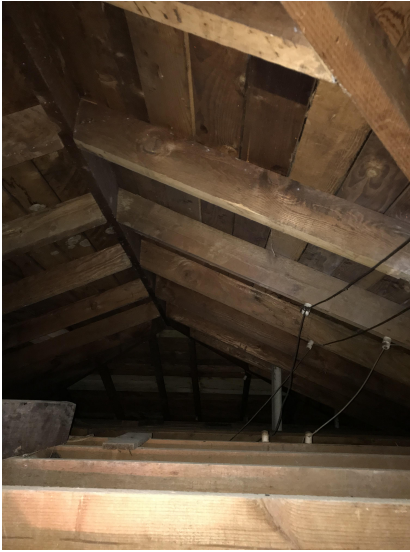
Photo #11: Roof Framing and Ridge Board at West Wing of the Building

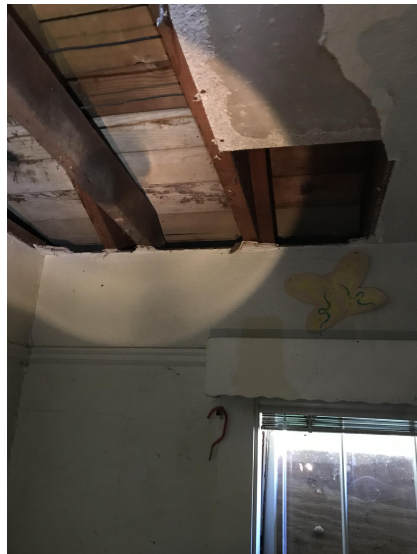
Photo #14: Roof Framing and Ceiling Joist at East Wing of the Building

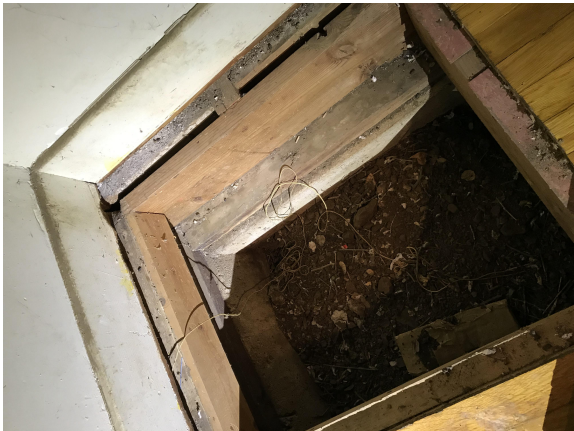
Photo #15: Crawl Space Access Opening in Floor Framing at East Wing

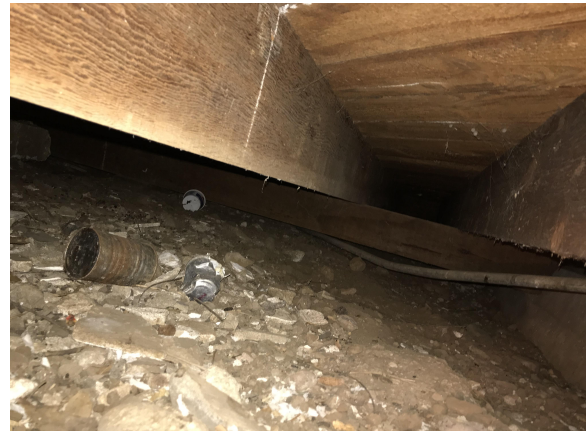
Photo #16: Isolated Concrete Footing at North and South Sections of Lodge
