Arborist Report and Tree Survey

**AN EVALUATION OF THE EXISTING TREES
SRGNC CRES, LLC PROJECT
First STREET, 100 BLOCK
LOS ALTOS, CALIFORNIA**

**PREPARED BY
MICHAEL L. BENCH
CONSULTING ARBORIST**

**SITE OBSERVATIONS:
September 28, 2016;
October 12, 2016**

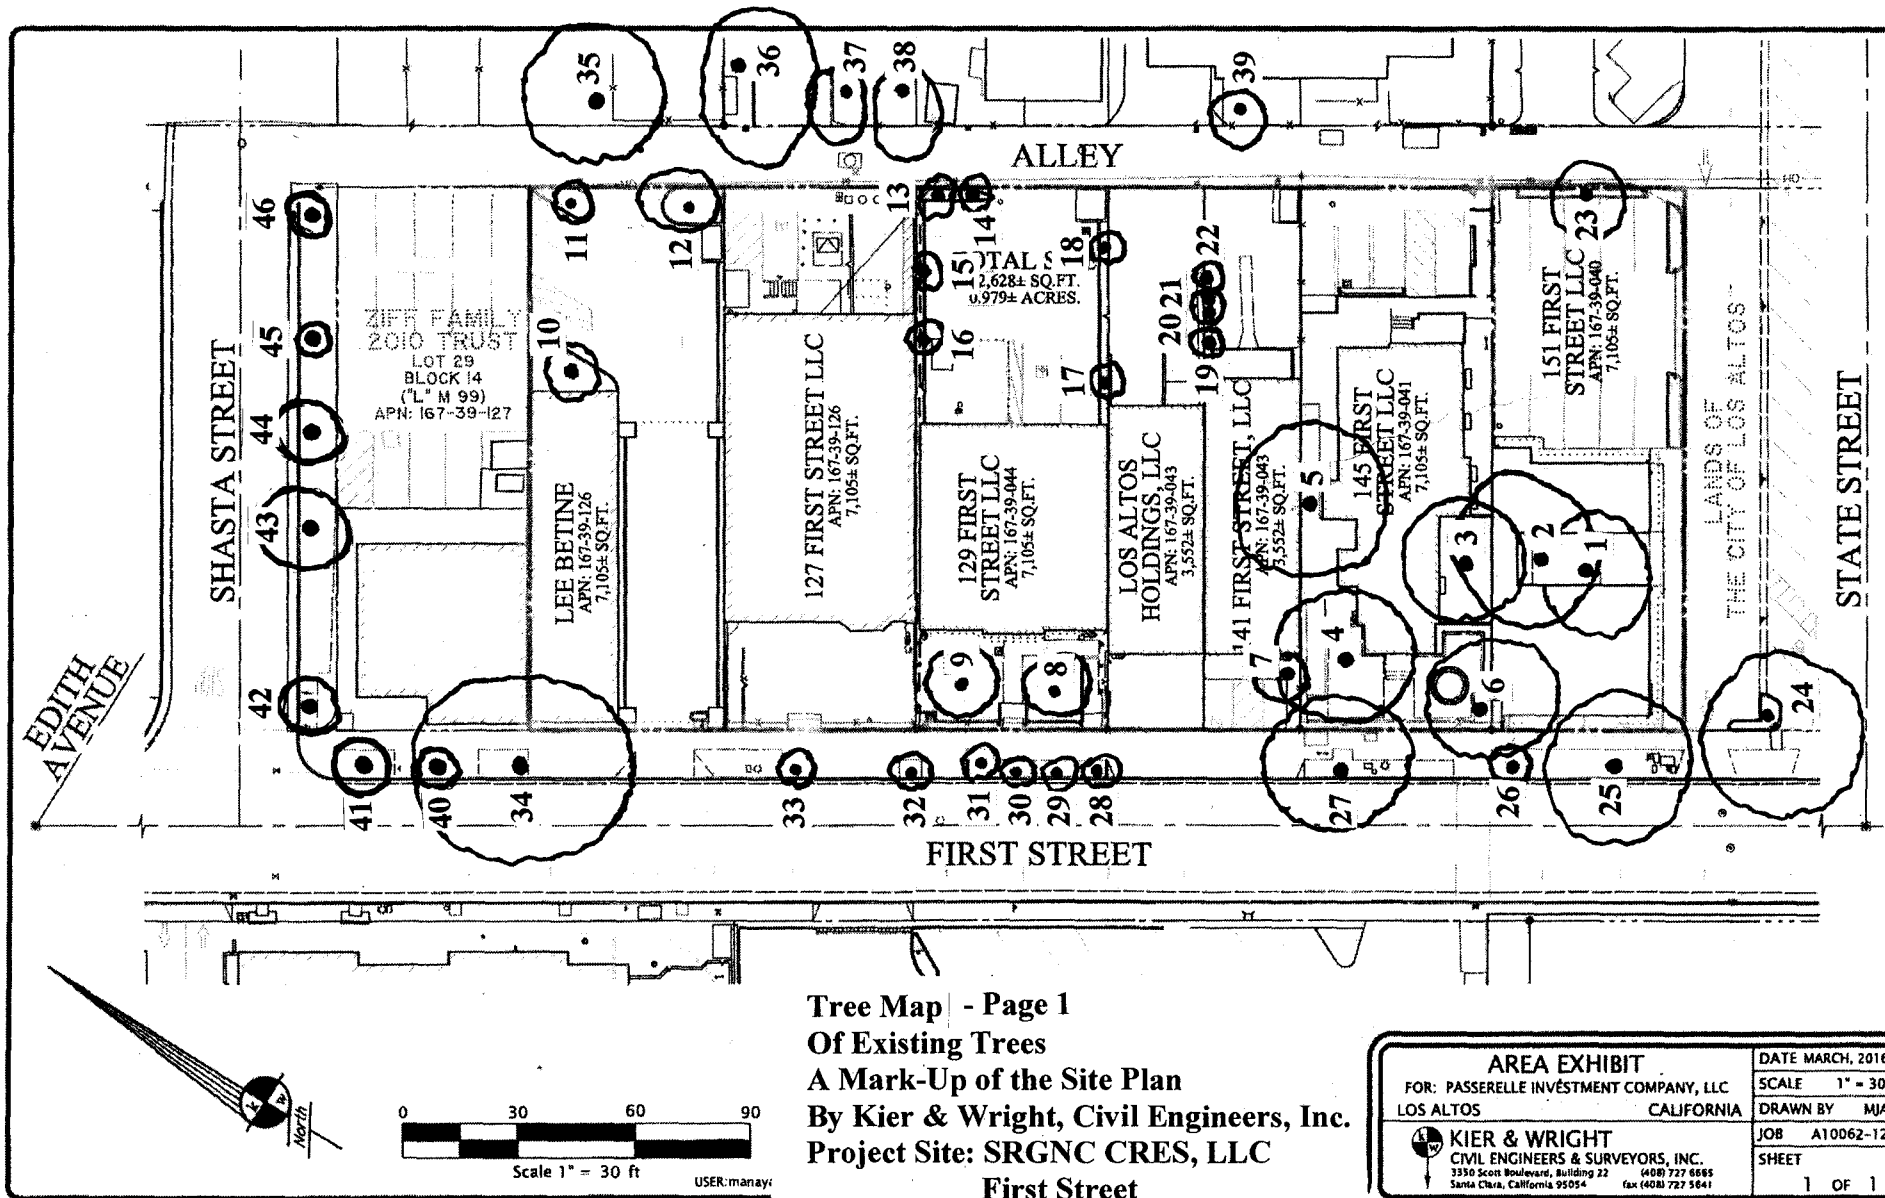
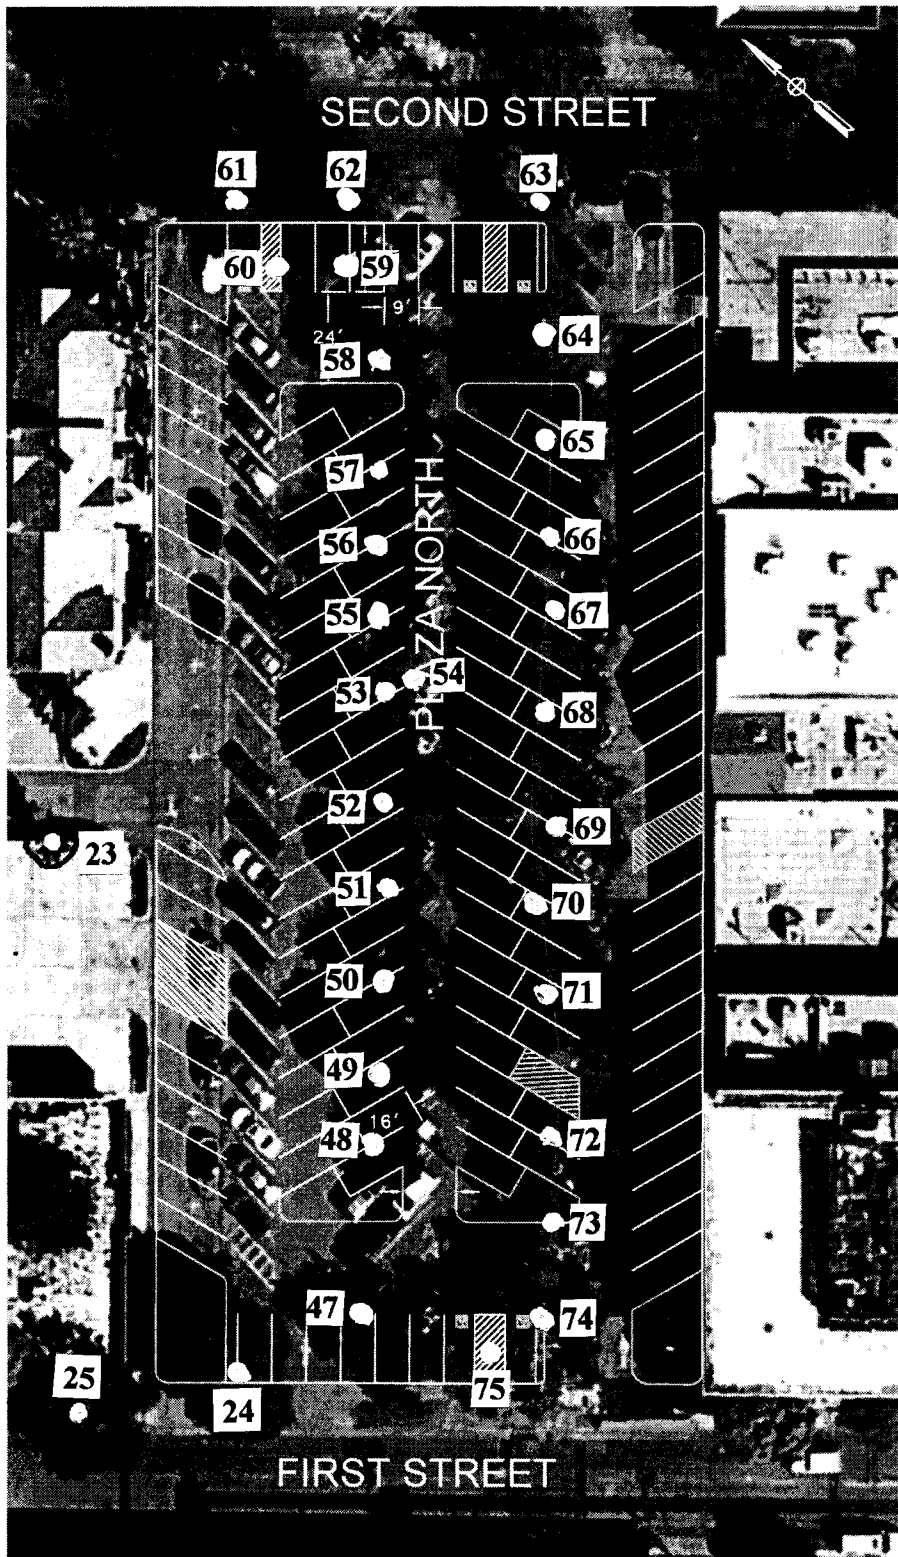
Tree Map - Page 2
A Mark-Up of the Site Plan
Prepared By AECOM
Project Site: SRGNC CRES, LLC
Los Altos, CA
Observations: 10-12-16
Michael L. Bench
Consulting Arborist

I marked the locations of the trees on the Site Plans provided and have called these markups the Tree Maps. Trees # 1-46 are noted on Map 1, and Trees # 47-75 are shown on Map 2.

I recommend that the Tree Protected Fencing be located as shown on the attached map. Any changes must be approved by the Project Arborist. Fencing must be chain-link, a minimum height of 6 feet, mounted on 2 inch diameter galvanized steel posts driven 24 inches (minimum) into the ground. Maximum spacing of posts is 10 feet. The fence must be in place prior to the arrival of any other materials or equipment and must remain in place until all construction is completed and passed final inspection. The protective fencing must not be temporarily moved during construction.
