APPENDIX D

ARBORIST REPORT

March 15th, 2021

Site: 355 1st St, 365 1st St, 371 1st St, and 373 1st St, Los Altos

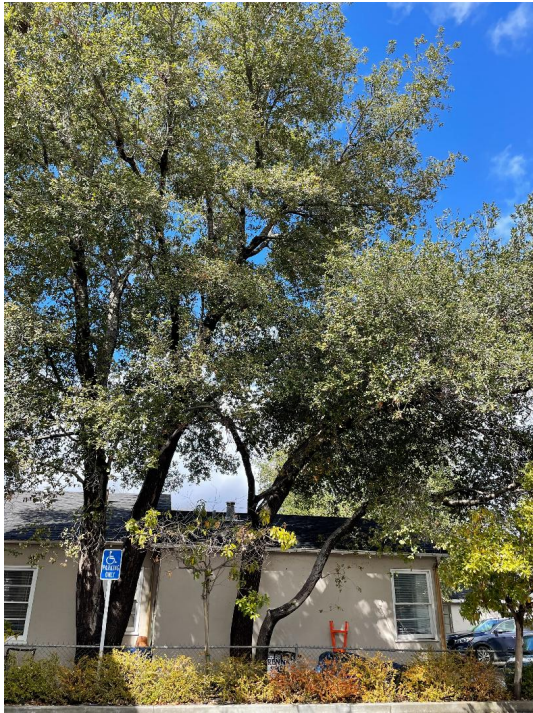
Oak tree #15 is in fair condition. The tree has poor form with codominant stems at 4 feet. The codominant leaders have formed included bark within the union. Included bark can significantly raise the risk of a leader failure. The tree is completely covered by hardscapes.

Showing included bark at 4 feet

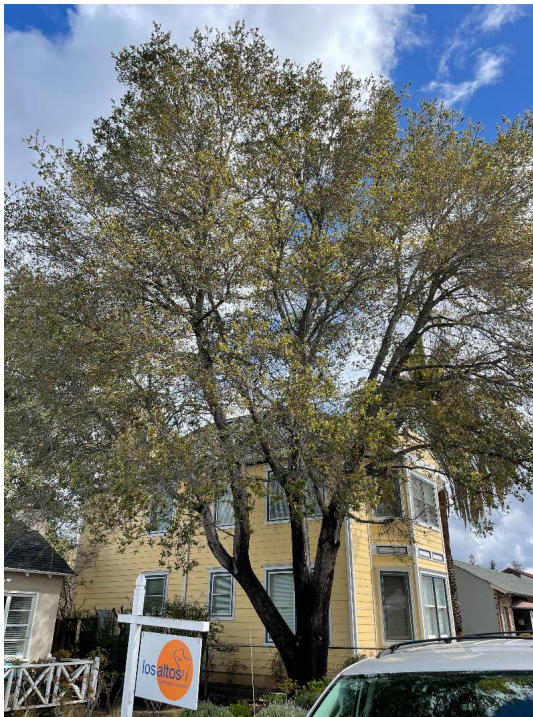
Oak trees #16-19 are located between 2 parking areas at 371 and 373 first street. Oaks #18, and #19 are of a protected size. The trees are in fair to good condition except oak tree #16 in poor condition. The property at 371 and 373 are at different grades. The lot at 371 where the trunks of the oaks are located is lower than the property at 373 first street. Demolition would likely have a high impact on these trees, also the trees would take up a large area of available space if retained. Oak trees #18 and #19 are within a few feet from the existing foundation.

Showing oak trees #18 and #19
