> November 18, 2019 Project No. 19-200-M

SUBJECT: Pavement Rehabilitation Options Fremont Avenue- Grant Street to Stevens Creek Los Altos, California

Pavement Rehabilitation/ Digouts Plan

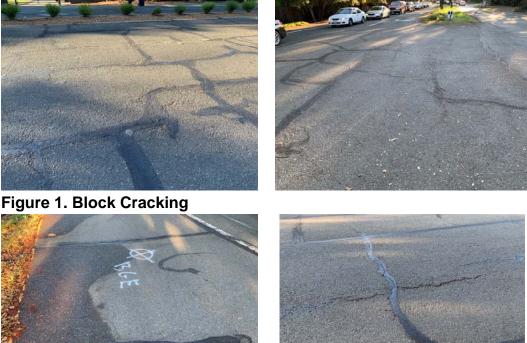
The major pavement failure types observed in the field were block cracking (Figure 1), transverse cracking (Figure 2) and raveling (Figure 3). These types of failure are typically caused by shrinkage of the asphalt concrete which indicates the asphalt binder has hardened over time. Based on our review they do not appear to be load related.

Based on the existing pavement evaluation, life cycle cost analysis, coring data, and R-value testing result, the recommended pavement rehabilitation strategy is 3" CIR with a 1.5" HMA Overlay. This recommendation is based on the following factors:

- Based on the coring data, the asphalt concrete pavement thickness is 8³/₄" to 14" thick which is conducive to CIR treatment.
- Based on our field observations the major pavement failure types observed in the field are block cracking and transverse cracking. The street does not exhibit base failures. These types of failures will be mitigated by the CIR treatment.

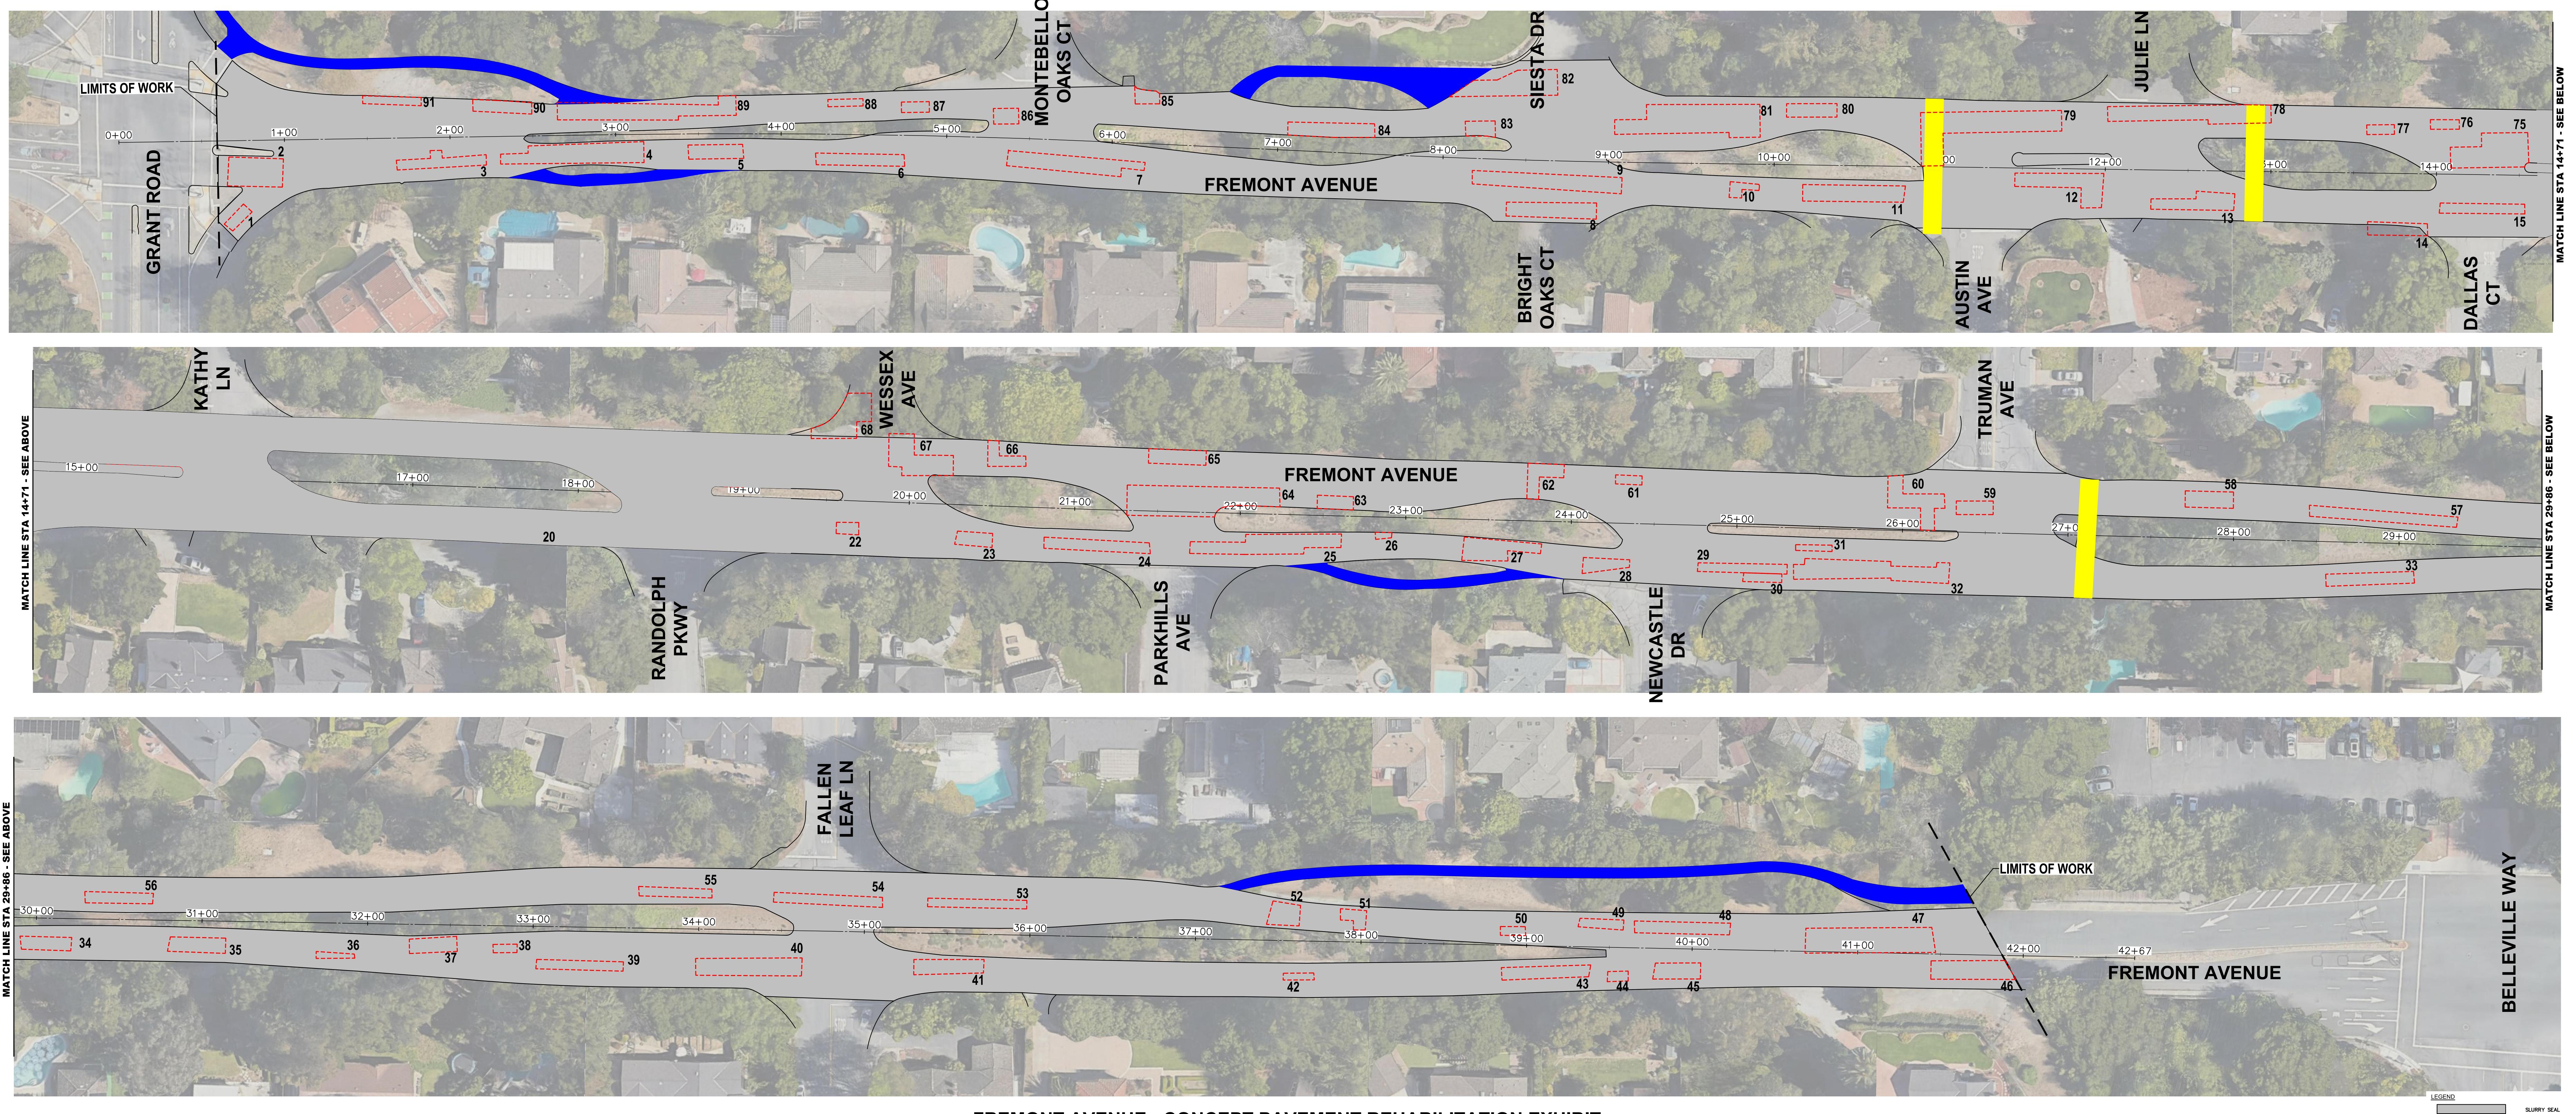
FREMONT AVENUE - CONCEPT PAVEMENT REHABILITATION EXHIBIT

The total pavement rehabilitation area is approximately 218,200 square feet. Road pavement conditions were examined and locations with severe cracks have been identified. A total area of 35,455 square feet is severely distressed and requires removing all or a portion of the pavement section and replacing with hot mix asphalt pavement, commonly called digouts. This is approximately 16.3% of the total pavement rehabilitation area. Projects with areas exceeding 15% digouts are candidates for Cold In-place Recycling (CIR) per CIR industry representatives. CIR eliminates the need for digouts.
