HISTORIC STRUCTURE REPORT

Halsey House

City of Los Altos | December 2019

Architectural
Resources Group

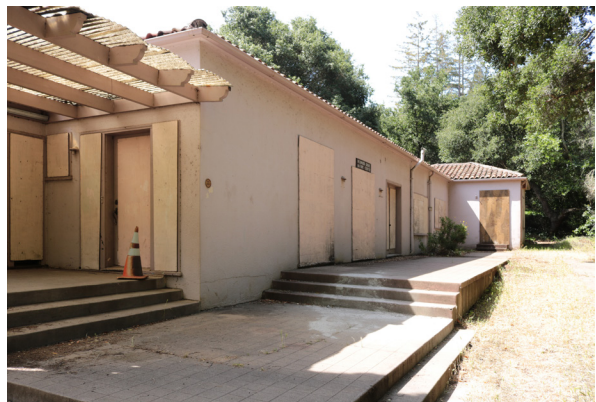
View of north elevation looking west. Note the lack of handrails at both sets of stairs (ARG, 2019).

the building. Primary access to the interior is gained from a set of original concrete stairs located at the north terrace. These stairs lack handrails. Two sets of concrete stairs provide entry into the house from the courtyard at the west. The wrought iron handrails exhibit significant corrosion and lack compliant extensions. Exterior doors are typically elevated above exterior grade which further contributes to a lack of universal access.

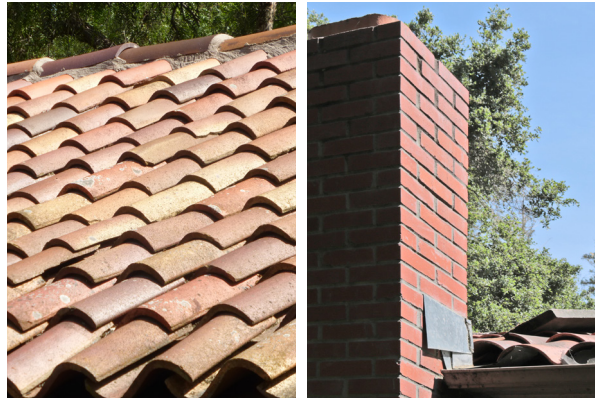
The clay tiles are in overall fair condition, with what appears to be an accumulation of dirt and some biological growth particularly at the west elevation where several mature trees overhang the roof. There is also a heavy accumulation of tree debris and some discarded material on the roof. Some clay tiles are missing and should be replaced in-kind. The multiple layers of flashing at the brick chimney are not fully secured and are irregular in appearance.

Clay tile roof (left); metal flashing at west chimney (right); (ARG, 2019).

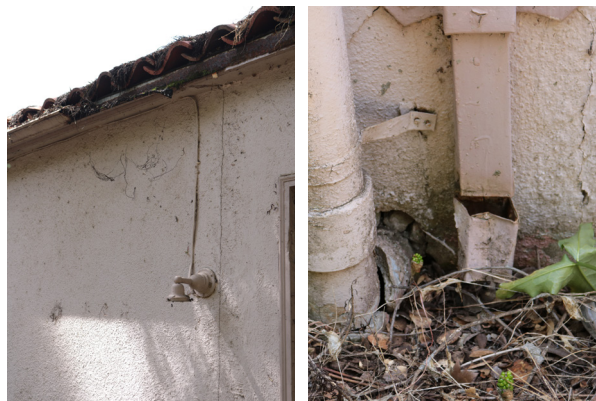
The metal roof gutters and rain leaders are generally in fair condition with some minor corrosion present. There is a section of gutter missing along the east elevation. Some of the rain leaders are not secured to the exterior wall as the bracket fasteners are either missing or corroded and some of the rain leaders exhibit corrosion and damage at grade. Corrosion is present at the gutter straps along the north elevation.

Missing segment of roof gutter (left); damaged rain leader (right); (ARG, 2019).

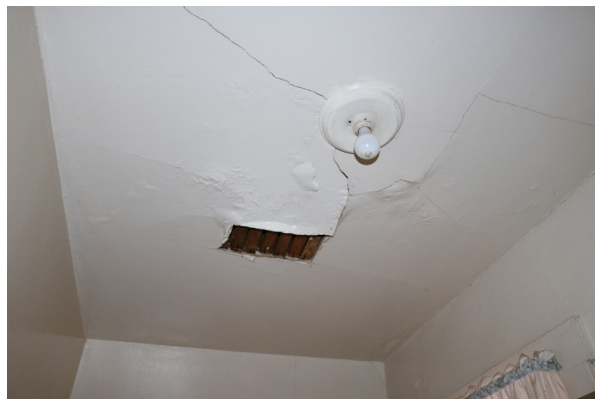
There is water damage visible at the East Restroom and the Discovery Lab. At the East Bathroom there is significant loss of the plaster finish which has exposed a large area of the

Water damage and exposed lath in East Restroom (ARG, 2019).

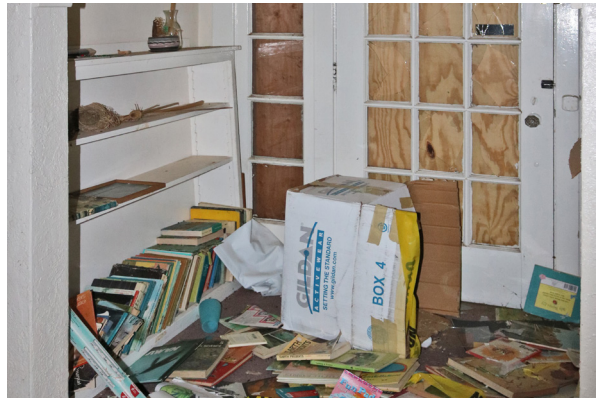
Painted wood built-in bookcase at the Book Nook (ARG, 2019).

There are two types of interior wood casework: the painted open wood shelves of the Kid's Room and the Book Nook, and the painted wood casework of the kitchens, West Restroom, and the East Hall. The painted wood shelves are in fair condition with light scuffing and paint loss present.

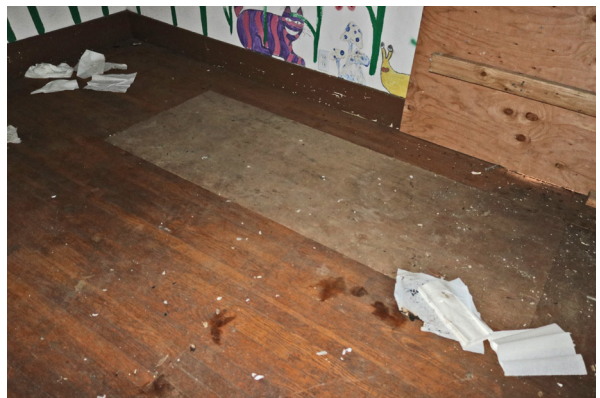
Plywood patch at the wood floor in the Kid's Room (ARG, 2019).

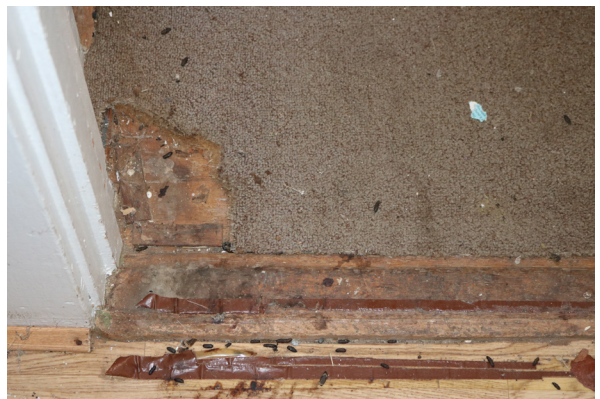
Section of missing carpet revealing the original wood flooring beneath in the West Hall (ARG, 2019).

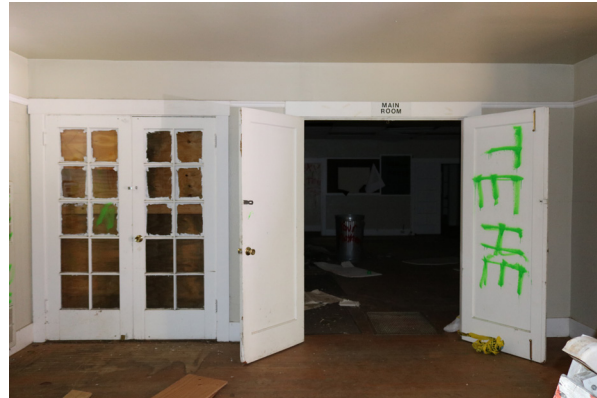
The historic interior doors are largely intact and in good condition. Original doors include panelled or French doors with some original glass door knobs intact. Damage is largely limited to paint loss and scuffing typical of everyday use. Graffiti is present on the paired doors of the Entry. The door of the pantry in the West Kitchen is missing and a large section of paint is missing from a door in the Animal Room.

Graffiti at the original paneled wood door of the Entry (ARG, 2019).

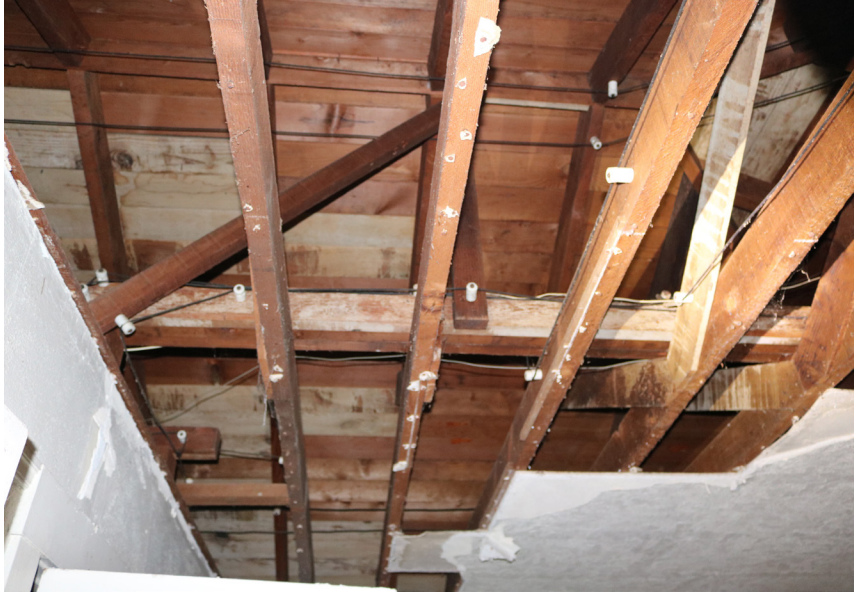
Craft room, view of partially collapsed ceiling and exposed roof framing.
