Kiely Arborist Services LLC

Revised January 27th, 2022

Site: 166 Lyell Street, Los Altos CA

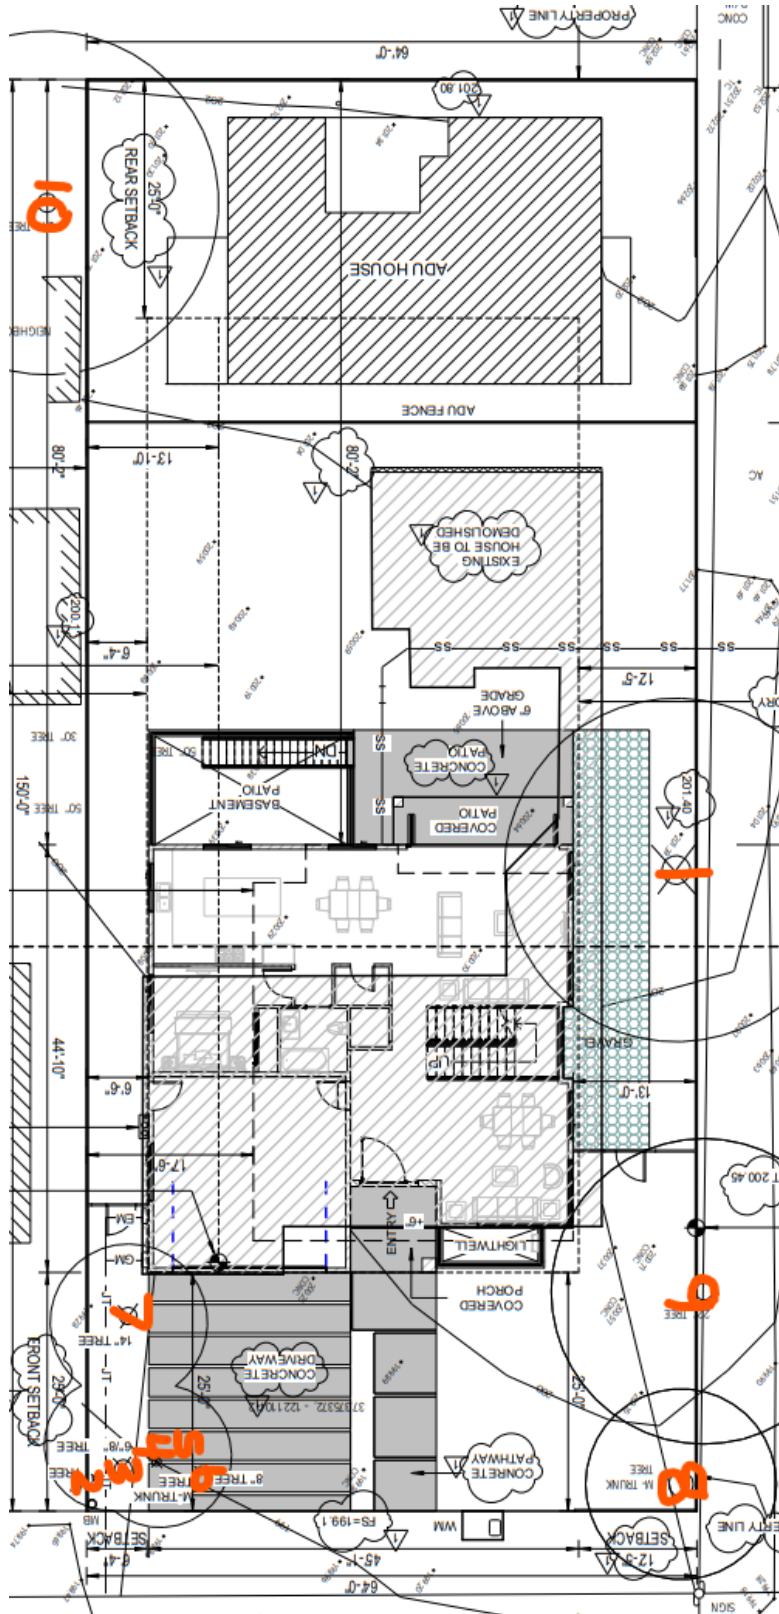
Showing tree locations

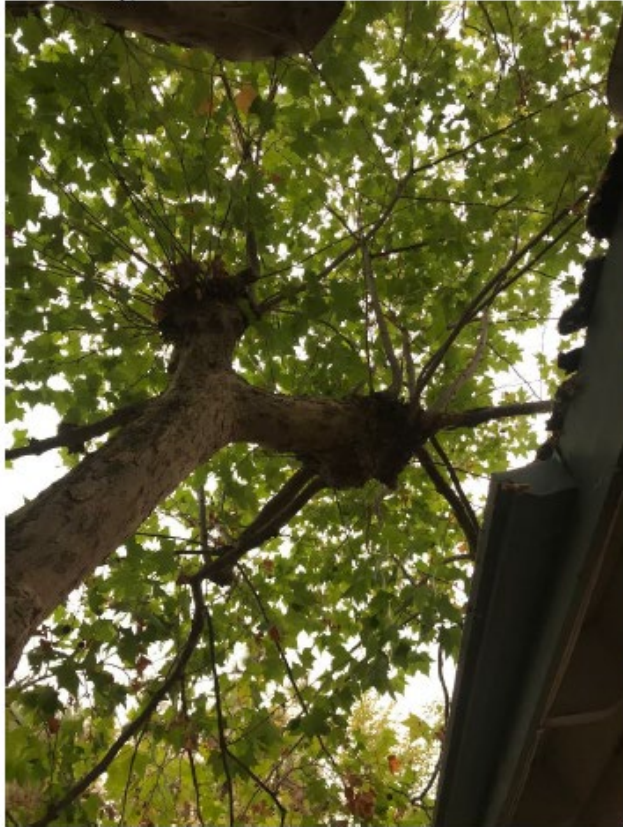
Showing topped London Plane tree #1

London Plane sycamore tree #1 is proposed for removal. The tree is in poor condition as it has been topped in the past. Topping trees creates risk of future limb failure and is not an approved pruning practice by ANSI Standards or Best Management Practices. Growth following a topping cut consist of many small shoots arising from the topping cut. These new shoots are a trees defense mechanism to stay alive in such an event where a limb would fail. The new shoots develop into limbs and do not form proper branch to trunk unions and will therefore increase risk of failure. Topping trees leads to decay at the point of origin leading to an increase of risk of limb failure, can weaken a tree to a point of death, can cause sunscald, makes trees unsightly, and is expensive due to frequently reoccurring corrective pruning needed throughout the remainder of the tree's lifespan. If the tree were to be retained, the basement cut would need to maintain a distance equal to the existing home on the site from the tree or 5 feet. If the plan were redesigned the tree would still be too close to the existing/proposed home and future damages would be likely due to root pressure on the foundation/basement wall. Removing and replacing the tree further away from the foundation will eliminate future risk of damages and will eliminate the future risk of limb failure due to the topping cuts made in the past. A new tree can be easily planted slightly further away from the proposed home and properly maintained so that there is little to no risk of limb failure or foundation damage. This tree meets the following criteria to support tree removal: (1) The condition of the tree with respect to disease, imminent **danger of falling, proximity to existing or proposed structures** and interference with utility services. (2) **The necessity to remove the tree for economic or other enjoyment of the property.** The alternative would be to redesign the home to the existing home set back from the tree. This is not reasonable for a tree in poor condition that has been topped.

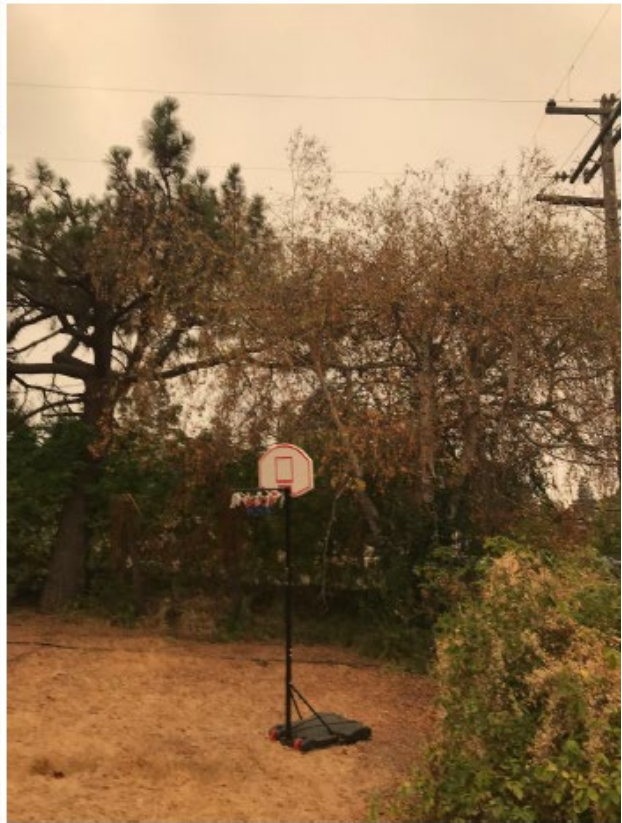
8 P	Birch (<i>Betula pendula</i>)	18.0	F	25/25	Poor vigor, poor form, topped for line clearance in decline, nearly dead.
9 P	Jeffery Pine (<i>Pinus jeffreyi</i>)	18.6	D	25/25	Fair to poor vigor, poor form, topped for line clearance.
10* P	Coast Live Oak (<i>Quercus agrifolia</i>)	24est	B	35/30	Good vigor, good form, 3 feet from property line.

The landscape at 166 Lyell Street is under drought stress. All of the grass is dead and is a sign that no irrigation has been provided for the trees. Many Birch trees were observed on the lot. Birch trees require significant dry season irrigation to maintain a healthy canopy. The Birch trees are drought stressed and are in decline. London Plane tree #1, Birch tree #8, and Jeffrey Pine #9 are located underneath high voltage utility lines and have been topped in the past for line clearance. Topping trees creates poor structure, weakens tree roots, and can make for a tree with a higher risk of limb failure. Birch tree #8 has declined further since my last site visit and now has a condition rating of F.

Showing topped trees #8 and #9

Birch tree #8 will need to have tree protection fencing located 12 feet from the tree where possible.

Pine tree #9 will need to have tree protection fencing located at 3 feet from the proposed basement cut, and out to 15 feet from the tree wherever else possible. Below is a diagram showing the recommended placement of the tree protection fencing.

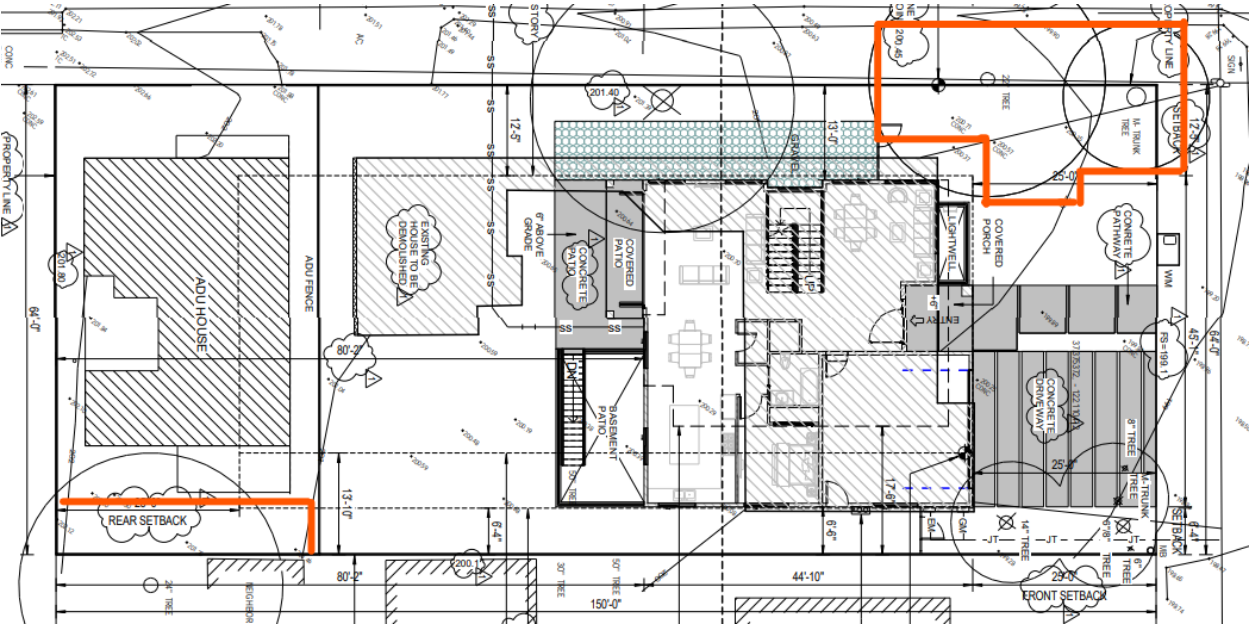
Showing the recommended tree protection fencing placement

Tree protection fencing for the neighbor’s oak tree #10 should be 6-foot-tall metal chain link type supported by 2 inch metal poles pounded into the ground by no less than 2 feet. The support poles should be spaced no more than 10 feet apart on center. The fencing must extend off of the property line fence out to a distance of 3 feet from the proposed ADU or 15 feet from the tree whichever is further from the tree.
