AGENDA REPORT

TO: Historical Commission
FROM: Sean Gallegos, Staff Liaison
SUBJECT: Halsey House Update

CIP Project, CF-01004 Halsey House Renovation/Replacement

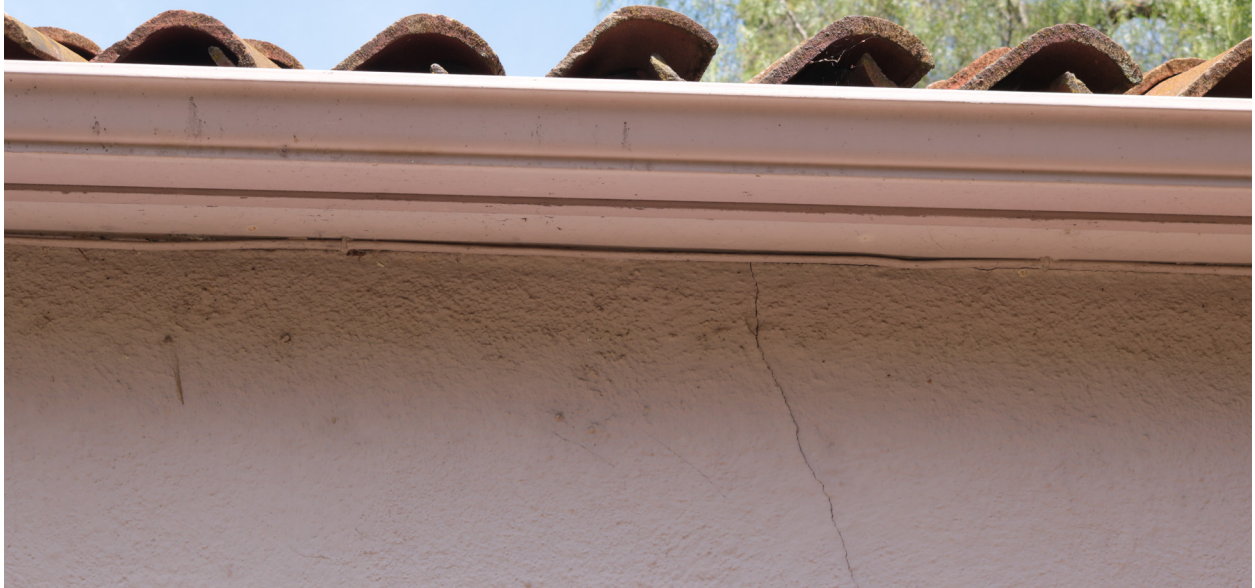
Detail view of stucco crack at south elevation.

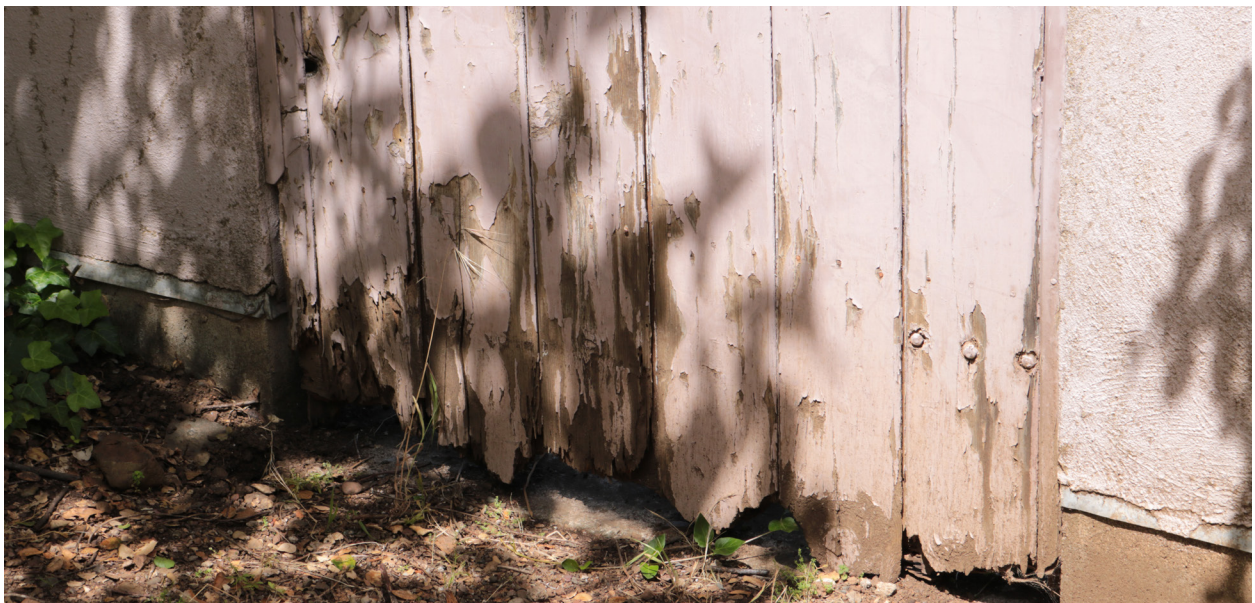
Detail view of wood deterioration at courtyard gate.

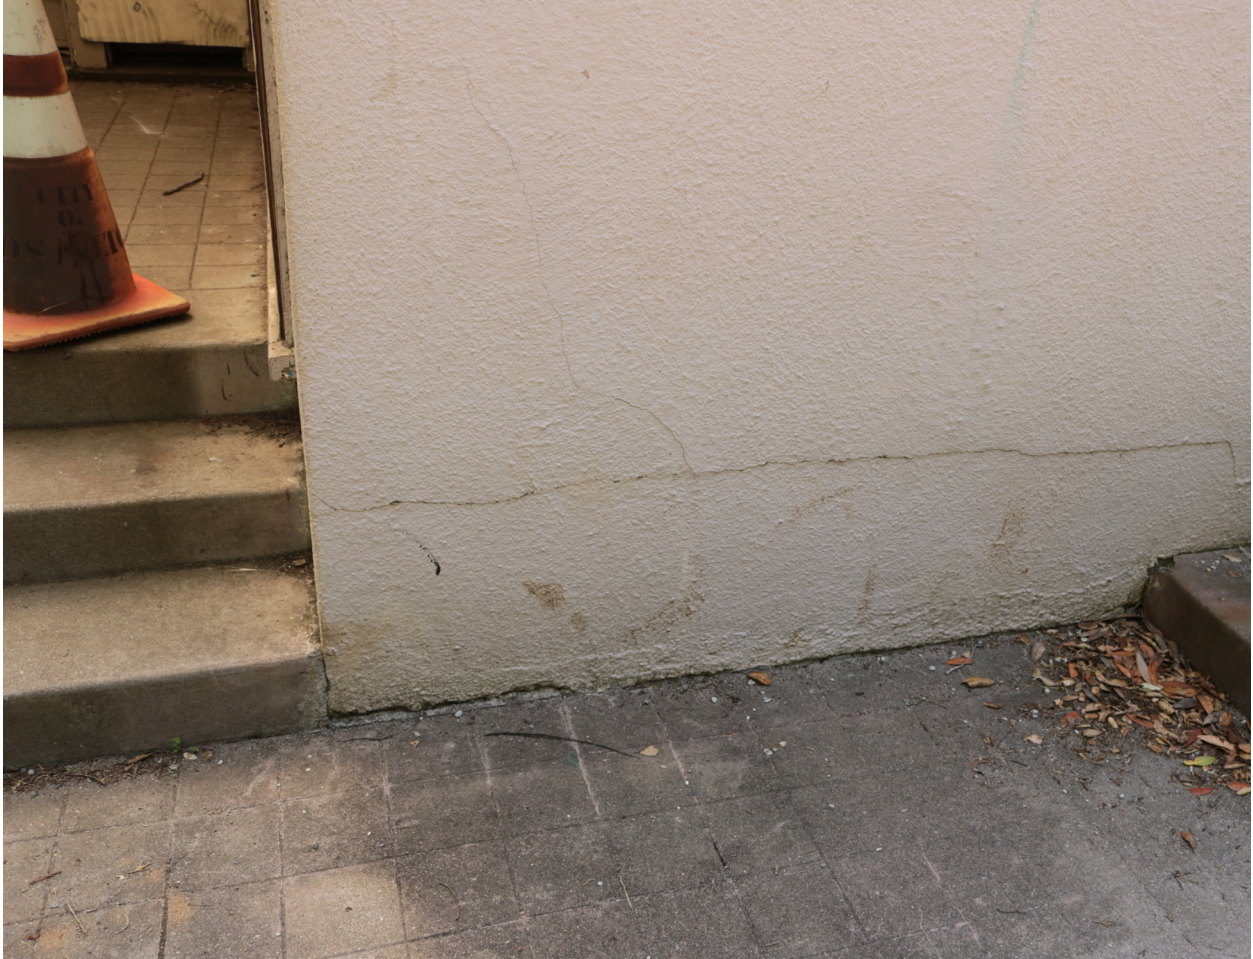
Existing stucco conditions at north elevation adjacent to main entrance.

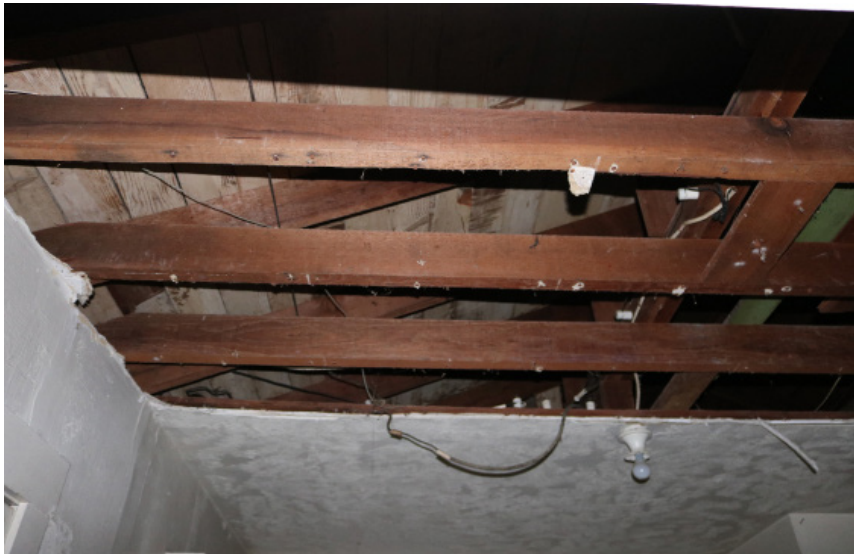
View of exposed framing where west wing kitchen ceiling has partially collapsed.
