Facility Condition Assessment Services

Tier 1 Report of
Facility Condition Assessment

For
City of Los Altos
City Hall
3 N. San Antonio Road
Los Altos,
California 94022-3000

Date of Report: September 16, 2016

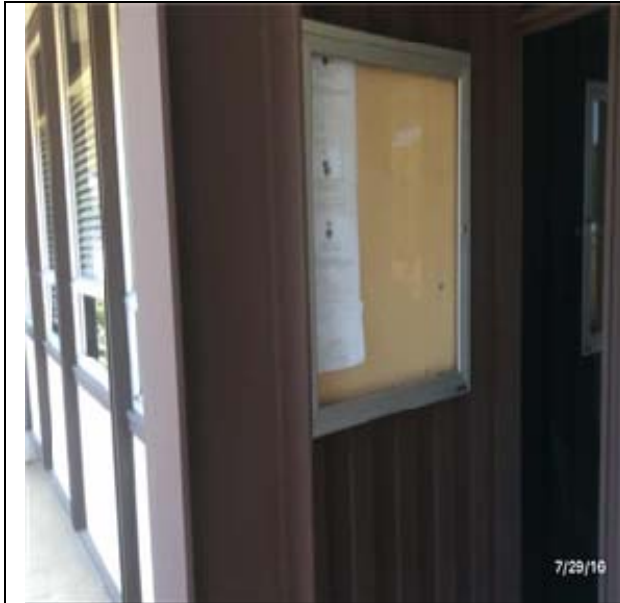
The wall construction was observed to be in fair condition and well maintained; there are no instances of deterioration, cracking or damage observed. Therefore no actions will be generated during the study period for works associated with the structural steel frame structure.

B1031 Steel Frame Structure:- View of Structural Steel Columns and Beams Frame

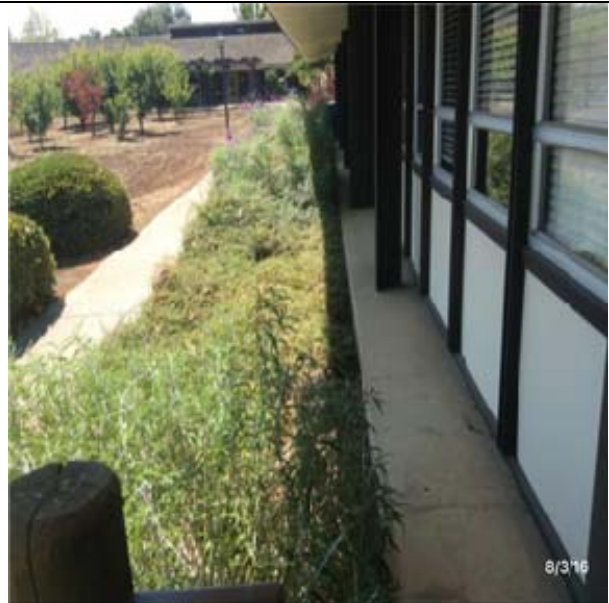
The insulated wall panels to the glazing were observed to be in fair to poor condition. The panels form part of the glazing system therefore we anticipate replacement at the same time as the windows in the mid-term of the study period the study period. The exterior wood cladding appeared to be in fair condition with no apparent defects, therefore no actions will be generated during the study period.

B2011 Exterior Wall Construction:- View of Insulated wall panels to glazing

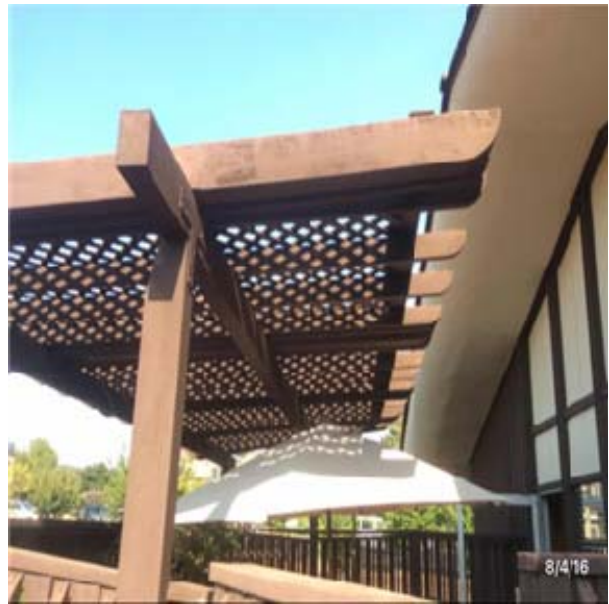
The structure was observed to be in poor condition, therefore replacement is included in the study period.

B2014 Exterior Sun Control Devices:- View of Exterior Sun Control Devices

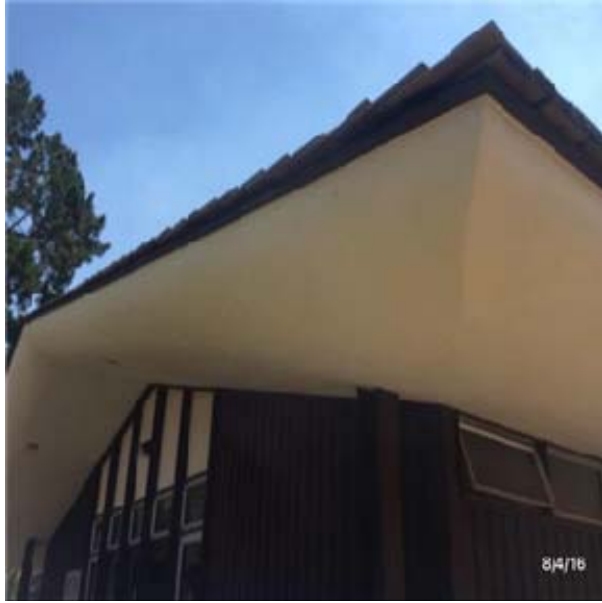
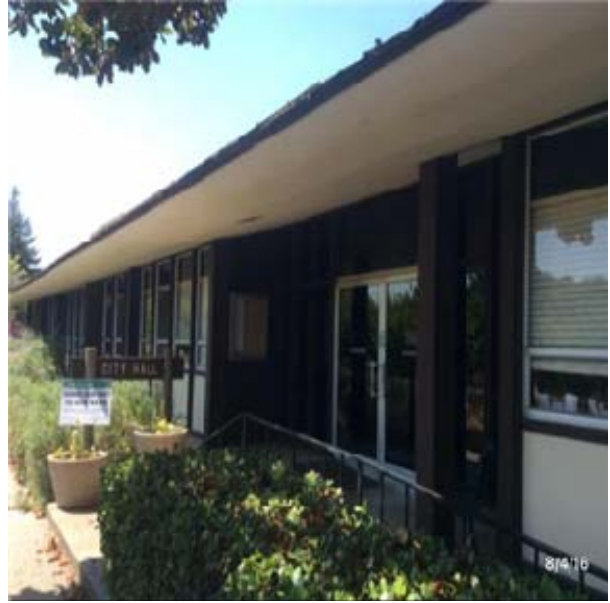
The exterior soffits appeared to be in fair condition; therefore we do not anticipate any actions during the study period. We do however recommend repainting of these surfaces later in the study period to maintain the appearance of the building and also protect the asset.

B2016 Exterior Soffits:- View of Exterior Soffits

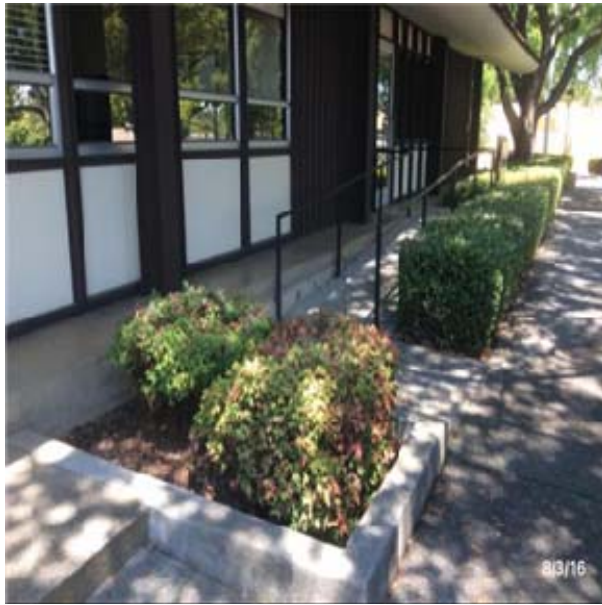
The window systems appeared to be in poor - fair condition. We noted some deterioration of frame and/or glass which would require actions and the frames are over their EUL of thirty years, therefore we recommend replacement in the mid-term of the study period including the insulated wall panels previously mentioned.

B2021 Windows:- View of Aluminum Window Units - Fixed or Single Hung

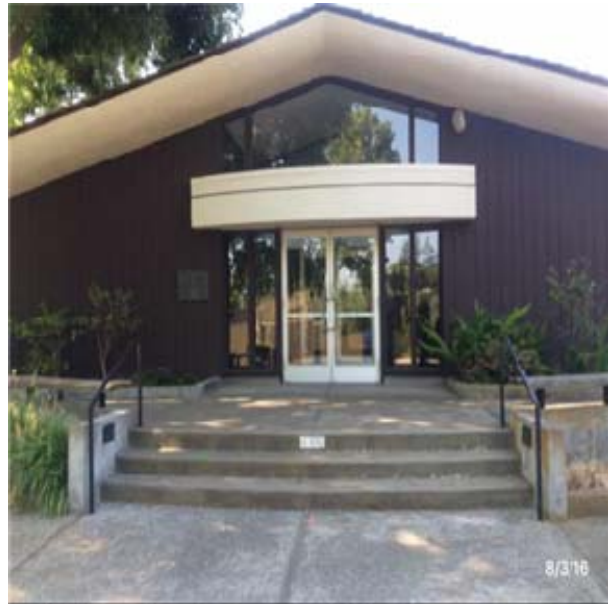
B2021 Windows:- View of Wood Window Units - Fixed or Single Hung

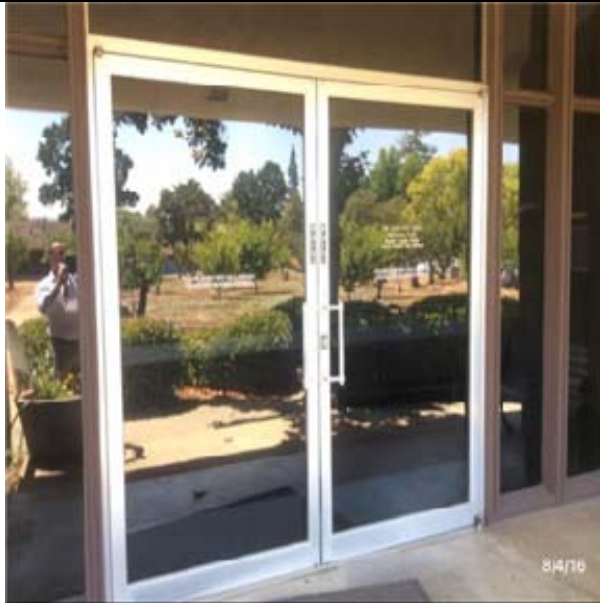
The glazed doors appeared to be in fair condition considering their age. They operated in a satisfactory manner and the hardware performed as required. We anticipate replacement of the doors during the study period to keep the building in good appearance some of the doors are noted as being original. ADA modifications are anticipated at the beginning of the study period.

B2031 Glazed Doors & Entrances:- View of Double Aluminum Glazed Doors

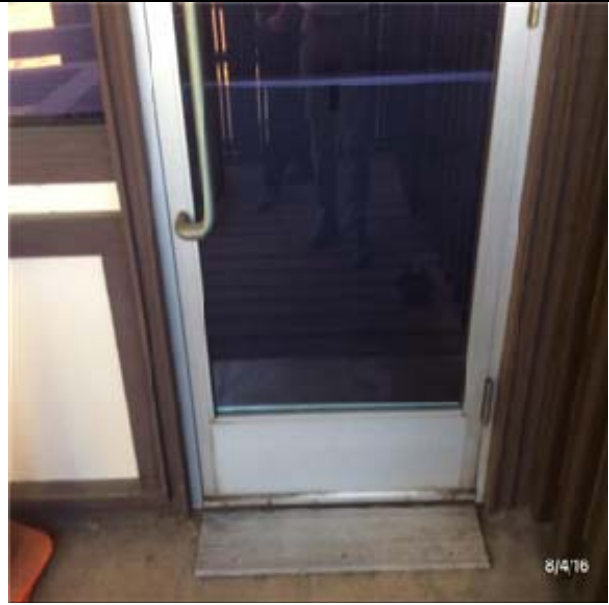
B2031 Glazed Doors & Entrances:- View of Single Aluminum Glazed Doors

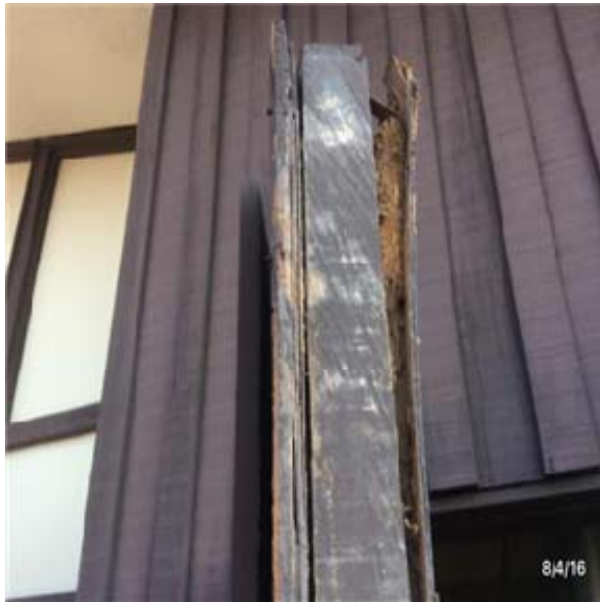
B2039 Other Doors & Entrances:- View of Exterior Double Wood Door(s)

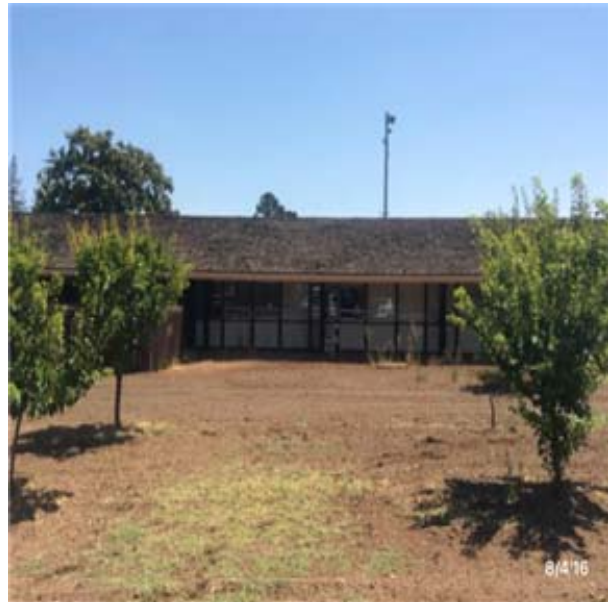
The roof construction was not visible due to the presence of acoustic ceiling tiles to the interior space. The maintenance staff reported that the roof does leak.

B3011 Roof Finishes:- View of Wood Shake Roof

- + B Shell: Replace Exterior Double Wood Door(s) at an estimated cost of \$7,749 in year 2016
- + B Shell: Replace Wood Shake Roof at an estimated cost of \$329,665 in year 2016

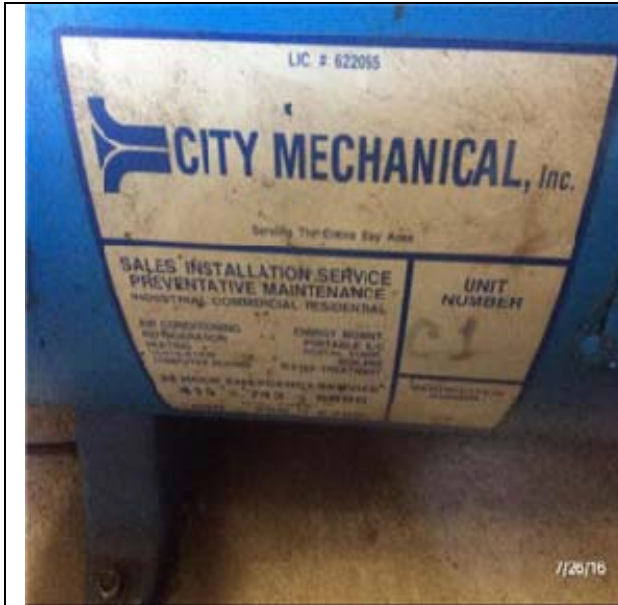
D2099 Other Piping Systems:- View of Air Compressor
- 2 H.P.

- + D Services: Replace Air Compressor - 2 H.P. at an estimated cost of \$11,236 in year 2016
- + D Services: Replace Boiler Circulation Pump/Motors 1 H.P. at an estimated cost of \$10,127 in year 2016

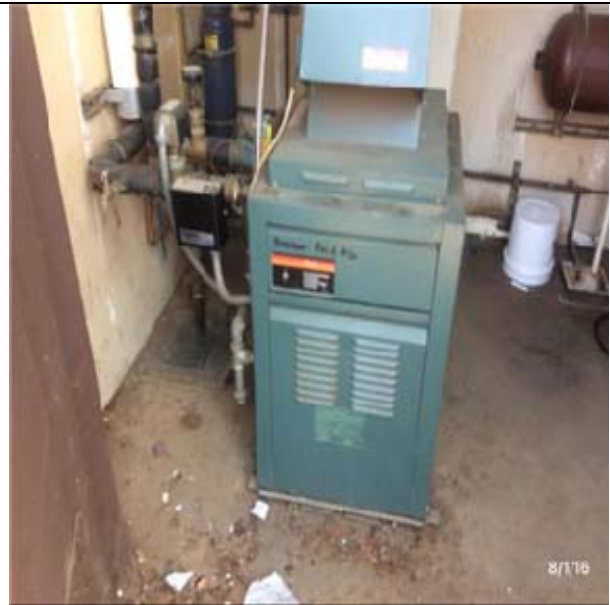
D3021 Boilers:- View of HW Boiler - Oil/Gas - 205 to
1000 MBH Range

- + D Services: Replace Split-System (Indoor Furnace Unit) 251 to 350 BTU at an estimated cost of \$18,895 in year 2018
- + D Services: Replace HW Boiler - Oil/Gas - 205 to 1000 MBH Range at an estimated cost of \$19,597 in year 2018

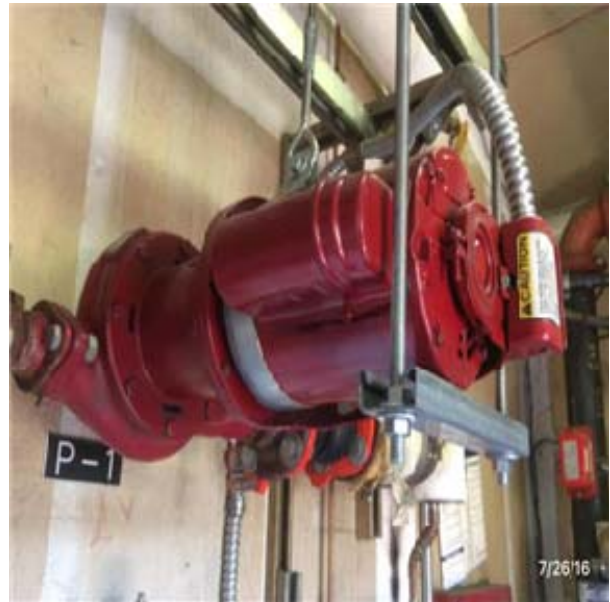
D3022 Boiler Room Piping & Specialties:- View of Boiler
Circulation Pump/Motors 1 H.P.

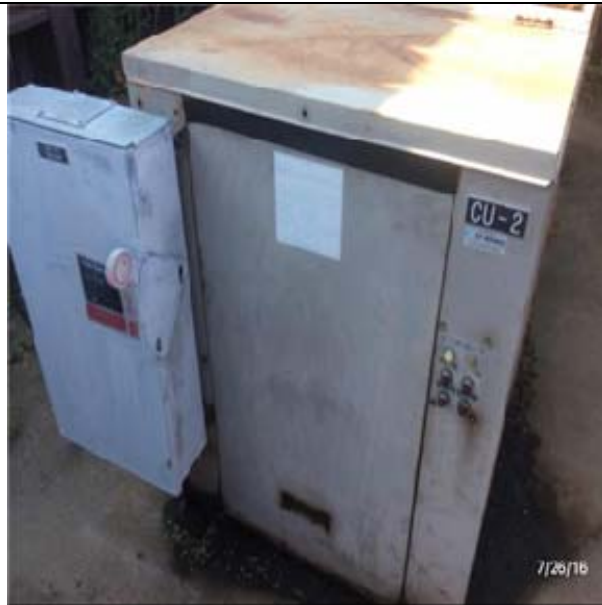
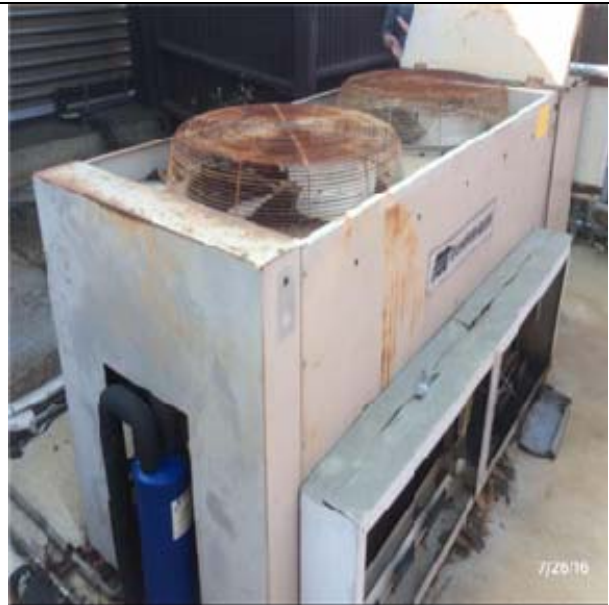
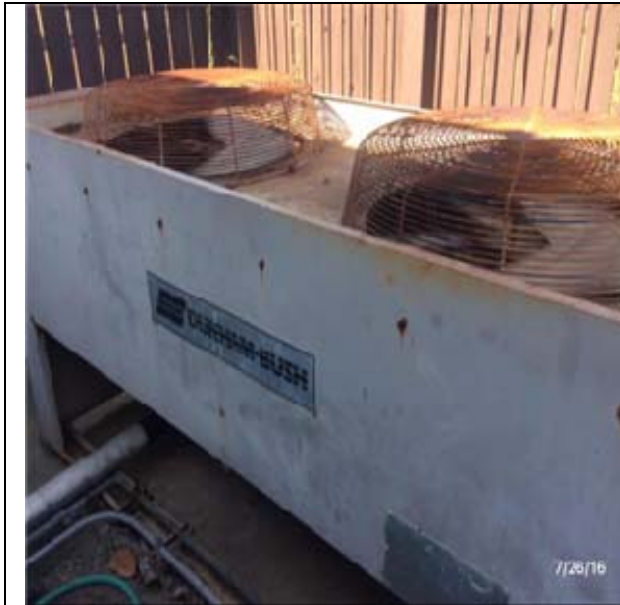
D3032 Direct Expansion Systems:- View of Split-System (Air Cooled Condenser Chiller Unit)

- + D Services: ADA Modifications to Lavatories at an estimated cost of \$5,000 in year 2016
- + D Services: Replace Split-System (Air Cooled Condenser Chiller Unit) at an estimated cost of \$20,418 in year 2016

- + D Services: Replace Split-System (Air Cooled Condenser Chiller Unit) at an estimated cost of \$30,627 in year 2016
- + D Services: Replace AHU - VAV System at an estimated cost of \$58,713 in year 2016

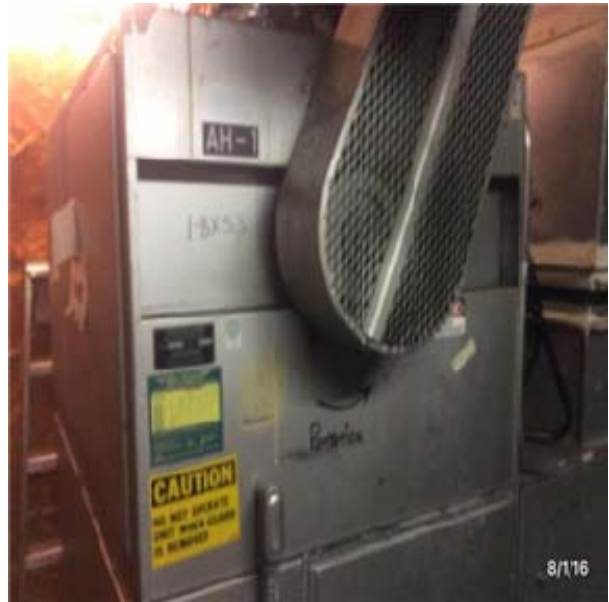
D3041 Air Distribution Systems:- View of AHU - VAV System

- + D Services: Replace AHU - VAV System at an estimated cost of \$58,713 in year 2016
- + D Services: Replace HVAC Pneumatic Controls at an estimated cost of \$73,062 in year 2016

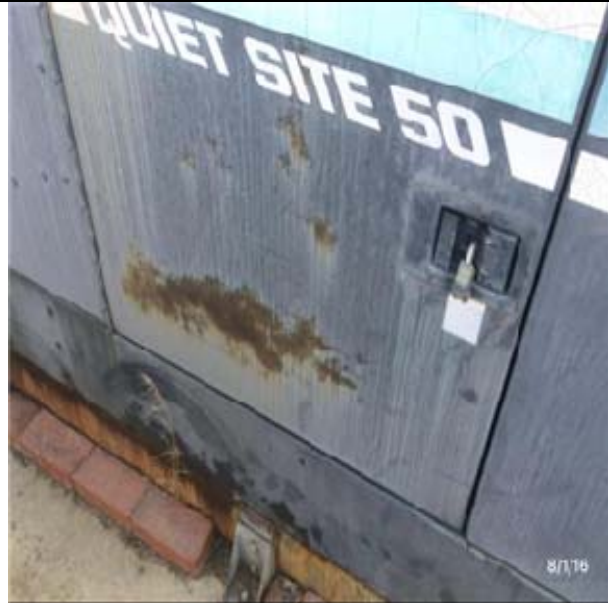
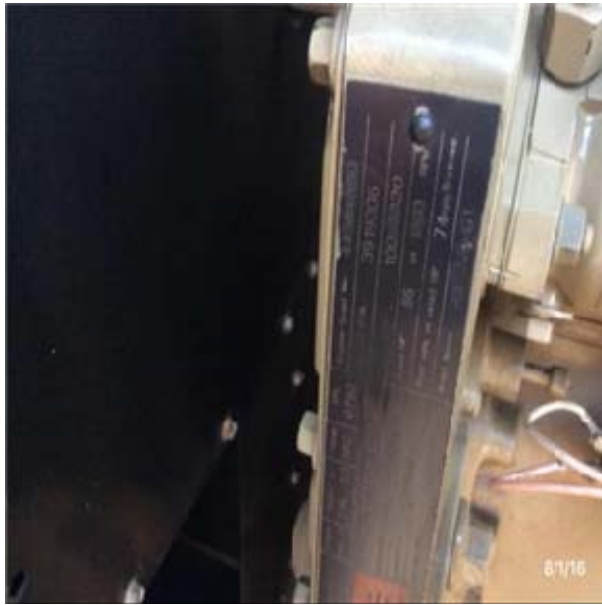
G4092 Site Emergency Power Generation:- View of Generator Sets, Diesel Engine - 50 kW
