**Tier 1 Report of
Facility Condition Assessment**

**For
City of Los Altos
Children's Corner
97 Hillview Avenue
Los Altos,
California 94022-3740**

Date of Report: June 10, 2016

Faithful+Gould, Inc.

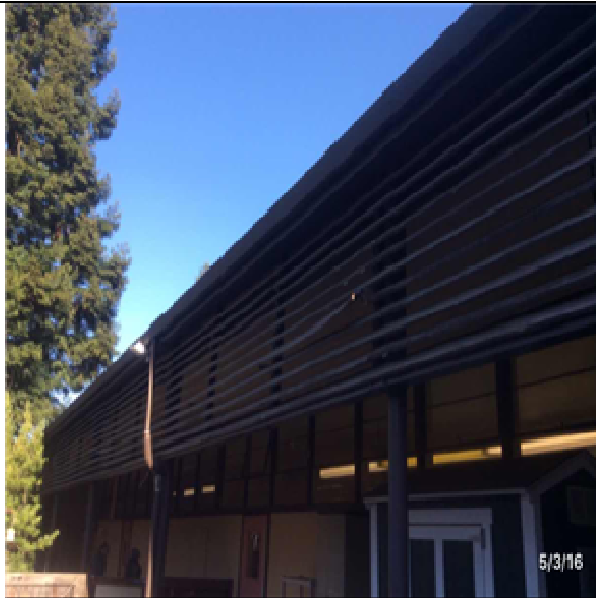
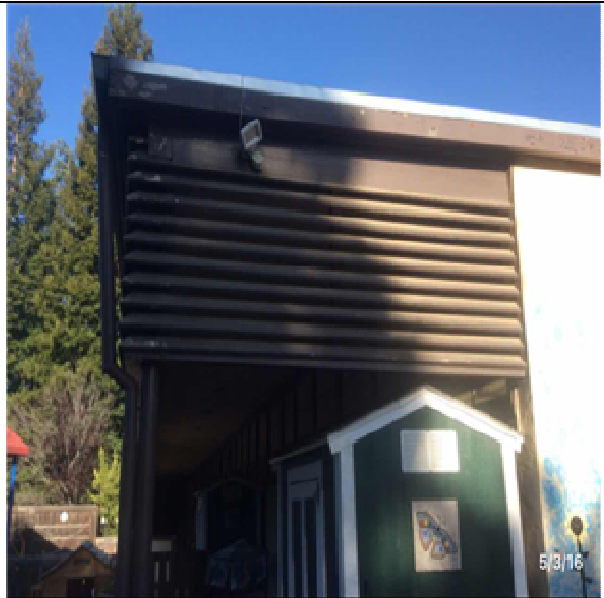
The wood has not been painted for a considerable time and is in a poor condition and in urgent need of repair and or replacement. It was reported that maintenance has been deferred due to the presence of lead based paint.

B2014 Exterior Sun Control Devices:- View of Exterior Sun Control Louvers

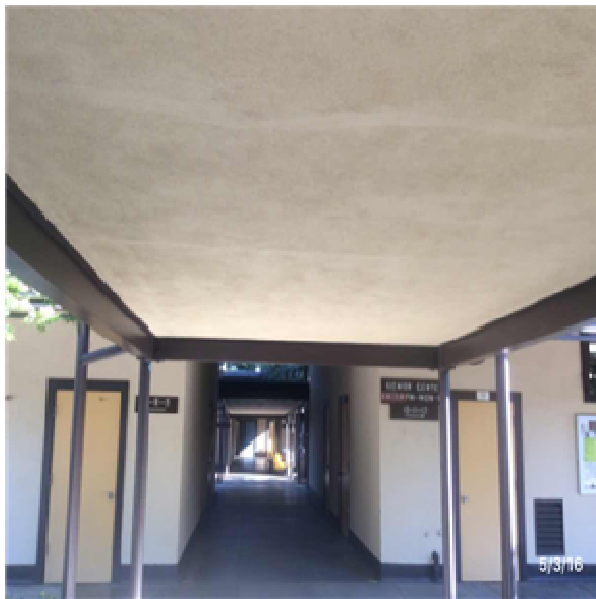
The exterior soffits appeared to be in fair condition; therefore we do not anticipate any actions during the study period. We do however recommend repainting of these surfaces later in the study period to maintain the appearance of the building and also protect the asset.

B2016 Exterior Soffits:- View of Exterior Soffits to Canopy

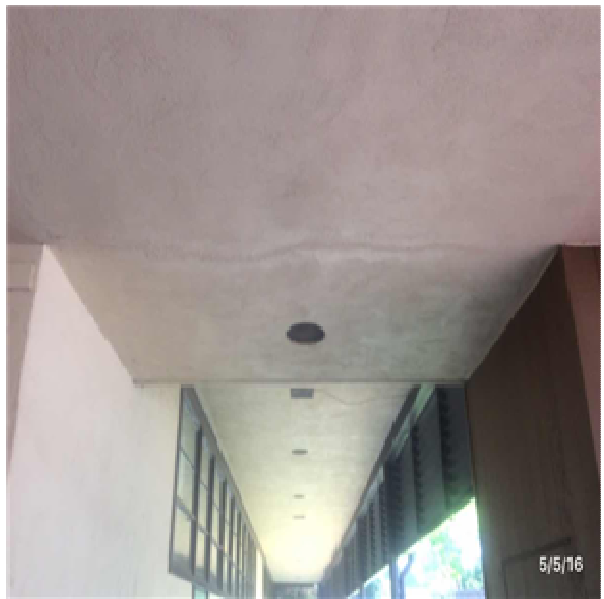
B2016 Exterior Soffits:- View of Exterior Soffits to Corridor

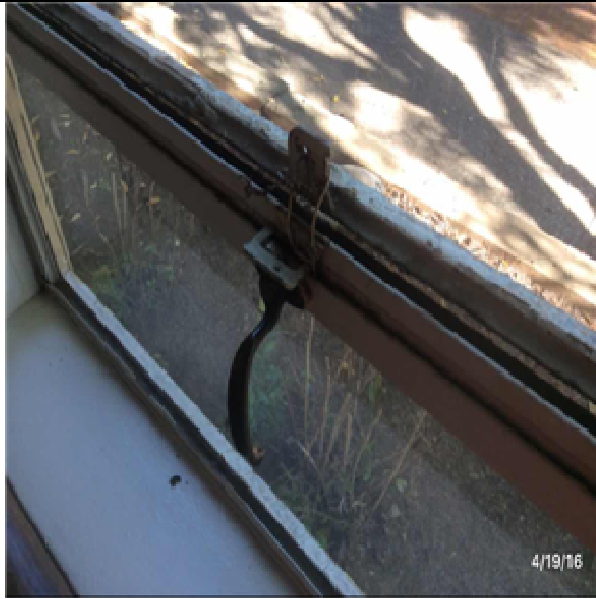
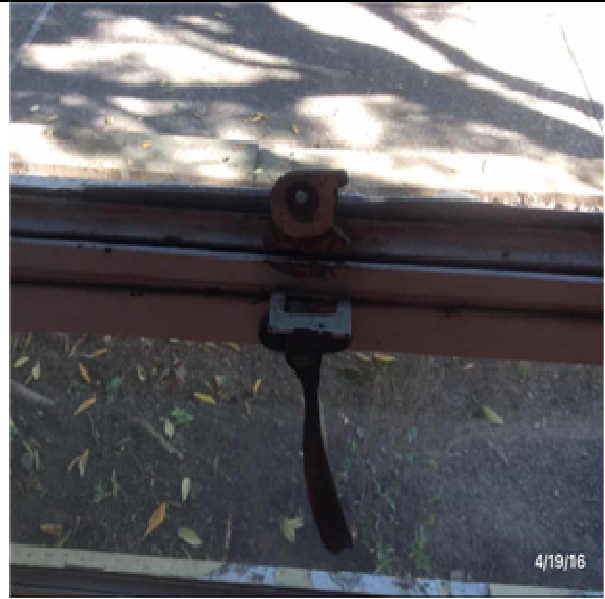
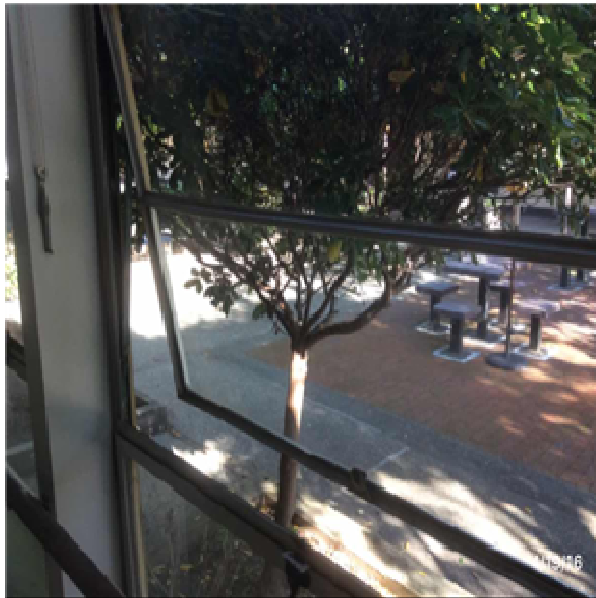
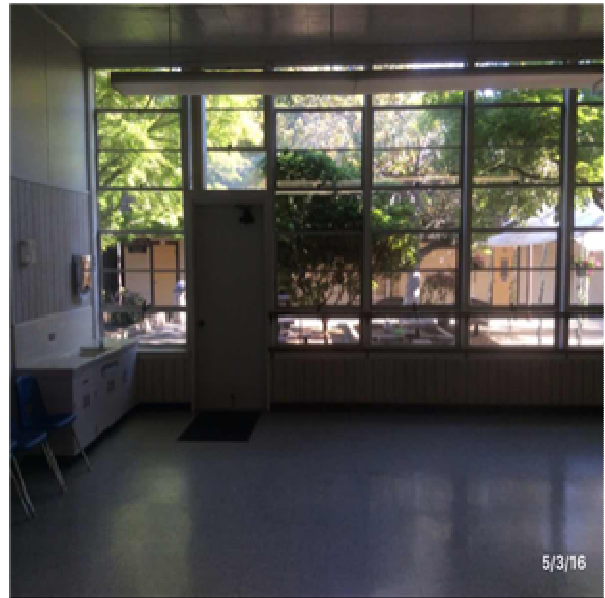
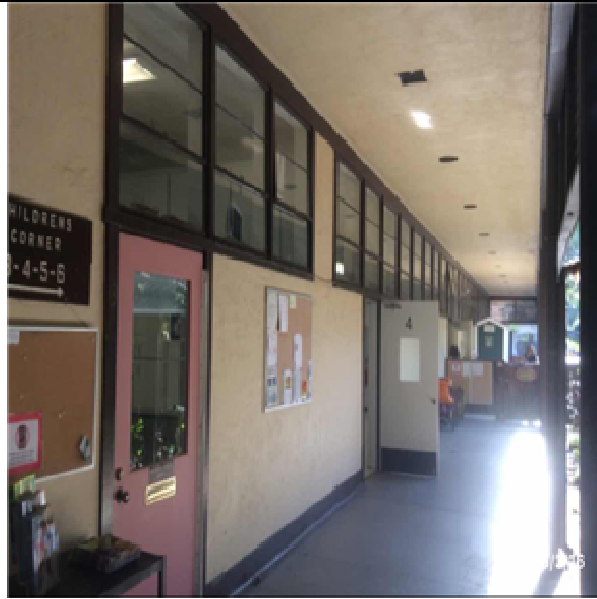
The windows at the building were observed to be in poor condition. We have assumed the windows to be original based on the current condition, which would put the windows well past their useful life. Glass has been replaced recently due to difficulty of operation, and the frames showed signs of rust and corrosion. Maintenance personnel reported that they are unable to find replacement window catches. We recommend replacing the window immediately in order to maintain the appearance and security of the building as well as prevent water penetration.

B2021 Windows:- View of Steel Window Units - Casement, Double Hung, Vent or Sliding

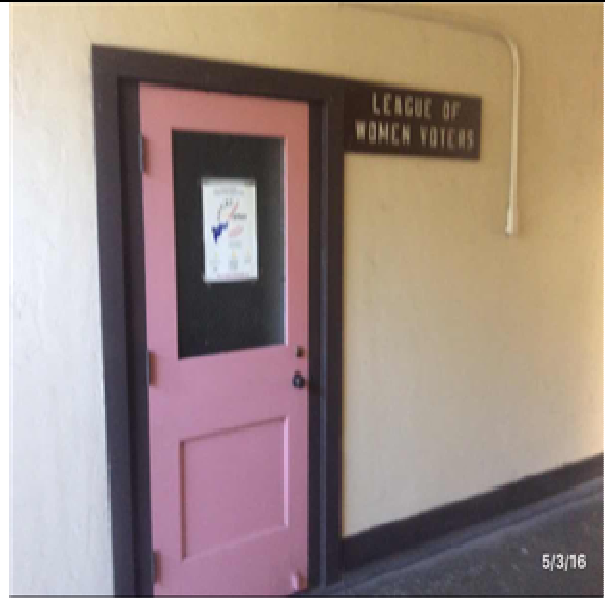
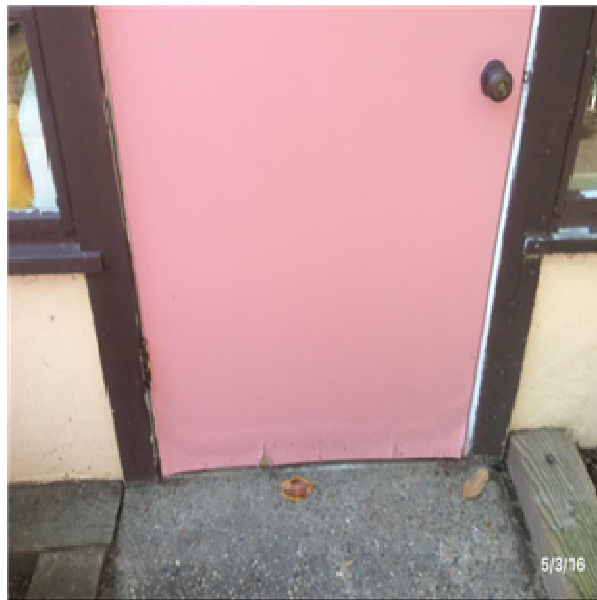
The wood doors at the building were observed to be in poor to fair condition. We have assumed the doors to be original based on the current condition, which would put the doors well past their useful life. Some doors have been repaired but there are signs of degradation. We recommend replacing the doors immediately in order to maintain the appearance and security of the building as well as prevent water penetration. The new door surface finish and door frames will require repainting later in the study period. The cost of this work has been included within the amount to undertake the repainted of the exterior walls.

B2032 Solid Exterior Doors:- View of Exterior Single Solid Core Wood Doors

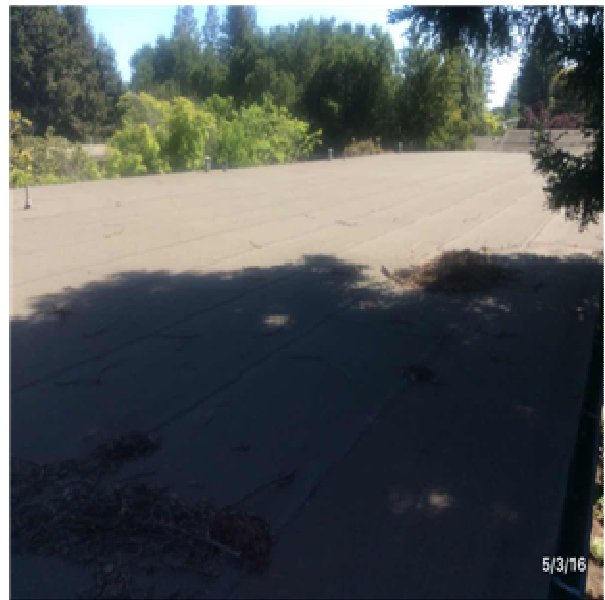
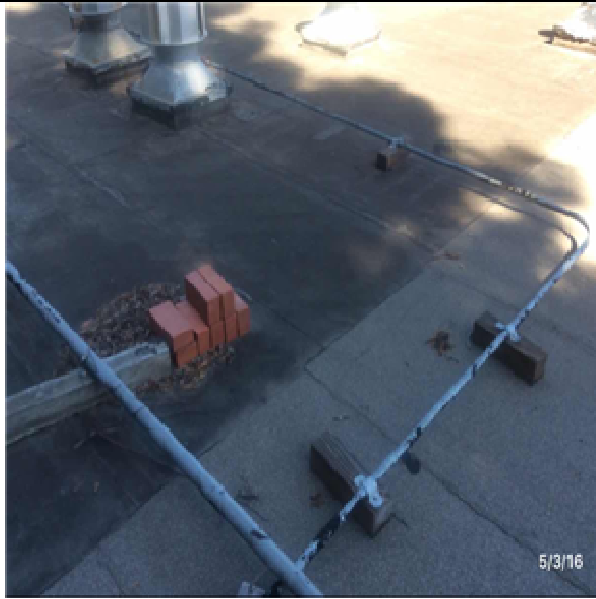
The BUR covering appeared to be in poor to fair condition with no reported leaks, however there is deterioration due to age and other similarly aged roofs to the Community Center have already been repaired. We are unaware of the age of the roof covering, however we assume it to be more than fifteen years of age, therefore based on the typical EUL of twenty years for this type of covering and current observed condition, we anticipate replacement early in the study period.

B3011 Roof Finishes:- View of BUR (Built-up Roofing) Covering

ID	Type	Recommendation	Priority	Year	Expenditures
134163	B3010	Replace BUR (Built-up Roofing) Covering to Canopy	Priority 2	2016	\$6,460
134164	B3010	Replace BUR (Built-up Roofing) Covering	Priority 2	2016	\$56,165
134165	B3010	Replace Galvanized Steel Perimeter Gutters & Downspout	Priority 2	2016	\$3,242

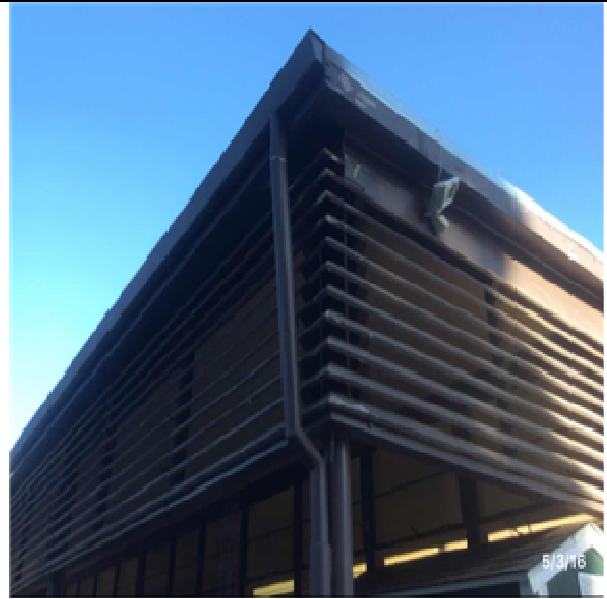
The gutters appear in poor condition. Maintenance personnel reported that the gutters and down spouts are difficult to maintain due to the fact that they are connected directly to the below ground drainage. The typical EUL for this type of gutter system is twenty years; therefore, we recommend replacing the gutters and downspouts at the beginning of the study period.

B3016 Gutters and Downspouts:- View of Galvanized Steel Perimeter Gutters & Downspout

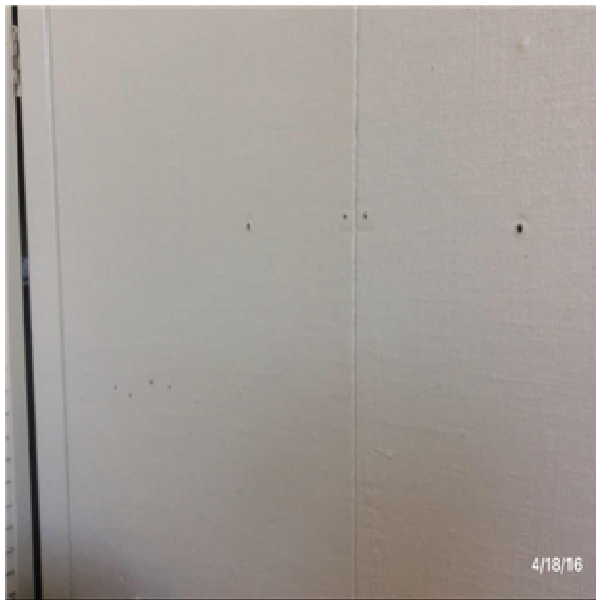
The wall construction is not visible due to its location, however, there are no instances of deterioration, cracking or damage observed. Therefore no actions will be generated during the study period for works associated with the fixed partitions.

C1011 Fixed Partitions:- View of Stud Walls with board finish

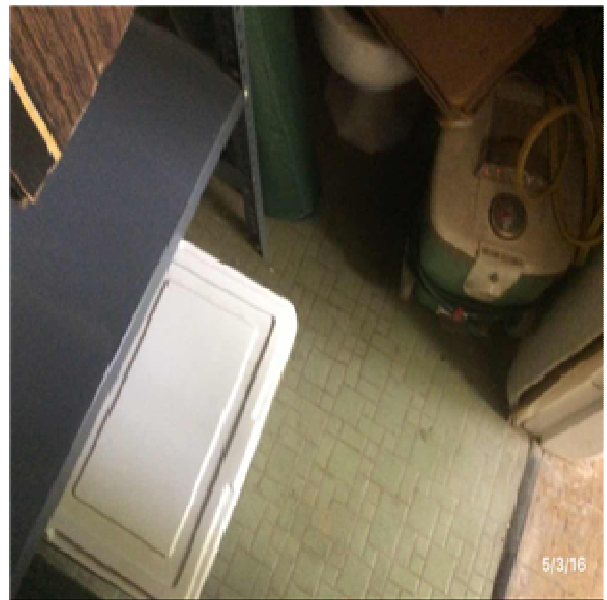
The floor finishes appeared in poor - fair condition throughout the building. The ceramic tile at the restroom was in fair - poor condition given its age. The ceramic tile has a EUL of thirty years, however this restroom is currently out of use and we did not observe any broken or loose tiles or missing grout; therefore, we expect the ceramic tile to last beyond the study period. The vinyl tile have a EUL of eighteen years; however, considering the observed condition, we have extended the RUL on this flooring to later in the study period.

C3024 Flooring:- View of Ceramic Tile

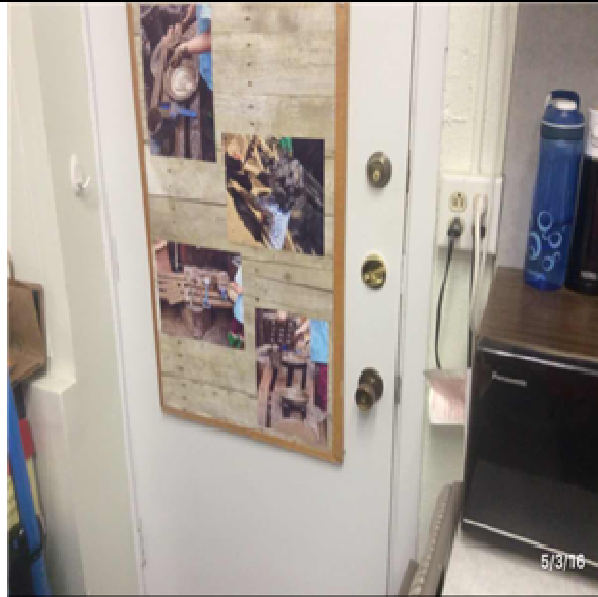
C1021 Interior Doors:- View of Interior Single Wood Door(s)

ID	Type	Recommendation	Priority	Year	Expenditures
134166	C1020	Replace Interior Single Wood Door(s)	Priority 3	2021	\$4,389

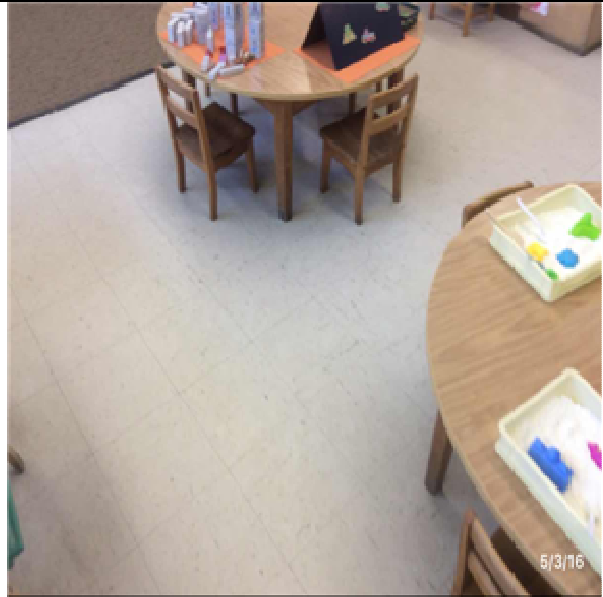
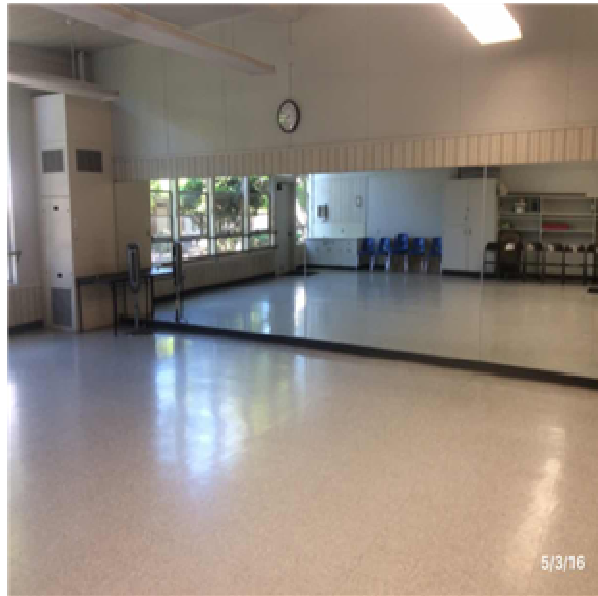
C3024 Flooring:- View of Vinyl Composite Tile (VCT)

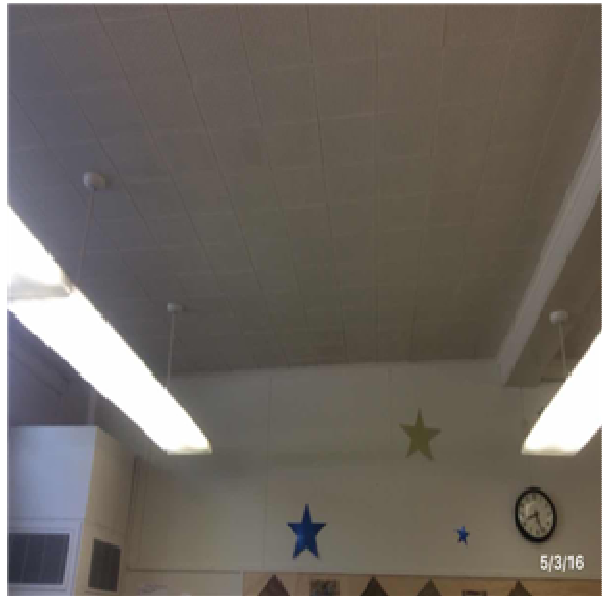
The acoustic tiles appeared in fair condition overall with no noticeable separation; however based on their age and the fact that the tile may be hard to source for repairs, we have included to replace the ceiling tiles later in the study period.

C3032 Suspended Ceilings:- View of Acoustic Ceiling System - Standard

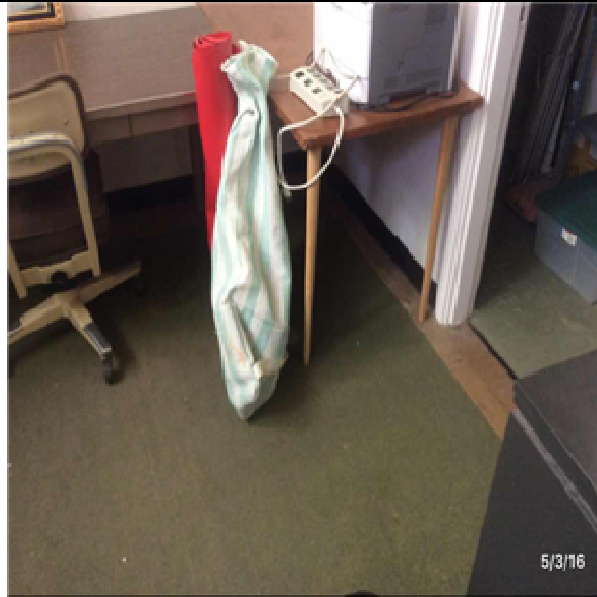
The carpet at the offices is in fair condition. We are unaware of the age of the carpeting, however we assume it to be more than fifteen years of age, therefore based on the typical EUL of ten years for this type of covering and current observed condition, we anticipate replacement early in the study period.

C3025 Carpeting:- View of Broadloom Standard without Padding

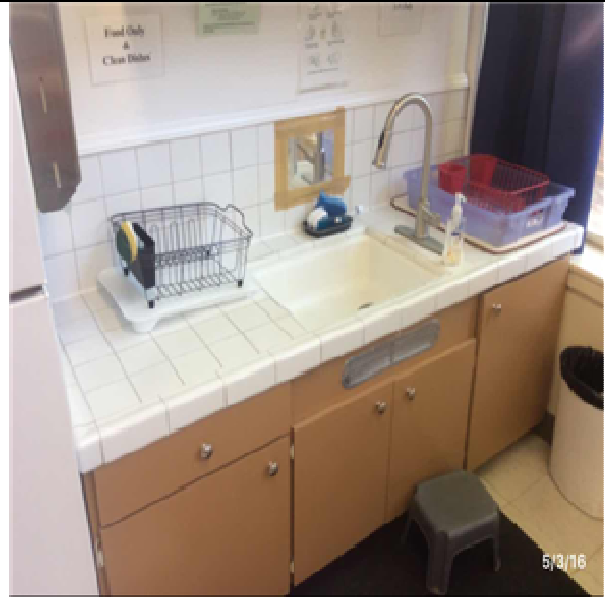
The lavatories were observed to be in poor condition. The countertop lavatories drained properly and appeared to not have any cracks in the china; however, they are assumed to be original and based on their typical EUL of thirty-five years we recommend that they are considered for replacement during the study period. The wall mounted lavatory was observed to be in a poor condition, however, it was reported as not in use by maintenance personnel so has not been included in the study.

D2013 Lavatories:- View of Vanity Top Lavatories

ID	Type	Recommendation	Priority	Year	Expenditures
134171	D2010	Replace Vanity Top Lavatories	Priority 2	2016	\$3,938
134172	D2010	ADA kitchen	Priority 1	2016	\$2,800

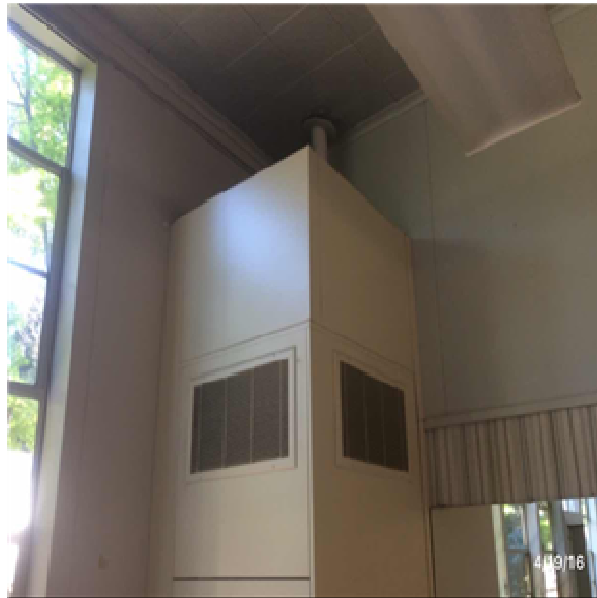
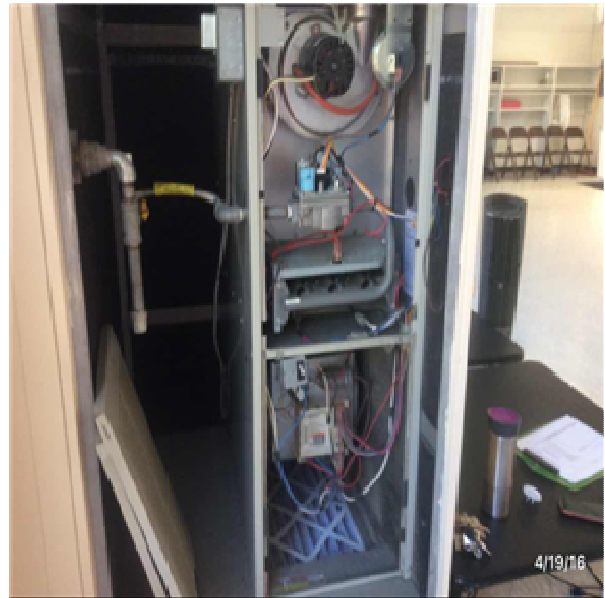
The heater in room 4 appeared to be in fair condition. Heater units such as this typically have a EUL of thirty years; therefore based on the RUL and current observed condition of the systems the unit has been recommended for replacement later in the study period to maintain reliable and efficient operation.

D3021 Boilers:- View of Furnace – Gas

ID	Type	Recommendation	Priority	Year	Expenditures
134173	D3020	Replace Furnace - Gas	Priority 3	2025	\$6,000
134174	D3020	Replace Furnace - Gas	Priority 3	2025	\$6,000
134175	D3020	Replace Furnace - Gas	Priority 3	2025	\$6,000

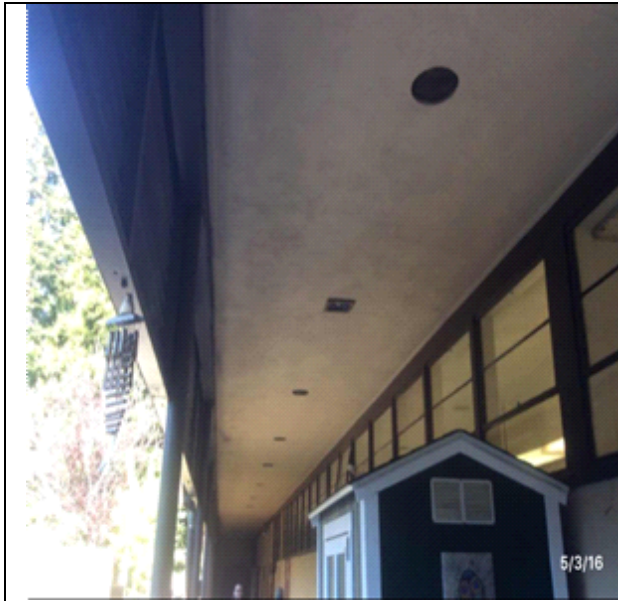
D5022 Lighting Equipment:- View of Recessed Can Light Fixture(s)

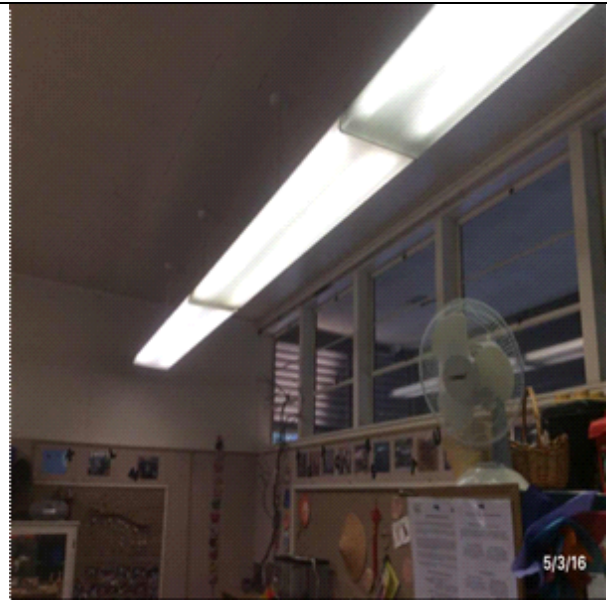
D5022 Lighting Equipment:- View of Interior Light Fixtures - Fluorescent

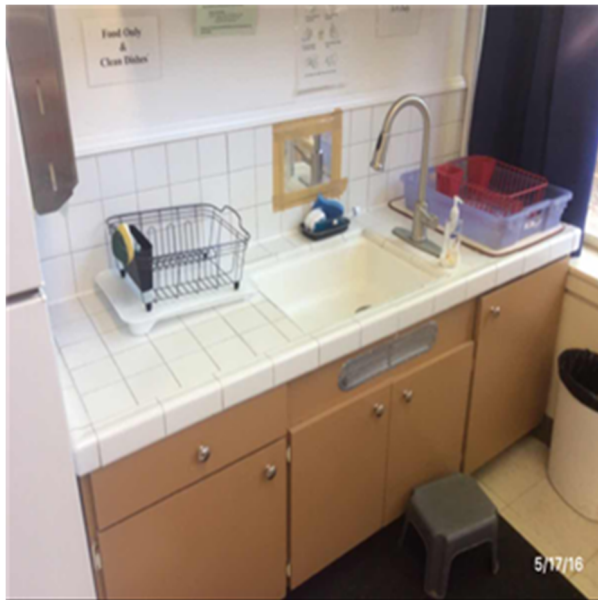
E2012 Fixed Casework:- View of Kitchen Cabinet(s) - Standard

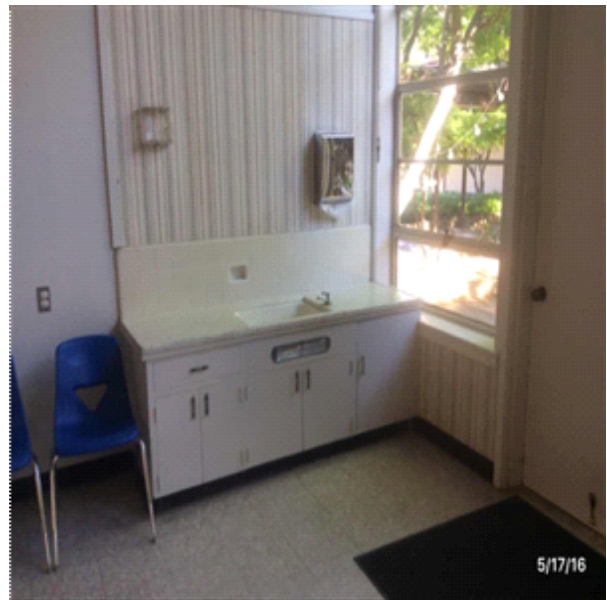
E1095 Unit Kitchens:- View of Unit Kitchens - Counter Top - Ceramic
