Facility Condition Assessment

**For
City of Los Altos
Classrooms 13-15
97 Hillview Avenue
Los Altos,
California 94022-3740**

Date of Report: June 10, 2016

Faithful+Gould, Inc.

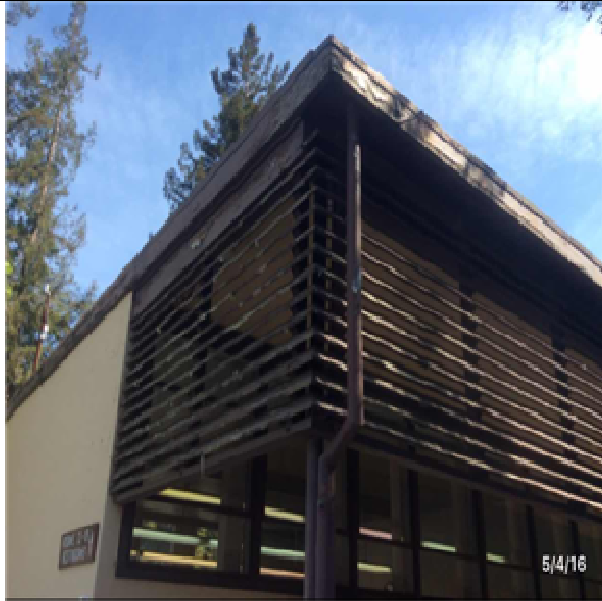
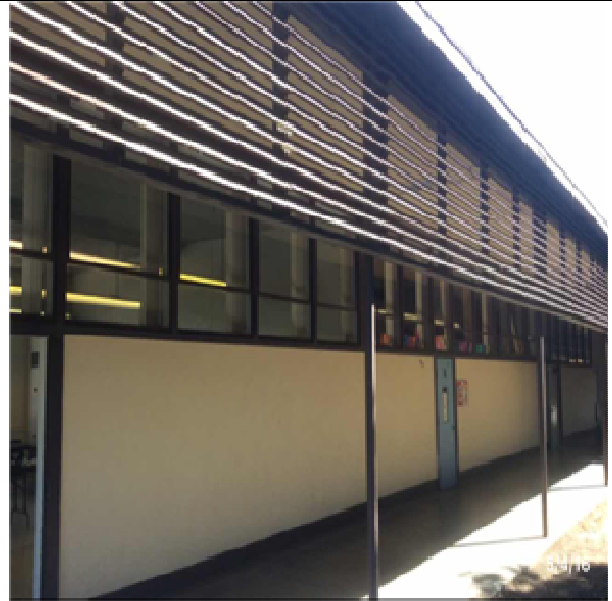
B2014 Exterior Sun Control Devices:- View of Exterior Sun Control Louvers

ID	Type	Recommendation	Priority	Year	Expenditures
134807	B2010	Repaint Exterior Wall Surfaces	Priority 3	2018	\$1,905
134808	B2010	Replace Exterior Sun Control Louvers	Priority 2	2016	\$21,105
134809	B2020	Replace Steel Window Units - Casement, Double Hung, Vent or Sliding	Priority 2	2016	\$96,067
134810	B2030	Replace Single Solid Core Wood Doors	Priority 2	2016	\$19,751
134811	B2030	ADA Doors	Priority 1	2016	\$186,282

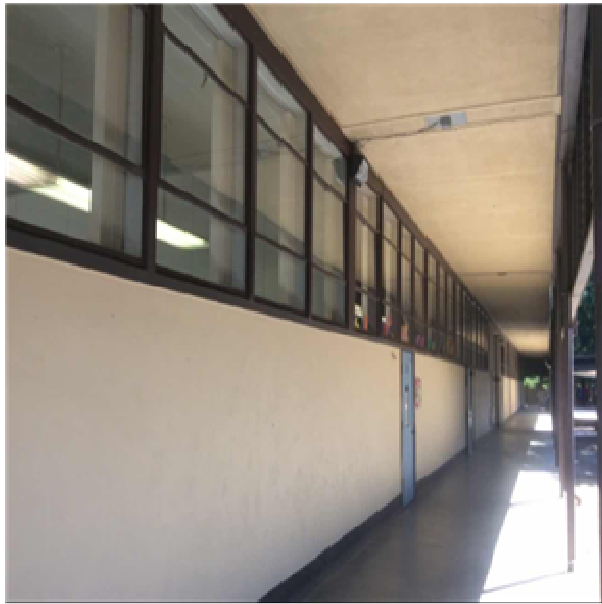
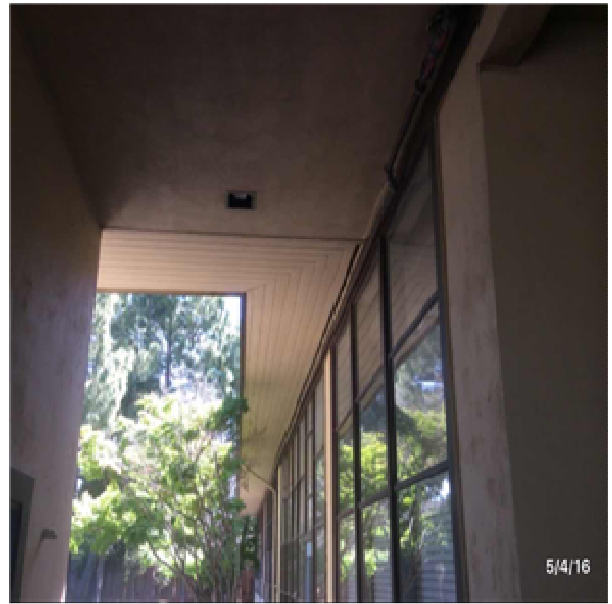
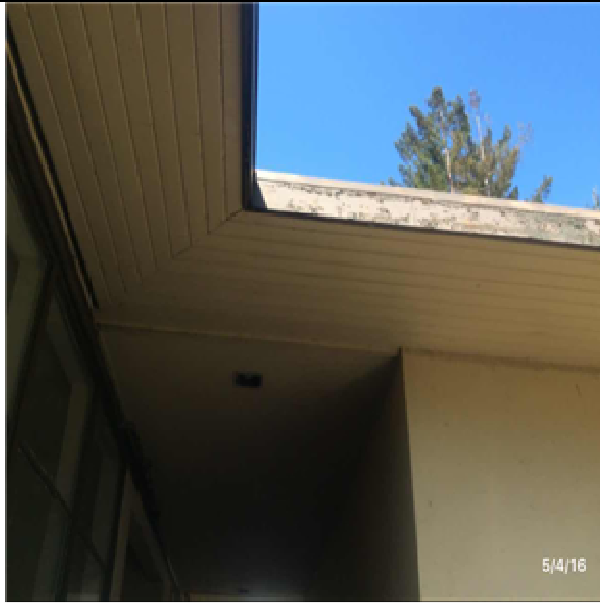
The wood has not been painted for a considerable time and is in a poor condition and in urgent need of repair and or replacement. It was reported that maintenance has been deferred due to the presence of lead based paint.

B2016 Exterior Soffits:- View of Exterior Soffits

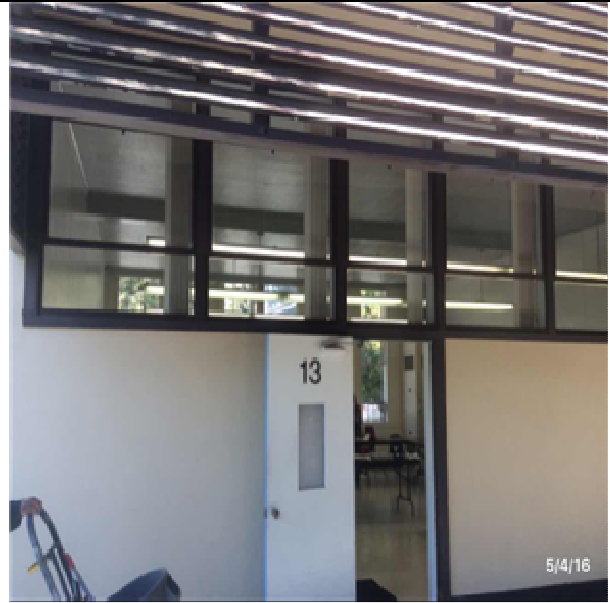
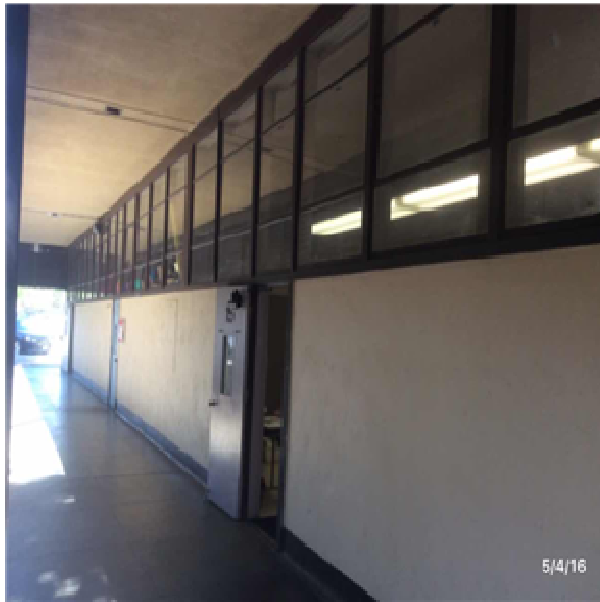
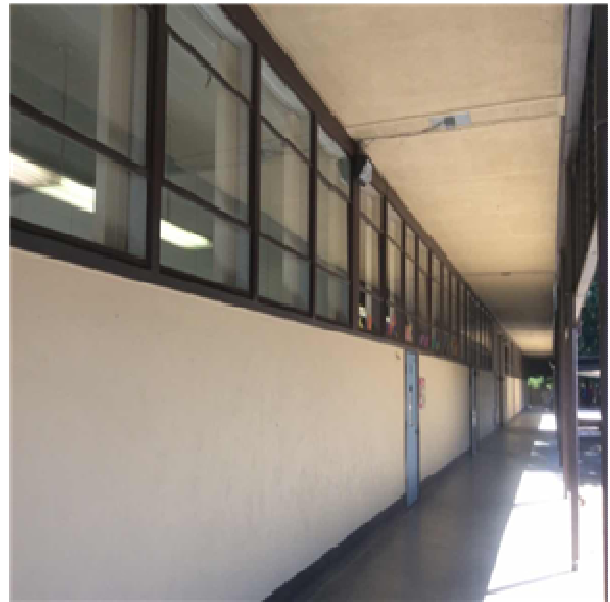
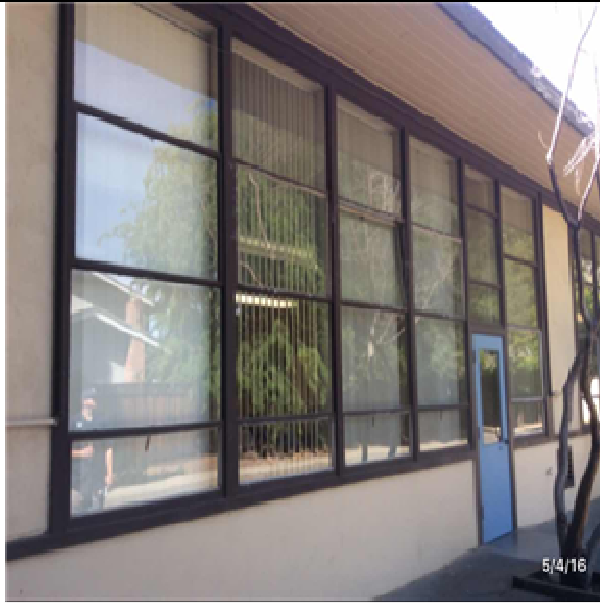
The windows at the building were observed to be in poor condition. We have assumed the windows to be original based on the current condition, which would put the windows well past their useful life. Glass has been replaced recently due to difficulty of operation, and the frames showed signs of rust and corrosion. We recommend replacing the window immediately in order to maintain the appearance and security of the building as well as prevent water penetration.

B2021 Windows:- View of Steel Window Units - Casement, Double Hung, Vent or Sliding

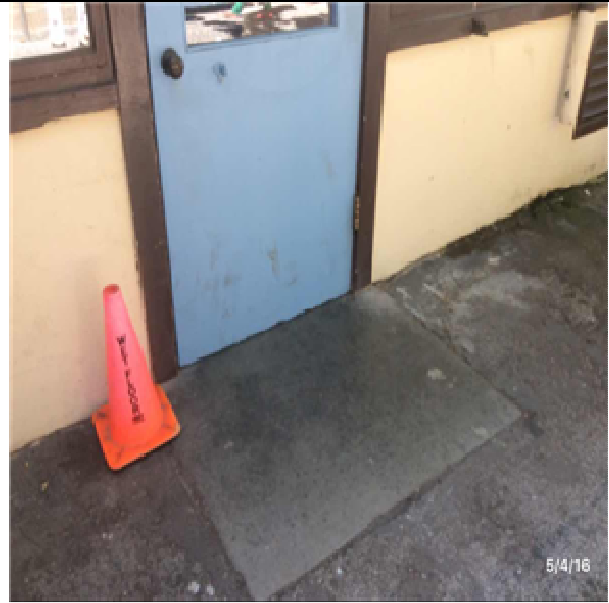
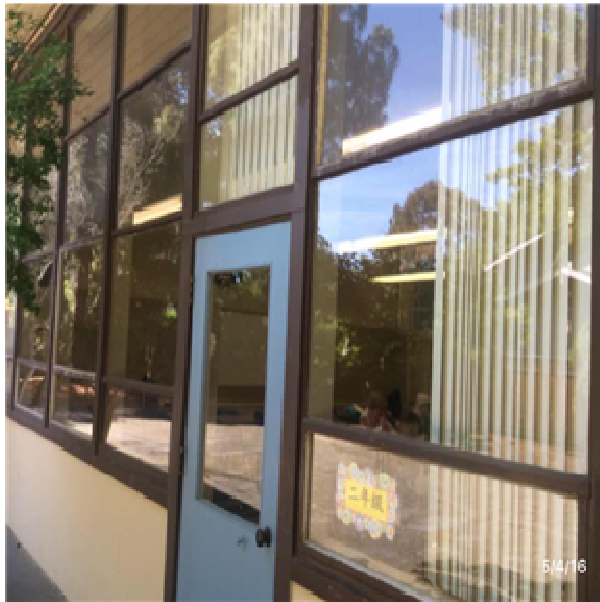
The wood doors at the building were observed to be in poor to fair condition. We have assumed the doors to be original based on the current condition, which would put the doors well past their useful life. Some doors have been repaired but there are signs of degradation. We recommend replacing the doors immediately in order to maintain the appearance and security of the building as well as prevent water penetration. The new door surface finish and door frames will require repainting later in the study period. The cost of this work has been included within the amount to undertake the repainted of the exterior walls.

B2032 Solid Exterior Doors:- View of Single Solid Core Wood Doors

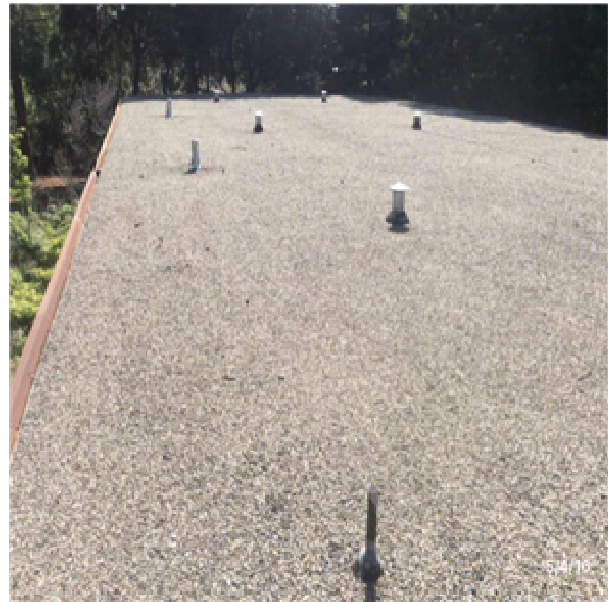
The BUR covering appeared to be in poor condition with evidence of leaks observed. The maintenance personnel also verified reported roof leaks. There is deterioration due to age and other similarly aged roofs to the Community Center have already been repaired. We are unaware of the age of the roof covering, however we assume it to be more than fifteen years of age, therefore based on the typical EUL of twenty years for this type of covering and current observed condition, we anticipate replacement early in the study period.

B3011 Roof Finishes:- View of BUR (Built-up Roofing) System

ID	Type	Recommendation	Priority	Year	Expenditures
134812	B3010	Replace BUR (Built-up Roofing) System	Priority 2	2016	\$95,555
134813	B3010	Replace Galvanized Steel Perimeter Gutters & Downspout	Priority 2	2016	\$2,759

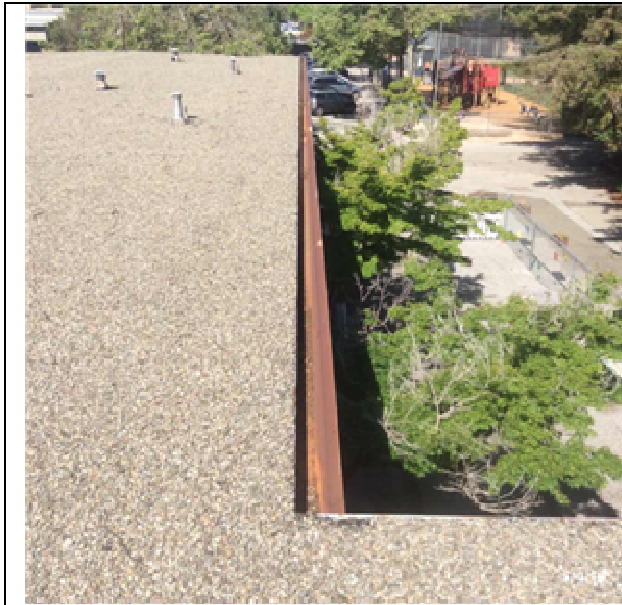
The gutters appear in poor condition. Maintenance personnel reported that the gutters and down spouts are difficult to maintain due to the fact that they are connected directly to the below ground drainage. The typical EUL for this type of gutter system is twenty years; therefore, we recommend replacing the gutters and downspouts at the beginning of the study period.

B3016 Gutters and Downspouts:- View of Galvanized Steel Perimeter Gutters & Downspout

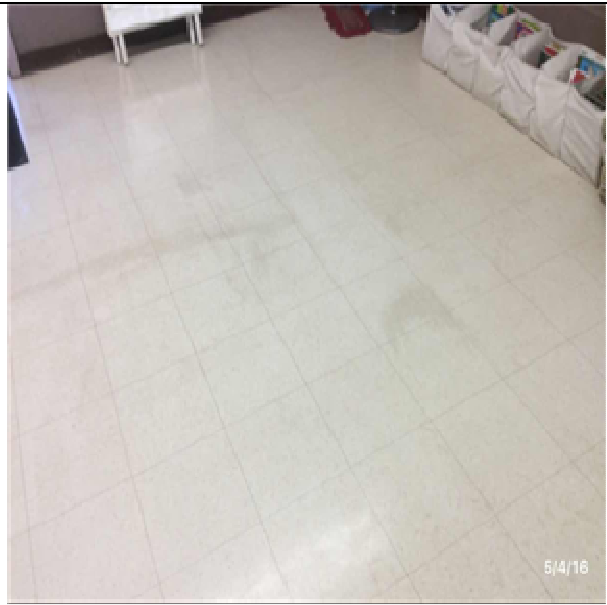
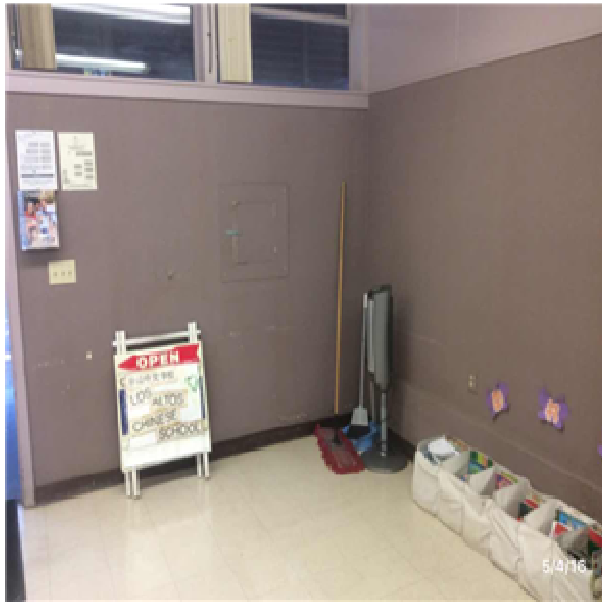
The floor finishes appeared in poor - fair condition throughout the building. We are unaware of the age of the epoxy floor covering at the storage areas, however we assume it to be more than fifteen years of age, therefore based on the typical EUL of ten years for this type of covering and current observed condition, we anticipate replacement early in the study period. The vinyl tile have a EUL of eighteen years; however, considering the observed condition, we have extended the RUL on this flooring to later in the study period.

C3024 Flooring:- View of Vinyl Composite Tile (VCT)

ID	Type	Recommendation	Priority	Year	Expenditures
134814	C3010	Replace Painted Finish - Standard	Priority 2	2018	\$13,896
134815	C3020	Replace Epoxy Floor Coating	Priority 2	2016	\$4,410
134816	C3020	Replace Vinyl Composite Tile (VCT)	Priority 2	2021	\$21,204
134817	C3030	Replace Acoustic Ceiling System - Standard	Priority 3	2021	\$15,020

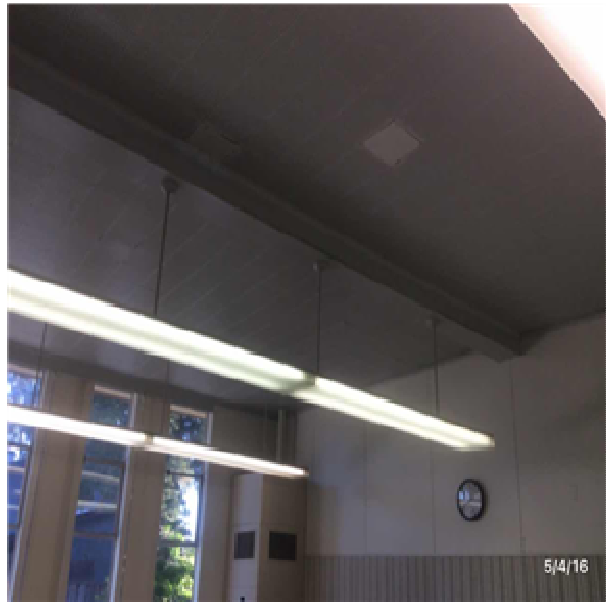
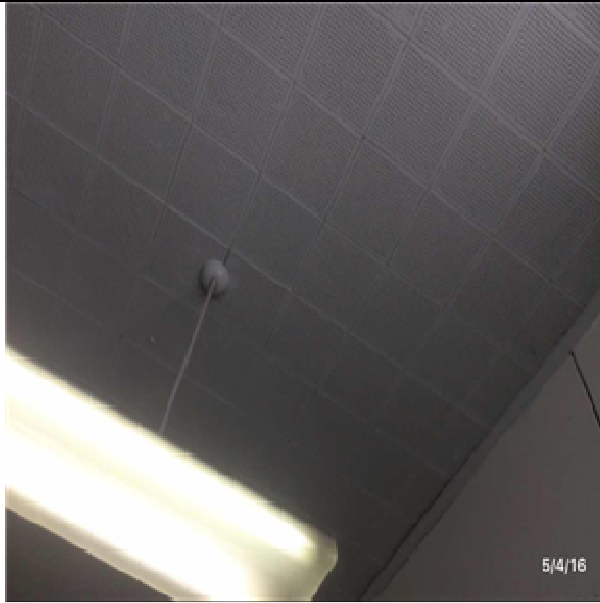
The acoustic tiles appeared in fair condition overall with no noticeable separation; however based on their age and the fact that the tile may be hard to source for repairs, we have included to replace the ceiling tiles later in the study period. The GWB ceilings appeared to be in a fair condition therefore we do not anticipate replacement during the study period.

C3032 Suspended Ceilings:- View of Acoustic Ceiling System - Standard

C3032 Suspended Ceilings:- View of Acoustic Ceiling System
- Standard

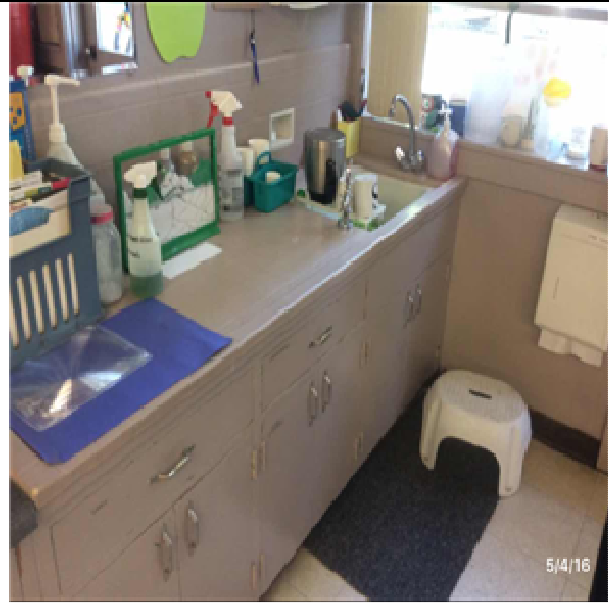
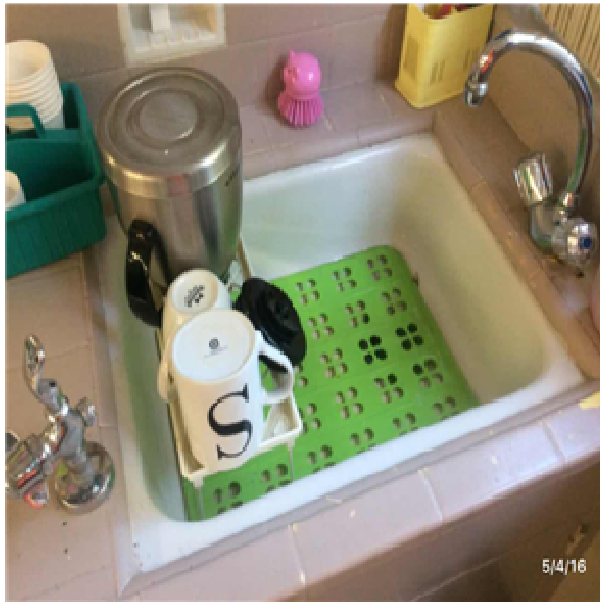
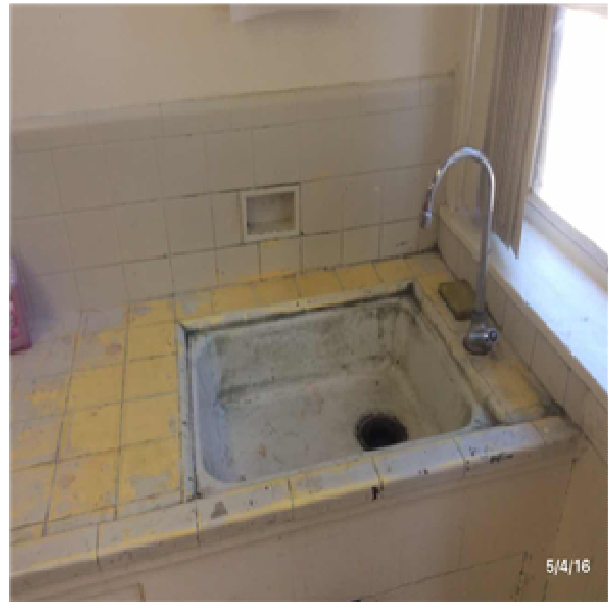
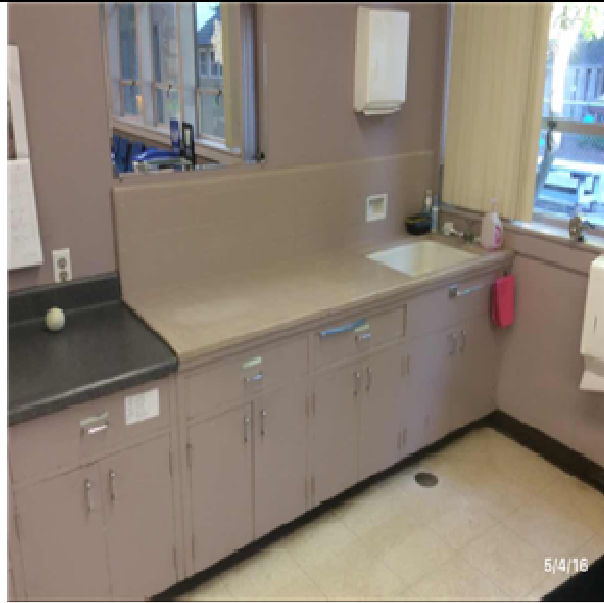
The lavatories were observed to be in poor condition. The lavatories drained properly and appeared to not have any cracks in the china; however, they are assumed to be original and based on their typical EUL of thirty-five years we recommend that they are considered for replacement during the study period.

D2013 Lavatories:- View of Vanity Top Lavatories

ID	Type	Recommendation	Priority	Year	Expenditures
134818	D2010	Replace Vanity Top Lavatories	Priority 2	2016	\$3,938
134819	D2010	ADA Kitchen	Priority 1	2016	\$6,720

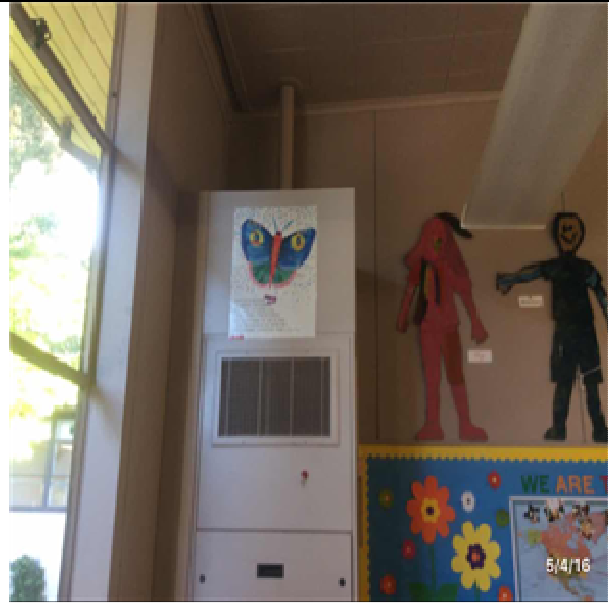
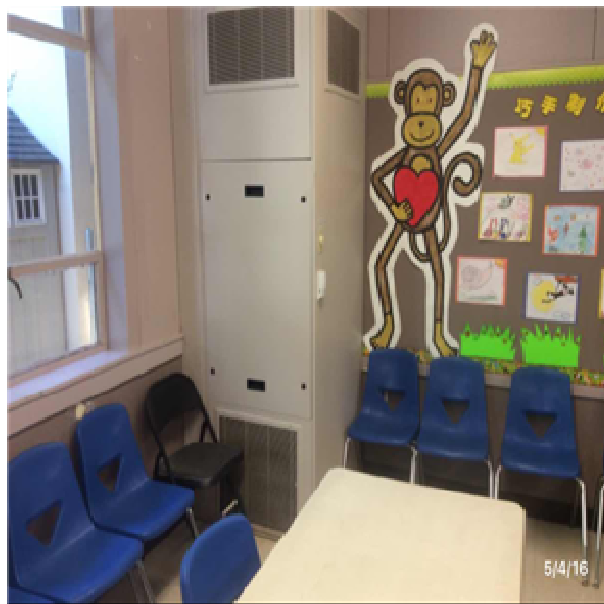
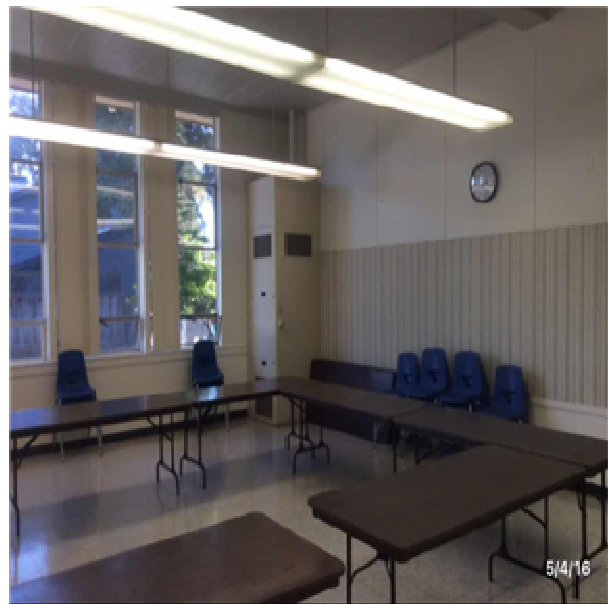
The heaters appeared to be in fair condition. Heater units such as this typically have a EUL of thirty years; therefore based on the RUL and current observed condition of the systems the units have been recommended for replacement later in the study period to maintain reliable and efficient operation.

D3021 Boilers:- View of Furnace - Gas

ID	Type	Recommendation	Priority	Year	Expenditures
134820	D3020	Replace Furnace - Gas	Priority 3	2025	\$6,000
134821	D3020	Replace Furnace - Gas	Priority 3	2025	\$6,000
134822	D3020	Replace Furnace - Gas	Priority 3	2025	\$6,000

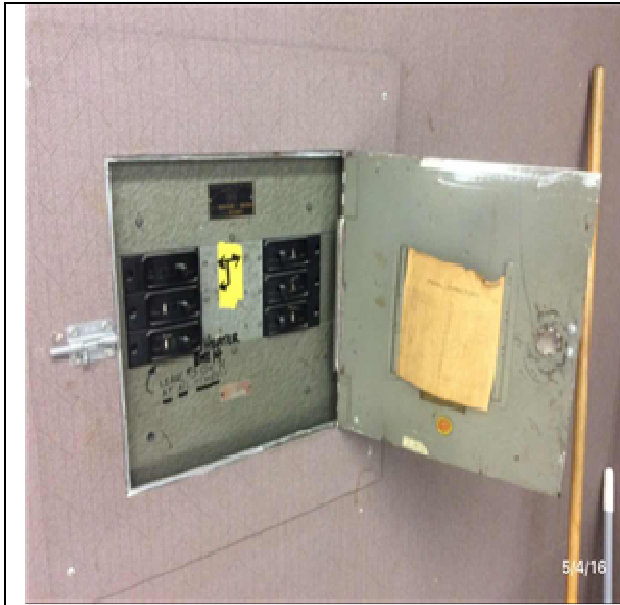
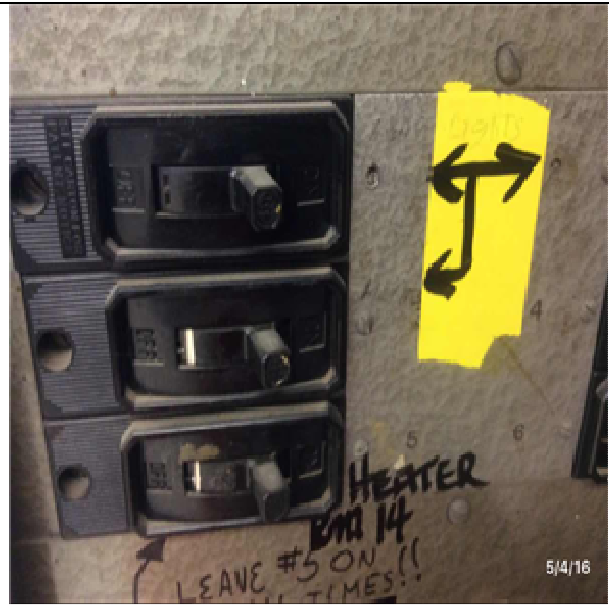
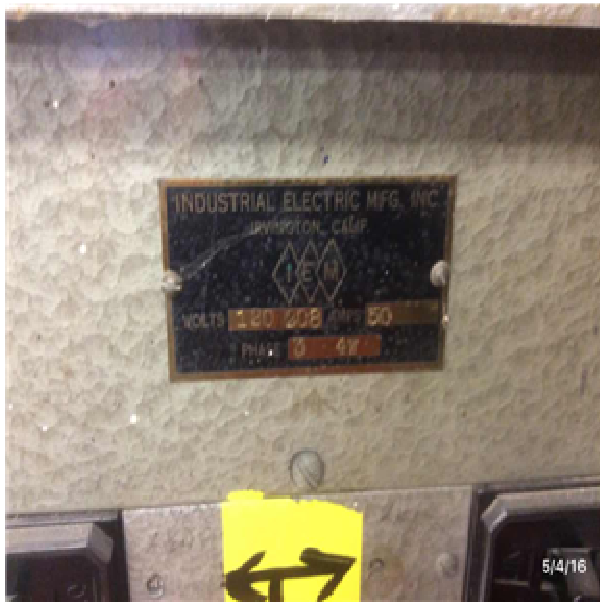
The MDP and branch panels appeared to be in poor condition due to their age. There were no signs of deterioration at the panels. The typical EUL for electrical switchboard such as this is thirty years; therefore replacement will be necessary immediately. We do recommend further evaluation of the branch panels via an infrared electrical inspection which will highlight if high temperatures, excessive electrical resistance, failing components, ground faults and short circuiting issues exist.

D5012 Low Tension Service & Dist:- View of Panelboards -
120/208volts, 60amp

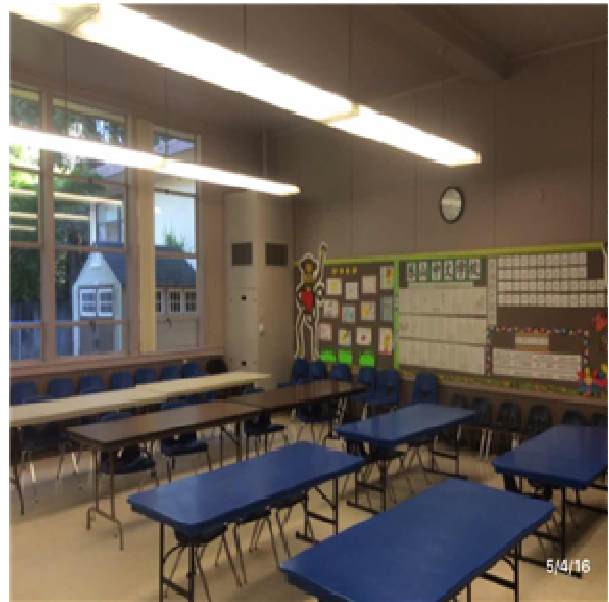
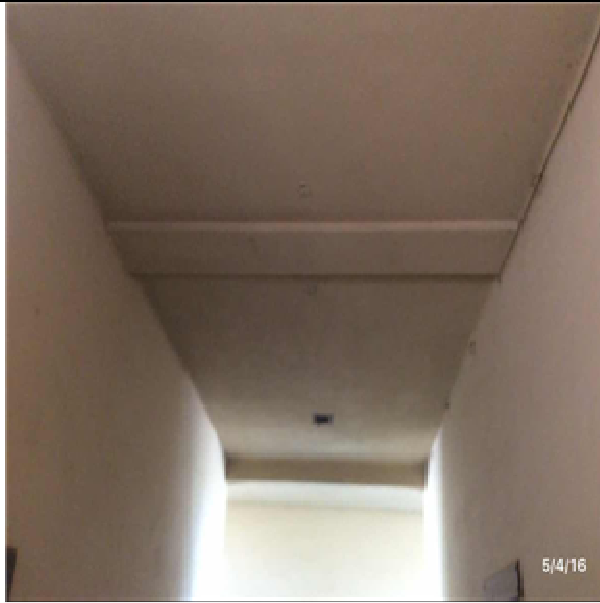
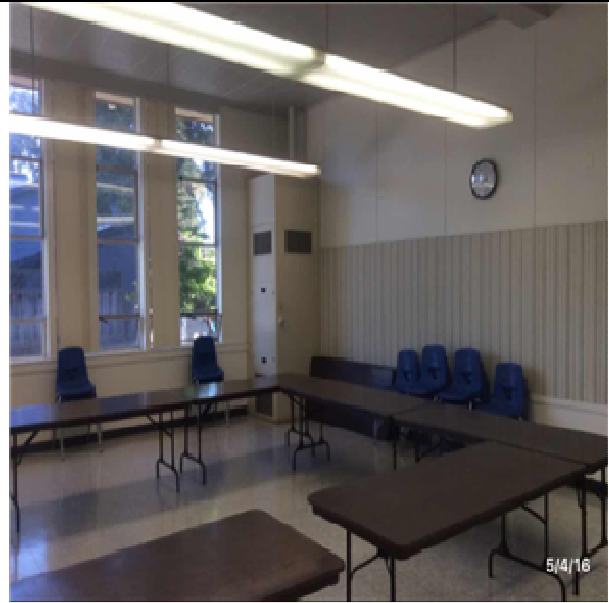
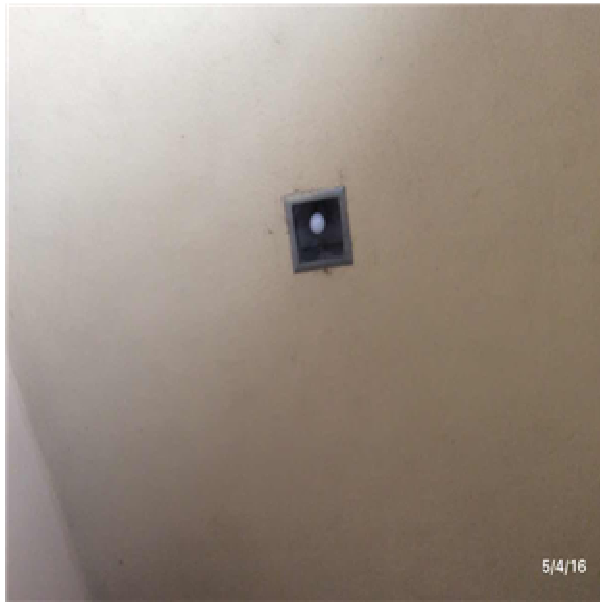
D5022 Lighting Equipment:- View of Interior Light Fixtures -
Fluorescent

D5022 Lighting Equipment:- View of Recessed Can Light Fixtures

D5022 Lighting Equipment:- View of Interior Light Fixtures - Fluorescent
