**Tier 1 Report of**

**Facility Condition Assessment**

**For  
City of Los Altos  
Concessions / Restroom  
97 Hillview Avenue  
Los Altos,  
California 94022-3740**

**Date of Report: June 10, 2016**

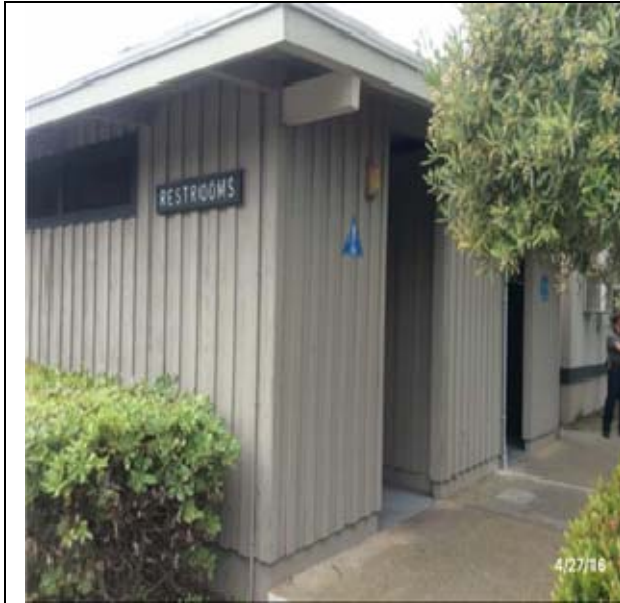
A1011 Wall Foundations:- View of Slab-on-Grade Reinforced Concrete Raft

The footings are not visible due to their location below the exterior wall construction. However there is no deterioration to the wall constructions that they are supporting, therefore we assume them to be in fair condition and free from defects. We do not anticipate a requirement for replacement during the study period.

The slab-on-grade was observed to be in fair condition, there were no signs of undue settling or cracks noted. We do not anticipate replacement or repair during the study period.

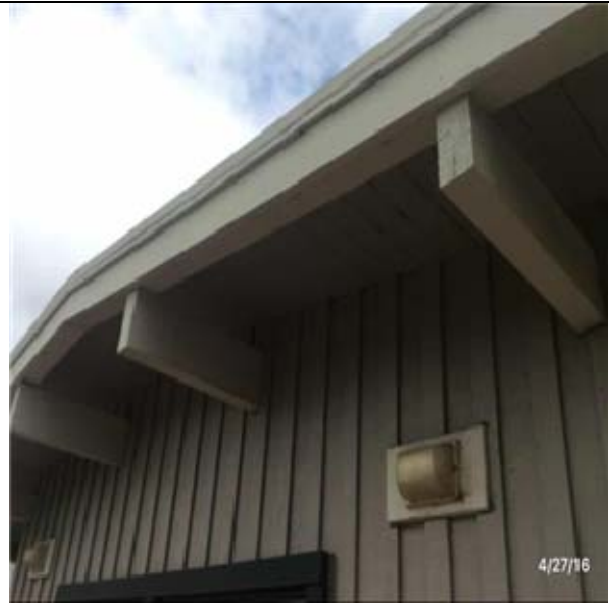
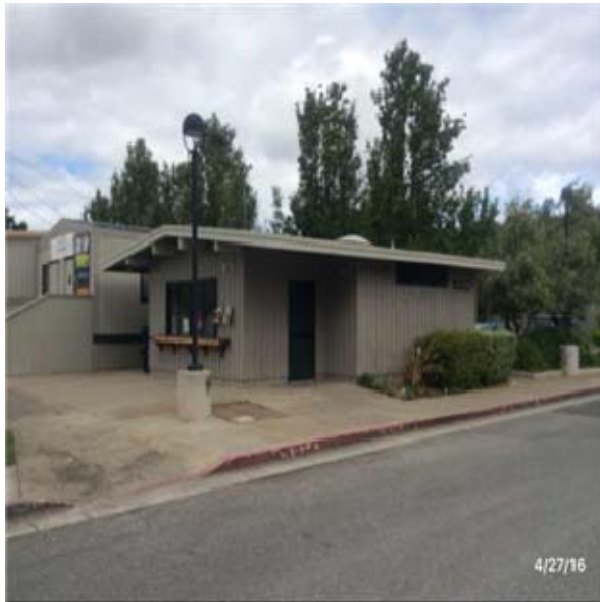
B1022 Pitched Roof Construction:- View of Traditional Wood Beams and Rafters

The roof construction and deck are visible due to the open construction and there are no signs of roof leaks or roof deflection therefore, no action for repair or replacement is required within the study period.

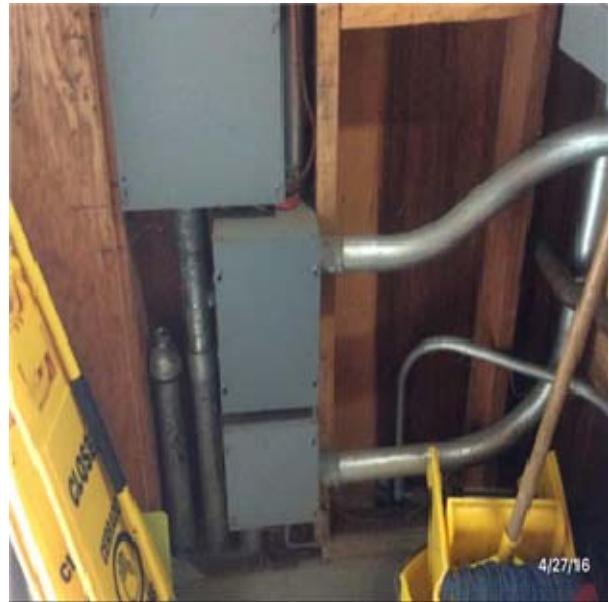
B1033 Wood Frame Structure:- View of Structural Wood Columns and Beams

The wall construction was observed to be in fair condition and well maintained; there are no instances of deterioration, cracking or damage observed. Therefore no actions will be generated during the study period for works associated with the structural wood frame structure.

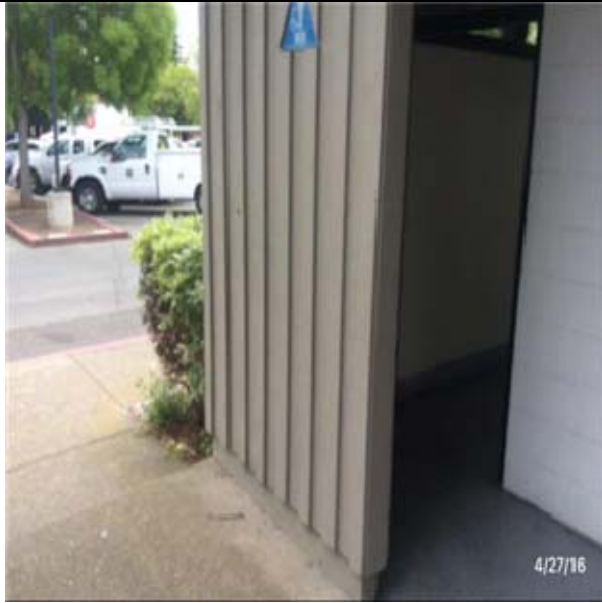
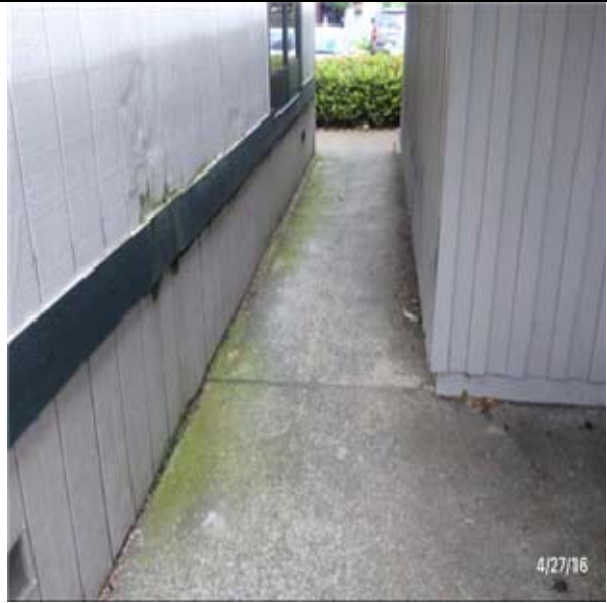
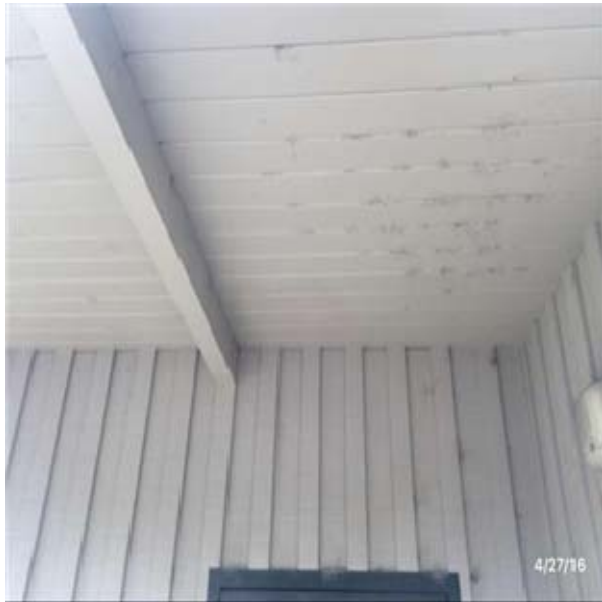
B2011 Exterior Wall Construction:- View of Wood Clapboard Siding

The exterior wall construction was observed to be in fair condition. The wood siding has been regularly painted. We recommend repainting of the surface of the wood siding during the term in the study period to maintain the appearance of the building and also the wood itself.

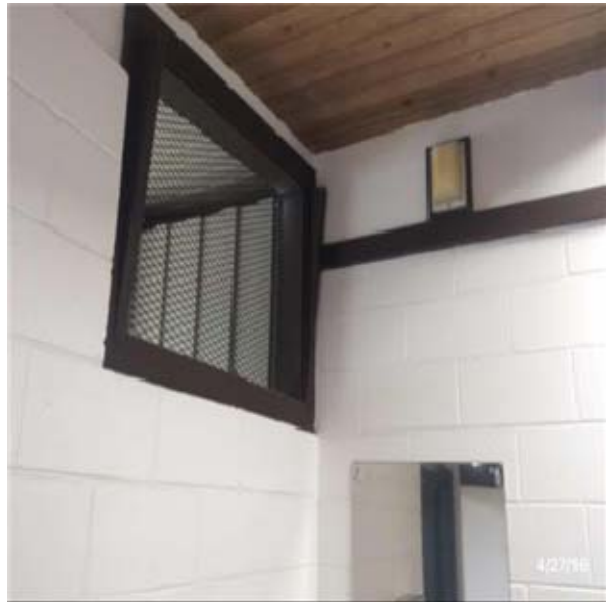
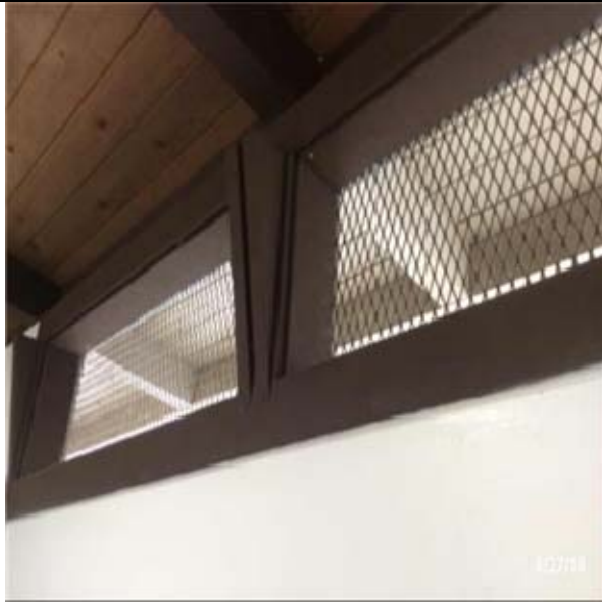
B2013 Exterior Louvers, Screens, and Fencing:- View of Metal screens in wood frames

The metal louvers appeared to be in fair condition; therefore we do not anticipate replacement in the study period. We recommend repainting of the surface of the louvers during the term in the study period as part of the repainting of the building exterior.

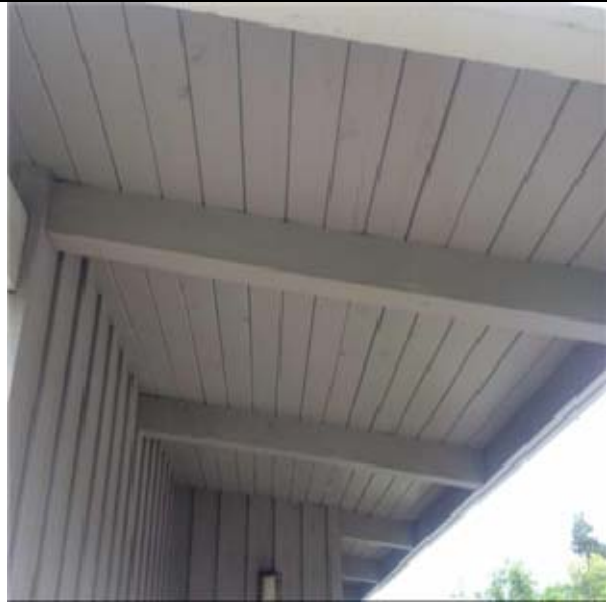
B2016 Exterior Soffits:- View of Exterior Soffits

The exterior soffits appeared to be in fair condition; therefore we do not anticipate any actions during the study period. We do however recommend repainting of these surfaces later in the study period to maintain the appearance of the building and also protect the asset.

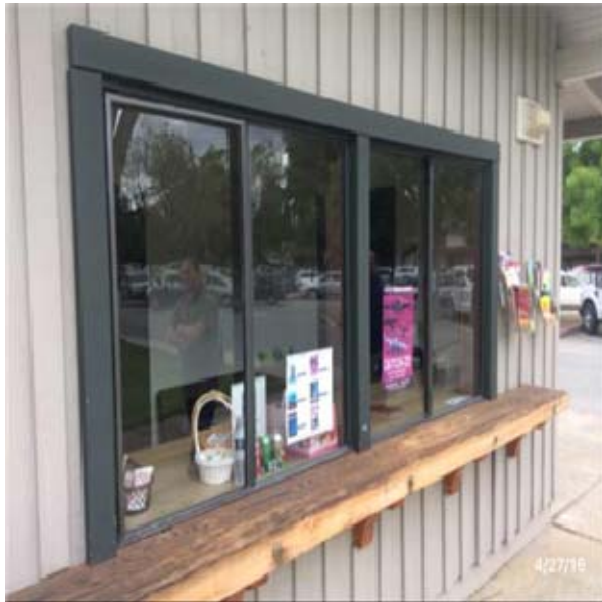
B2021 Windows:- View of Aluminum Window Units - Casement, Double Hung, Vent or Sliding

The window systems appeared to be in fair condition. We noted no deterioration of frame and/or glass which would require any actions during the study period.

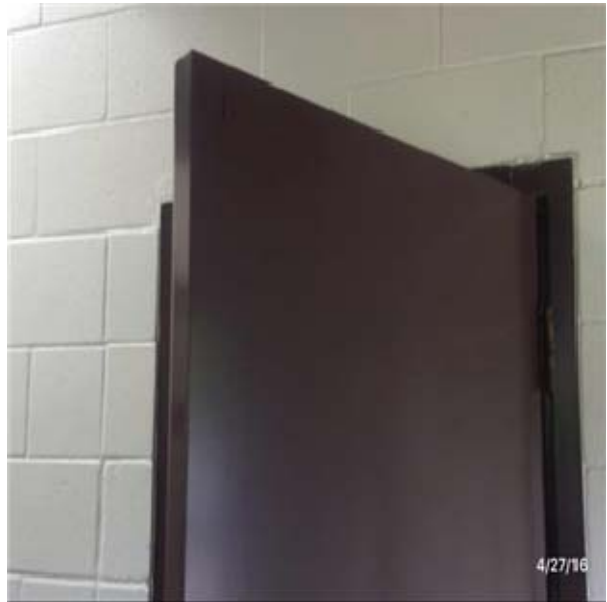
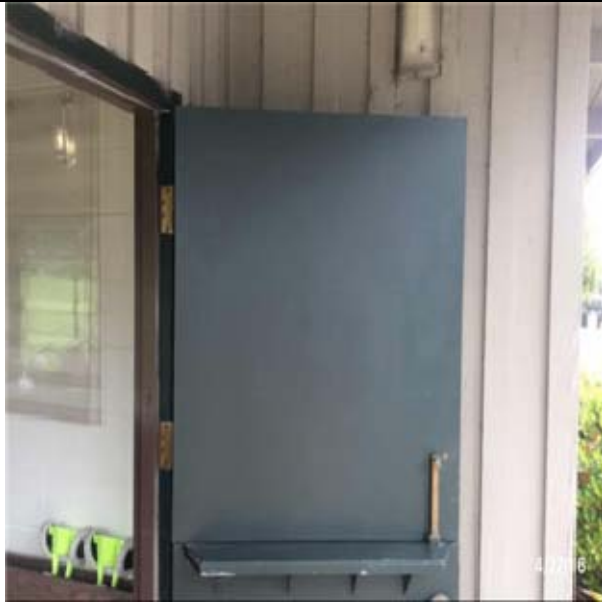
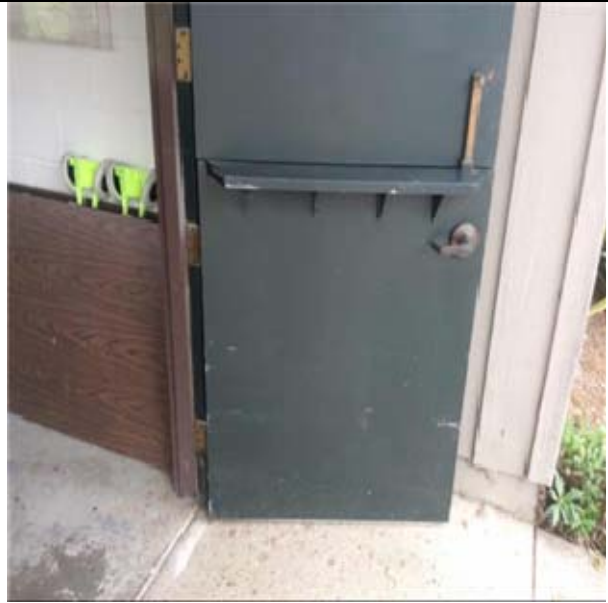
B2039 Other Doors & Entrances:- View of Exterior Single HM Doors

The hollow metal doors appeared to be in fair condition with no major signs of damage or deterioration. There were no issues with these doors therefore no actions will be generated during the study period. The new door surface finish and door frames will require repainting later in the study period. The cost of this work has been included within the amount to undertake the repainting of the exterior walls.

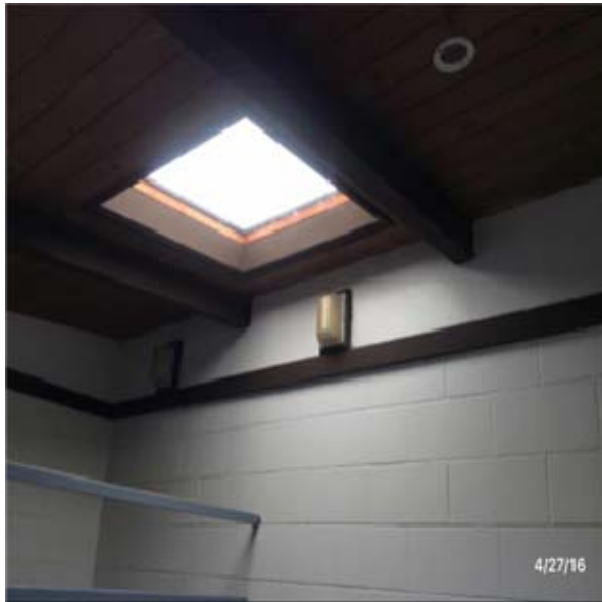
B3021 Glazed Roof Openings:- View of Skylight - Plastic

The skylights appeared to be in fair condition. The skylights had no reported or observed moisture ingress present; However, The typical EUL for this type of skylight is thirty years. We recommend replacing the skylights at the same time as the replacement roof covering during the study period.

ID	Type	Recommendation	Priority	Year	Expenditures
134850	B3010	Replace BUR (Built-up Roofing) System	Priority 2	2018	\$18,622
134851	B3020	Replace Skylight - Plastic	Priority 2	2018	\$1,975

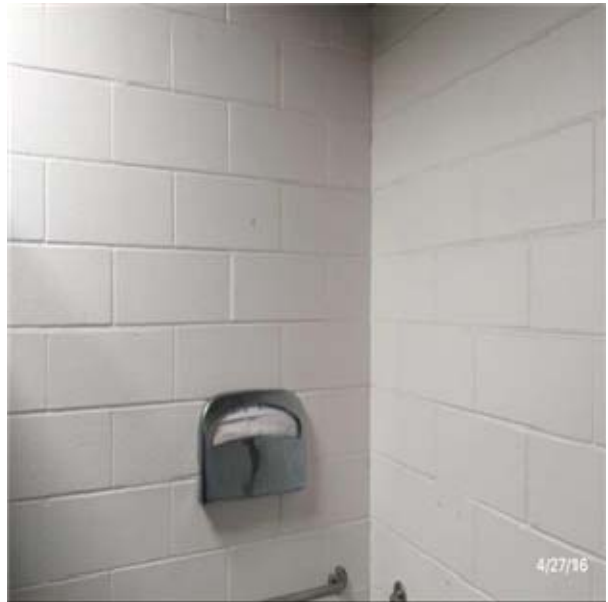
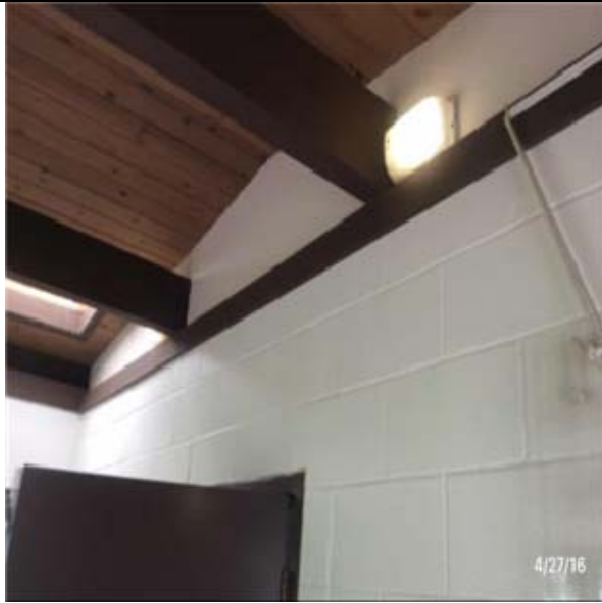
C3012 Wall Finishes to Interior Walls:- View of Painted Finish - Standard

The interior wall finishes were observed to be in poor condition. We anticipate the repainting of the interior surfaces early in the study period to maintain appearances.

ID	Type	Recommendation	Priority	Year	Expenditures
134852	C3010	Replace Painted Finish - Standard	Priority 2	2018	\$3,359
134853	C3020	Replace Floor Paint - Non Slip	Priority 1	2016	\$725
134854	C3020	Replace Floor Paint - Non Slip	Priority 1	2021	\$725
134855	C3020	Replace Floor Paint - Non Slip	Priority 1	2016	\$1,702
134856	C3020	Replace Floor Paint - Non Slip	Priority 1	2021	\$1,702
134857	C3030	Replace Wood Ceiling - Painted or Stained	Priority 1	2018	\$22,472

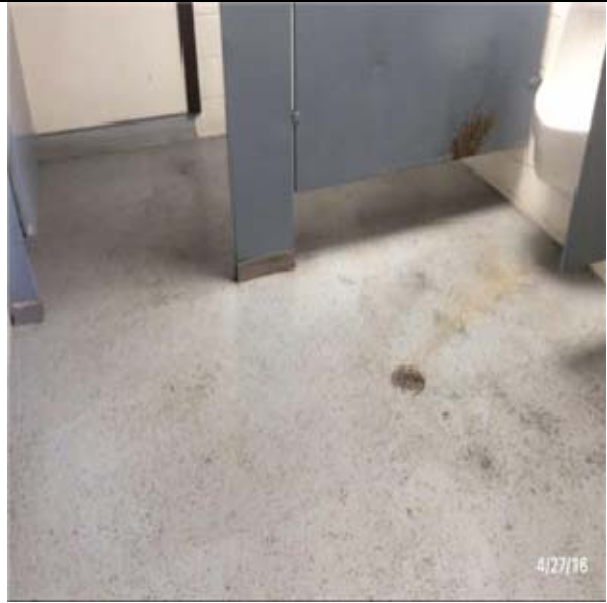
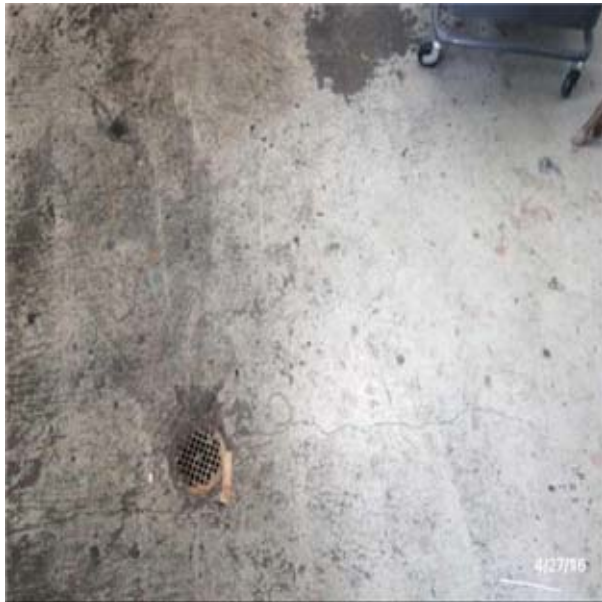
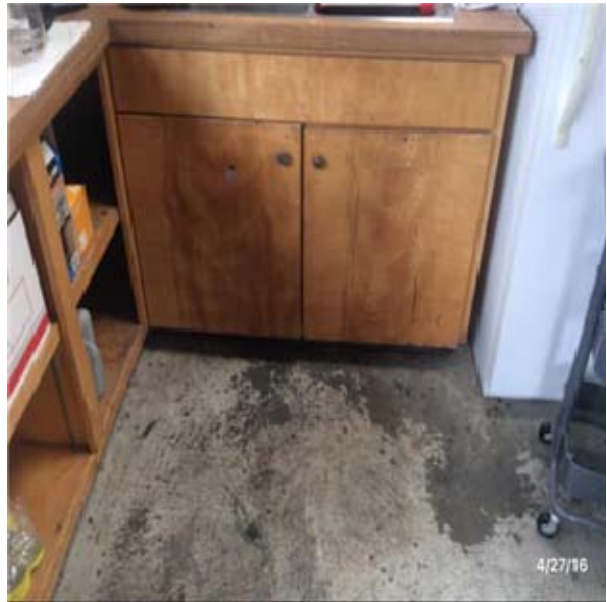
C3023 Hardeners and Sealers:- View of Floor Paint - Non Slip

The floor finishes appeared in poor - fair condition throughout the building. We are unaware of the paint finish, however the maintenance personnel confirmed that it was not an epoxy finish. We are unaware of the age of the floor paint, however we assume it to be more than fifteen years of age, therefore based on the typical EUL of five years for this type of finish and current observed condition, we anticipate repainting both early and later in the study period.

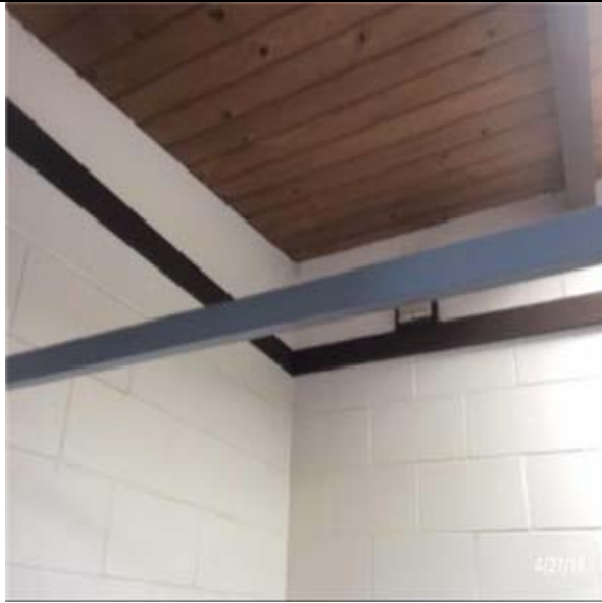
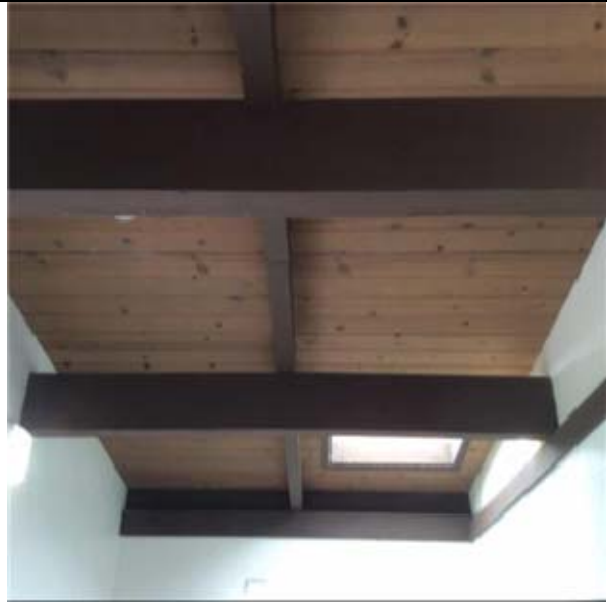
C3031 Ceiling Finishes:- View of Wood Ceiling - Painted or Stained

The interior wood ceilings were observed to be in fair condition. We anticipate the repainting of the interior surfaces early in the study period to maintain appearances, at the same time as the interior wall finishes.

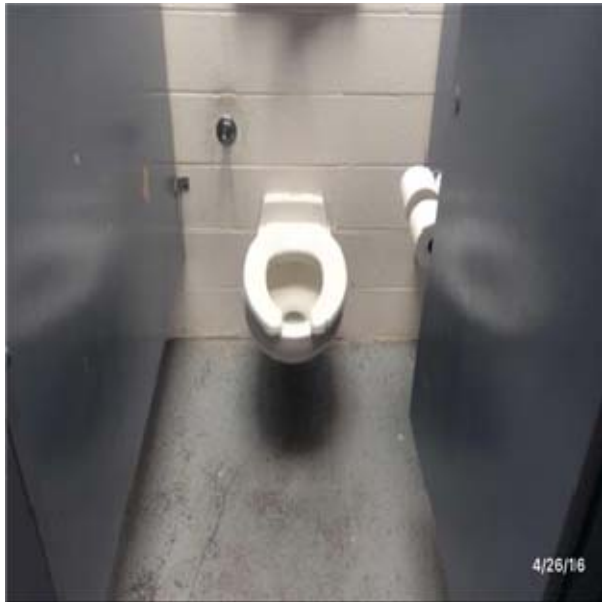
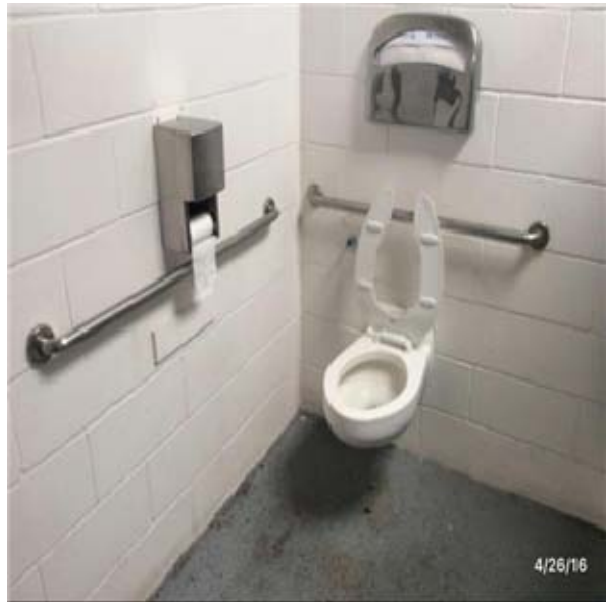
D2011 Water Closets:- View of Wall Mounted Water Closets

The water closets were observed to be in poor condition. They are assumed to be original and based on a typical EUL of thirty-five years we recommend that they are considered for replacement during the study period. The flush valves may fail during the study period and therefore to maintain function they may need to be replaced. This work has not been included in this study as we anticipate it will be carried out on an as needed basis as part of routine maintenance.

ID	Type	Recommendation	Priority	Year	Expenditures
134858	D2010	Replace Countertop Double Bowl Kitchen Sink	Priority 2	2018	\$1,663
134859	D2010	Replace Wall Mounted Water Closets	Priority 3	2021	\$8,400
134860	D2010	ADA Adaptions	Priority 1	2016	\$11,760
134861	D2010	Replace Wall Hung Lavatories	Priority 3	2021	\$4,298
134862	D2010	ADA Adaptions	Priority 1	2016	\$5,600
134863	D2020	Replace Domestic Hot Water Heater - Electric	Priority 2	2016	\$1,575

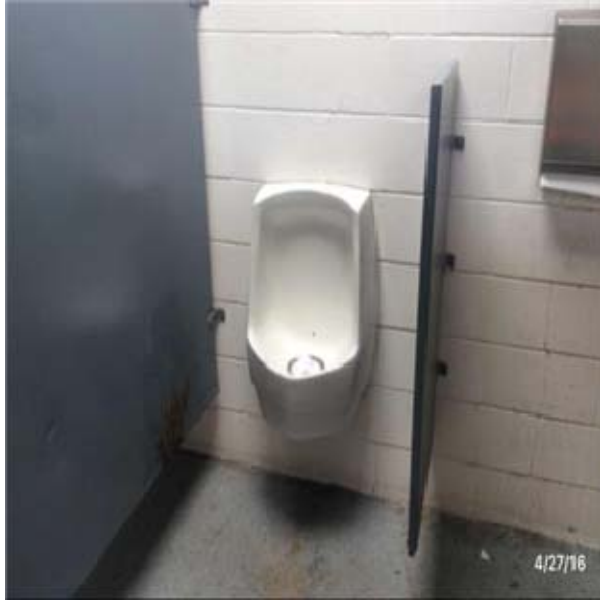
D2012 Urinals:- View of Wall Hung Urinal

The urinal was observed to be in fair to good condition. The urinal drained properly and appeared to not have any cracks in the china; based on a typical EUL of thirty years, therefore no action for replacement is anticipated during the study period.

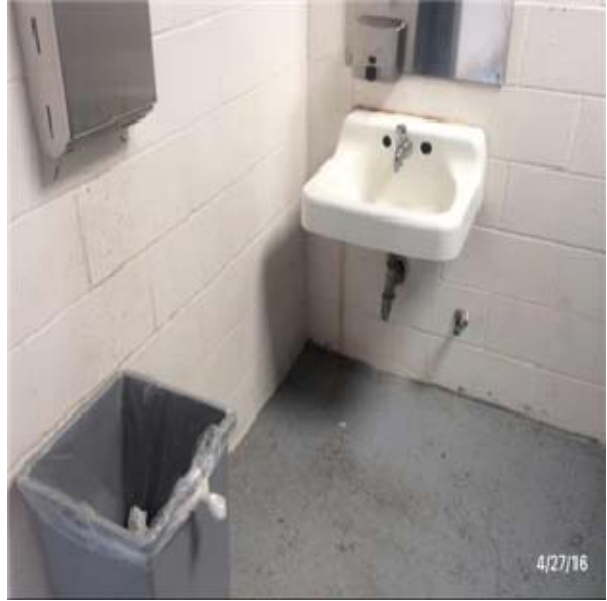
D2013 Lavatories:- View of Wall Hung Lavatories

The lavatories were observed to be in poor condition. The lavatories drained properly and appeared to not have any cracks in the china; however, they are assumed to be original and based on a typical EUL of thirty-five years we recommend that they are considered for replacement during the study period.

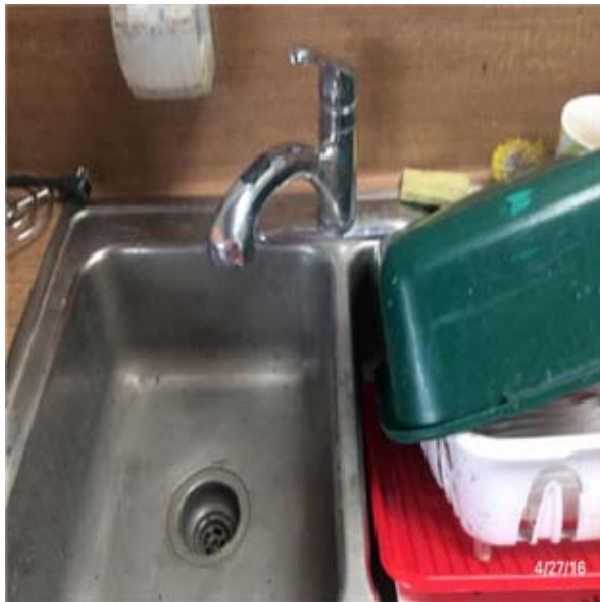
D2014 Sinks:- View of Countertop Double Bowl Kitchen Sink

The counter top stainless sink was observed to be in poor - fair condition. The sinks drained properly and appeared not to have any damage in the stainless steel finish; however, given the fact that the countertop and kitchen cabinets will need replacement during the study period, we recommend the sinks and faucet is replaced at the same time.

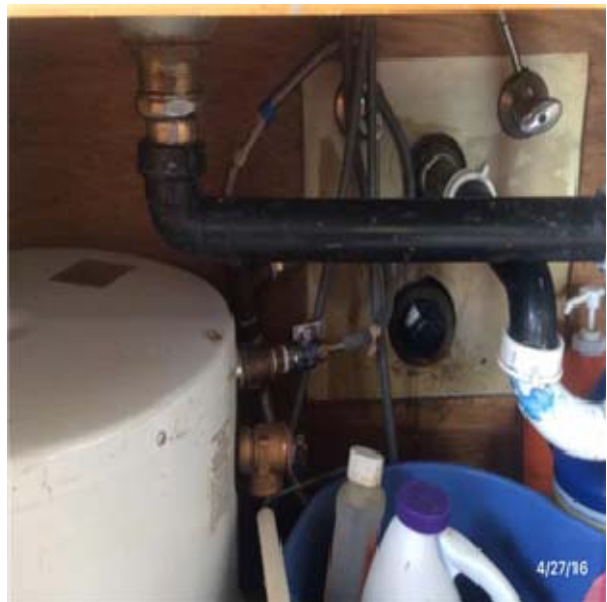
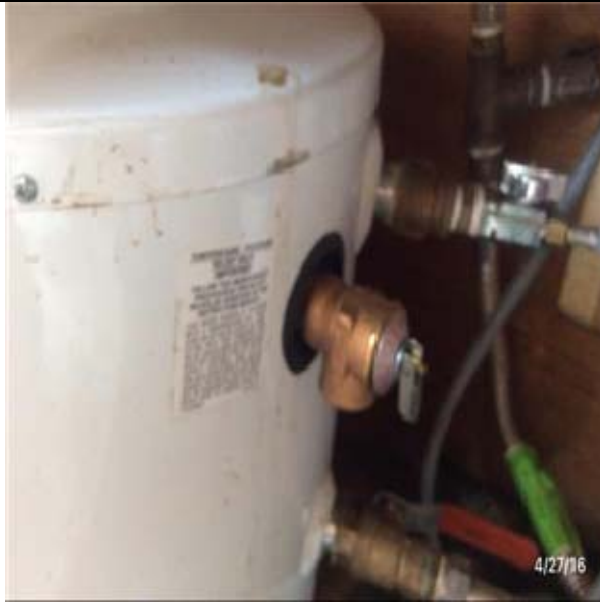
D2022 Hot Water Service:- View of Domestic Hot Water Heater  
- Electric

The domestic water heater appeared to be in fair condition. We are unaware of any operating issues; however we assume that the unit is more than fifteen years of age and therefore is due for replacement early in the study period, based on a typical EUL of fifteen years.

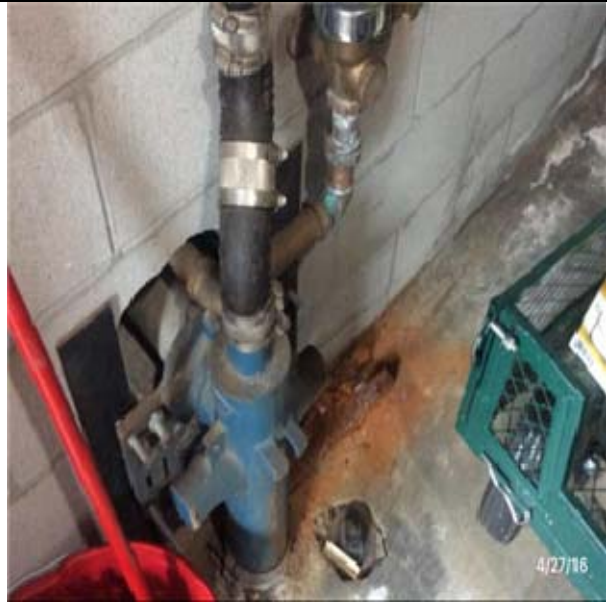
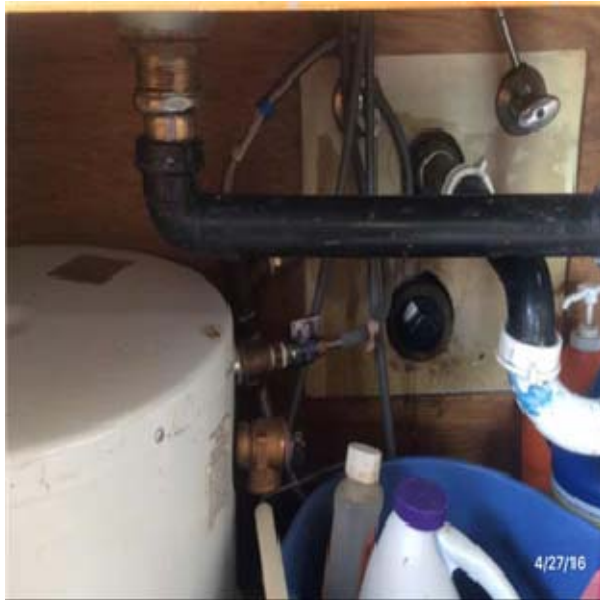
D2031 Waste Piping:- View of Sanitary Water Gravity Discharge

The waste piping appears in fair condition. Maintenance personnel reported that some waste piping has been replaced at the kitchen. The typical EUL for this type of waste piping is fifty years; therefore it is not included in the study period.

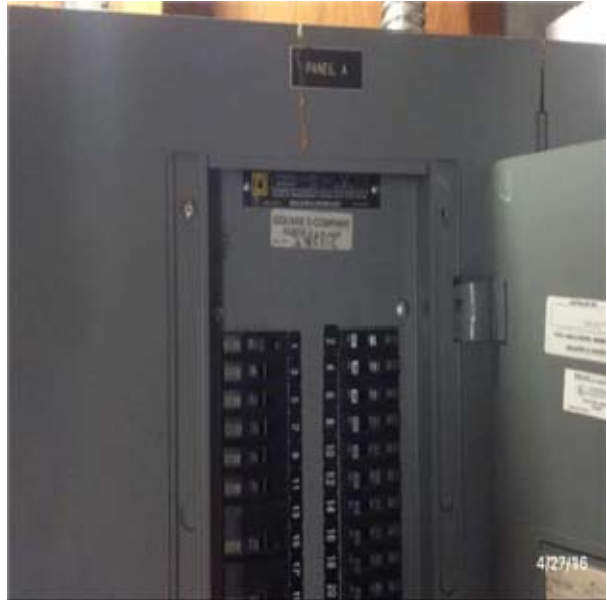
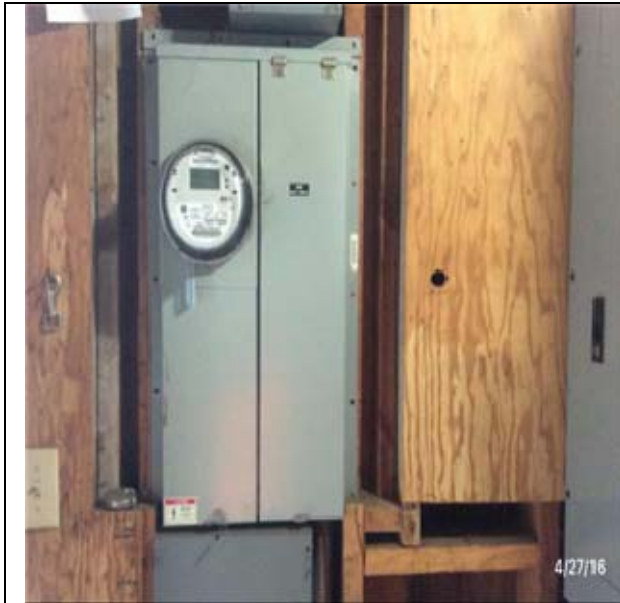
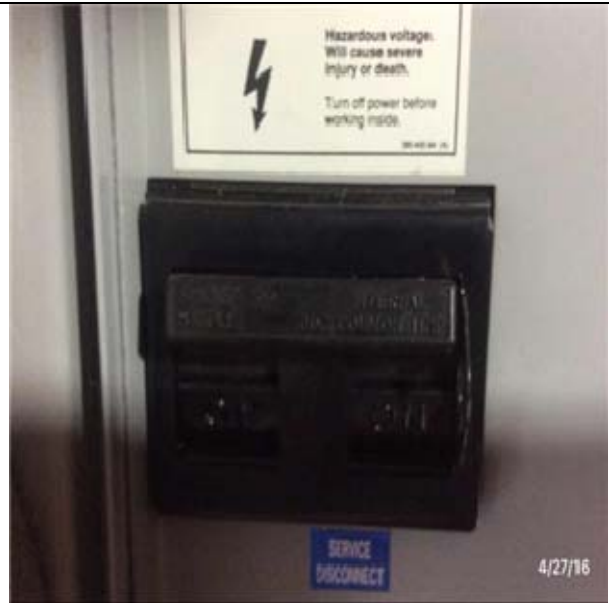
D5012 Low Tension Service & Dist:- View of Panelboard - 120/240volts, 60 to 2000amp

The panels appeared to be in fair condition due to their age. There were no signs of deterioration at the panels. The typical EUL for electrical switchboard such as this is thirty years; therefore replacement will be necessary during the study period. We do recommend further evaluation of the branch panels via an infrared electrical inspection which will highlight if high temperatures, excessive electrical resistance, failing components, ground faults and short circuiting issues exist.
