**Facility Condition Assessment Services**

**Facility Condition Assessment**

**For  
City of Los Altos  
Multi-Purpose Building  
97 Hillview Avenue  
Los Altos,  
California 94022-3740**

**Date of Report: June 10, 2016**

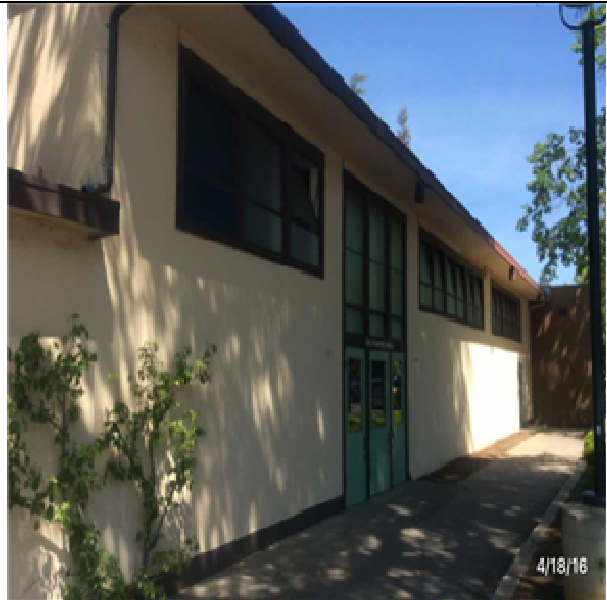
B2021 Windows:- View of Steel Window Units - Casement, Double Hung, Vent or Sliding

The windows at the building were observed to be in poor condition. We have assumed the windows to be original based on the current condition, which would put the windows well past their useful life. Glass has been replaced recently due to difficulty of operation, and the frames showed signs of rust and corrosion. Maintenance personnel reported that they are unable to find replacement window catches. We recommend replacing the window immediately in order to maintain the appearance and security of the building as well as prevent water penetration.

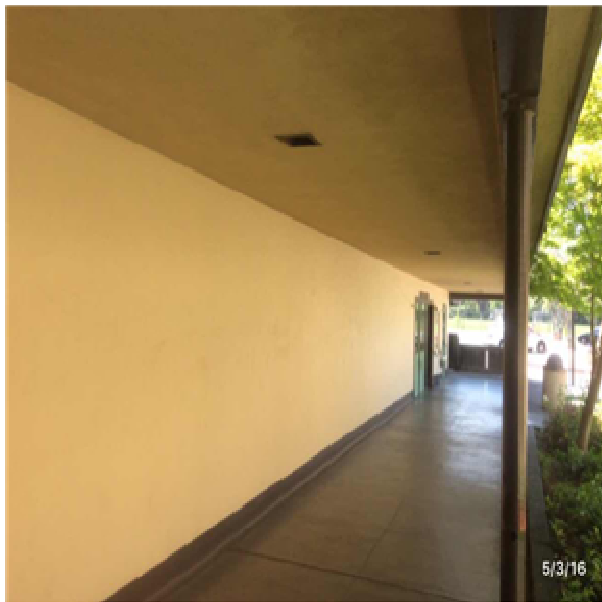
B2016 Exterior Soffits:- View of Exterior Soffits

The exterior soffits appeared to be in fair condition; therefore we do not anticipate any actions during the study period. We do however recommend repainting of these surfaces later in the study period to maintain the appearance of the building and also protect the asset.

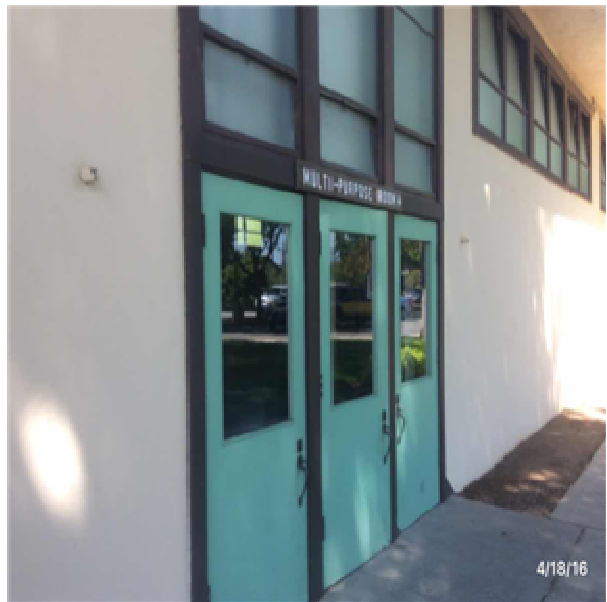
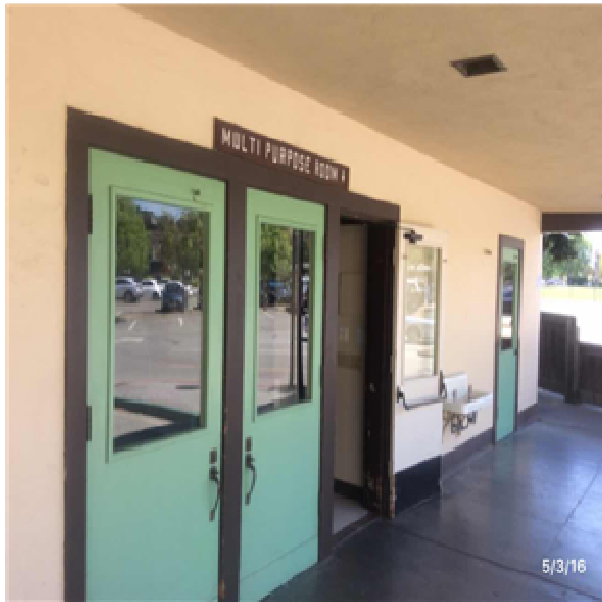
B2032 Solid Exterior Doors:- View of Single Solid Core Wood Doors

All the wood doors at the building were observed to be in poor condition. We have assumed the doors to be original based on the current condition, which would put the doors well past their useful life. Some doors have been repaired but there are signs of degradation. We recommend replacing these doors immediately in order to maintain the appearance and security of the building as well as prevent water penetration. The new door surface finish and door frames will require repainting later in the study period. The cost of this work has been included within the amount to undertake the repainted of the exterior walls.

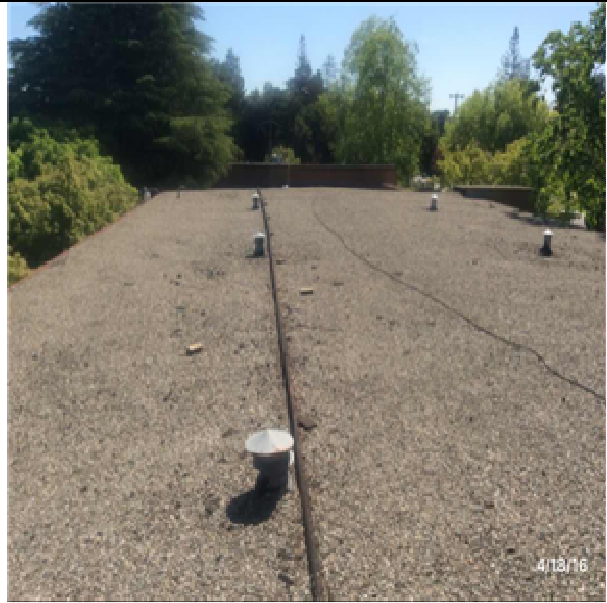
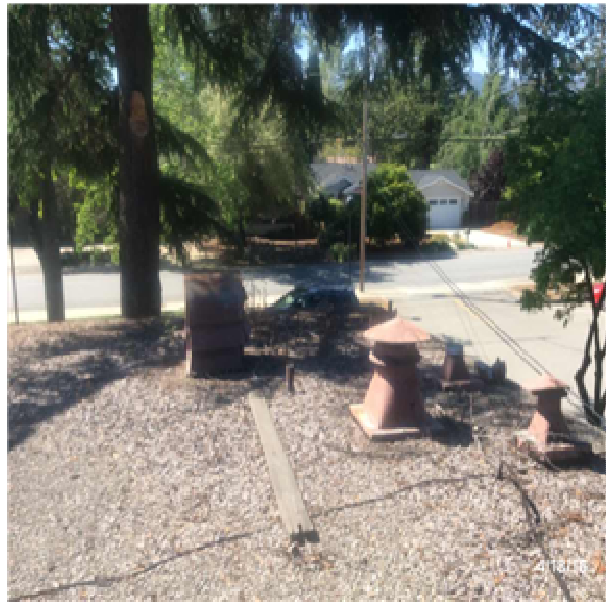
B3011 Roof Finishes:- View of BUR (Built-up Roofing) Covering

The BUR covering appeared to be in poor condition with evidence of leaks observed. The maintenance personnel also verified reported roof leaks. There is deterioration due to age and other similarly aged roofs to the Community Center have already been repaired. We are unaware of the age of the roof covering, however we assume it to be more than fifteen years of age, therefore based on the typical EUL of twenty years for this type of covering and current observed condition, we anticipate replacement early in the study period.

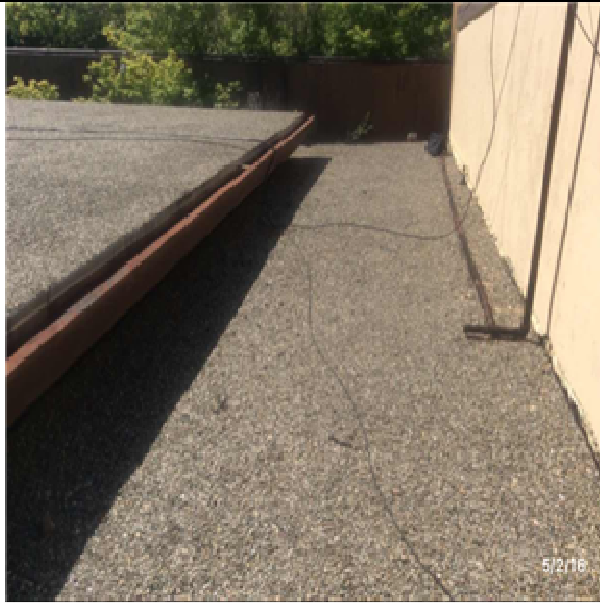
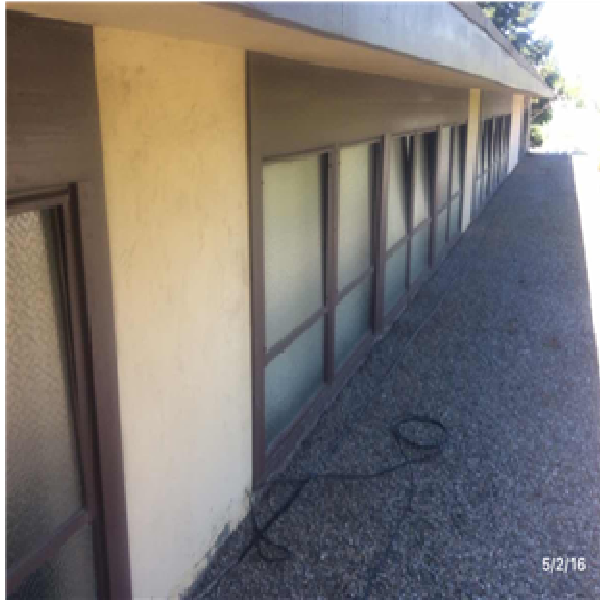
B3011 Roof Finishes:- View of BUR (Built-up Roofing)  
Covering to Canopy

The BUR covering appeared to be in poor condition with evidence of leaks observed. The maintenance personnel also verified reported roof leaks. There is deterioration due to age and other similarly aged roofs to the Community Center have already been repaired. We are unaware of the age of the roof covering, however we assume it to be more than fifteen years of age, therefore based on the typical EUL of twenty years for this type of covering and current observed condition, we anticipate replacement early in the study period.

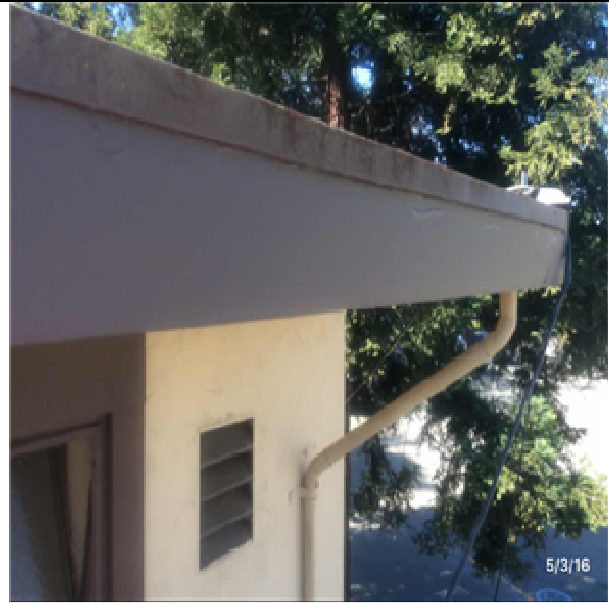
B3016 Gutters and Downspouts:- View of Galvanized Steel  
Perimeter Gutters & Downspout

The gutters appear in poor condition. Maintenance personnel reported that the gutters and down spouts are difficult to maintain due to the fact that they are connected directly to the below ground drainage. The typical EUL for this type of gutter system is twenty years; therefore, we recommend replacing the gutters and downspouts at the beginning of the study period.

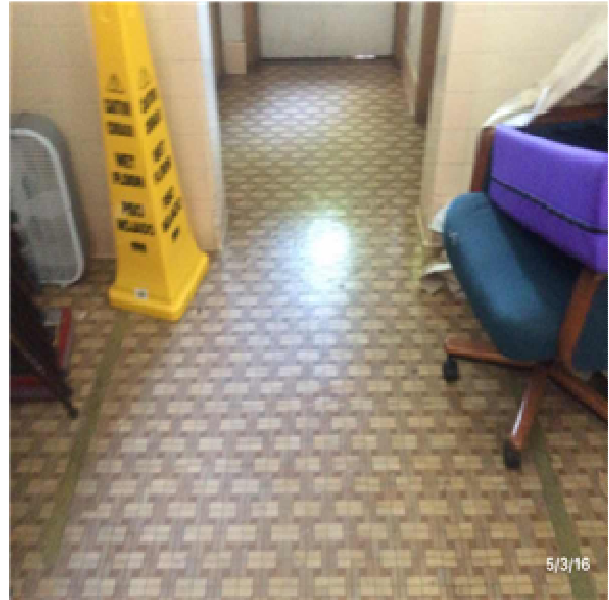
C3024 Flooring:- View of Ceramic Tile

The ceramic tile and vinyl tile was in fair - poor condition given their age. The vinyl tile have a EUL of eighteen years; however, considering the observed condition, we have extended the RUL on this flooring to later in the study period. The ceramic tile has a EUL of thirty years. We did not observe any broken or loose tiles or missing grout; therefore, we expect the ceramic tile to last beyond the study period.

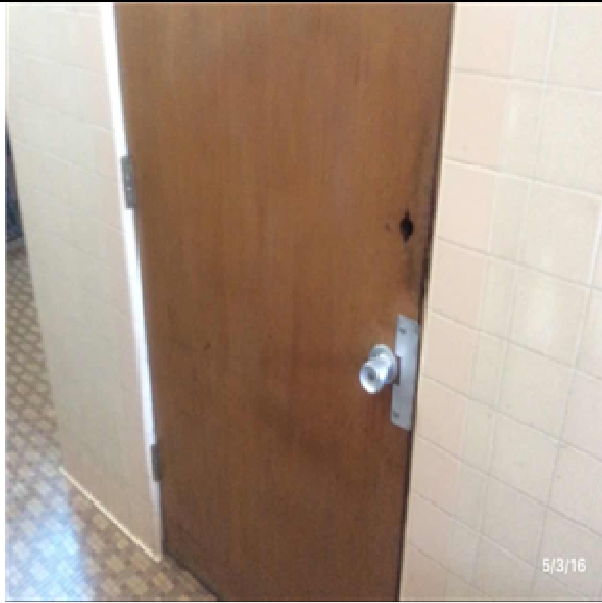
C1021 Interior Doors:- View of Interior Single Wood Door(s)

All the wood doors at the building were observed to be in poor condition. We have assumed the doors to be original based on the current condition, which would put the doors well past their useful life. Some doors have been repaired but there are signs of degradation. We recommend replacing these doors immediately in order to maintain the appearance and security of the building. The new door surface finish and door frames will require varnishing later in the study period. The cost of this work has been included within the amount to undertake the repainting of the interior walls.

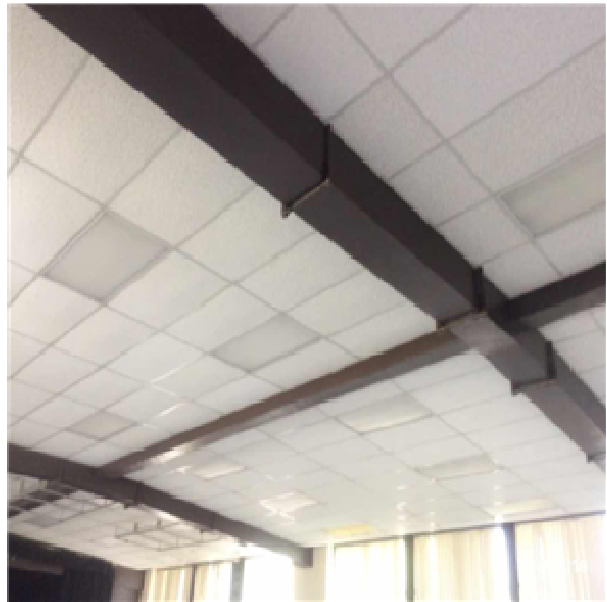
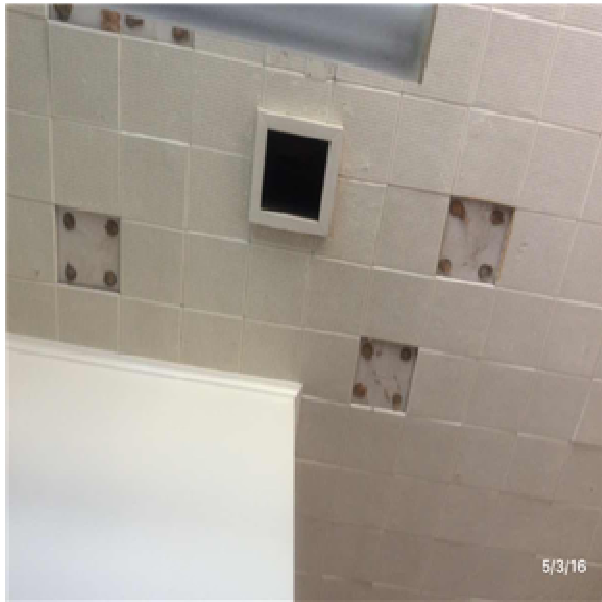
C3032 Suspended Ceilings:- View of Acoustic Ceiling System - Standard

ceilings and current observed condition, we anticipate replacement in the middle study period. We observed that certain tiles in the kitchen were stained and missing as a result of roof leaks.

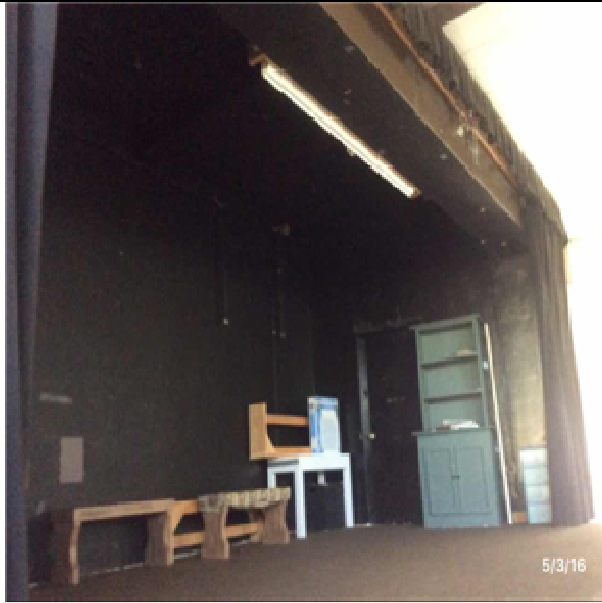
C3025 Carpeting:- View of Broadloom Standard without Padding

The carpet at the stage is in fair condition. We are unaware of the age of the carpeting, however we assume it to be more than fifteen years of age, therefore based on the typical EUL of ten years for this type of covering and current observed condition, we anticipate replacement early in the study period.
