**Facility Condition Assessment Services**

**Facility Condition Assessment**

**For  
City of Los Altos  
Parks Office / Children's Corner  
97 Hillview Avenue  
Los Altos,  
California 94022-3740**

**Date of Report: June 10, 2016**

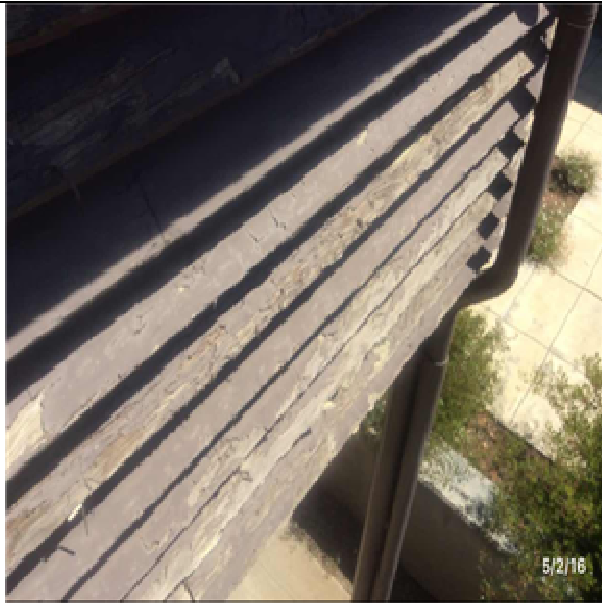
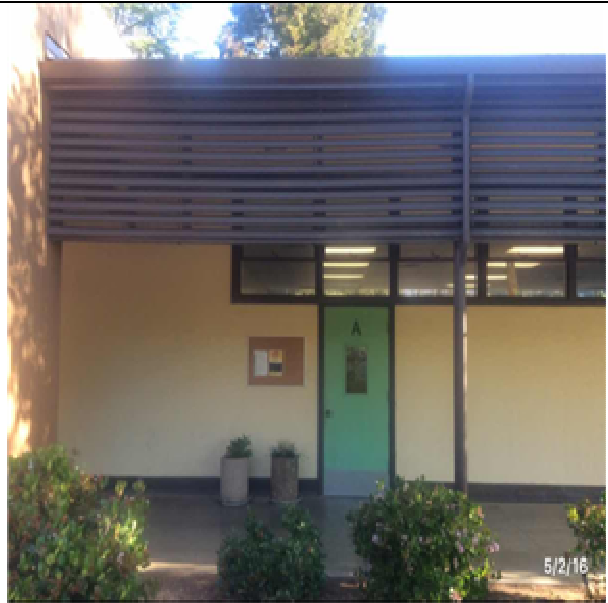
The wood has not been painted for a considerable time and is in a poor condition and in urgent need of repair and or replacement. It was reported that maintenance has been deferred due to the presence of lead based paint.

B2014 Exterior Sun Control Devices:- View of Exterior Sun Control Louvers

ID	Type	Recommendation	Priority	Year	Expenditures
135389	B2010	Repaint Exterior Wall Surfaces	Priority 3	2018	\$1,905
135390	B2010	Replace Exterior Sun Control Louvers	Priority 2	2016	\$17,500
135391	B2030	Replace Single Solid Core Wood Doors	Priority 2	2016	\$19,751
135392	B2030	ADA Doors	Priority 1	2016	\$5,600

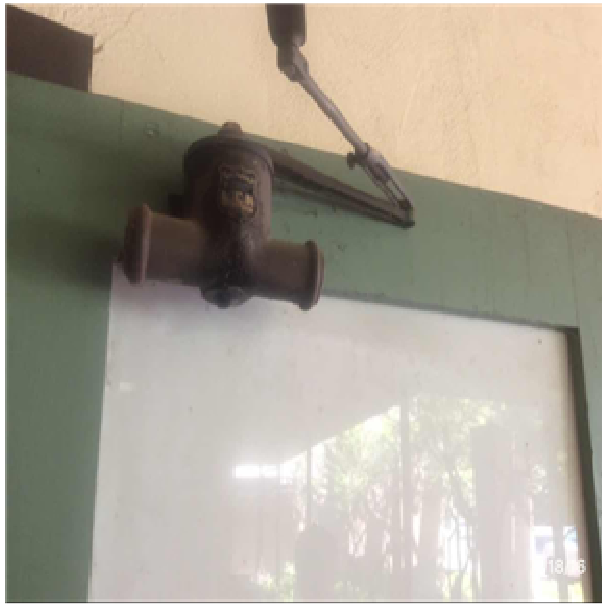
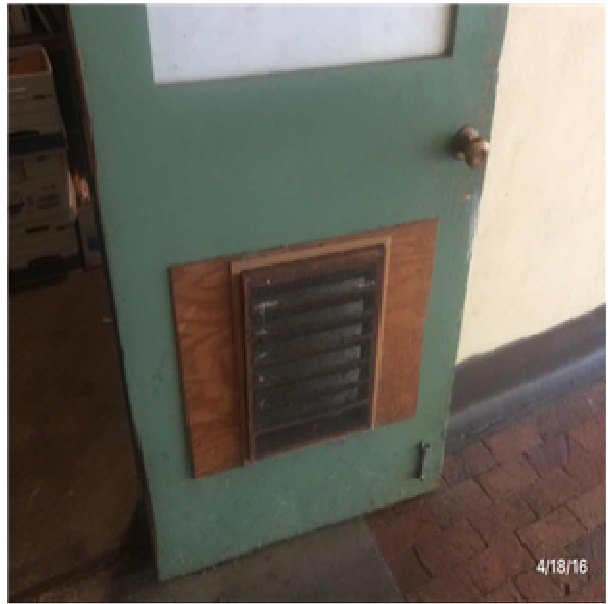
The wood doors at the building were observed to be in poor to fair condition. We have assumed the doors to be original based on the current condition, which would put the doors well past their useful life. Some doors have been repaired but there are signs of degradation. We recommend replacing the doors immediately in order to maintain the appearance and security of the building as well as prevent water penetration. The new door surface finish and door frames will require repainting later in the study period. The cost of this work has been included within the amount to undertake the repainted of the exterior walls.

B2032 Solid Exterior Doors:- View of Single Solid Core Wood Doors

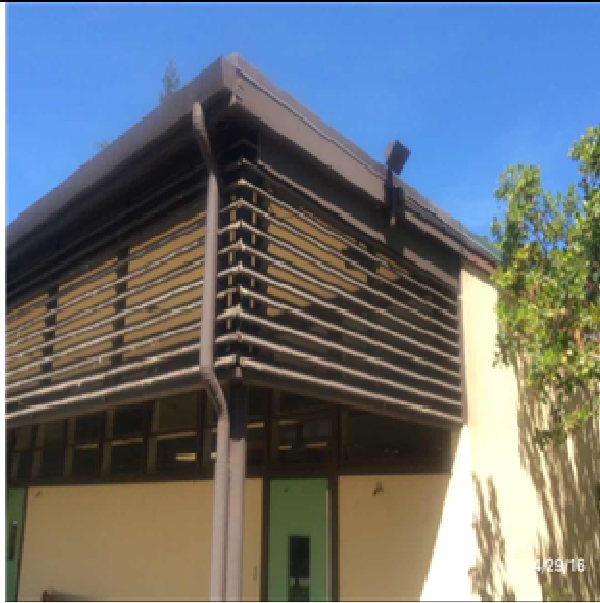
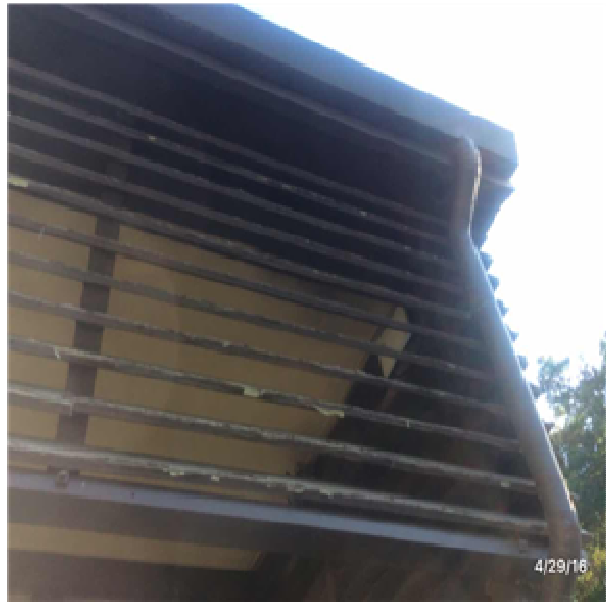
The gutters appear in poor condition. Maintenance personnel reported that the gutters and down spouts are difficult to maintain due to the fact that they are connected directly to the below ground drainage. The typical EUL for this type of gutter system is twenty years; therefore, we recommend replacing the gutters and downspouts at the beginning of the study period.

B3016 Gutters and Downspouts:- View of Galvanized Steel Perimeter Gutters & Downspout

ID	Type	Recommendation	Priority	Year	Expenditures
135393	B3010	Replace Galvanized Steel Perimeter Gutters & Downspout	Priority 2	2016	\$2,731
135394	B3010	Replace BUR (Built-up Roofing) Covering	Priority 2	2016	\$49,256

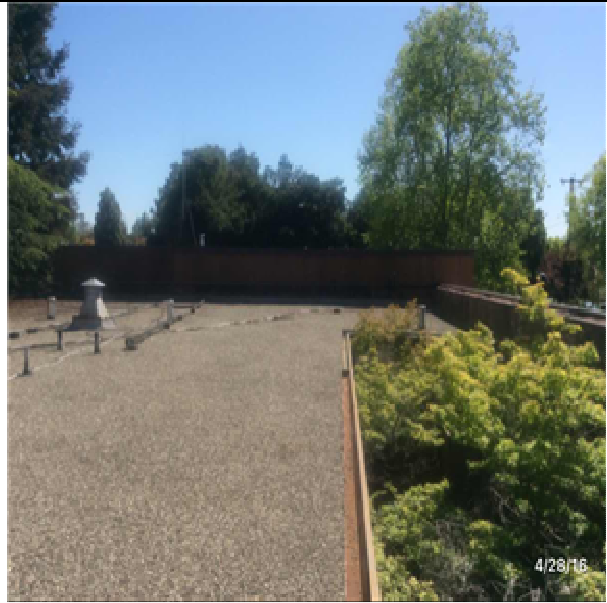
The BUR covering appeared to be in poor condition with evidence of leaks observed. The maintenance personnel also verified reported roof leaks. There is deterioration due to age and other similarly aged roofs to the Community Center have already been repaired. We are unaware of the age of the roof covering, however we assume it to be more than fifteen years of age, therefore based on the typical EUL of twenty years for this type of covering and current observed condition, we anticipate replacement early in the study period.

B3011 Roof Finishes:- View of BUR (Built-up Roofing) Covering

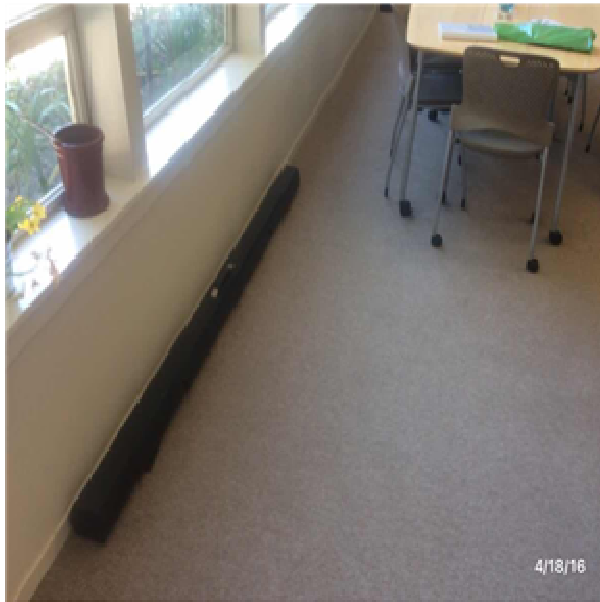
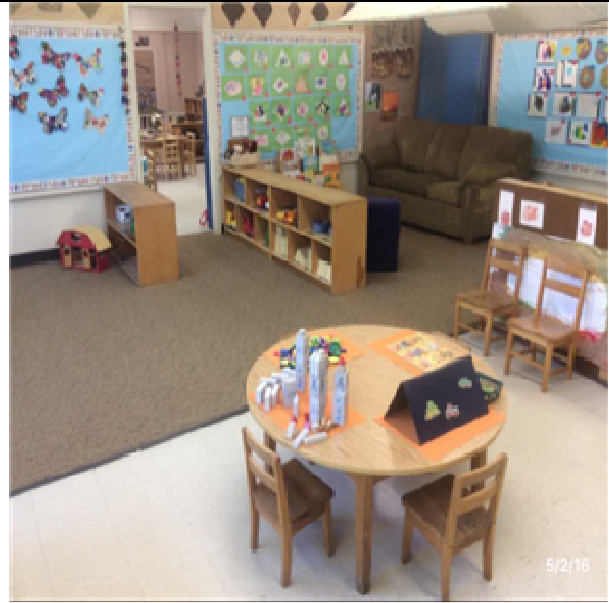
The carpet at the parks offices is in fair condition, however the carpet at the children's corner office is in poor condition. We are unaware of the age of the carpeting, however we assume it to be more than fifteen years of age, therefore based on the typical EUL of ten years for this type of covering and current observed condition, we anticipate replacement at both early and later in the study period.

C3025 Carpeting:- View of Broadloom Standard without Padding

ID	Type	Recommendation	Priority	Year	Expenditures
135395	C3010	Replace Painted Finish - Standard	Priority 3	2016	\$11,338
135396	C3010	Replace Painted Finish - Standard	Priority 3	2024	\$11,338
135397	C3020	Replace Broadloom Standard without Padding	Priority 3	2016	\$3,848
135398	C3020	Replace Broadloom Standard without Padding	Priority 3	2022	\$3,848
135399	C3020	Replace Broadloom Standard without Padding	Priority 2	2016	\$7,753
135400	C3020	Replace Epoxy Floor coating	Priority 2	2016	\$9,520
135401	C3020	Replace Vinyl Composite Tile (VCT)	Priority 2	2021	\$4,320
135402	C3030	Replace Acoustic Ceiling System - Standard	Priority 3	2021	\$9,894
135403	C3030	Replace Acoustic Ceiling System - Standard	Priority 3	2021	\$6,120

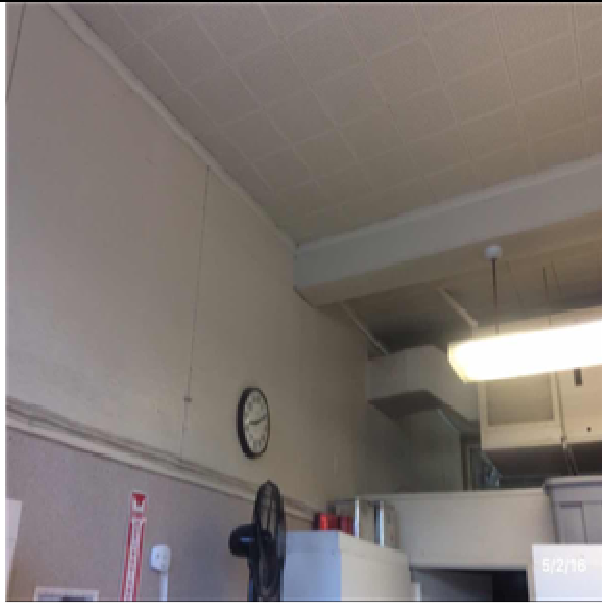
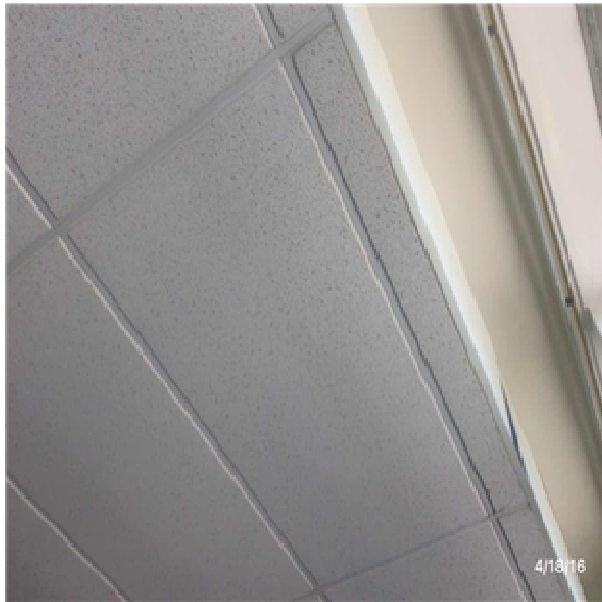
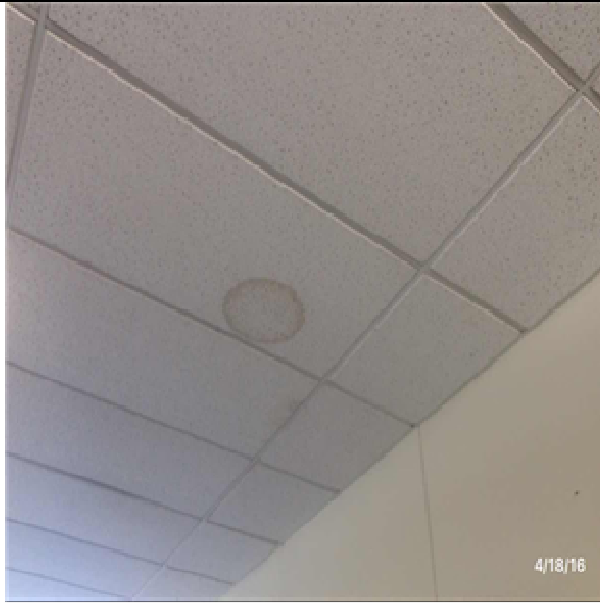
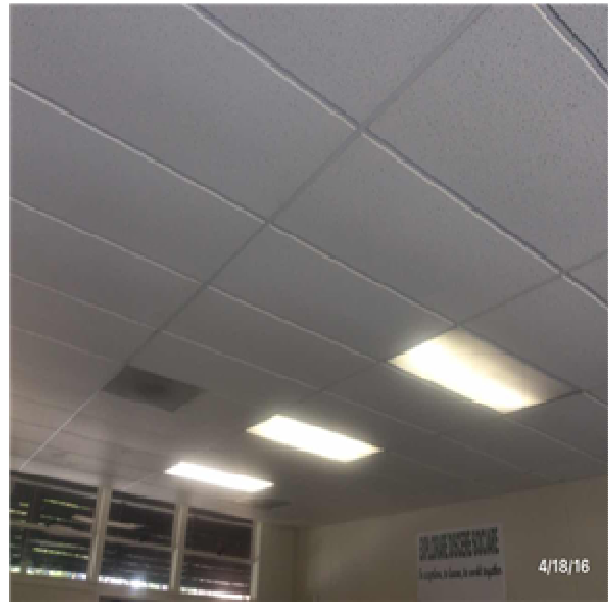
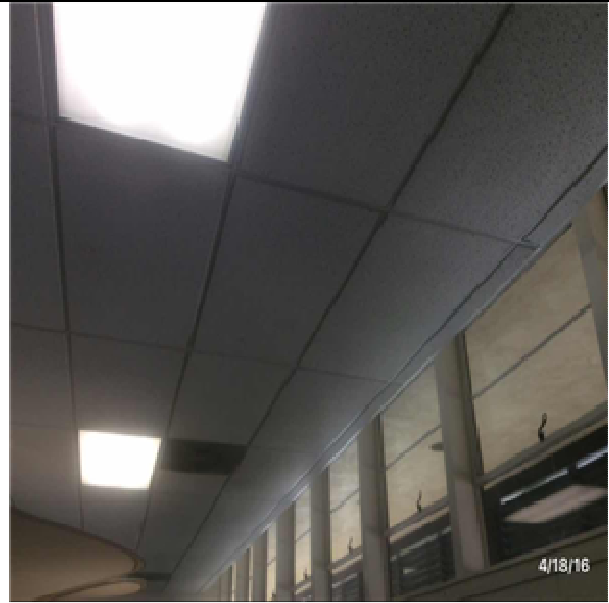
The adhered acoustic tiles appeared in poor condition overall, the suspended acoustic tiles appeared in a fair condition. We are unaware of the age; however we assume it to be more than fifteen years of age, therefore based on the typical EUL of twenty years for both type of ceilings and current observed condition, we anticipate replacement in the study period. We observed that certain tiles in the park's office were stained as a result of roof leaks.

C3032 Suspended Ceilings:- View of Acoustic Ceiling System  
- Standard

C3032 Suspended Ceilings:- View of Acoustic Ceiling System - Standard

C3032 Suspended Ceilings:- View of Acoustic Ceiling System -  
Standard

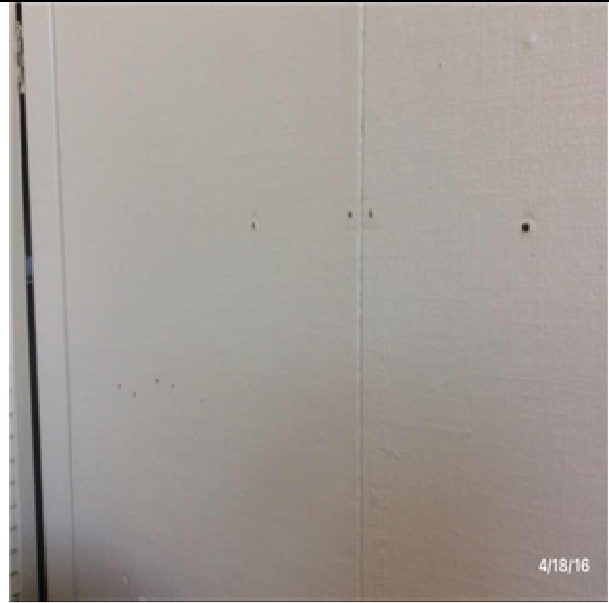
The wall construction is not visible due to its location, however, there are no instances of deterioration, cracking or damage observed. Therefore no actions will be generated during the study period for works associated with the fixed partitions.

C1011 Fixed Partitions:- View of GWB Stud Walls

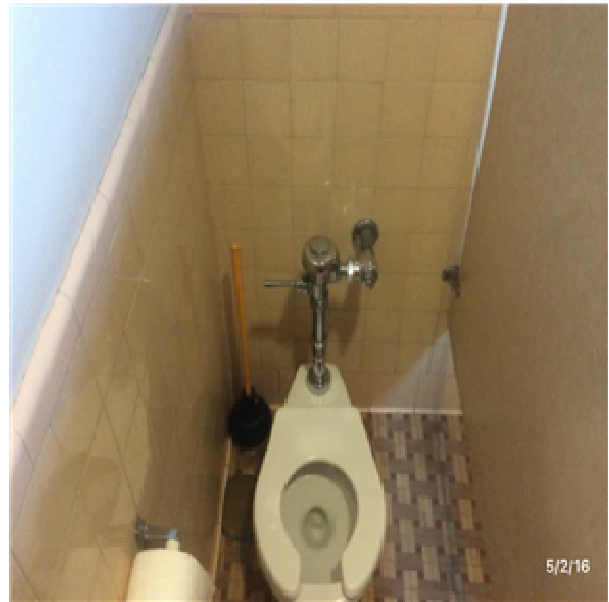
The floor finishes appeared in poor - fair condition throughout the building. We are unaware of the age of the epoxy floor covering at the storage areas, however we assume it to be more than fifteen years of age, therefore based on the typical EUL of ten years for this type of covering and current observed condition, we anticipate replacement early in the study period. The ceramic tile at the restroom was in fair - poor condition given its age. The vinyl tile have a EUL of eighteen years; however, considering the observed condition, we have extended the RUL on this flooring to later in the study period. The ceramic tile has a EUL of thirty years. We did not observe any broken or loose tiles or missing grout; therefore, we expect the ceramic tile to last beyond the study period.

C3024 Flooring:- View of Ceramic Tile

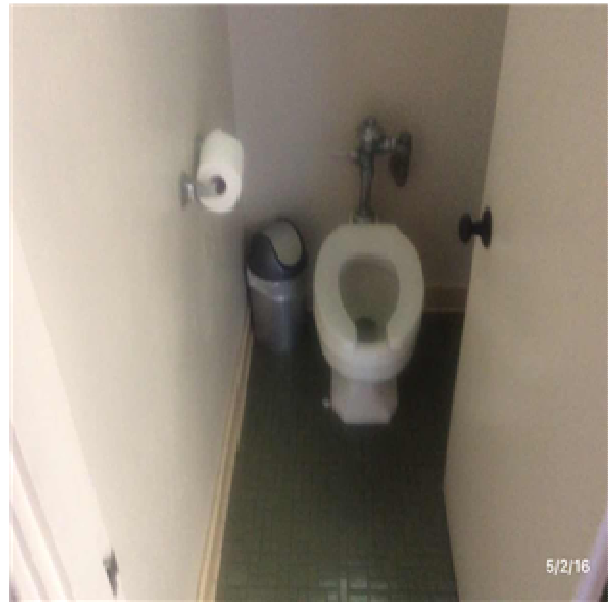
The water closets were observed to be in poor condition. Water closets such as this have a EUL of thirty-five years. We believe the water closets to be original therefore they are over thirty-five years old. We recommend a full replacement early in the study period. The flush valves may fail during the study period and therefore to maintain function they may need to be replaced. This work has not been included in this study as we anticipate it will be carried out on an as needed basis as part of routine maintenance.

D2011 Water Closets:- View of Floor Mounted Water Closets
