Facility Condition Assessment Services

Facility Condition Assessment

**For
City of Los Altos
Recreation /Administration Office
97 Hillview Avenue
Los Altos,
California 94022-3740**

Date of Report: June 10, 2016

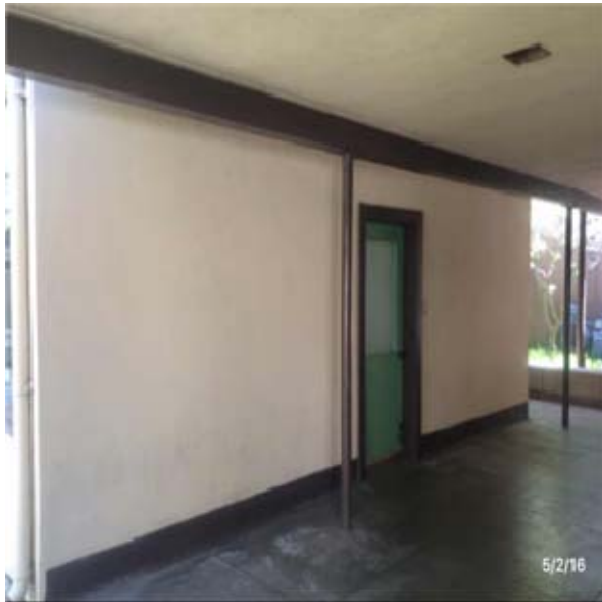
B2011 Exterior Wall Construction:- View of Stucco over Stud Walls

The stucco appeared to be in fair condition with no instances of deterioration observed. We do however recommend repainting of exterior surfaces later in the study period to maintain the appearance of the building and also protect the asset.

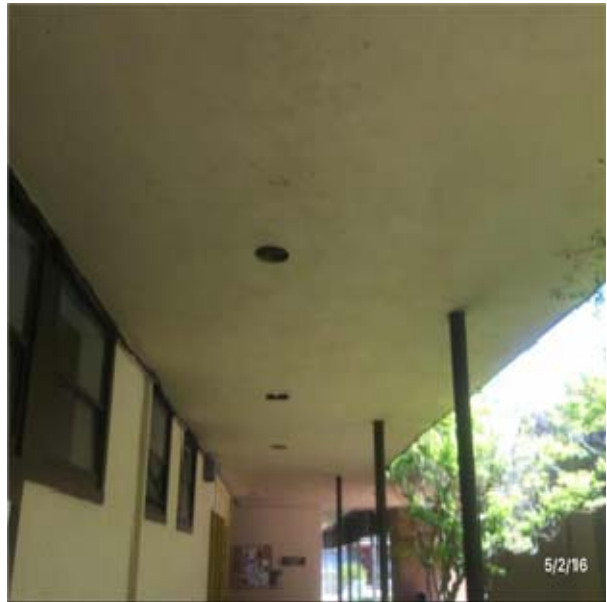
B2016 Exterior Soffits:- View of Exterior Soffits

The exterior soffits appeared to be in fair condition; therefore we do not anticipate any actions during the study period. We do however recommend repainting of these surfaces later in the study period to maintain the appearance of the building and also protect the asset.

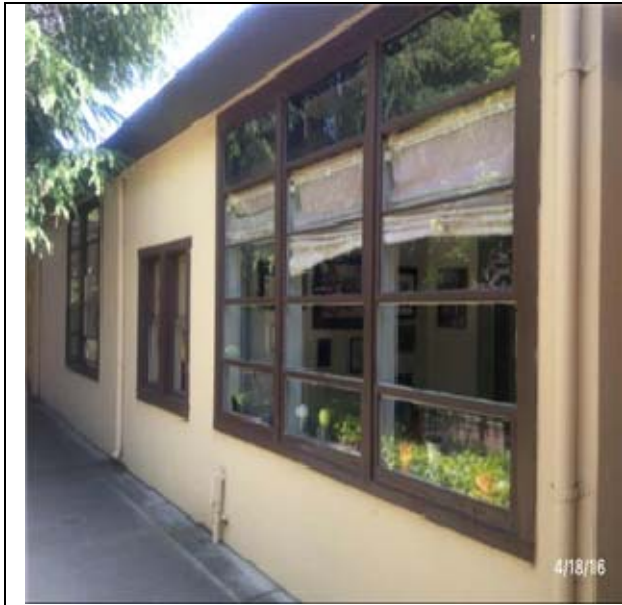
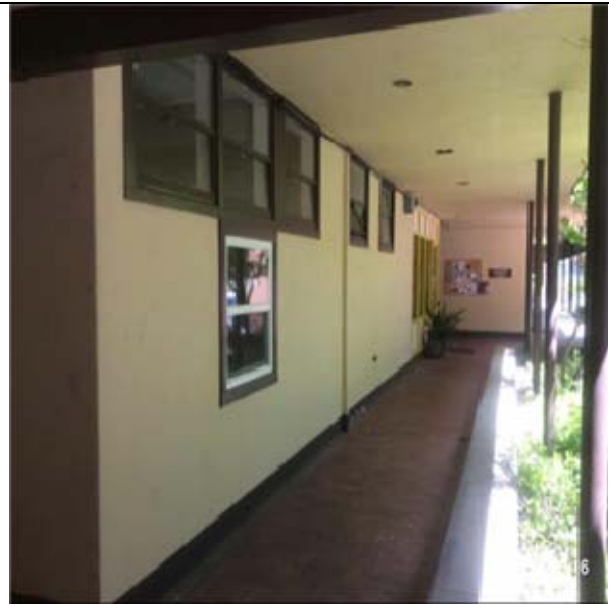
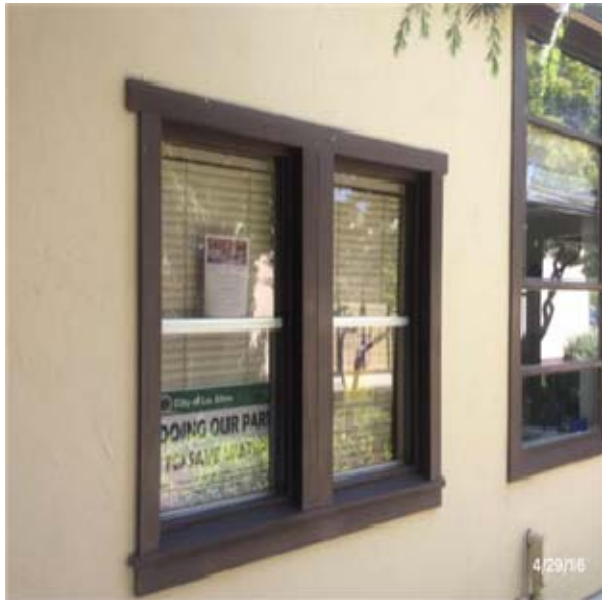
B2021 Windows:- View of Steel Window Units - Casement, Double Hung, Vent or Sliding

The windows at the building were observed to be in poor condition. We have assumed the windows to be original based on the current condition, which would put the windows well past their useful life. Glass has been replaced recently due to difficulty of operation, and the frames showed signs of rust and corrosion. Maintenance personnel reported that they are unable to find replacement window catches. We recommend replacing the window immediately in order to maintain the appearance and security of the building as well as prevent water penetration.

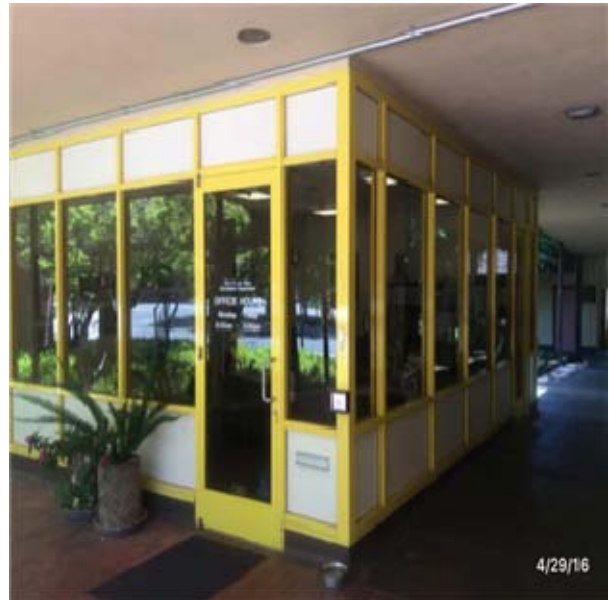
B2023 Storefronts:- View of Storefronts - Glazed Aluminum Framed with Swing Doors

The storefront systems appeared to be in fair condition. This door was electrically operated with a push button at the exterior and interior. It operated satisfactory with the hardware performing as required; however, the storefront was installed in 1985 and based on an EUL of 30 years, puts the shopfront at the end of its useful life. We recommend replacement of the entire storefront system and automated door later in the study period to maintain adequate access and to keep the building in good appearance and working order.

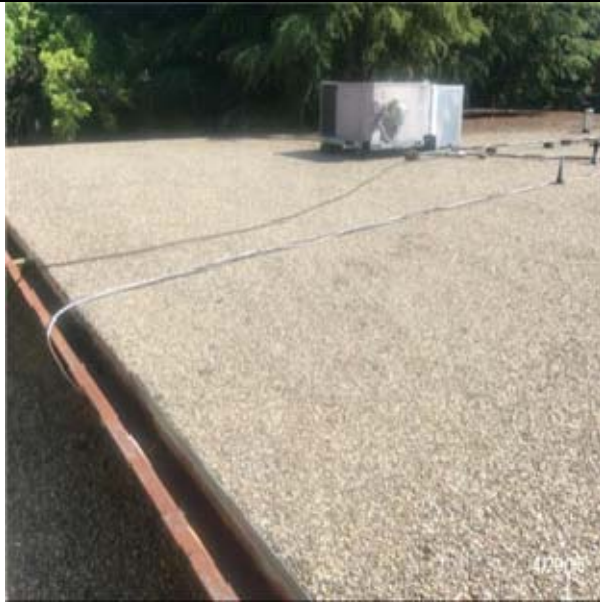
B3011 Roof Finishes:- View of BUR (Built-up Roofing) Covering

The BUR covering appeared to be in poor to fair condition with no reported leaks, however there is deterioration due to age and other similarly aged roofs to the Community Center have already been repaired. We are unaware of the age of the roof covering, however we assume it to be more than fifteen years of age, therefore based on the typical EUL of twenty years for this type of covering and current observed condition, we anticipate replacement early in the study period.

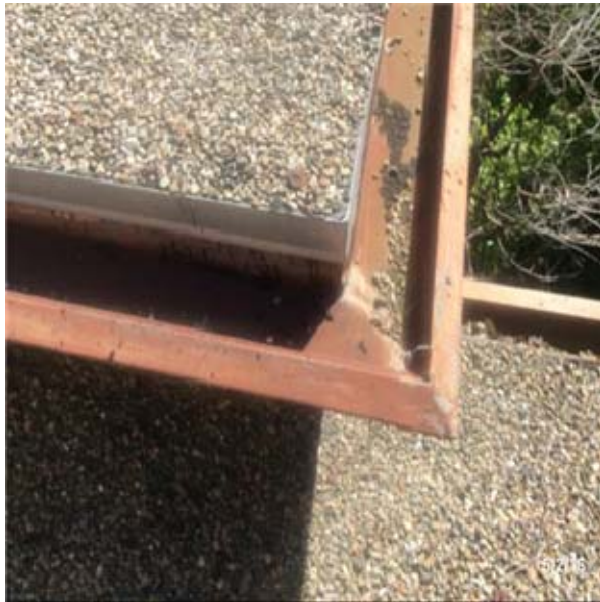
B3016 Gutters and Downspouts:- View of Galvanized Steel Perimeter Gutters & Downspout

The gutters appear in poor condition. Maintenance personnel reported that the gutters and down spouts are difficult to maintain due to the fact that they are connected directly to the below ground drainage. The typical EUL for this type of gutter system is twenty years; therefore, we recommend replacing the gutters and downspouts at the beginning of the study period.

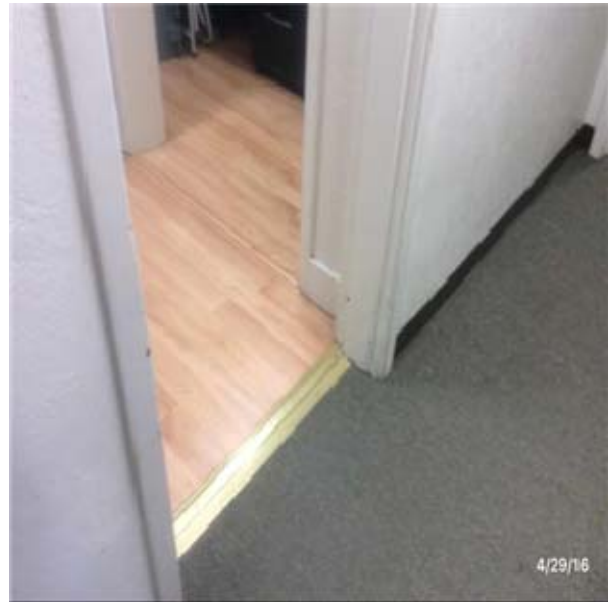
C1011 Fixed Partitions:- View of Wood framing with board finish

The wall construction is not visible due to its location, however, there are no instances of deterioration, cracking or damage observed. Therefore no actions will be generated during the study period for works associated with the fixed partitions.

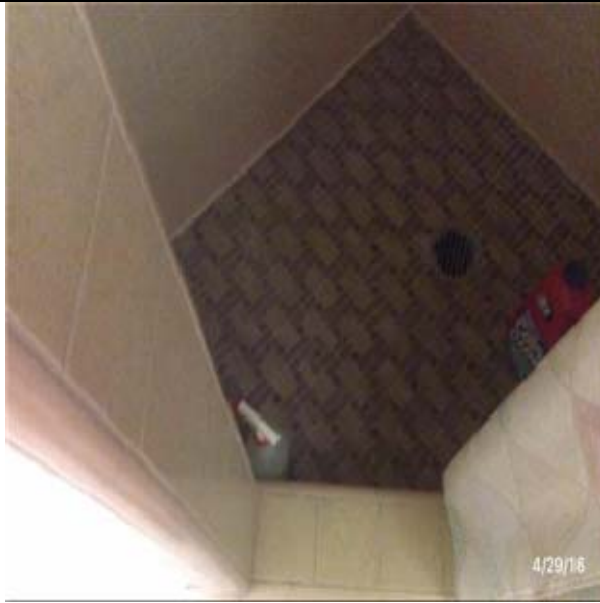
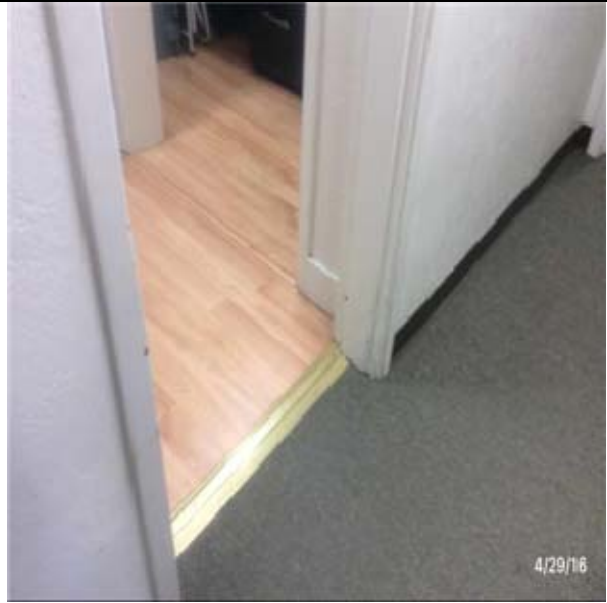
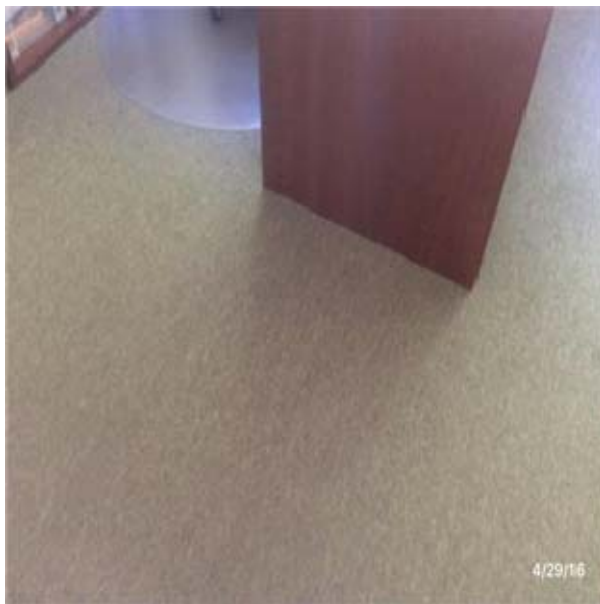
C3024 Flooring:- View of Ceramic Tile

The floor finishes appeared in poor condition throughout the building. We are unaware of the age of the laminate wood floor, however we assume it to be more than fifteen years of age, therefore based on the typical EUL of twenty years for this type of covering and current observed condition, we anticipate replacement early in the study period. The vinyl sheet at the restroom is well past its useful life. We recommend replacement in the study period. The ceramic tile has an EUL of thirty years. We did not observe any broken or loose tiles or missing grout; therefore, we expect the ceramic tile to last beyond the study period.

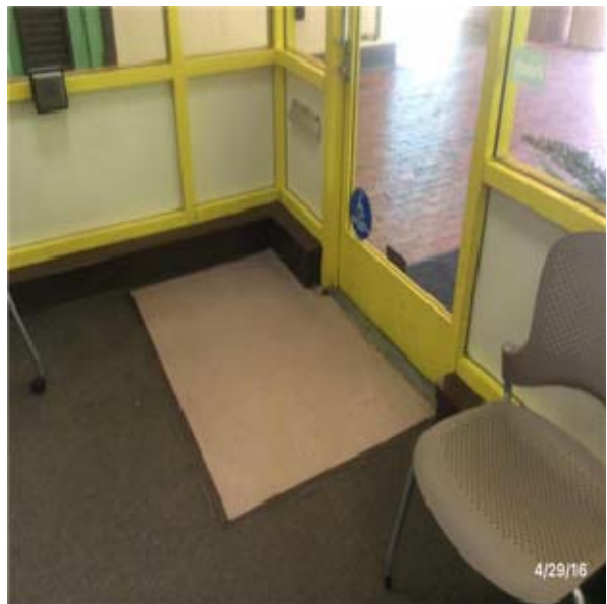
C3025 Carpeting:- View of Broadloom Standard without Padding

The carpet at the offices is in fair condition. We are unaware of the age of the carpeting, however we assume it to be more than fifteen years of age, therefore based on the typical EUL of ten years for this type of covering and current observed condition, we anticipate replacement early in the study period.

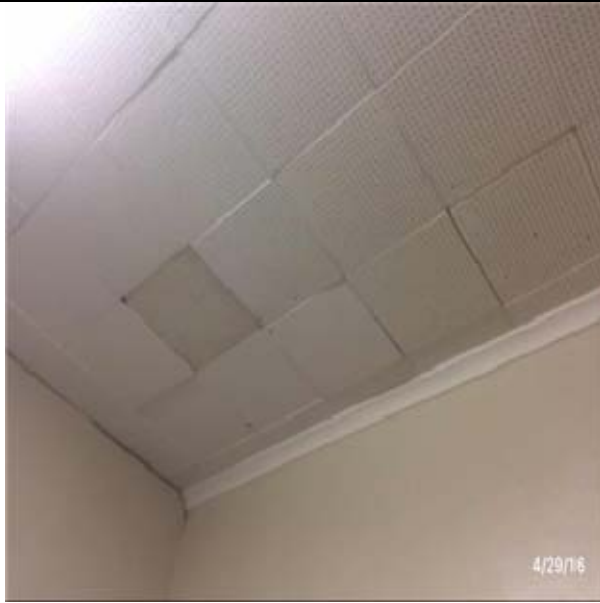
C3032 Suspended Ceilings:- View of Acoustic Ceiling System
- Standard

The acoustic tiles generally appeared in poor condition. We are unaware of the age; however we assume it all to be more than fifteen years of age, therefore based on the typical EUL of twenty years for these type of ceilings and current observed conditions, we anticipate replacement early in the study period.

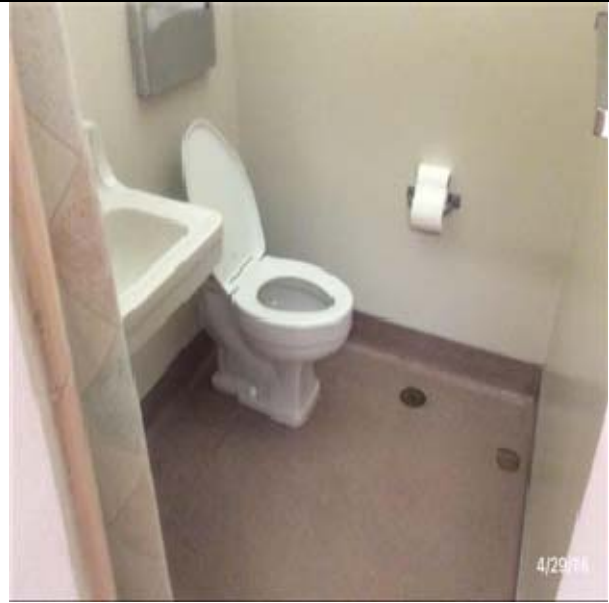
D2013 Lavatories:- View of Wall Hung Lavatories

The lavatories were observed to be in poor condition. The wall mounted lavatory drained properly and appeared to not have any cracks in the china; however, it is assumed to be original and based on a typical EUL of thirty-five years we recommend that it is considered for replacement during the study period. The countertop lavatory was observed to be in a poor condition, however, it was reported as not in use by maintenance personnel so has not been included in the study.

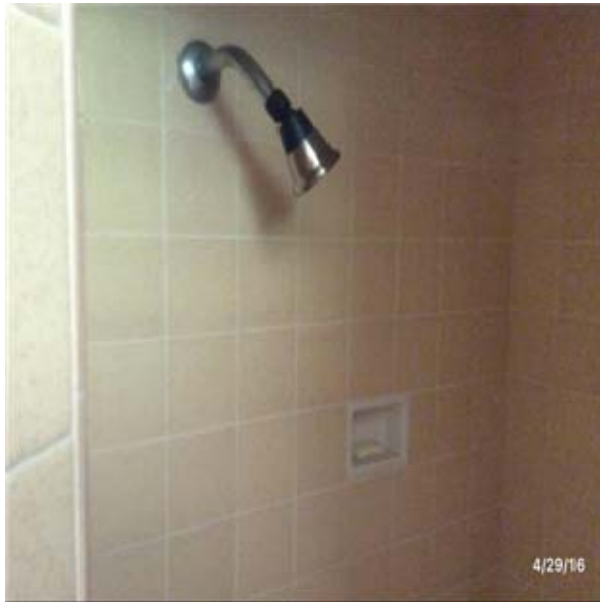
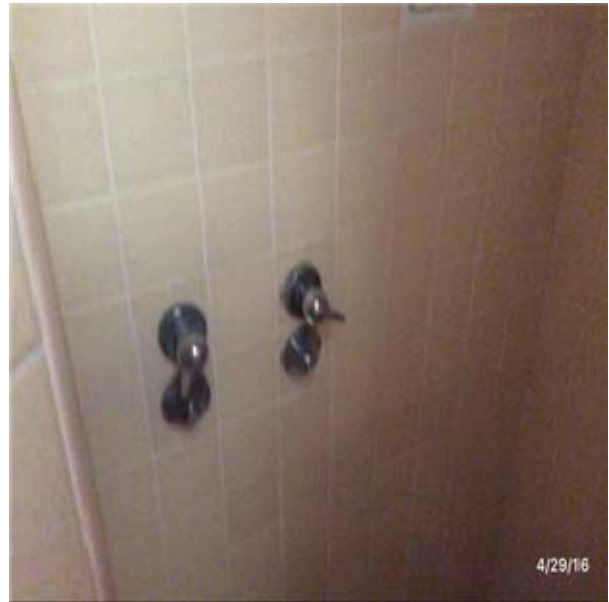
D2017 Showers:- View of Shower System - Head, Arm,
Bypass, Stops, Handles

The shower head, components and mixing valves appeared to be in poor to fair condition with some leaking. We do not know the age of the components; however, due to the condition, we recommend replacement early in the study period.
