AGENDA REPORT

SUBJECT: Receive an update on the Halsey House Historic Structures Report, and direct staff accordingly

HISTORIC STRUCTURE REPORT - DRAFT

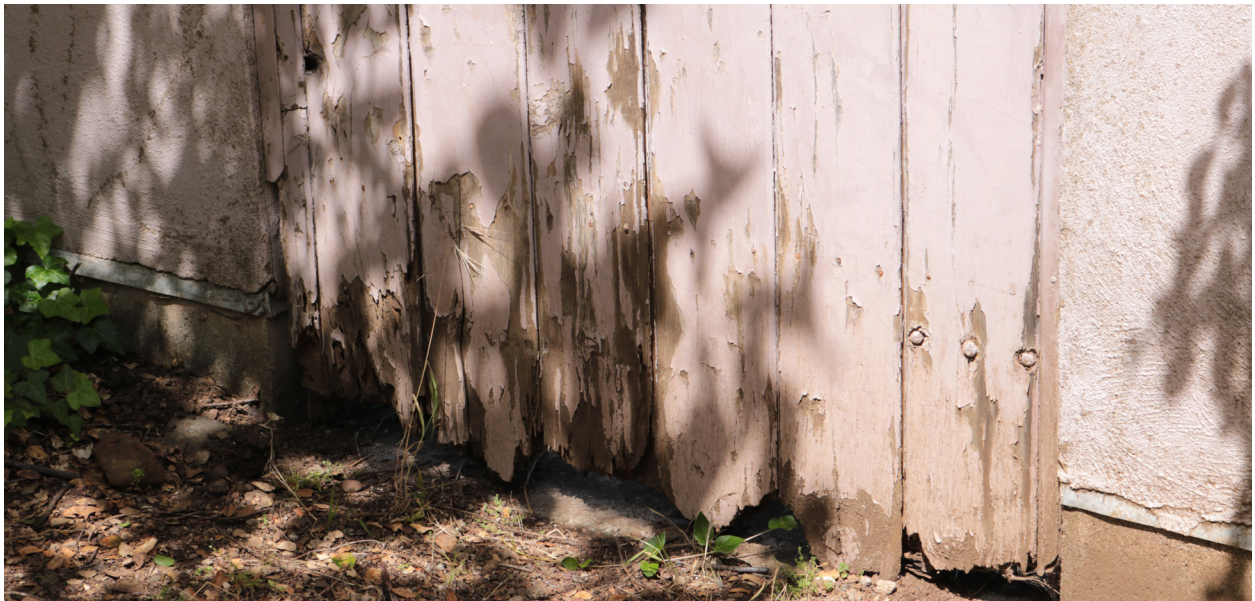
Detail view of wood deterioration at courtyard gate.

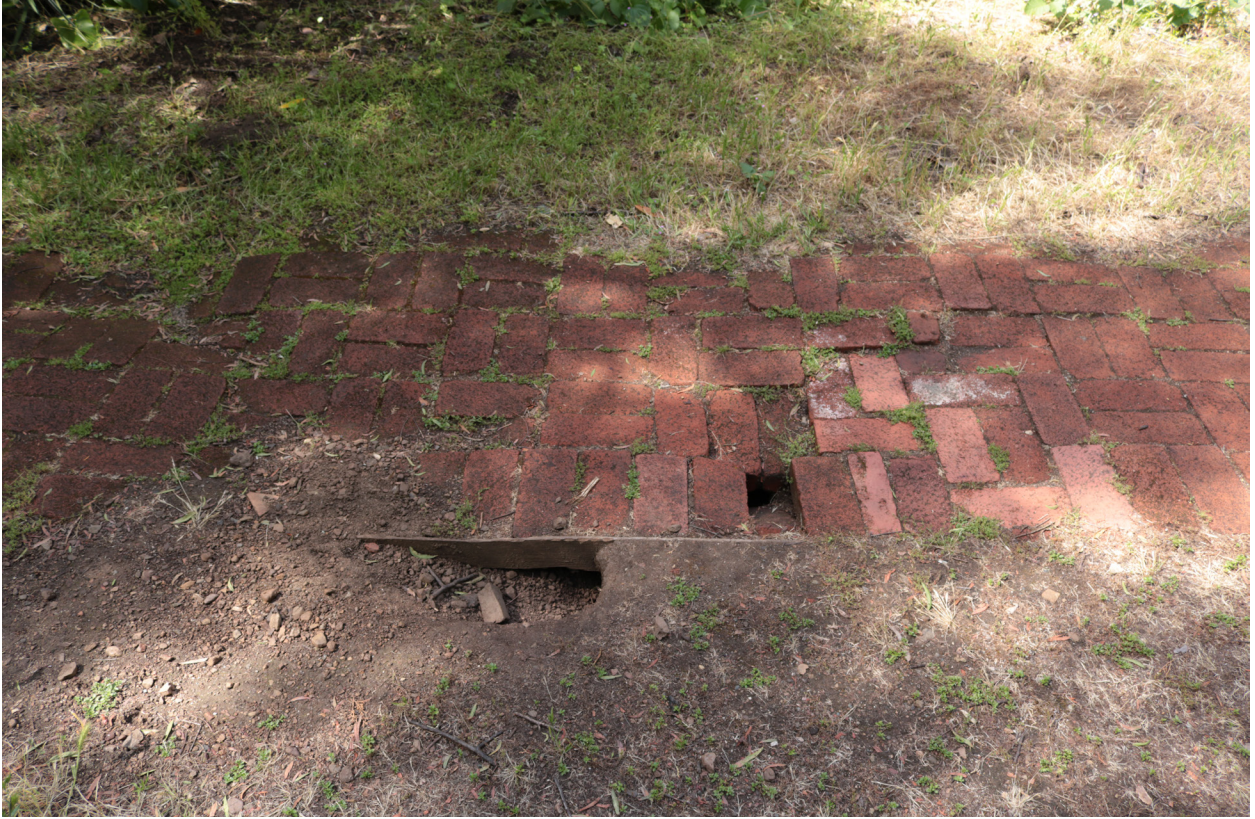
Along the east elevation, a non-original concrete path adjoins a brick path and leads to the single exterior door on this side of the building. It is unknown when these paths were installed. While the concrete path is in overall good condition with some minor accumulation of tree duff present, the brick path is in fair to poor condition. This path is overgrown with plants, some pavers have settled creating an uneven walking surface, and there is significant soil erosion along and adjacent to the path.

View of walkway paving along east elevation.
