**CITY OF LOS ALTOS
CITY COUNCIL MEETING
April 14, 2015**

SUBJECT: Approve removal of a Canary Island Pine tree at 86 Third Street and replace with a 36-inch box specimen evergreen

Re: Canary Island Pine Tree near the 86 Third Street Project

**Assessment of
One (1) Canary Island Pine (*Pinus canariensis*) Specimen
at
86 3rd Street
Los Altos, California**

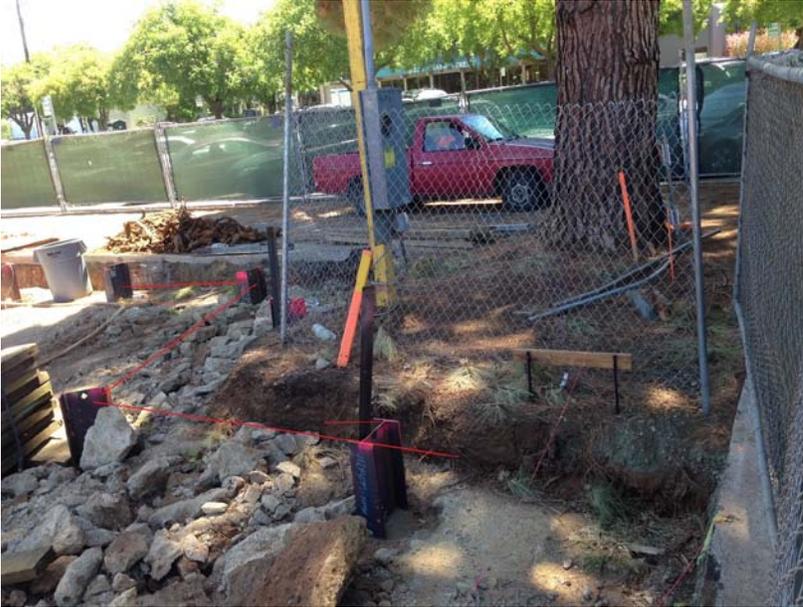
Figure 1 shows the excavation on the tension side of the slight lean.

The degree of anticipated damage from trenching and replacing existing asphalt may require removal of 70 percent of root system. The loss of more than 50 percent of the root environment will create a high risk for failure, therefore removal is recommended.

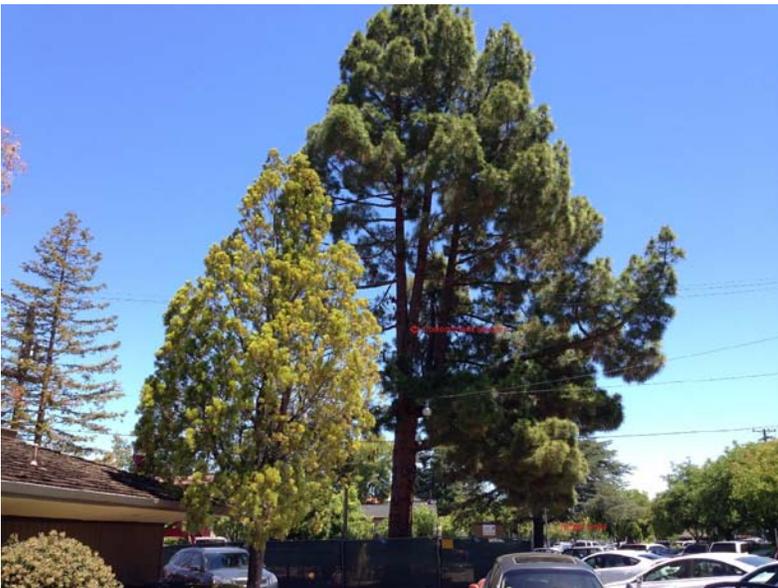
Observation: Codominant leaders create an inherent structural weakness and a moderate risk of failure. City parking lot is the target. Pruned for utility line clearance. Asphalt encompasses 70 percent of root environment. There are four broken limbs two to four inches in diameter hanging in the crown and on the ground. The existing asphalt has been damaged by roots and creates a tripping hazard.

Figure 2 shows the codominant leaders and the parking lot that is the target area for either a branch failure or root failure.

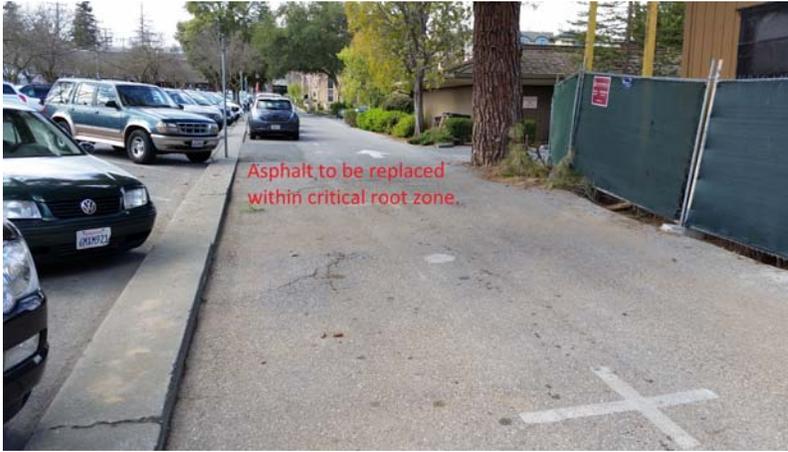
Figure 3: Asphalt alley to be excavated sufficient to replace asphalt and achieve similar finished grade.

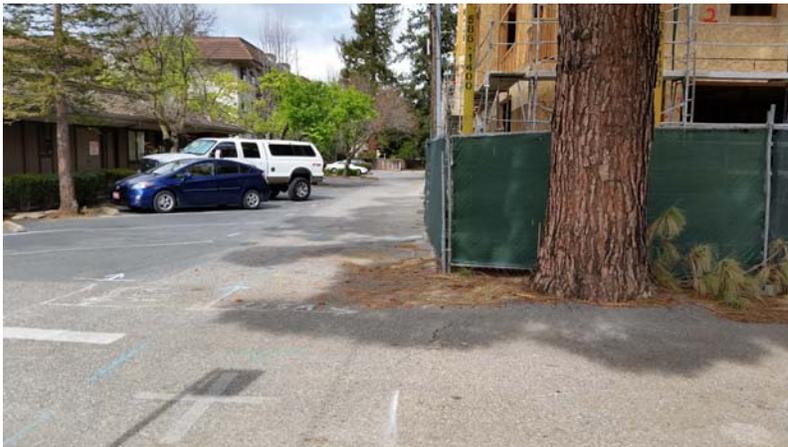
Figure 4: Asphalt alley to be replaced on two sides of root flare.

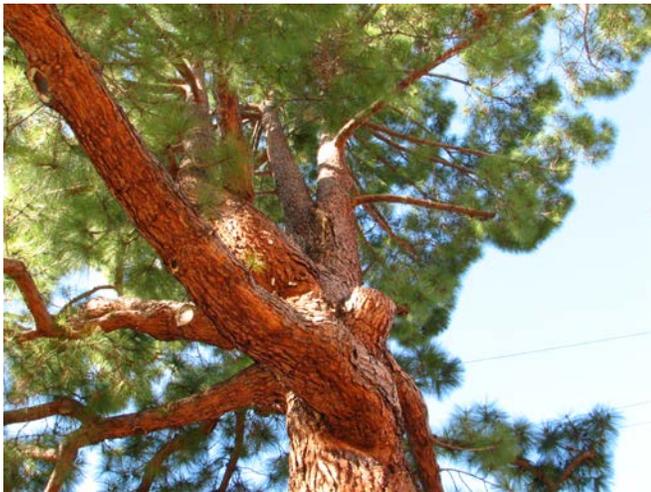
The subject pine exhibits large diameter scaffold limbs that extend southward, that are of diameters greater than 50% of the mainstem diameter, This means that they are more likely to split out than limbs measuring less than 50% of the mainstem diameter.

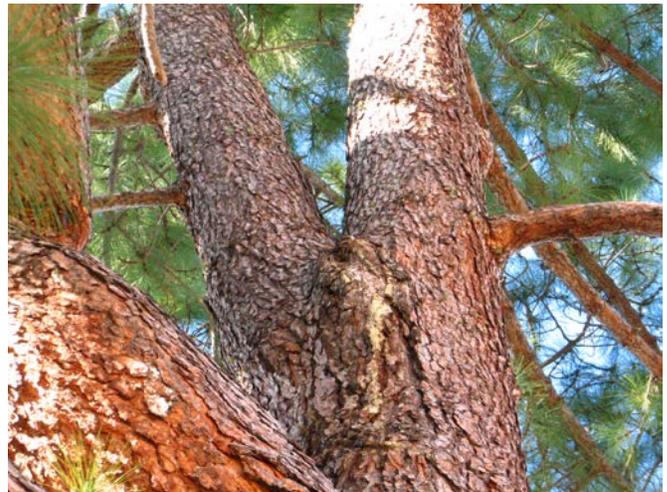
WLCA finds that the tree maintains good live twig density and extension, but a codominant fork at 25 to 30 feet elevation with bark inclusion type formation brings the structural rating down to "poor", which then reduces the overall condition rating to 45% or "poor" overall. This defect could be managed through use of a through-bolt bracing rod at the fork and/or cable installation(s), and by careful endweight reduction pruning to remove the outermost portions of the tree's southward extended scaffold limbs to reduce load forces acting on the limb attachments. The endweight reduction issue is important, given that there are two to three scaffold limbs that measure more than 50% of the diameter of the main stem, which increases risk of those limbs splitting out. However, these heavy limbs are attached to the lower portion of the tree below the above-noted codominant mainstem fork. Therefore, reduction of endweight on these limbs will not affect stability of the fork itself, and will only stabilize the limbs on which pruning is performed.

Close-up view of the codominant mainstem fork in the subject tree which may be treated with a through bolt bracing system and/or arborist cable installation(s). This work may or may not reduce risk of splitout.

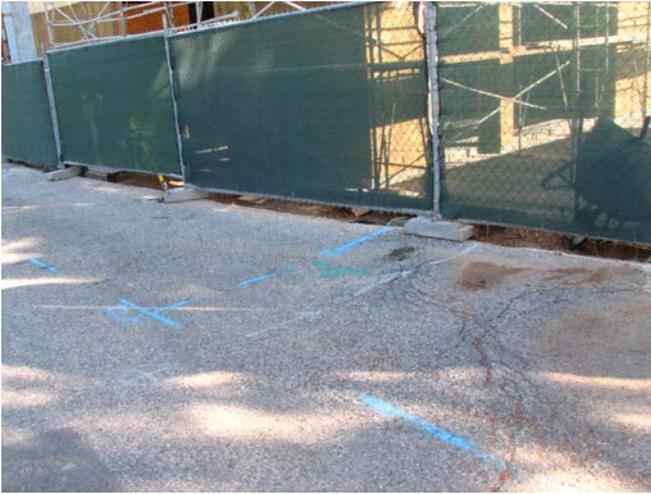
Asphalt is to be replaced between the blue line and the green fence (trunk edge). If this asphalt is replaced by excavating down into the baserock and replacing all baserock, then the root system of the tree will be severely compromised and the tree will need to be removed.

B: Asphalt renovation is limited to simple scarification, resurfacing, and resealing, without any excavation into or adulteration of the existing baserock beneath the existing asphalt layer. This may mean living with undulations caused by tree root expansion, and dealing with continued maintenance of the roadway related to on-going root expansion.

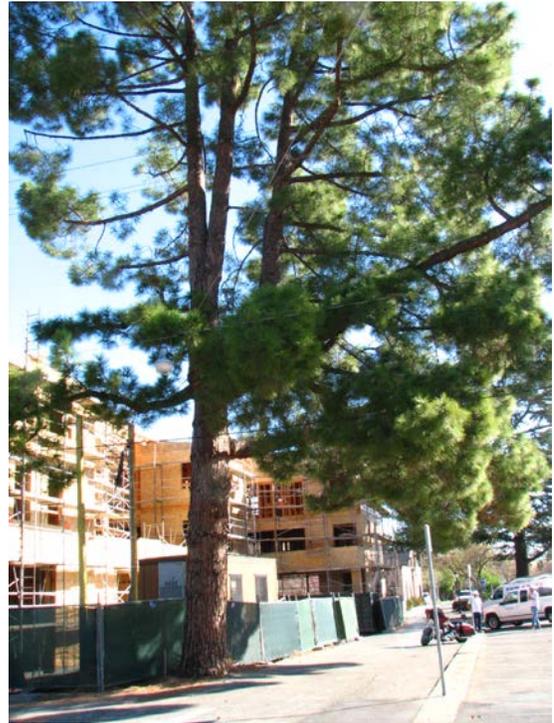
Profile of the subject tree looking east. Note the lopsided canopy extending right (southward).
