AGENDA REPORT

TO: Historical Commission
FROM: Zachary Dahl, Staff Liaison
SUBJECT: 482 University Avenue – Halsey House

SUBJECT: 482 University Avenue – Halsey House

ARCHITECTURAL EVALUATION
OF FIVE STRUCTURES LOCATED IN
REDWOOD GROVE PARK, LOS ALTOS, CALIFORNIA

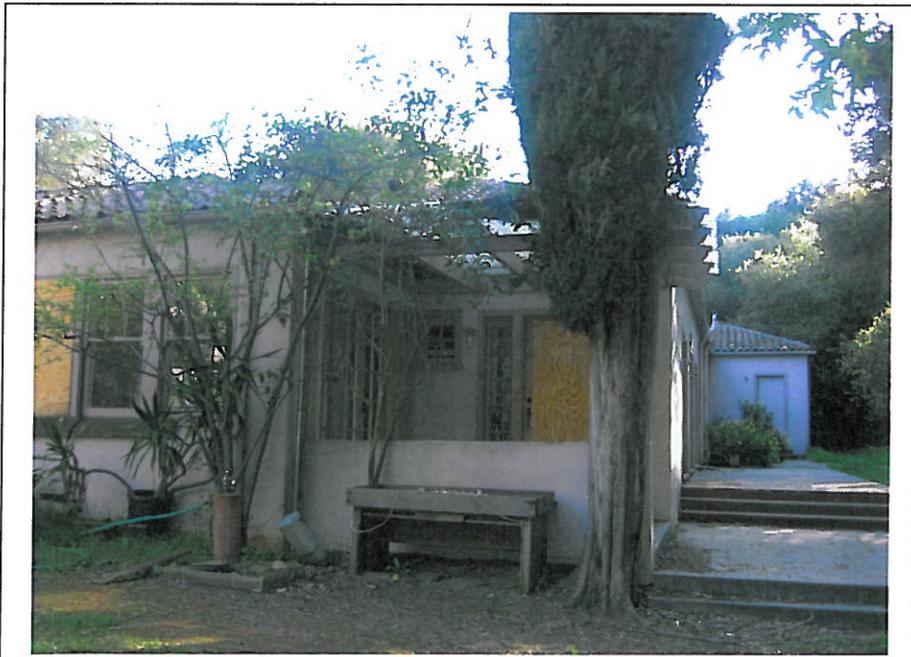
P5b. Description of Photo:
Primary Entrance (north corner)
March 2009
