AGENDA REPORT

TO: Historical Commission
FROM: Sean Gallegos, Staff Liaison
SUBJECT: 15-H-04 – 1365 Grant Road

15-H-04 – 1365 Grant Road

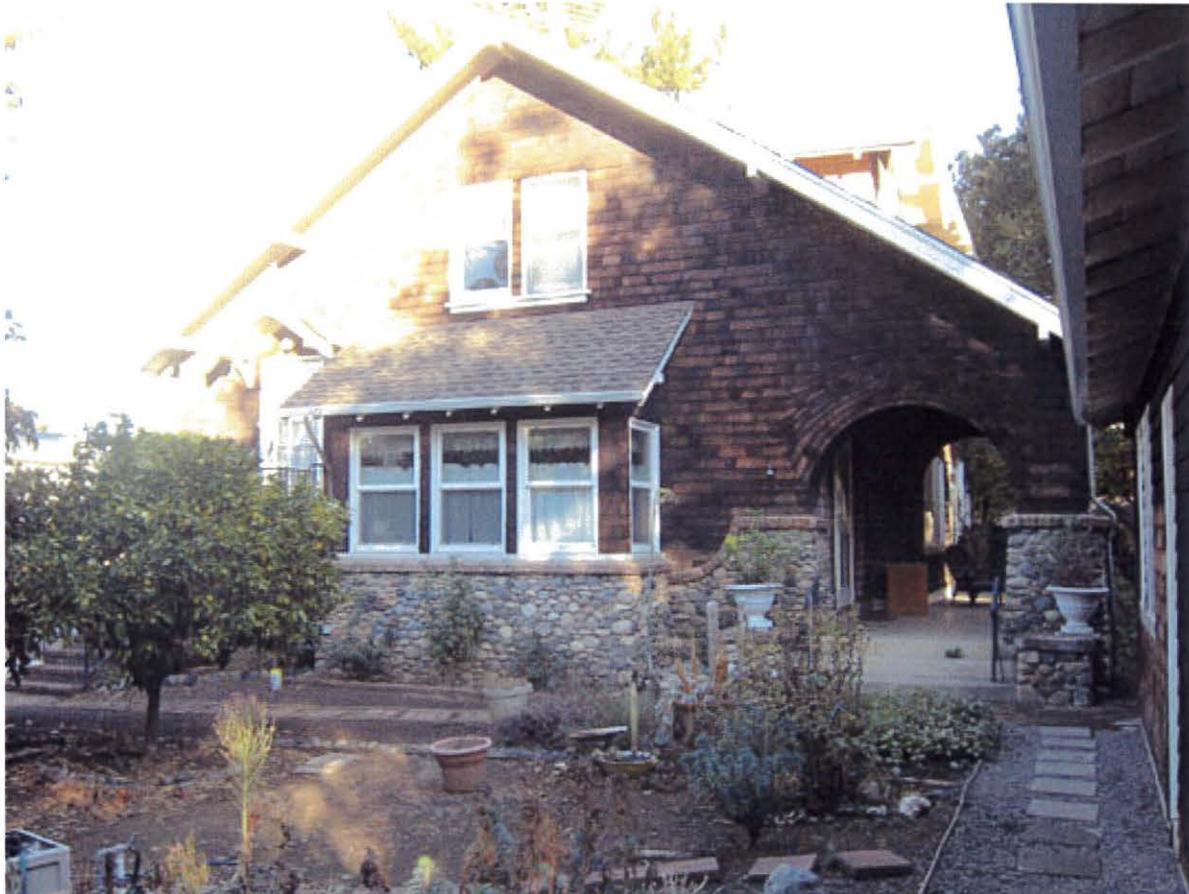
View of the east/front elevation of the house. Work to the first floor windows is not included in this phase. Work to the second floor windows is discussed below.

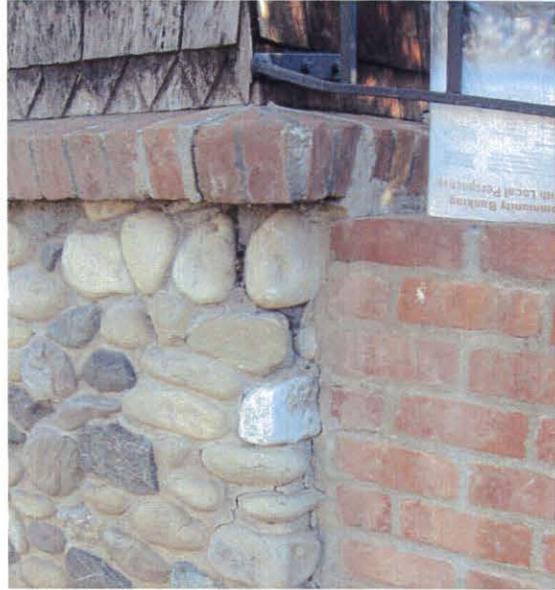
Cracks in the stone masonry will remain, but failing mortar in the brick masonry (a very limited amount) and gray Portland cement based mortar may be removed (without damaging the brick) and the brick may be repointed with a mortar that will be softer than the existing and match the existing in color.

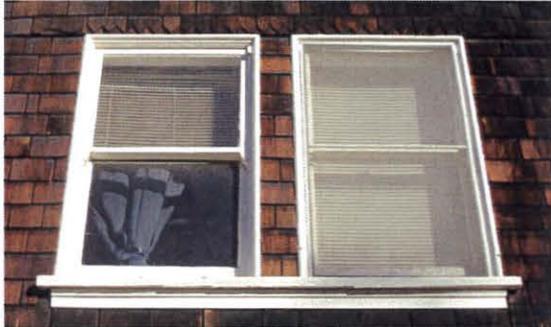
View of the second floor windows at the east elevation. These windows are wood one-over-one light, double hung sash in good condition. The windows will remain, but they will be re-glazed with laminated glass without a tint.

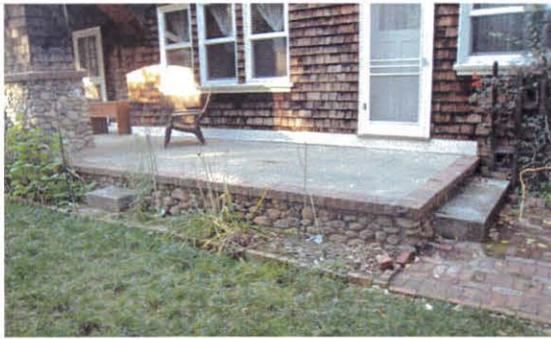
View of the existing patio proposed for removal and replacement with a larger concrete patio. Given that the patio is screened from public view by the side porch, the new patio will not be visible from Grant Road.

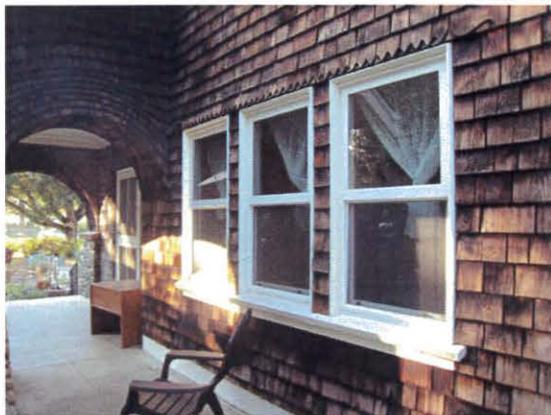
View of the three windows proposed for replacement with bi-fold doors. The decorative shingles above the windows will be retained.

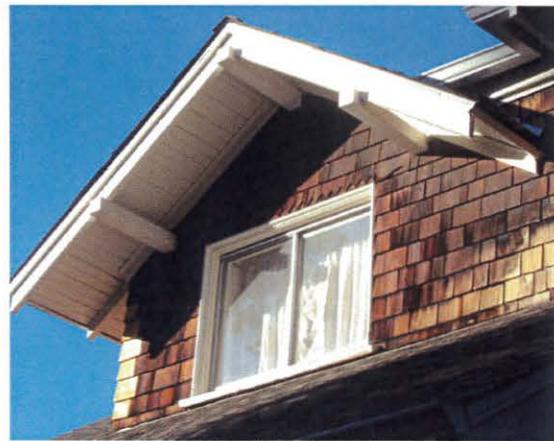
View of the easternmost windows at the second floor. These windows are not original nor are they considered historic. The windows will be replaced with double glazed wood casement sash with applied exterior and interior grids to suggest four lights per leaf. Please see window cut sheets incorporated into the drawings. The drawings show a new window to the right of the above window; it will be similar to the new sash proposed for the above opening, but double hung.

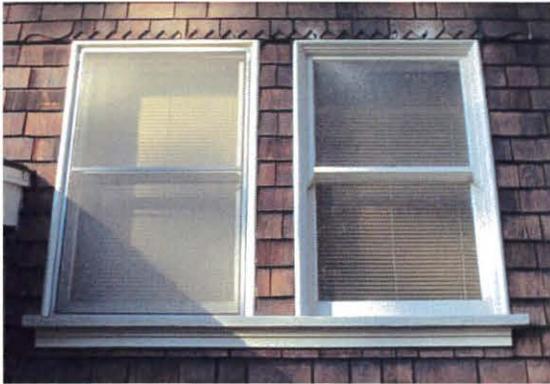
View of the existing second floor windows adjacent to the east porch. The windows will be replaced with double glazed wood four-over-four light sash with applied exterior and interior grids to suggest four lights per sash. Please see window cut sheets incorporated into the drawings for section details.

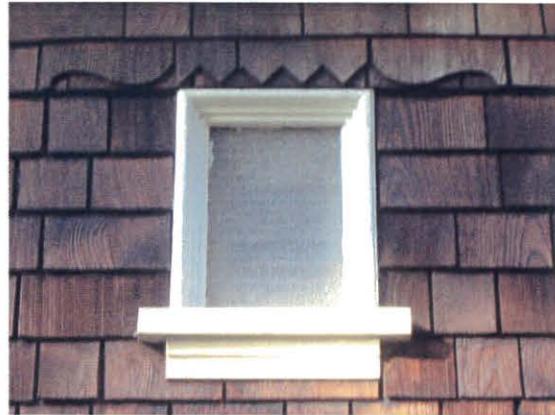
The above window is proposed for removal. It faces the east side garden and is not visible from a public right-of-way.

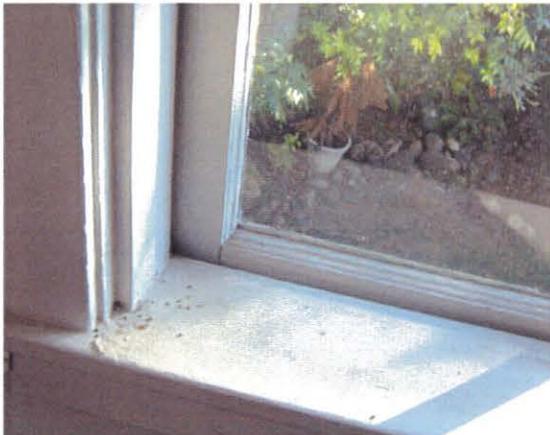
Image showing warped casement sash in the western grouping of casement windows at this elevation.

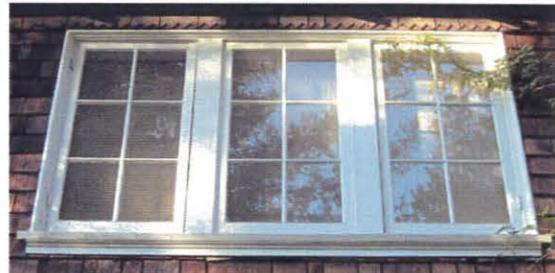
The above windows—the westernmost windows in this wall—will be replaced with double-glazed, wood casement sash with interior and exterior grids to suggest the same light configuration as the existing.

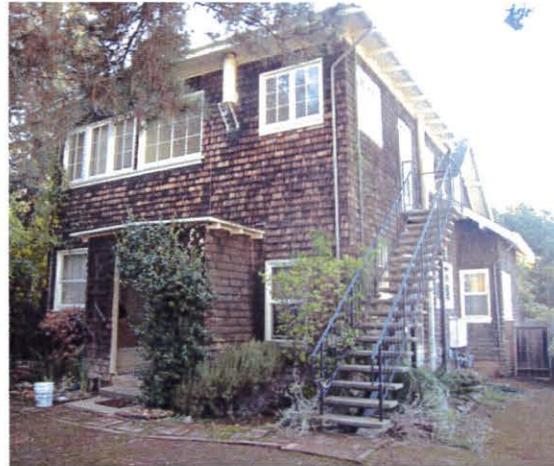
View of the west or rear elevation. Although this elevation is visible from Miravalle Avenue, the owner is proposing to replace all of the second floor windows with double-glazed, wood casement sash with interior and exterior grids to suggest the light configuration of the existing. The 12-light sash shown above is a fixed (inoperable) window; it is proposed for replacement with operable casement windows. The exterior staircase at the right will remain.

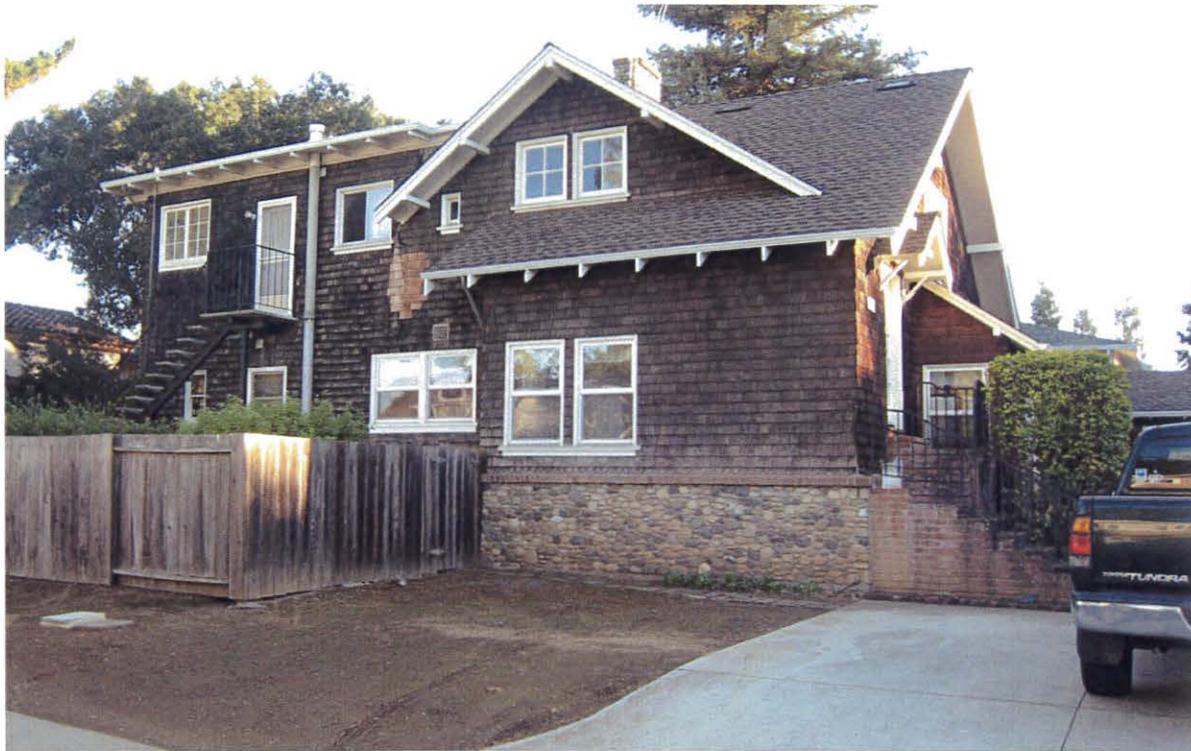
View of the south exterior wall of the house facing northwest. The chimney is proposed for removal. Because of its location at the crossing of the east gable roof forms, it is visible from Miravalle Avenue, but not readily visible from Grant Road.

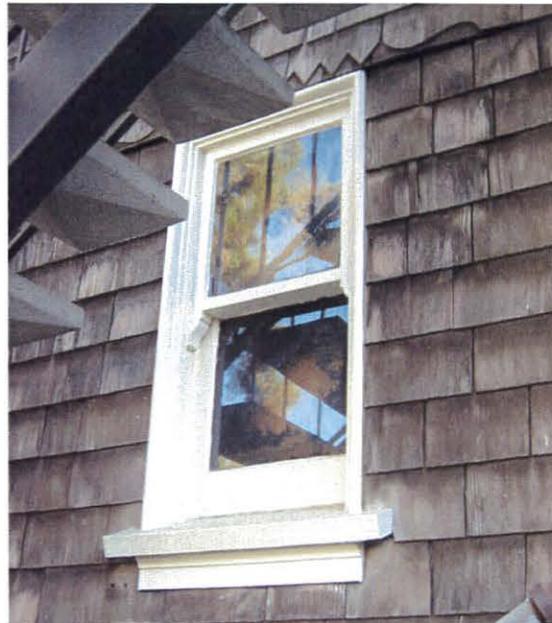
This is one of four windows proposed for removal from the first floor during phase 1. (The other three windows are at the north elevation: they are proposed to be replaced with doors.) This window illuminates the laundry room and is largely concealed behind the exterior staircase.

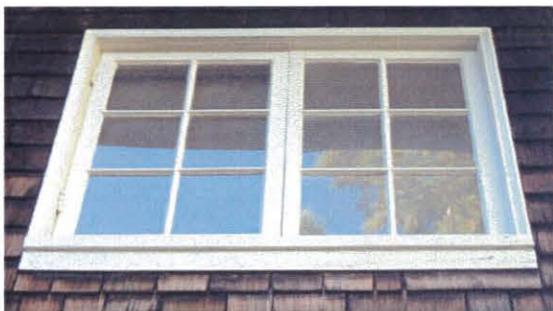
These are the westernmost casement sash in the south wall. They will be retained and possibly re-glazed with laminated glass with no tint.

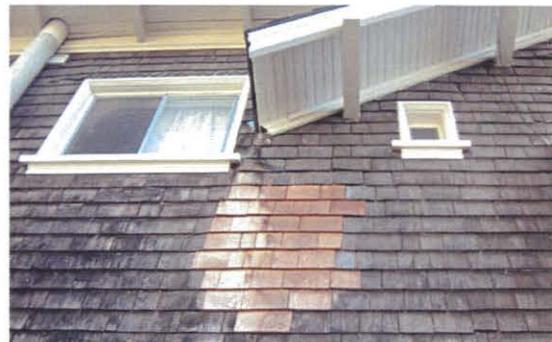
The windows at the left are non-historic sash which will be replaced with double-glazed, wood casement sash with interior and exterior grids to suggest the same light configuration as the adjacent historic windows. The small window at the right is the third and final small window proposed for removal.

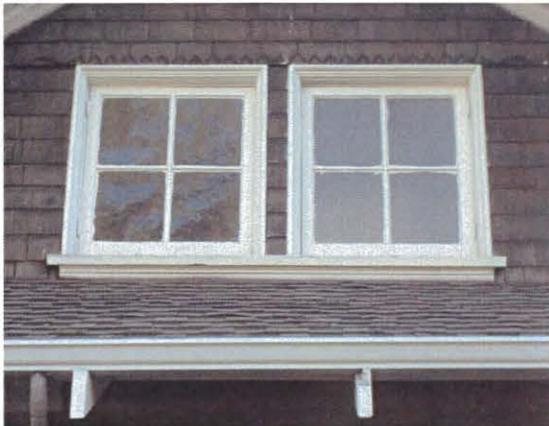
The gable end windows will be re-glazed with laminated glass with no tint.

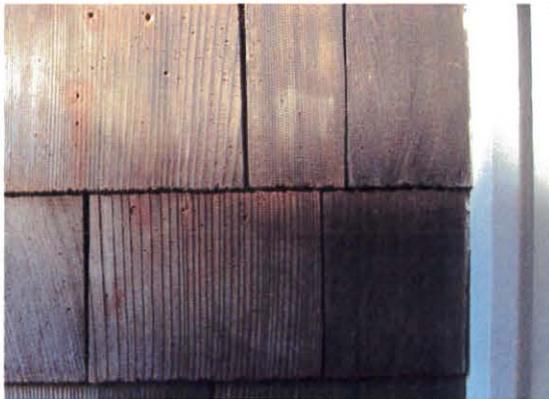
Detail view of north porch shingles which appear to be sawn redwood. These shingles are probably original to the building.

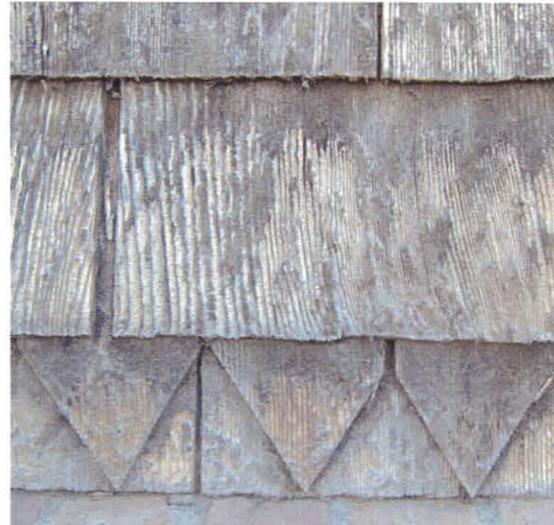
View of wood shingle deterioration due to the loss of lignin, probably caused by ultra-violet light.

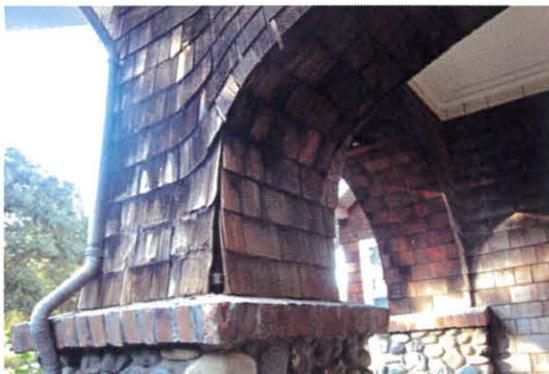
View of wood shingle damage at the north porch.

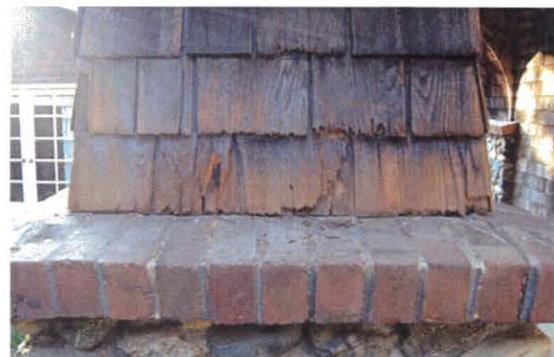
View of wood shingle damage at the north porch.

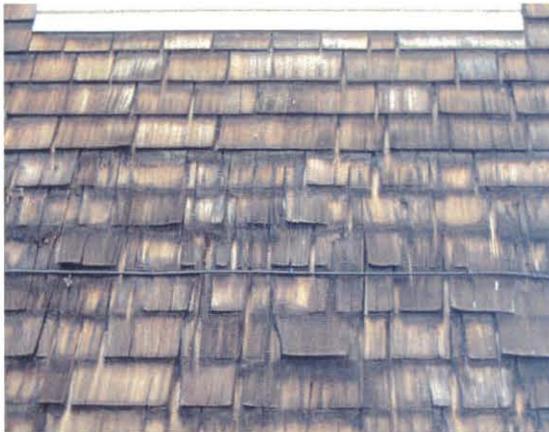
View of wood shingle damage at the south side of the west wall, between the first and second story windows. Damaged shingles will be replaced with cedar shingles. Less than 10% of the shingles need replacement. Transparent shingles stains will be tested to determine if staining will blend the new with the old; if successful, the new shingles will be stained to blend new shingles with the adjacent old shingles.
