DATE: June 2, 2021
AGENDA ITEM # 5

TO: Design Review Commission
FROM: Sean K. Gallegos, Associate Planner
SUBJECT: SC21-0004 – 444 Fir Lane

SC21-0004 – 444 Fir Lane

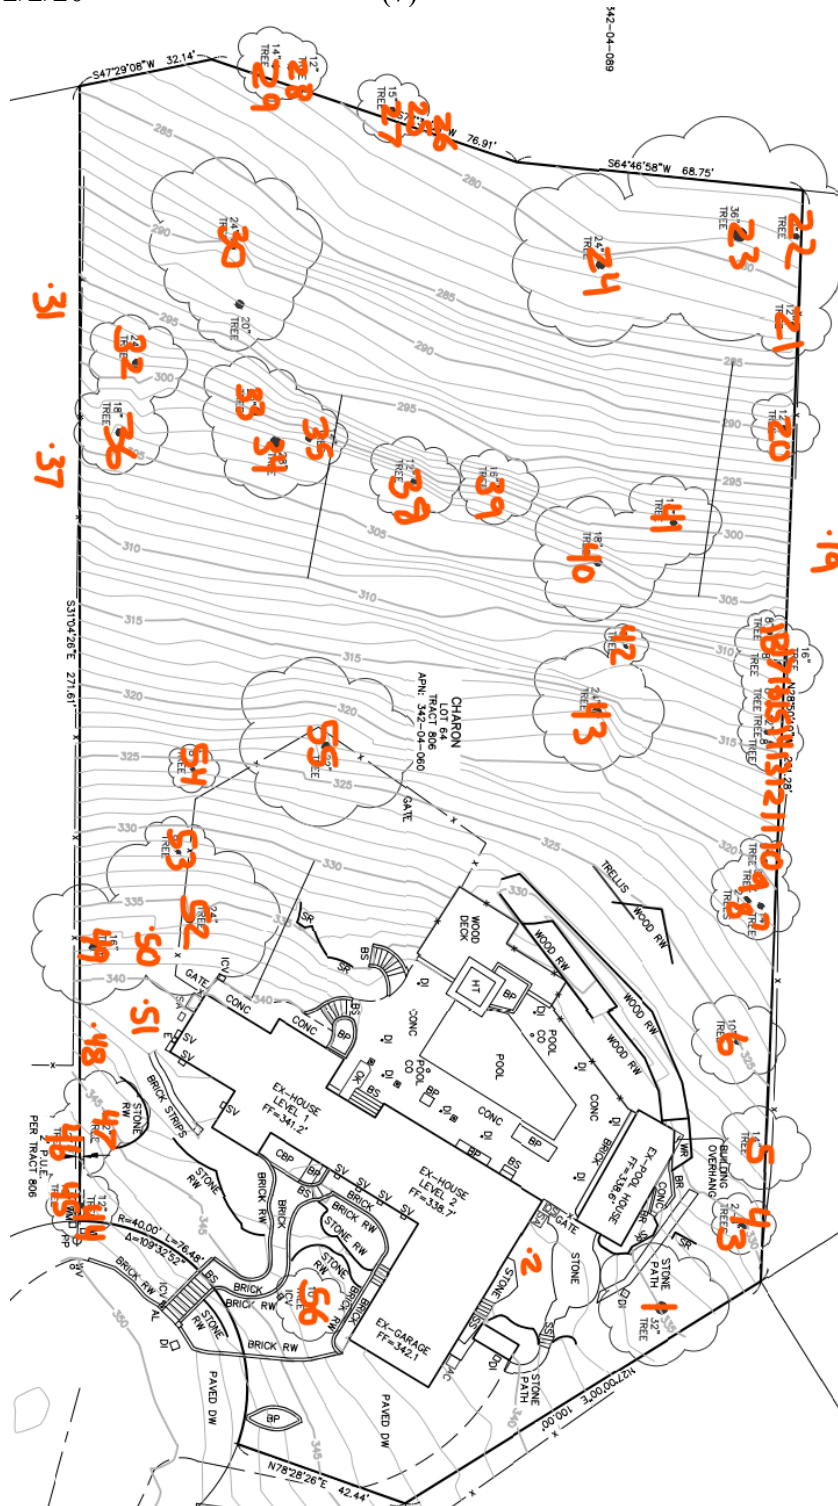
Showing tree locations

The existing landscape is in fair condition. The site is heavily sloped. Many poor species such as acacia and red iron bark eucalyptus trees were observed. The area to the north, far from the house down the hill has not been maintained or poorly maintained in the past.

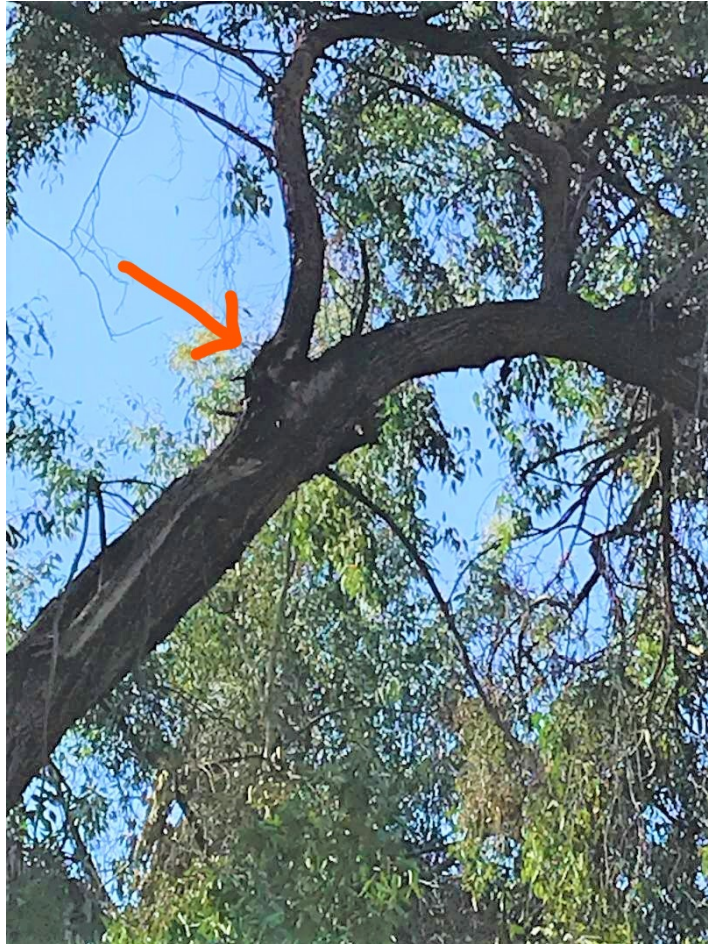
Red iron bark eucalyptus tree #23 is in poor condition. The tree has lost many large limbs as a history of limb loss was observed within the canopy. Many other similar limbs at high risk of failure were observed within the tree's canopy. This species is highly known for its tendency to lose limbs. Signs of root rot (loose bark) were observed near the base of the tree. A tree risk assessment is recommended for this tree. If the owner is not comfortable with the associated risk than this tree should be removed.

Arrow showing past limb failure. All growth after this area is at risk of failure

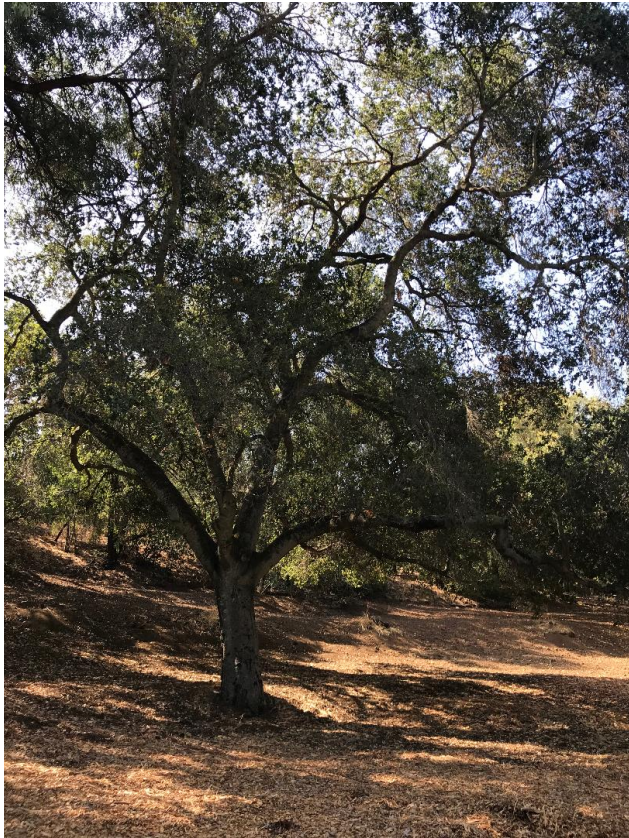
Showing oak tree #24

Coast live oak tree #24 is in good condition. This is a large aesthetically pleasing oak tree. Some of the limbs of the tree are overextended with heavy end weight observed. In order to reduce risk of limb failure due to the heavy end weight observed it is recommended to perform crown reduction pruning to reduce heavy end weight of the large lateral limbs. Cabling the large lateral limbs may also help to reduce risk of limb failure. This tree is a protected tree.

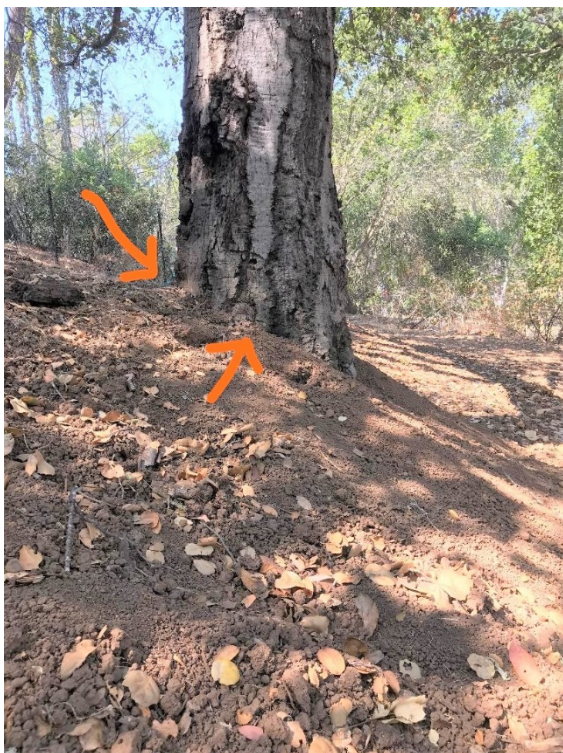
Soil looks to have been mounded up on the trunks of many of the oak trees on the high side of the slope. Soil is recommended to be removed until the root crowns are visible on all sides of the trees. Small tree wells on the high side of the slope near the trees would help to reduce risk of burying root crowns. Buried root crowns often lead to root rot as moisture is held at the base of the trees.

Showing buried root crown

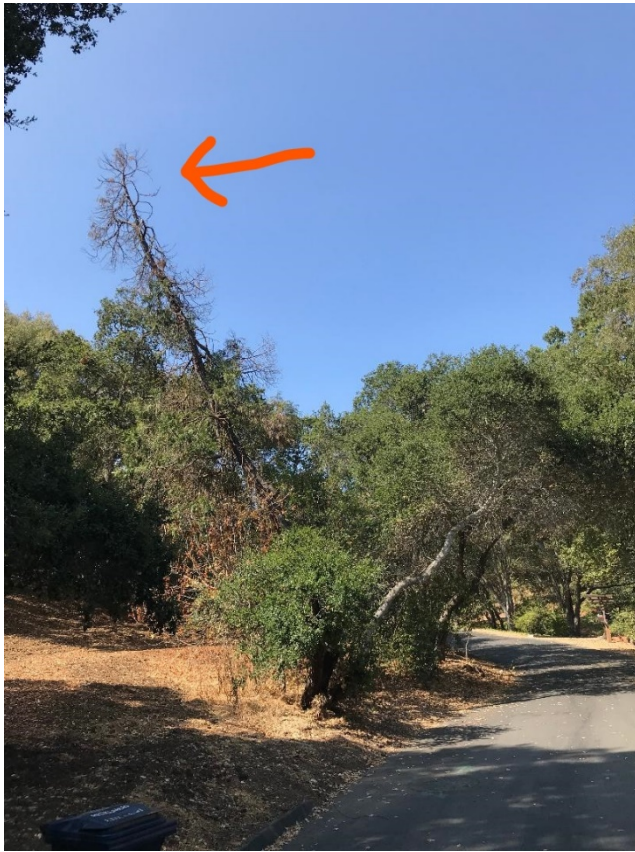
Incense cedar tree #27 is nearly dead. The tree leans into the property and is a hazard. Tree removal is recommended. This tree is a protected size and will need a permit to be removed.

Showing nearly dead cedar tree #27

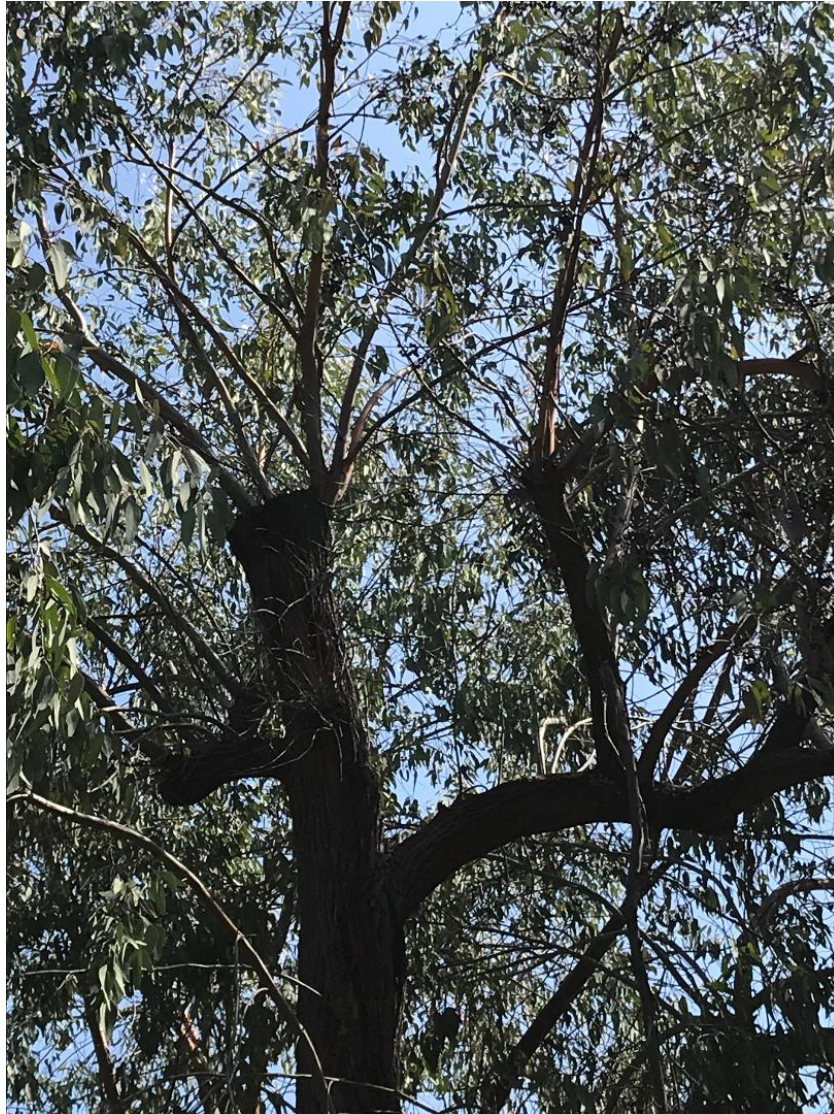
Red iron bark eucalyptus trees #32-39 are in poor condition. These trees have been radically topped in the past likely for a view. The trees are at high risk of limb failure due to the past poor maintenance. Red iron bark eucalyptus trees are known for losing limbs. The past topping cuts only increase risk of limb failure. Also, eucalyptus trees are considered a fire hazard as they have a significantly higher fuel load than the native oak trees. Eucalyptus trees are generally an undesirable species in the landscape.

Showing topped eucalyptus tree. Spouts are all prone to failure due to weak attachments

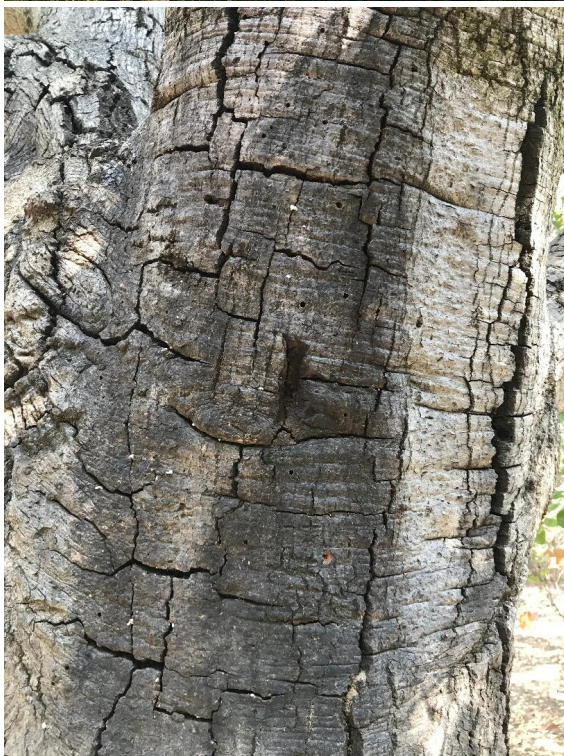
Coast live oak tree #40 is in poor condition. Many bleeding cankers were observed on the tree's trunk. Oak beetle damage on the trunk was also observed. An estimated 30% of the tree's conducting tissue has been lost. Large areas of dead wood and dieback were observed within the canopy of the tree. This tree is expected to continue to decline as beetles were observed. Beetles only attack trees in poor health and cannot successfully attack healthy trees. This tree is severely compromised and will likely die within the year. This tree is not expected to survive much longer. The dead/dying limbs are all at risk of failure. No mitigations are expected to help improve the tree's health.

Showing oak beetle damage

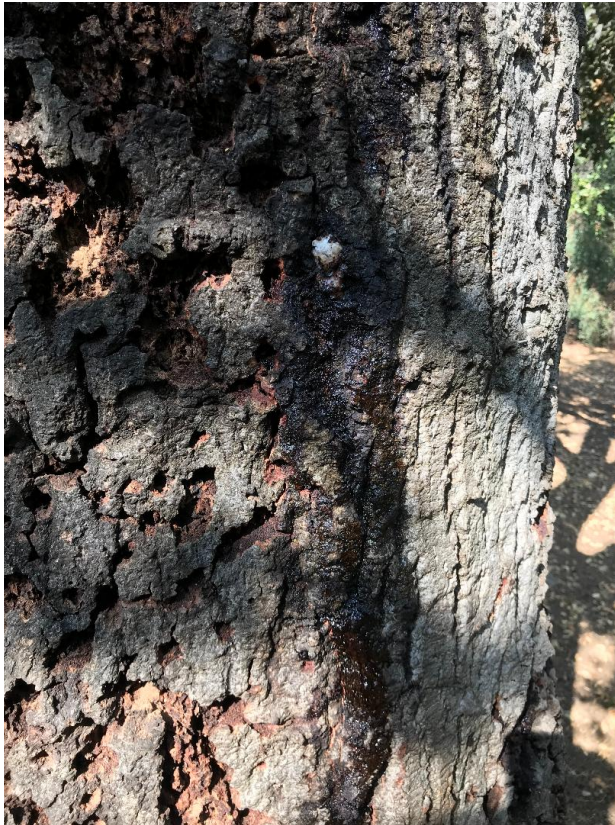
Showing bleeding canker

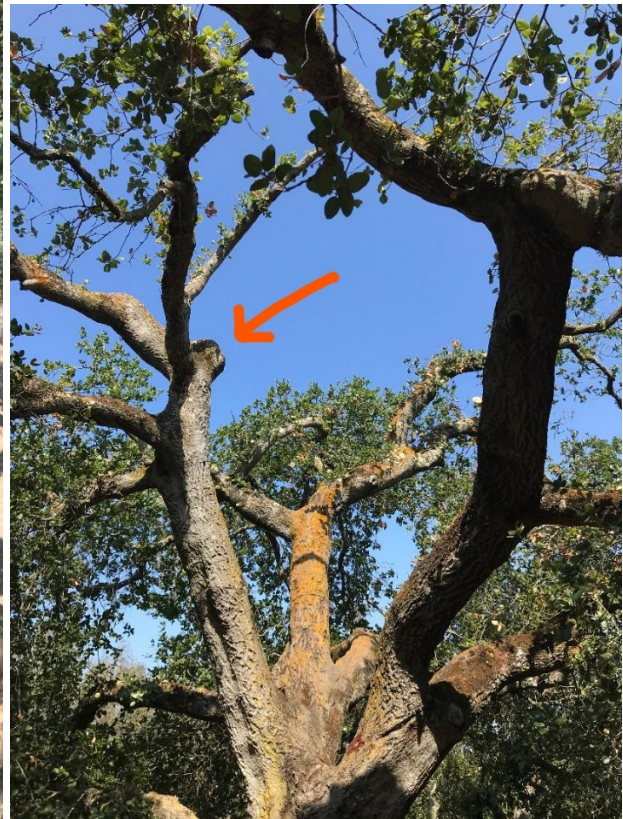
Showing topped tree and decline in vigor

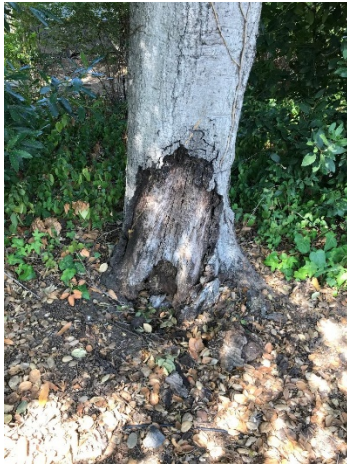
Oak tree #47 is severely decayed at grade and is a hazard to the property. Root rot and heartwood rot is evident. Removal is recommended. Because this tree is located near the property line it is recommended to show the neighbor the amount of decay observed before removing the tree. This tree is not a protected size tree in the city of Los Altos.

Showing evidence of decay at base of oak tree #47

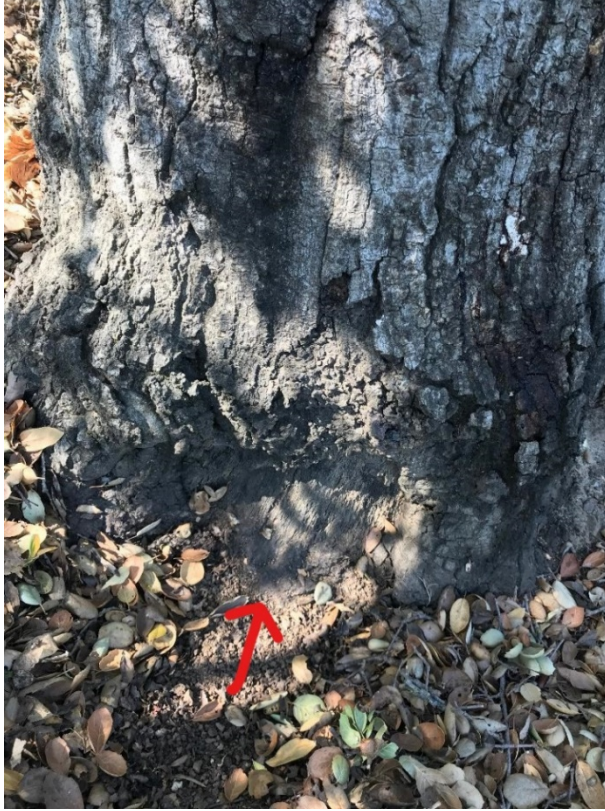
A home addition is proposed at the back of the existing home on the north west side of the property. The addition will require the removal of protected oak tree #52. Oak tree #52 is in poor condition. The tree has poor vigor with large areas of dead wood observed. Dead wood is a common symptom of Armillaria caused root rot (oak root fungus disease). Root rot scars were observed near grade. The structural integrity has been compromised as heart wood rot at the base of the tree is present. Sycamore borer was also observed on the bark of the tree near the base. This tree is near the existing home on site. The observed Armillaria root rot makes the tree a hazard to the property as the structural integrity of the tree has been compromised. Tree removal is recommended. Because many of the tree's signs of poor health point to Armillaria root rot (oak root fungus disease), testing was recommended to get a better understanding on the amount of decay within the tree.

Showing obvious root rot scar on east side of tree**Testing:**

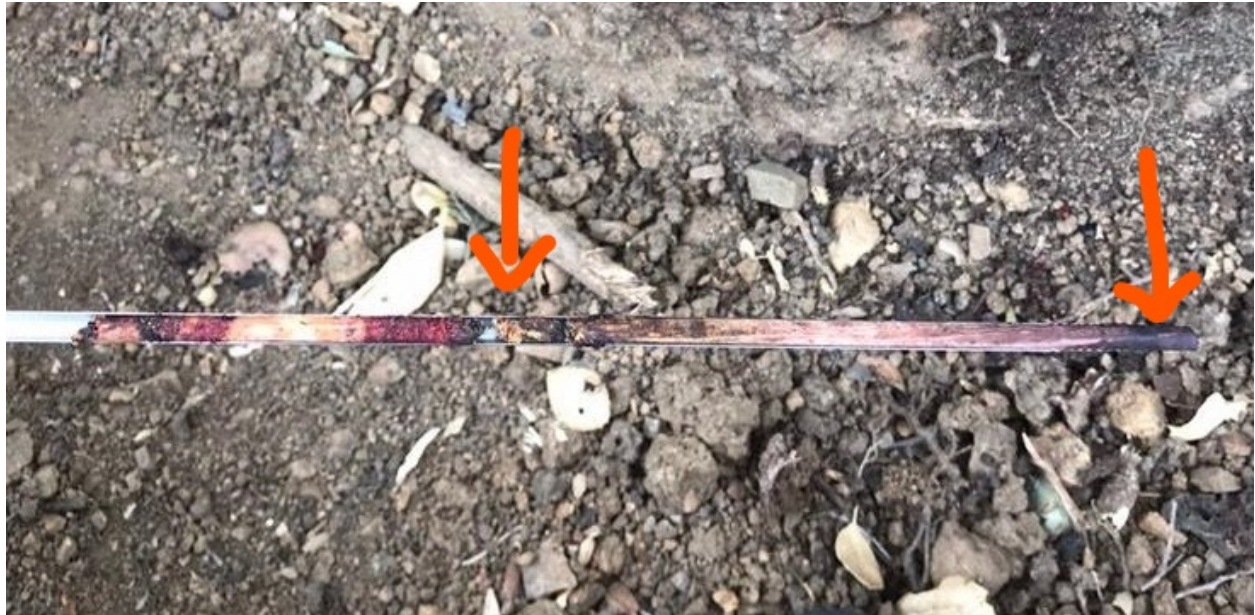
On November 11th, 2020, Kielty Arborist Services LLC visited the site to conduct testing on oak tree #52 to determine the extent of decay at the base of the tree as obvious Armillaria root rot disease scars were observed. The largest visible root rot scar is on the east side of the tree. Smaller root rot scars are visible on the south and west side of the tree but not as large as the visible scar on the east side of the tree. An increment borer was used to take a small core sample out of the tree on the north side of the tree as this side of the trunk looks to be less affected by root rot. An increment borer is a specialized tool used to extract a section of wood tissue from a living tree with relatively minor injury to the tree itself. It is often used by foresters, researchers, and scientist to determine the age of a tree or extent of decay. The science is also called dendrochronology. The core sample on the north side of the tree showed decay encountered at 3" and again at 7". White mycelial fans were observed within the core sample indicating presence of heartwood rot. A drill test using a Resi 300 and a cordless drill was then performed on the south side of the tree. Decay was encountered at 8 inches. This tree has been compromised by Armillaria root rot disease. Tree removal is recommended due to the hazardous nature of the tree. The city of Los Altos has criteria used to help decide whether or not to grant a permit. The following criteria matches the recommended tree removal. *(1)The condition of the tree with respect to disease, imminent danger of falling, proximity to existing or proposed structures and interference with utility services.* **SUPPORTING PHOTOS ON**

Showing increment bore on north side of tree. Decay in wood observed at 3" and again at 7"

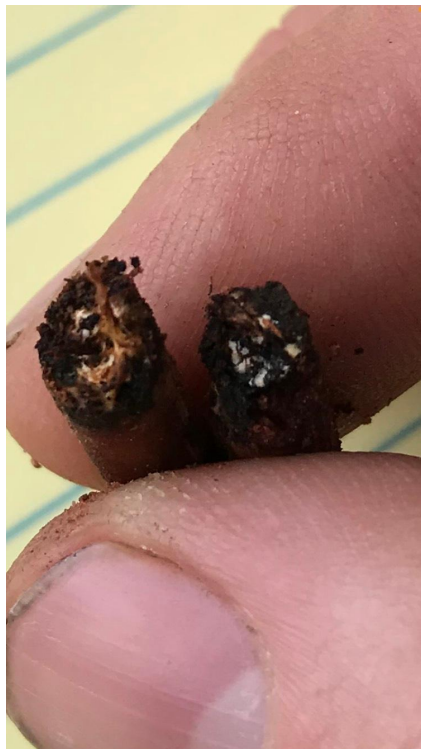
Showing mycelium (white areas) in increment taken on north side

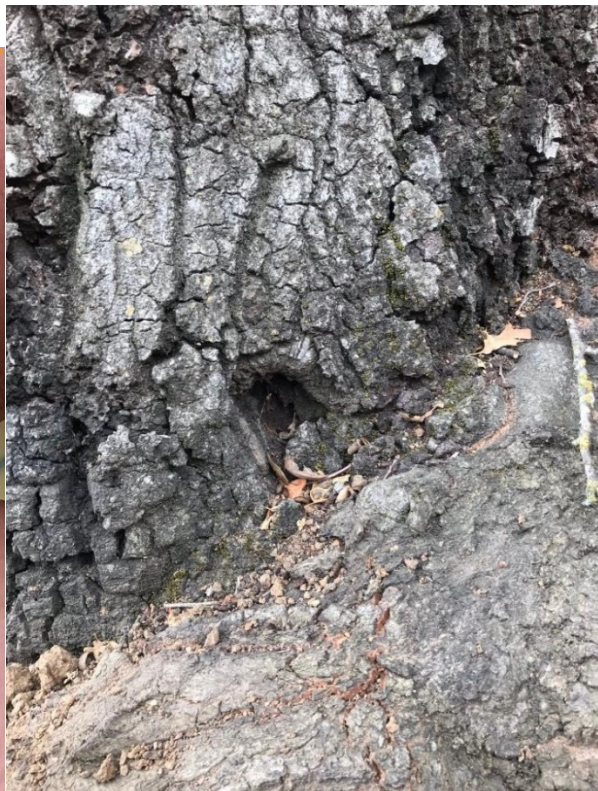
Showing root rot scar on west side of tree

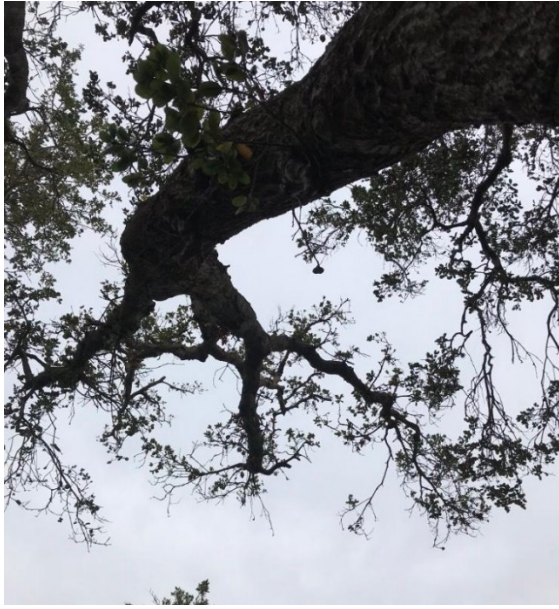
Showing decline in canopy as a result of Oak root fungus disease

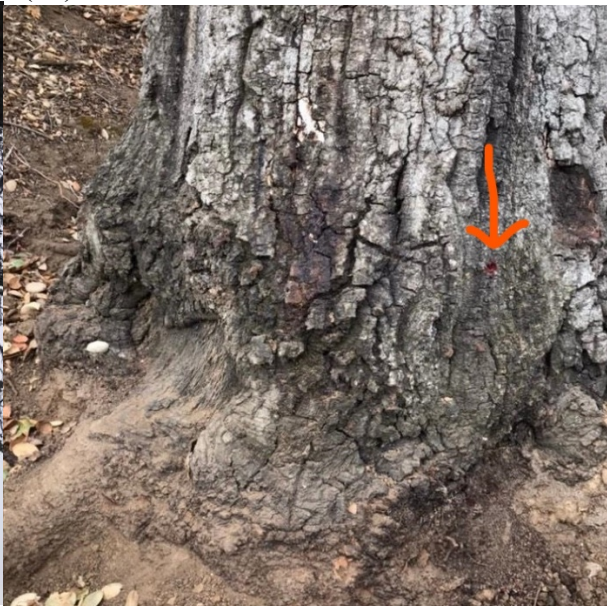
Showing increment bore location

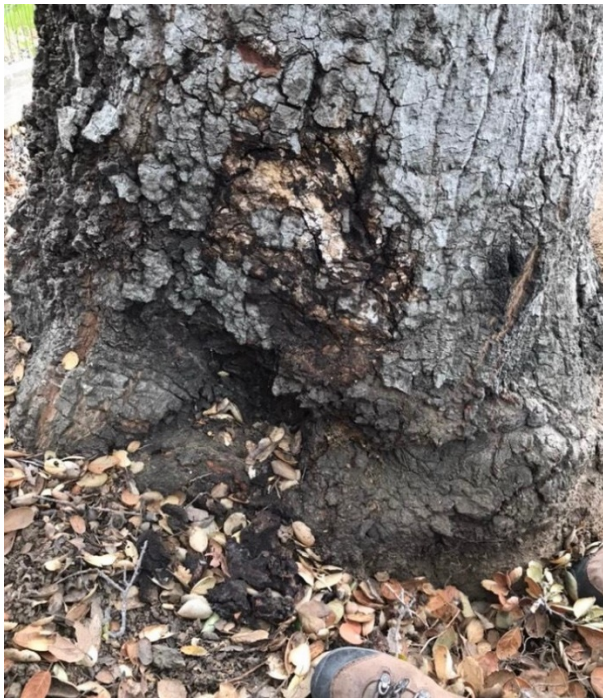
Showing evidence of root rot on south side of tree

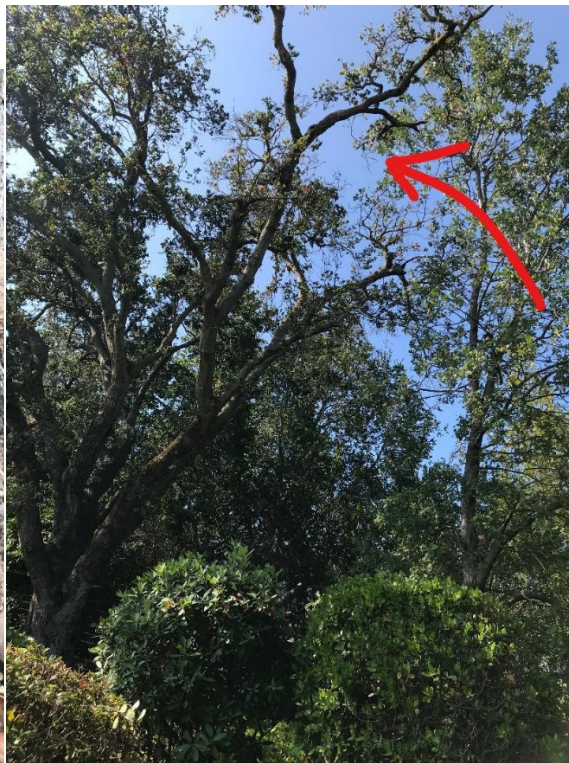
Showing die back in canopy
