SUBJECT: Inclusive Park Assessment

Meeting Date:	September 8, 2021
То:	Parks and Recreation Commission (PARC)
From:	Commissioners Morris and Valadez, JEDI Subcommittee
Subject:	Enhancing Park Inclusivity Project– Park Assessment Report
Version 4.0

PARK ASSESSMENT REPORT:

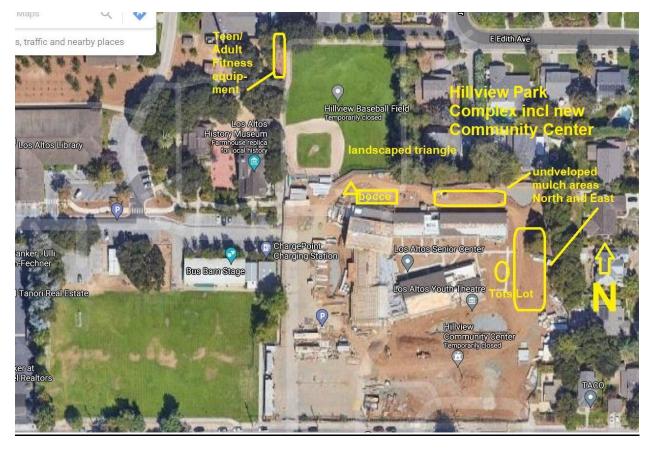
HILLVIEW COMPLEX:

- New Tots playground (2021) encircled by fence.
 - Notes: Consider shade options, additional accessible features, additional adult seating, and, given drought conditions, alternative feature or activity at existing water feature.
 - \circ $\;$ Suggestion 1: Install shade sails to shade from southerly sun.
 - Suggestion 2: Replace water feature with different accessible activity.

- Open mulch areas (one east of Community Center Tots playground and one north of path to Bocce Ball courts)
 - Notes: these are open areas of moderately varying grade levels; city plan for easterly area is for playcourt(s) and for northerly area is for an environmental water swale.

- Bocce Ball courts:
 - Notes: Consider shade options
 - Suggestion 1: Replace triangle-shaped landscaped area: could be a location for either accessible seating for viewing the baseball games, or a single inclusive playground feature (like a rotating wheelchair merry-go-round), or, for seniors and others, some wheelchair-friendly checkers/chess tables (which double as picnic tables).

- Teen/Adult Fitness playground (age rating unknown to us) at NW corner of Hillview Baseball Field:
 - \circ $\;$ Notes: Consider adding features and enhancing flatness of ground surface.

- Suggestion 1: either or both areas are prime targets for inclusive structures, and/or picnic/sitting/relaxation areas (with shade); can use alternative no-mow drought tolerant turf combined with various accessible play surfaces.

- Suggestion 1: Replace one feature with a feature usable by a person who uses a wheelchair (example: arm-pull rails or overhead rings).

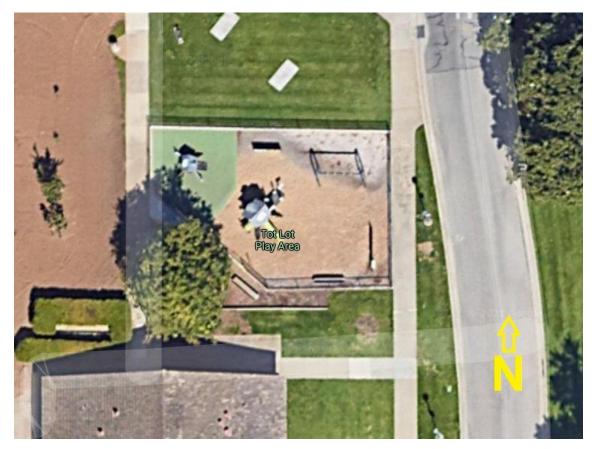
LAYC TOT LOT

- Notes: Playground (2018) for Ages 0-2. Consider increasing shade options. Artificial surface pad located at the west side of the playground.
- Suggestion 1: Install one or more shade sails to shade southerly sun travel.
- Suggestion 2: Add additional artificial surface to music feature.
- Suggestion 3: Replace one of the bucket swings with an inclusive swing.

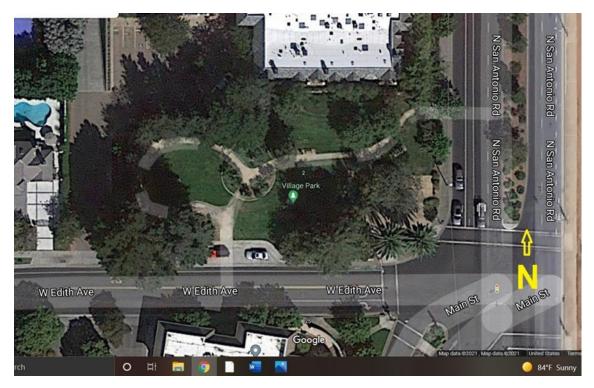
VILLAGE PARK

- West Patch:
 - Notes: open grassy area, encircled by benches; trees shade southern sky; a few grills.
 Highly used by downtown workers on lunches and breaks. Well shaded in the afternoon.
 Easy access from Edith with concrete path; exit ramp at southwest corner steep and exhibits drainage runoff mud and ruts. Consider adding inclusive activity.

- Southern Central patch
 - Notes: afternoon shade at west end, direct sun in middle, wet grass all day at east end due to dense evergreen tree shade. Consider adding activity.

- Northern Central Patch: situated adjacent to condo building, no changes suggested
- Eastern Patch:
 - Notes: Two paths from San Antonio and Corner to Eastern Patch seem steep for visitors who use wheelchairs or other walking aides (there are alternative paths available to visitors who use wheelchairs).

- Suggestion 1: Add wheelchair accessible checkers/chess tables; place them near the path to ease access and increase use by elders/all ages for table-based activities (see example picture under Rosita Park section).

- Suggestion 1: Add a few checkers/chess tables that are wheelchair accessible near the western path. (Could form a nice activity cluster of tables placed at eastern end of West Patch).

- Suggestion 1: Lessen slope of path coming from corner of San Antonio and Edith.

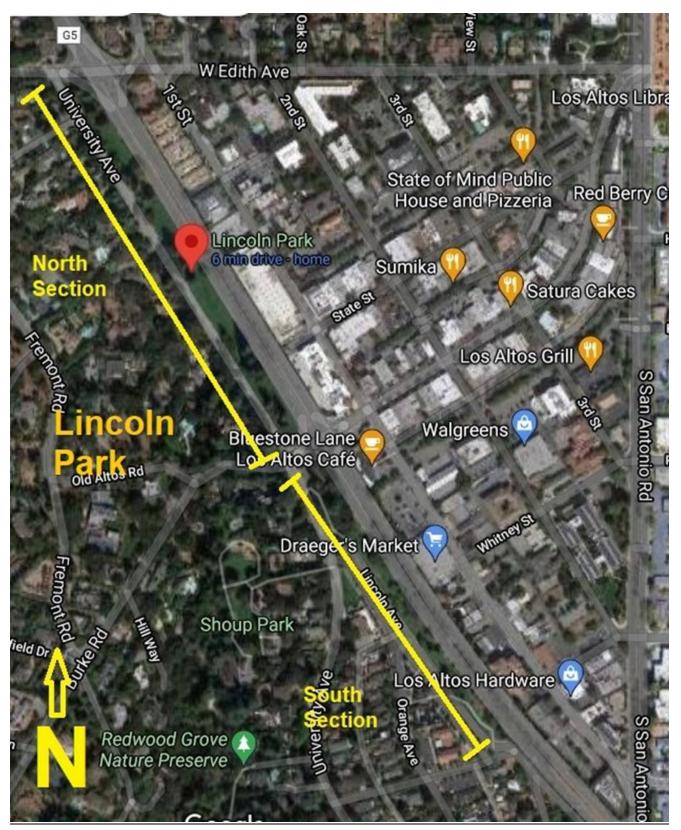
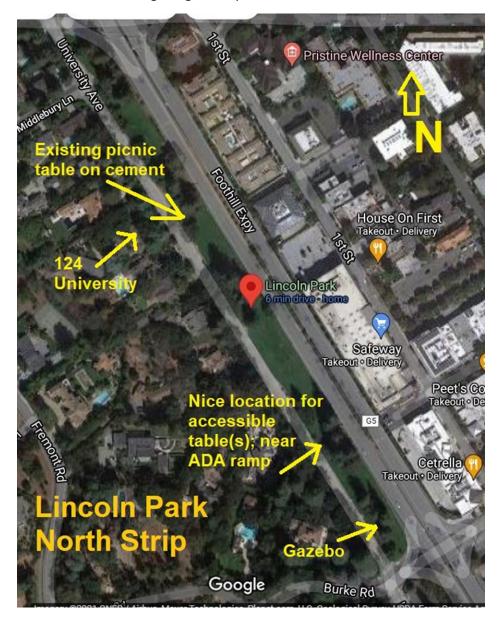
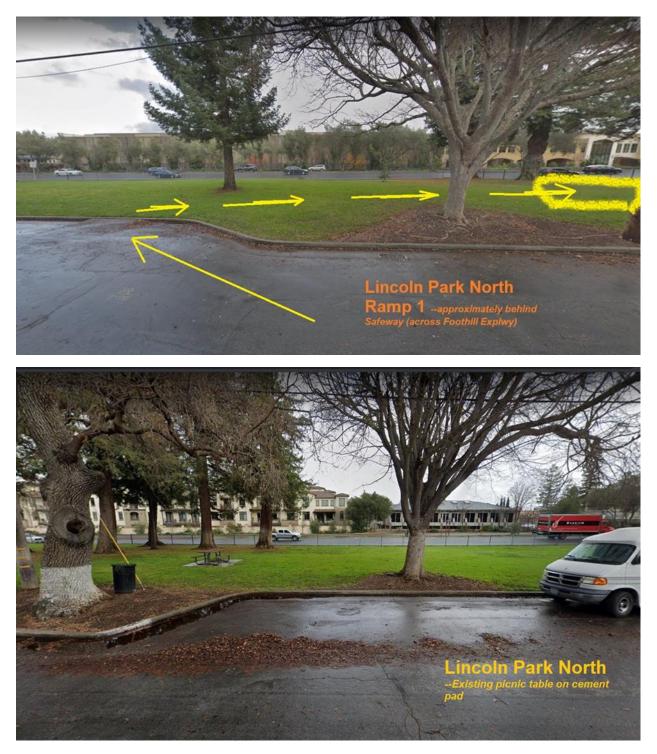
LINCOLN PARK

- Lincoln Northern Strip (bounded by Foothill, Edith, University, and Burke/Main)
 - Notes: The park is mostly open grass turf, except for the Gazebo, some sculptural art, trash cans, and one picnic table. Access ramps available to the street. Consider additional enablers for seating or picnicking.

- Suggestion 1: Add wheelchair path from street and ramp access into Gazebo.
 - Suggestion 2: Add wheelchair-accessible picnic table under shade in grass area that backs on southeast end of Safeway store. This area can be accessed through Ramp 1 at nearby parking cutout (see picture). Add Handicap Parking designated space in cutout and wheelchair accessible pathway to table (granite fines over compacted earth, sealed).

- Suggestion 3: Convert existing picnic table, located at approximately 124 University, to be wheelchair accessible; add wheelchair path to simple ramp at curb and add Handicap Parking designated space.

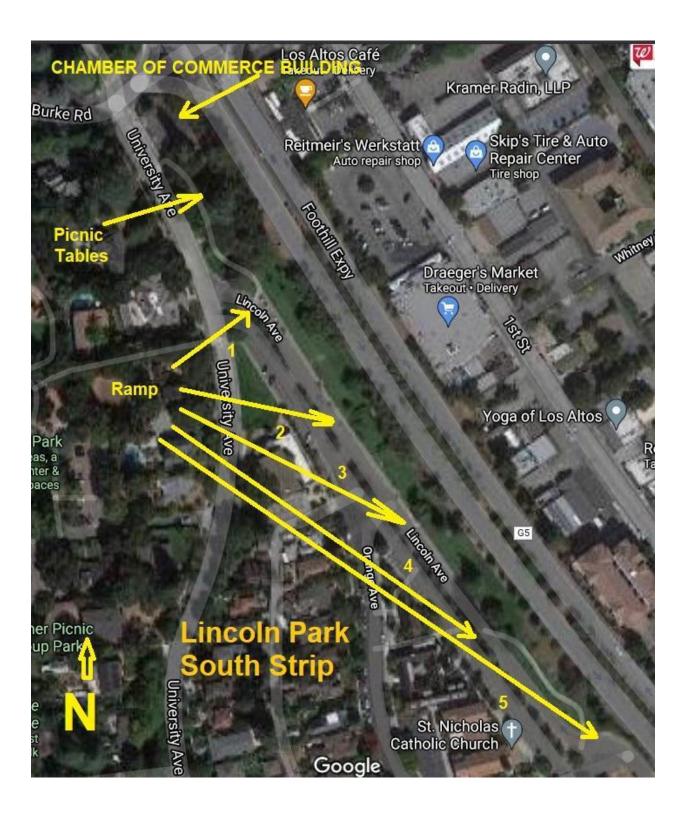
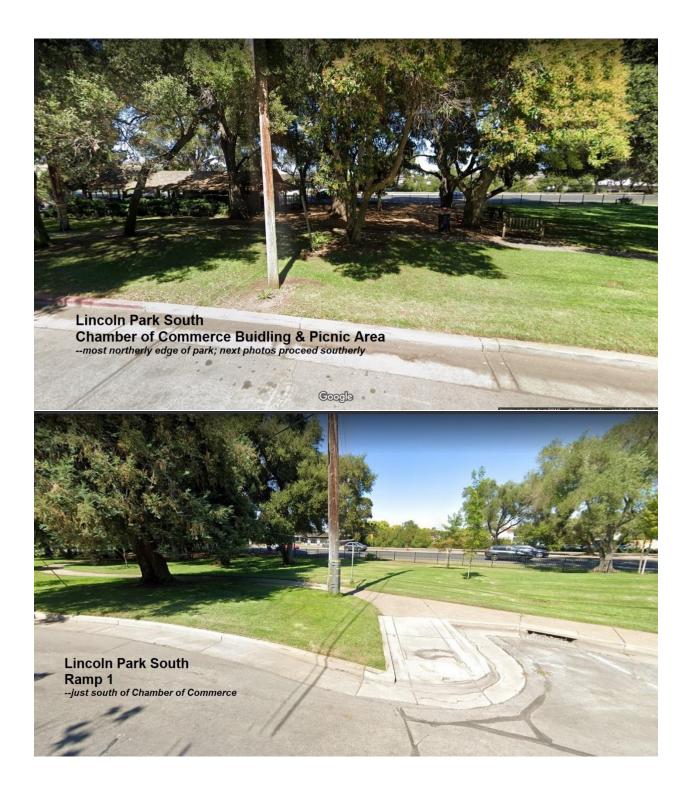
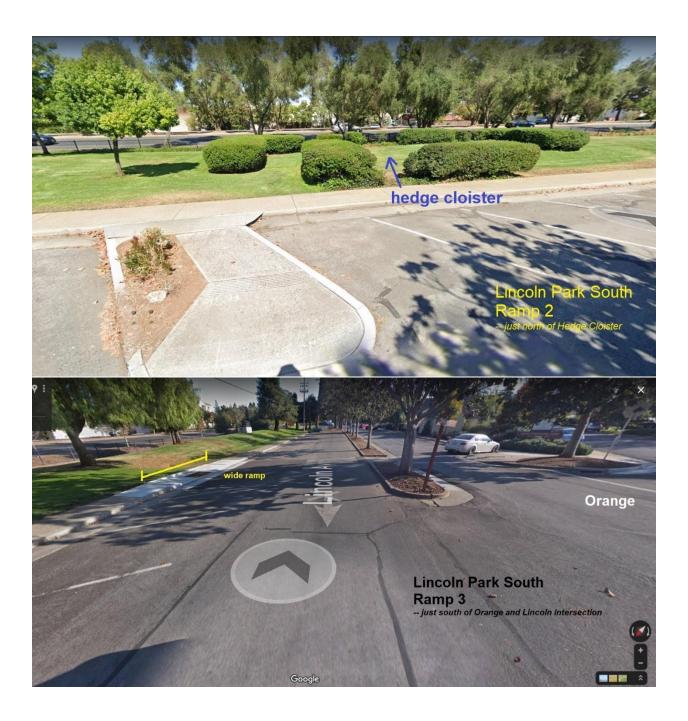
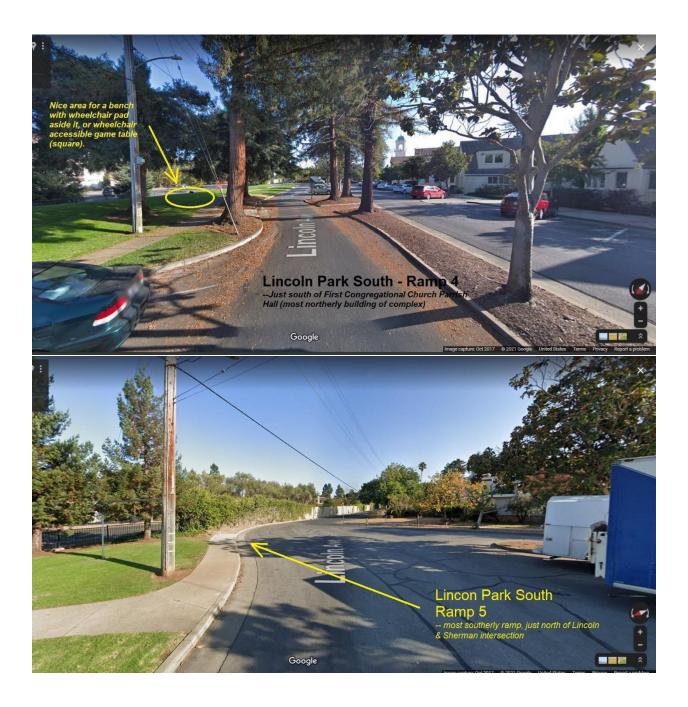
- Lincoln Southern Strip (bounded by Foothill, Burke/Main, University, Lincoln)
 - Notes: Picnic area near Chamber of Commerce (COC) at northern end; two art sculptures/monuments further south; five (5) cement ramps from street up to sidewalk. Consider additional enablers for picnicking or seating.

- Suggestion 1: replace at least one picnic table near COC with wheelchair accessible table, or keep existing tables as is and add an additional Wheelchair accessible picnic table nearby ADA Ramp 1 near COC. Would require a wheelchair-accessible path from ramp to table; can be decomposed granite over compacted earth (sealed).

- Suggestion 2: Install 1-2 wheelchair accessible picnic (rectangular) or game (square) table(s) and wheelchair-friendly path further south along park near ADA Access Ramp 2, placed aside or within hedge cloister(hedges arranged in a quadrangle). This would be a sunny installation.

- Suggestion 3: Install 1-2 game (square) table(s) or picnic bench with adjacent wheelchair pad and path further south along park near ADA Access Ramp 4 under trees or on northeastern (Foothill Expwy) side of trees to afford afternoon shade.

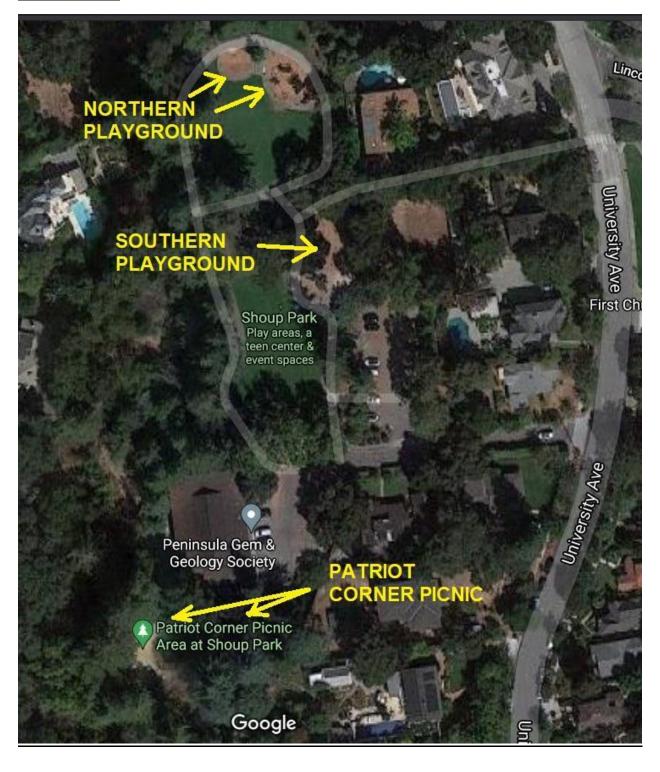
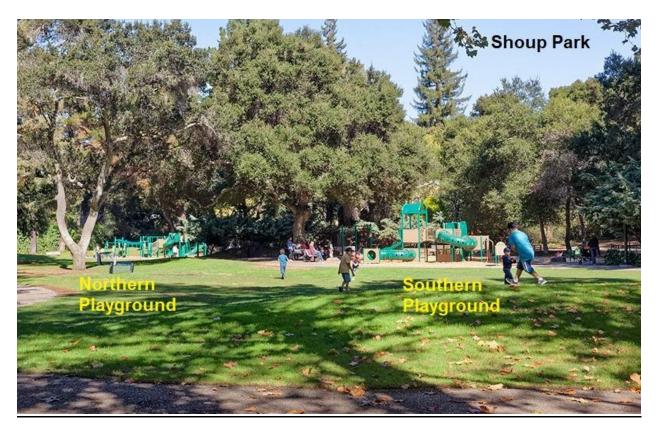
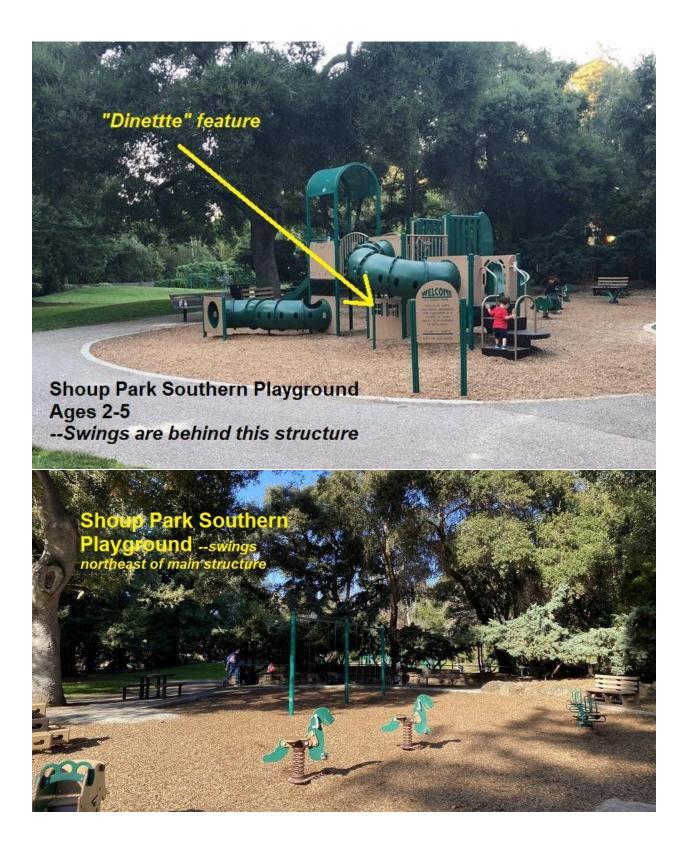
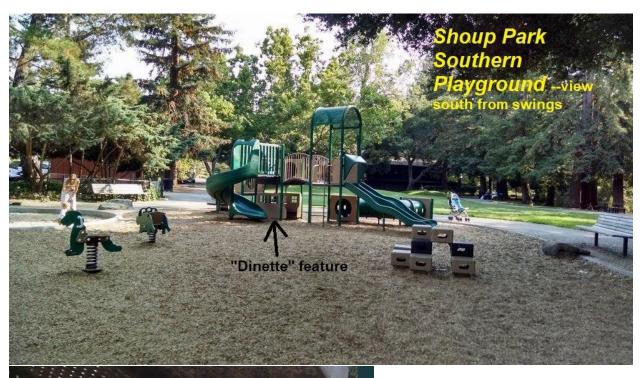
SHOUP PARK

- Shoup South Playground (2004) nearest Parking Lot:
 - Notes: Consider additional inclusive play structure features; ramp into structure area descends to bark.
 - Suggestion 1: Add on-grade accessible path and platform to left side swings, replace one swing with inclusive version.
 - Suggestion 2: Resurface entire area left of ramp in soft rubber play surface and replace 1-2 swings with inclusive model(s).
 - Suggestion 3: Modify Dinette feature to accommodate a wheelchair; add on-grade accessible path and platform to Dinette feature.

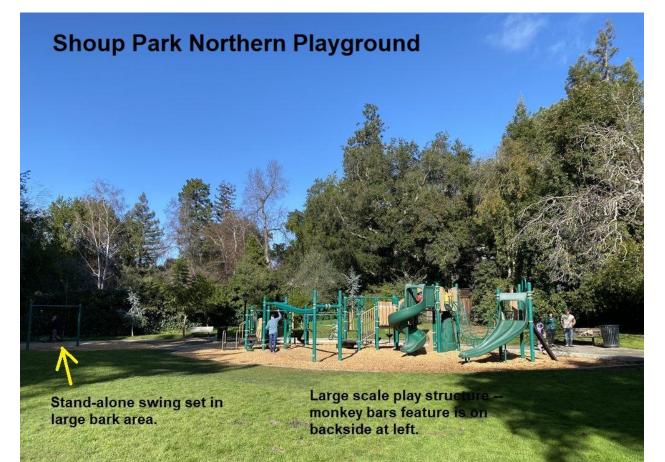
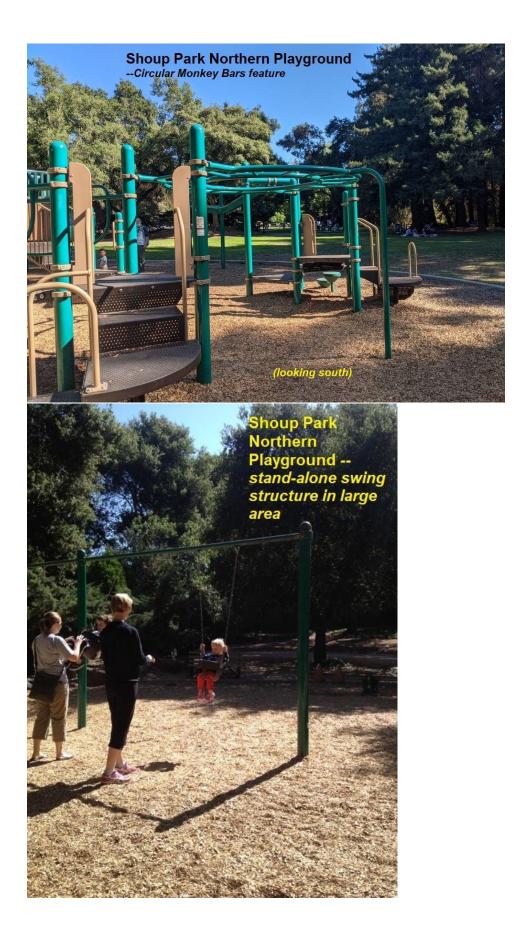
- Shoup North Playground (2004) farthest from Parking Lot:
 - Notes: two adjacent play rings (areas): East ring contains a swing structure supporting two swings; West ring contains a multi-featured play structure and ramps that descend into bark. Consider additional inclusive play structure features.
 - Suggestion 1: East ring: Replace one swing with an inclusive swing; add on-grade accessible path and platform to new feature.
 - Suggestion 2: East Ring: Enlarge/extend existing swing structure to add 1-2 new inclusive swings or a single wheelchair-hosting swing. Add on-grade accessible path and platform to new feature(s).
 - Suggestion 3: East Ring: Same as Suggestion 2 above except include soft rubberized surface.
 - Suggestion 4: West ring: Modify the circular horizontal ladder to hold a single inclusive feature; add on-grade accessible path and platform to new feature.

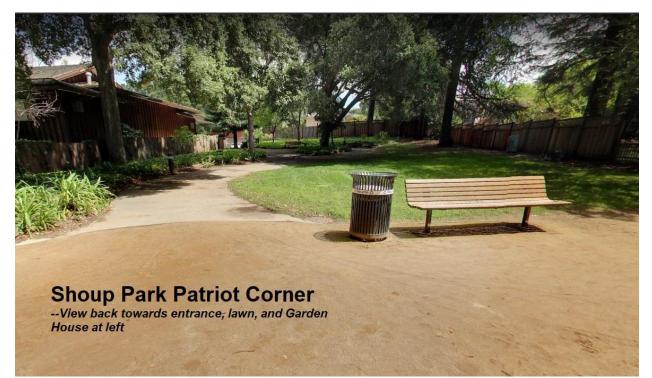
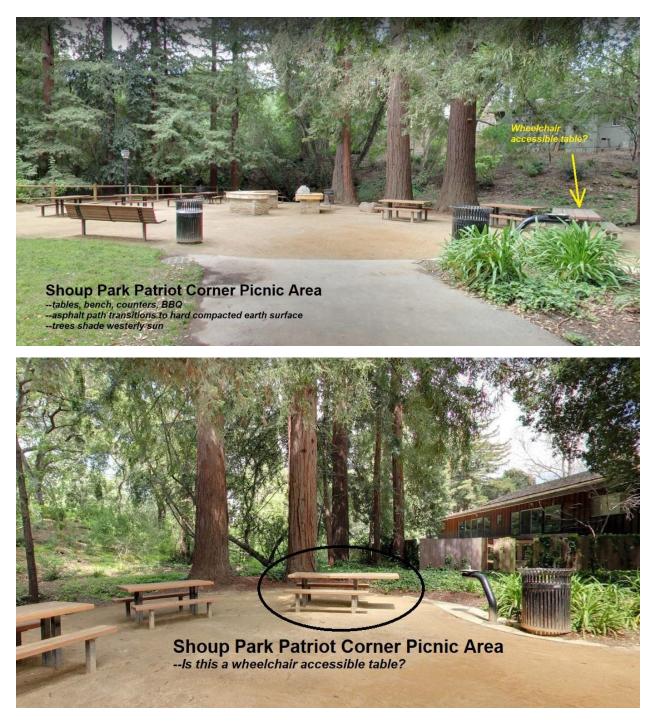
- Shoup Park Patriot Corner Picnic Area:
 - Notes: path from parking lot to picnic area is asphalt; picnic circle is compacted dirt surface; reasonably traversable with wheelchair; one table has extended top and may be wheelchair accessible. Consider adding inclusive seating and tables.
 - Suggestion 1: Replace 1-2 picnic tables with models that are wheelchair accessible and signify as such.
 - Suggestion 2: Move both trash receptacles away from bench, tables, and water fountain in order to eliminate differentiation in seating equity. Move receptacles to perimeter of picnic area and/or back toward the entrance adjacent to the asphalt path to make sure all tables are away from trash.

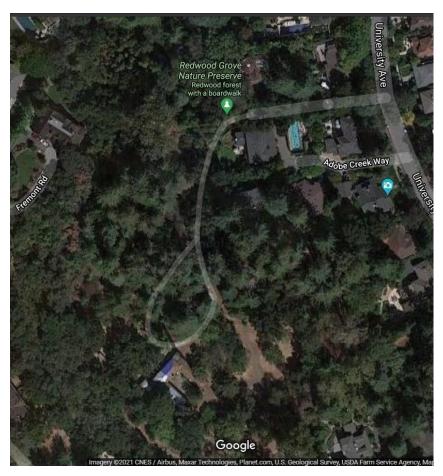
REDWOOD GROVE

- Notes: The initial path into the grove is accessible. Consider uneven transitions on boardwalk. Consider increasing accessibility in other portions of the park. Halsey House area was not inspected.
- At this time, we defer any specific suggestions to increase inclusivity at Redwood Grove pending decisions about the park by other City departments/groups.

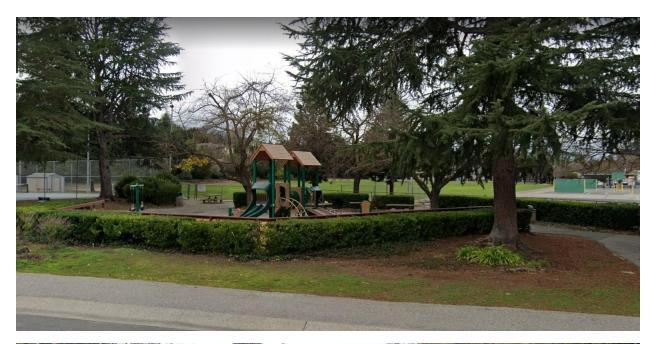
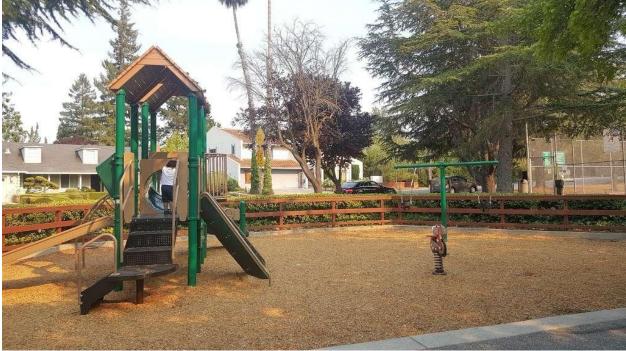
MONTCLAIRE PARK

- Notes: Play structure for ages 2-5 years (2008). Bark-filled play area; consider additional inclusive play features and ways to increase access into the play area.
- Suggestion 1: Replace one of the swings with an inclusive model; add on-grade accessible path and platform to new feature.
- Suggestion 2: Remove springy horse feature and install new inclusive feature atop synthetic playing surface connected to perimeter curb seamlessly.
- Suggestion 3: Modify 1-2 tables to accommodate wheelchair
- Suggestion 4: Smooth out swale at street entrance to park to allow wheelchair access.

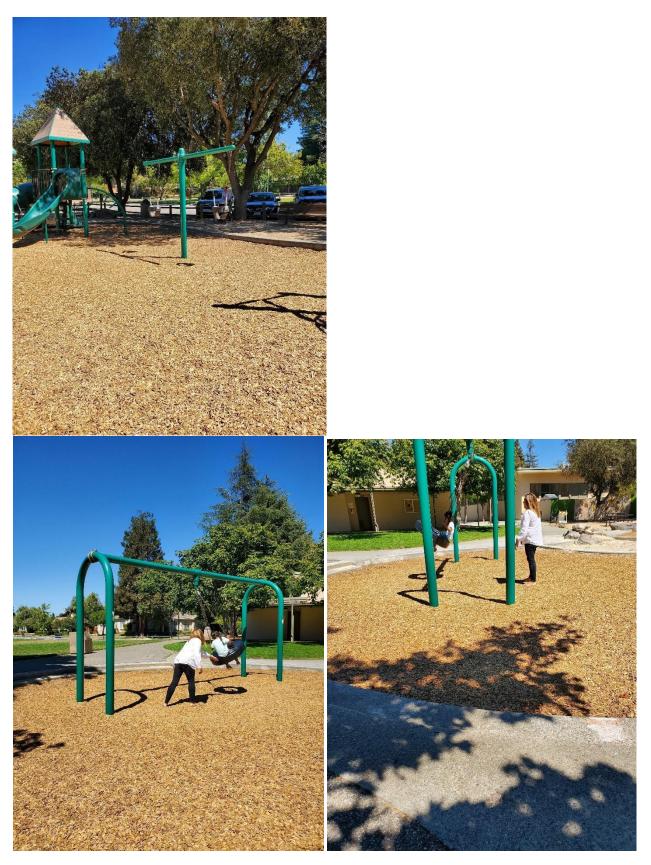
GRANT PARK:

- Notes: All ages play structure (2008). Play area is all bark surrounded by curb. Consider additional inclusive play features.
- Suggestion 1: replace tire swing with 1-2 inclusive swings; add on-grade accessible path and platform to new feature(s).
- Suggestion 2: (no picture) modify bicycle feature to be inclusive by removing pedals; add ongrade accessible path and platform to enhanced feature.

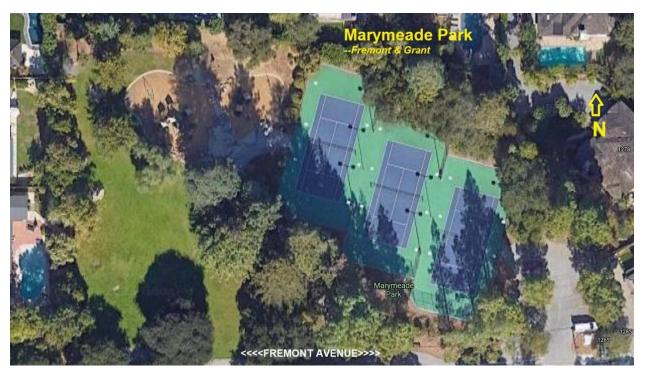
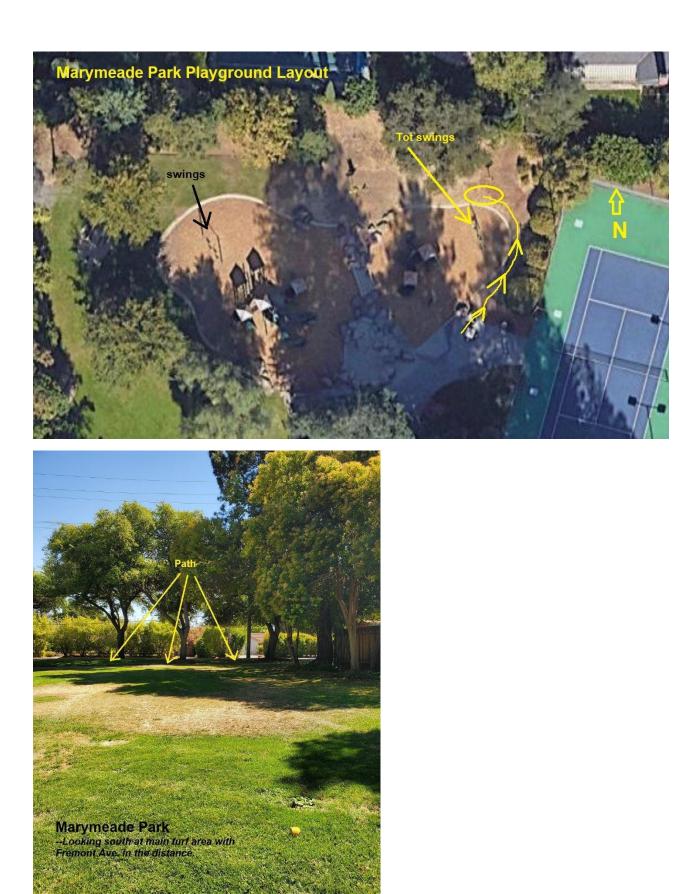
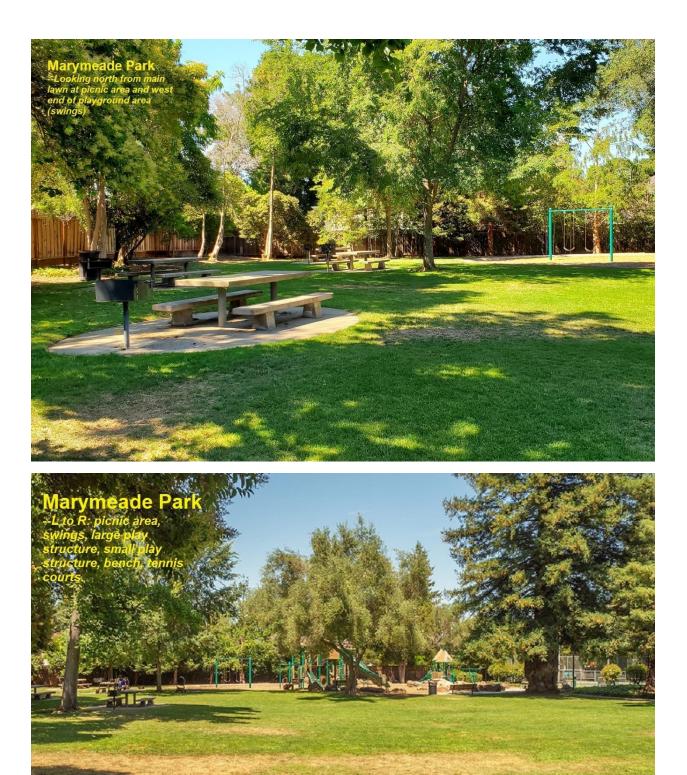
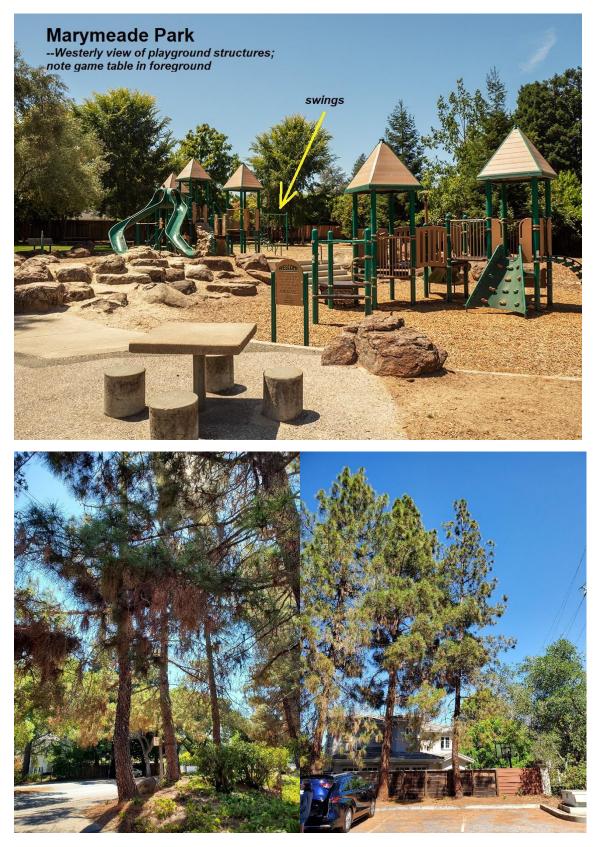
MARYMEADE PARK:

- Notes: Multi-age playground (2007). Consider adding inclusive playground features; pit is bark. Large turf area extends south of playground and picnic areas; consider adding inclusive benches and tables.

- Suggestion 1: Install 1 bench with adjacent wheelchair pad or 1 wheelchair accessible gaming or picnic table at southwest edges of lawn area near Fremont so traversing lawn is not required.

- Suggestion 2: Replace 1 swing with inclusive model (at either youth or tot locations).
- Suggestion 3: Install an additional ramped path along eastern perimeter of bark pit from south to north and install table or bench at top (approximately at oval in photo below).

- Suggestion 4: Modify one picnic table in picnic area to be wheelchair accessible.
- Suggestion 5: Modify existing square gaming table at south edge of Tot structure (see photo) by removing one permanent stool to enable wheelchair access to table.

- Suggestion 6: Install 1 bench with adjacent wheelchair pad or 1 wheelchair accessible gaming or picnic table near path in shade just south of playground areas (not too close to bathrooms).

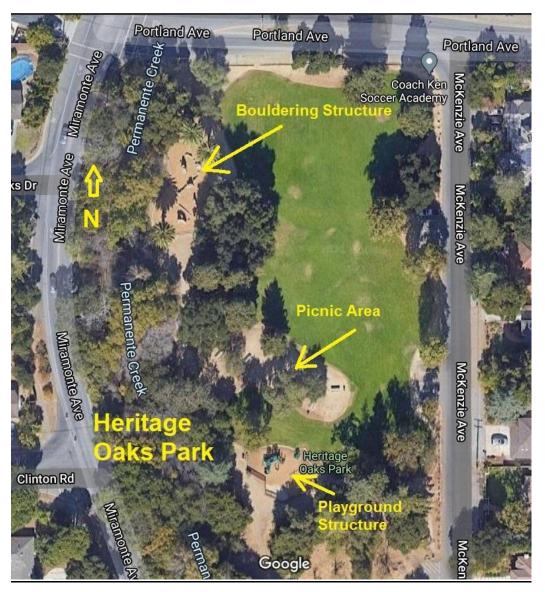
HERITAGE OAKS:

- Notes: Consider additional inclusive features on Play structure (2008) and on bouldering playground. Both play pits are all bark.
- Suggestion 1: Extend T-Bar for swings to add an inclusive model; add on-grade accessible path and platform to new feature.
- Suggestion 2: Install wheelchair path to digging activity feature.
- Suggestion 3: Modify one picnic table to allow wheelchair accessibility.
- Suggestion 4: Install accessible surface at small play structure.

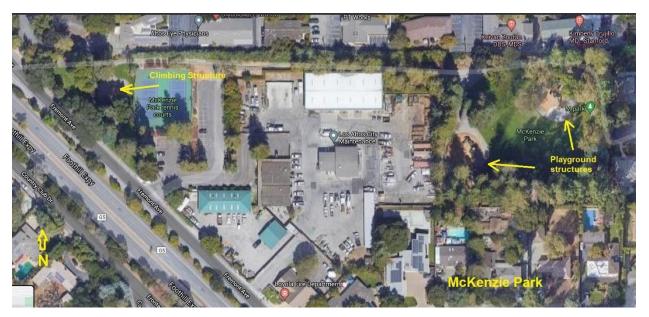
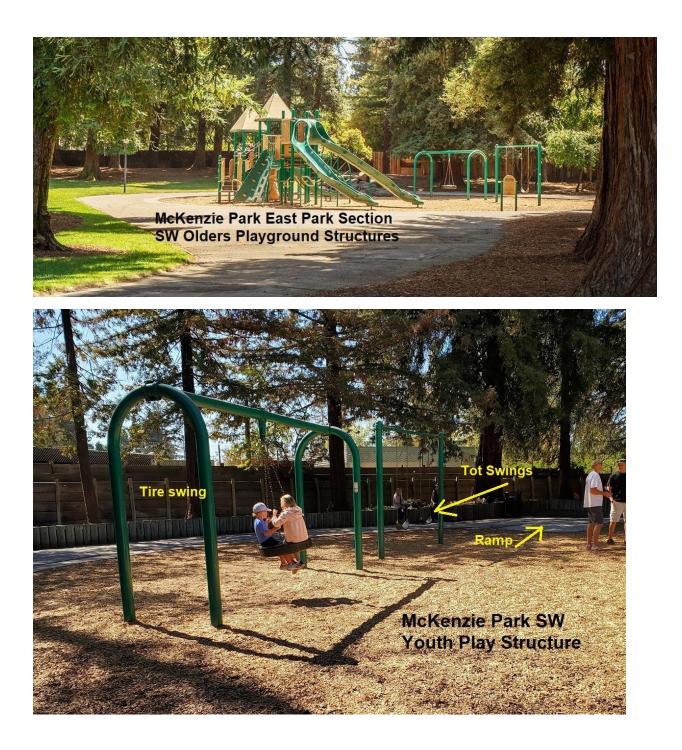
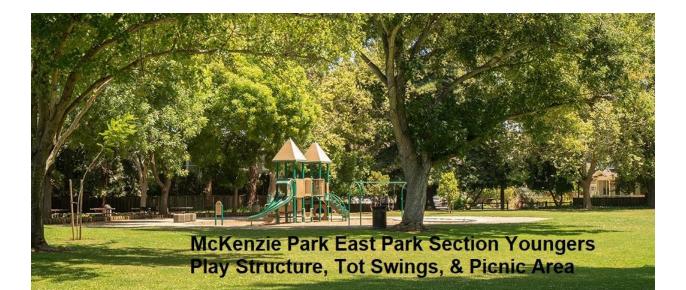
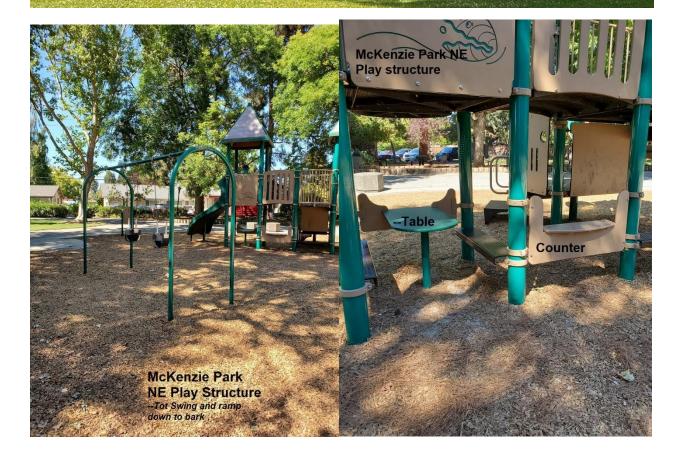
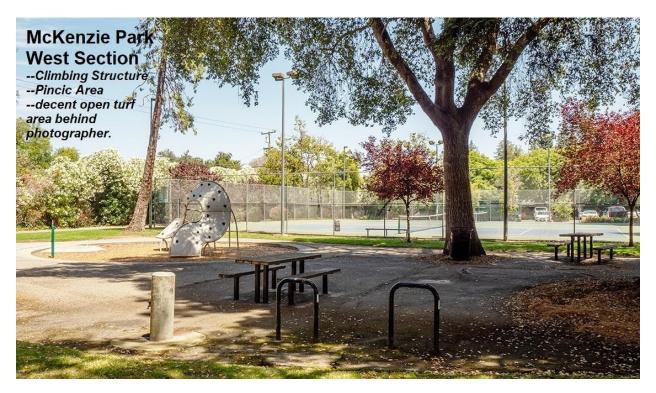
McKENZIE PARK:

- East Park Section: Southwest (SW) Play Structure Ages 5-12 (2007):
 - Notes: Playground surface is bark.
 - Suggestion 1: Extend existing swing structure to add an inclusive model. Add on-grade accessible path and platform to new feature.

- Notes: same as Ages 5-12 Play Structure.
 - Suggestion 1: Replace one of the tot swings with inclusive swing; add on-grade accessible path and platform to new feature.

- Suggestion 3: Modify one picnic table to allow wheelchair accessibility.
- West Park Section:
 - Notes: This section is buffered from residences, bound by medical offices on north, Tennis Courts and City yard on East, and Foothill Expressway southwesterly. There is an old Climbing Structure (age unknown) just west of the tennis courts.

- Suggestion 2: Replace tire swing with wheelchair swing; add on-grade accessible path and platform to new feature.
- East Park Section: Northeast (NE) Play Structure Ages 2-5 and Picnic Area (2007):

- Suggestion 2: Modify table or counter features of play structure to allow wheelchair accessibility; add on-grade accessible path and platform to enhanced feature.

- Suggestion 1: Replace Climbing Structure with a substantially sized inclusive activity feature, such as a sound/musical item or a wheelchair-capable merry-go-round. Install inclusive surface.

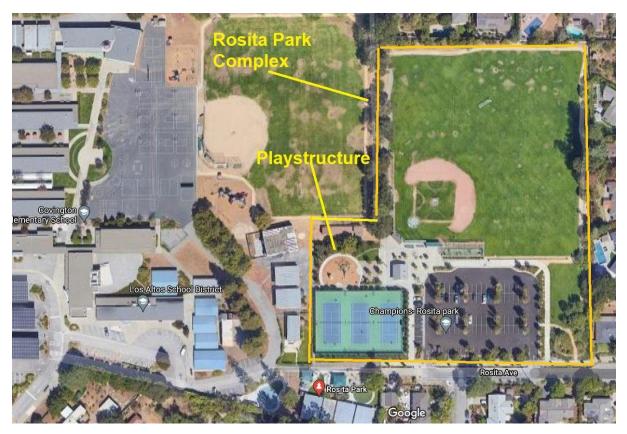
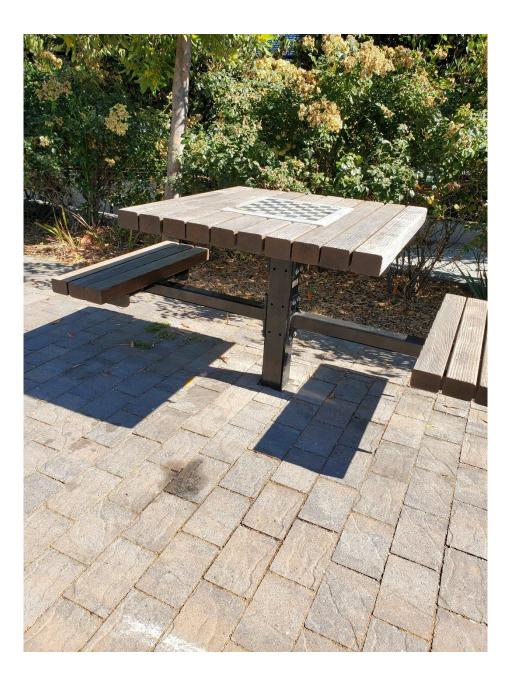
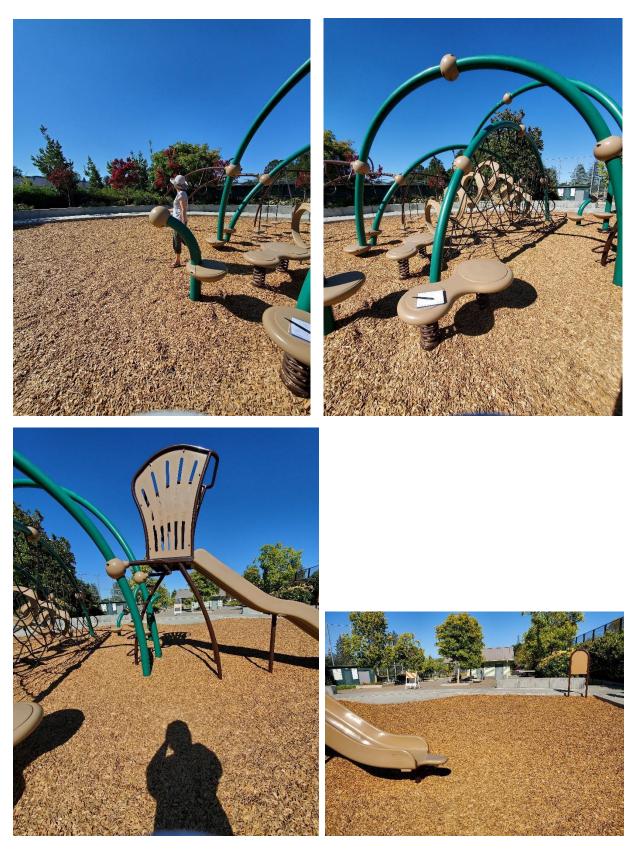
ROSITA PARK:

- Notes: Large all-ages play structure (2011); playground surfaces are bark. There are concrete ramps down into the bark. This playground is sun-intensive and, despite community members elsewhere in the park, there were no children on the play structure. There is substantial open space in this playground area. Consider adding shade and additional inclusive features.

- Suggestion 1: Add shade sails on southerly sides of play structure.
- Suggestion 2: Assess "Telephone" Feature for wheelchair accessibility and add on-grade accessible path and platform to this feature.

- Suggestion 3: Install a new inclusive feature in the open space within the perimeter of the playground; add on-grade accessible path and platform to new feature.

- Suggestion 4: Install 1-2 additional game (square) tables that are wheelchair accessible. I have included a picture of one that already exists, though non-benched sides need to be extended. (Note: This type of table is what we are suggesting for Village Park.)

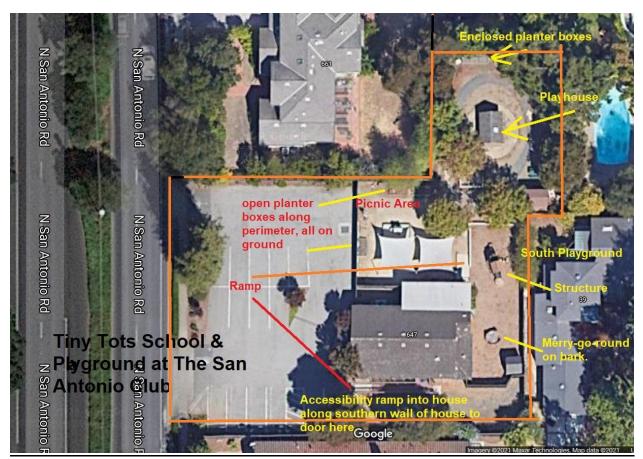
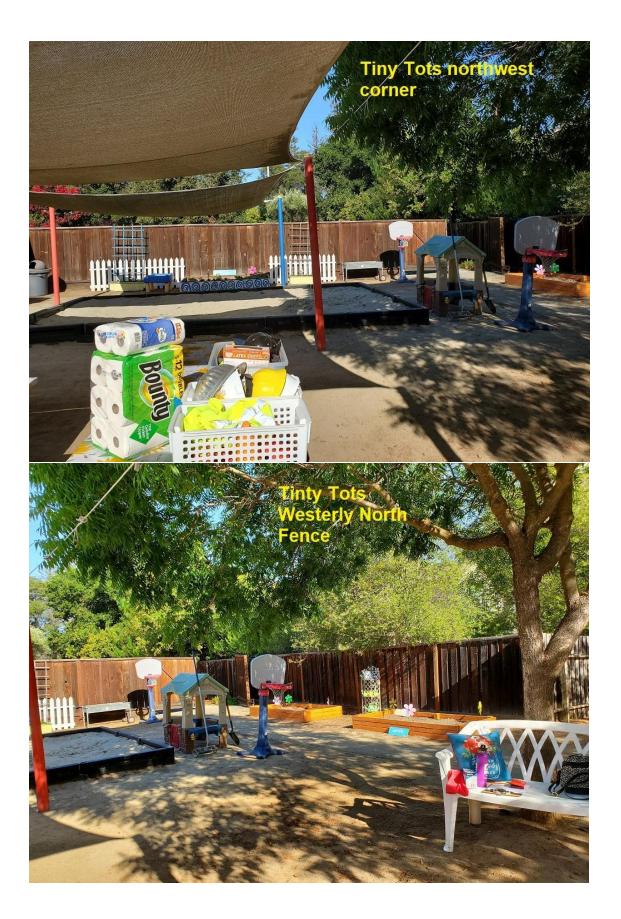
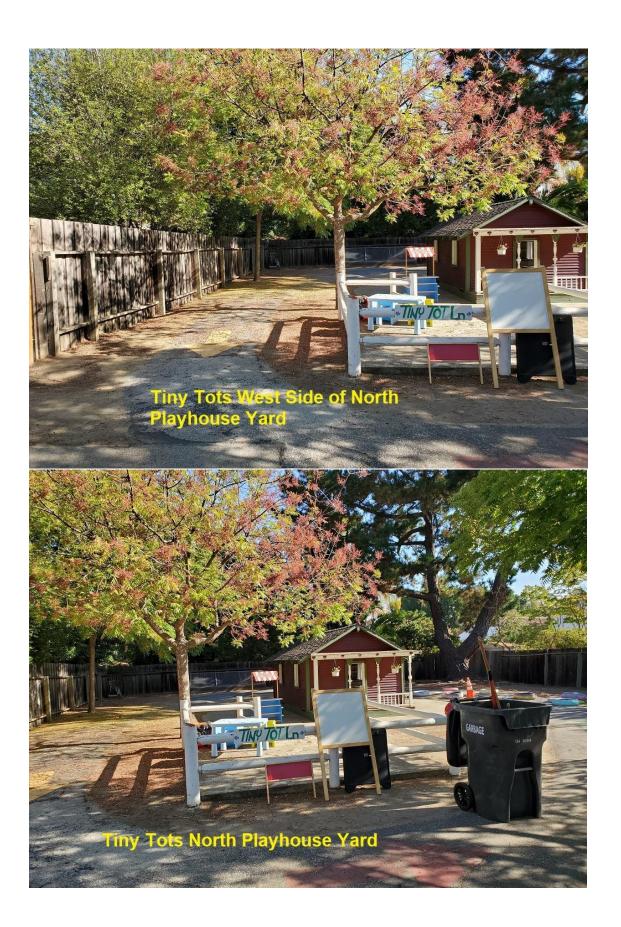
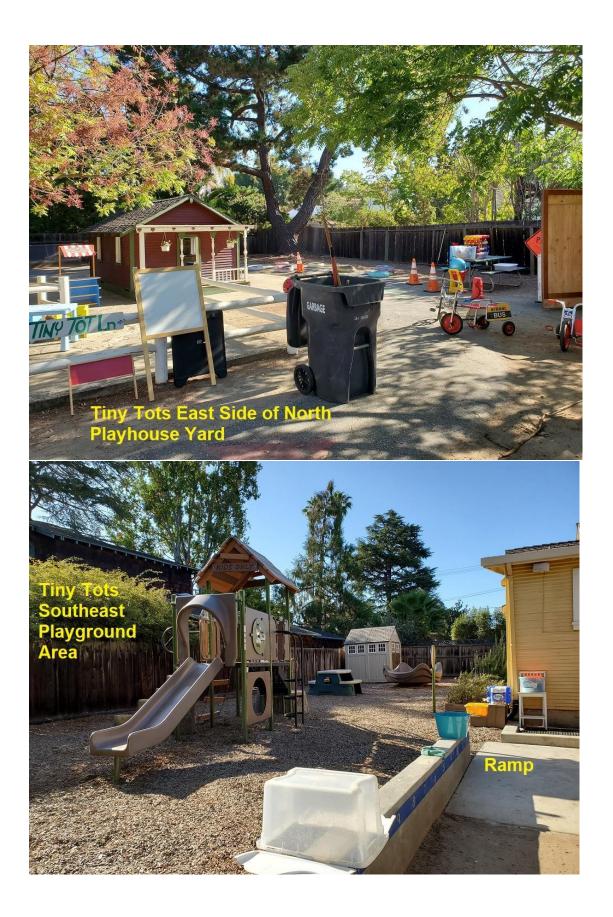
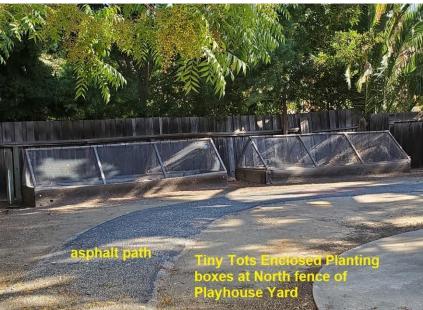
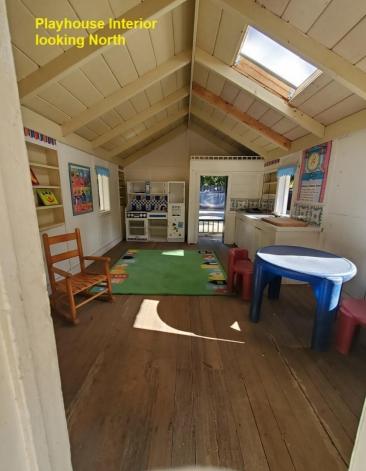
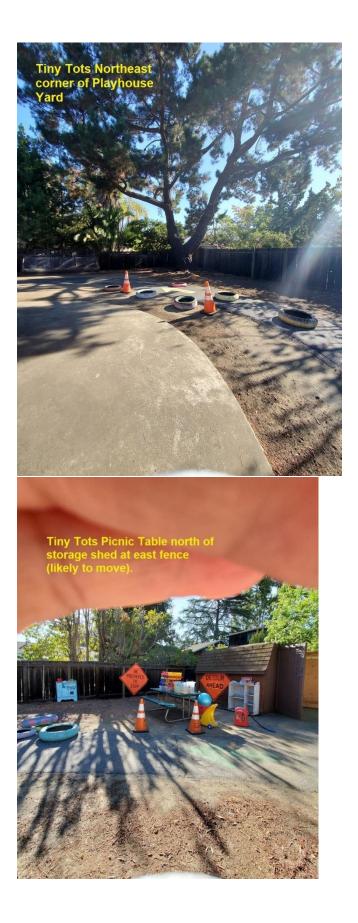
TINY TOTS SCHOOL AND PLAYGROUND AT THE SAN ANTONIO CLUB:

- Status: Due to lack of open public access, we are providing a more detailed description of this park. (Ignore cleaning supplies visible in pictures as the school was being prepared for opening.) Several excellent activities. Explore additional inclusive features including tables. Southeast Playground Area is in bark with play structure (2011) located at north end. There is a seamless concrete ramp to the bark grade (no curb). There is a semi-accessible merry-go-round (requires a lifted transfer to enter) at the south end. Consider enhancing accessible paths and accessibility to the mini-playhouse. Compacted earth and an asphalt path cover most of the rest of the ground surface, which is acceptable for wheelchairs, walkers, and crutches. Good shade everywhere sails and tree canopies -- EXCEPT over southeast playground area. As long as the programs do not extend into afternoon, this should be okay, but once all-day school is implemented, area becomes quite sun-intensive. This large yard has tremendous potential.

- Suggestion 1: Add on-grade accessible path to the merry-go-round.
- Suggestion 2: Install new inclusive activity feature in the northeast corner of the Playhouse Yard.

- Suggestion 3: Modify 1-2 activity boxes by elevating their height to be wheelchair accessible.
- Suggestion 4: Modify 1 picnic table to be wheelchair accessible.

- Suggestion 5: Add ramp from asphalt up onto playhouse platform; widen Playhouse entry to accommodate child's wheelchair.
