# STORM WATER MANAGEMENT MASTER PLAN

City of Los Altos

May 2010

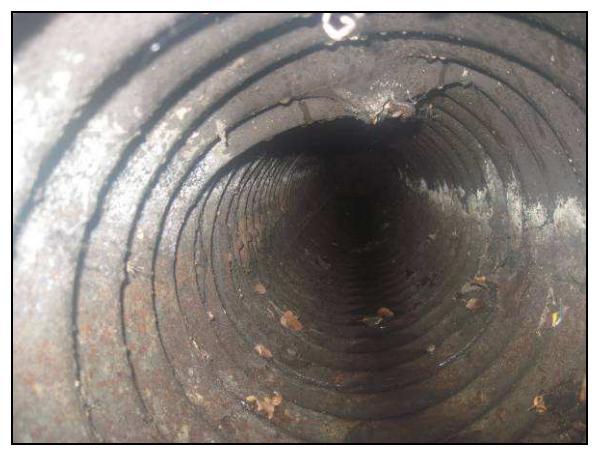
- Some of the pipe inlets into the manhole appear to be full of sediment. It is unclear if these pipes are abandoned or still in service (Photo 3.8).
- The corrugated metal pipe appears to have sustained some third-party damage (Photo 3.9).
- Minor debris was observed in some of the catch basins (Photo 3.7).

Photo 3.8. Sediment and large debris (bricks) in pipe

- Consider CCTV inspection of the corrugated metal pipe to assess condition.
- Clean pipes to clear debris and sediment buildup.

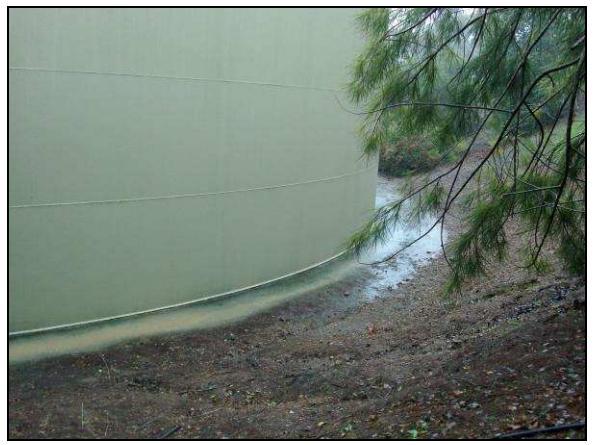
Photo 3.70. Note of inadequate surface drainage around perimeter of water tanks

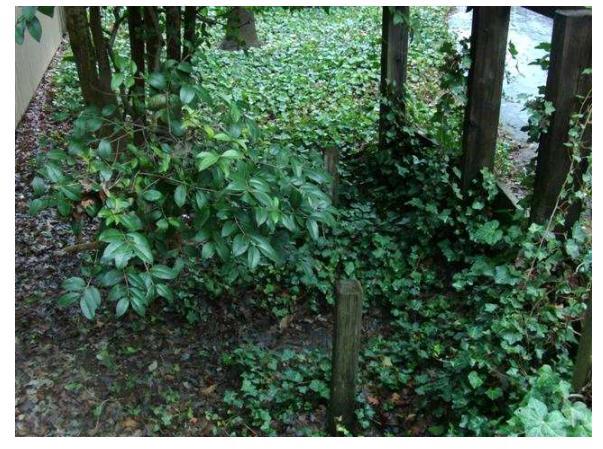
Area view showing susceptibility to burial

Update GIS/maps to show importance of line.

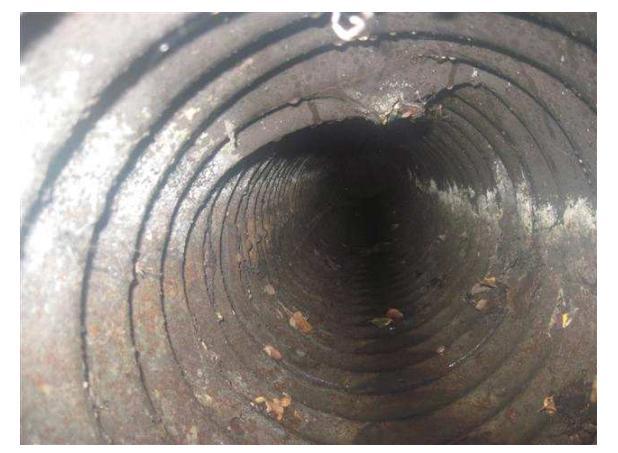
### Unknown L (catch basin)

- Structural Rating = 2 (Vanda concrete condition = 1; some third party damage on corrugated metal pipe, integrity in question)
- O&M Rating = 2 (Some pipes observed to be filled with debris)

Outlet with deflection at crown, possible thirdparty damage

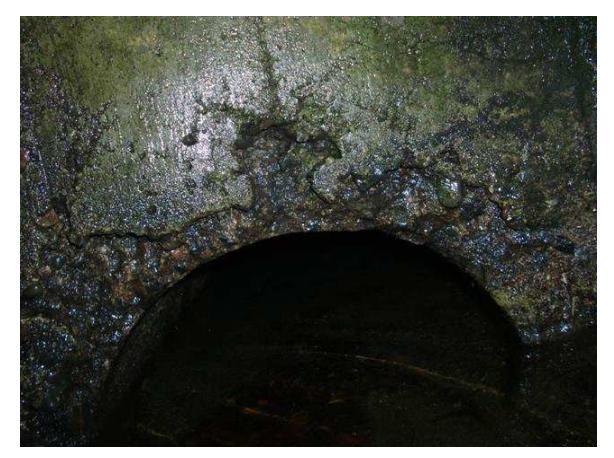
Inlet transition with damage to concrete

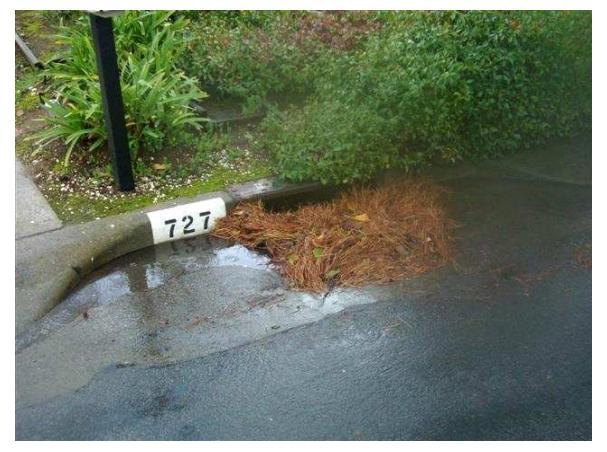
- Catch Basin G2C-609 was observed to have been covered with pine needles (Photo 3.22).
- View of the downstream pipe indicates that some debris may be obstructing the flow (Photo 3.23).

Inlet accumulates pine needles; pipe flows sluggishly (half full) under light rain, but a short downpour did not cause problems.

As-found condition with pine needles obstructing inlet

Cleaning is recommended on the pipe between G2C-609 and G2D-610.

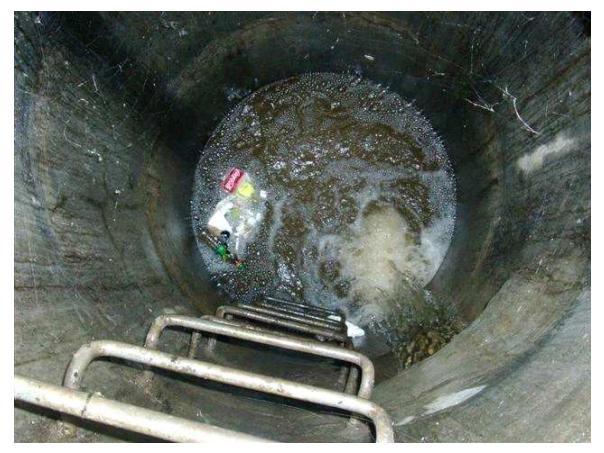
Combines flow from Vineyard into creek undercrossing; surcharged even in dry weather (creek elevation downstream of outfall may be higher).

Plan view during wet weather, showing surcharged conditions due to creek outfall

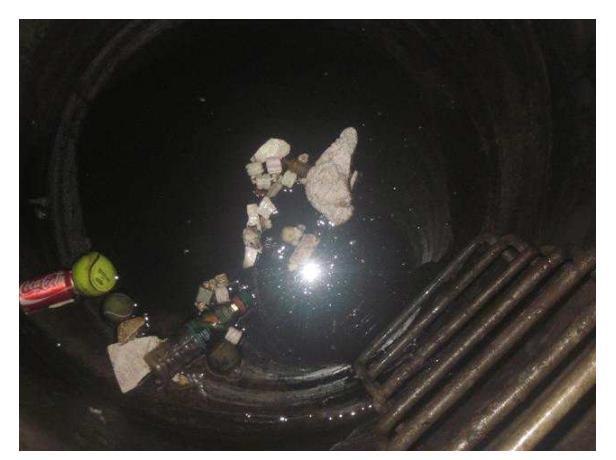
Debris in and surcharged condition during dry weather due to creek outfall elevation

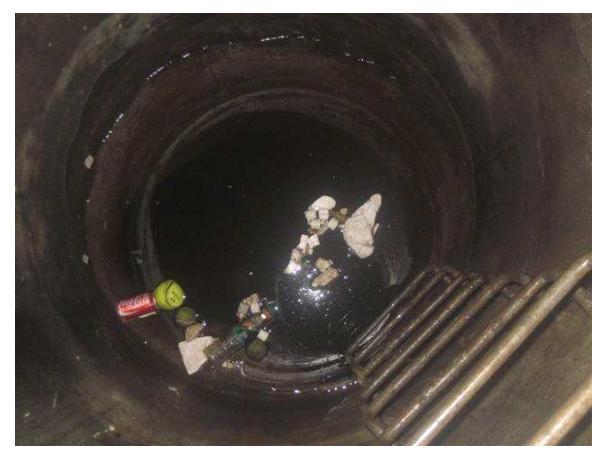
Debris in and surcharged condition during dry weather due to creek outfall elevation

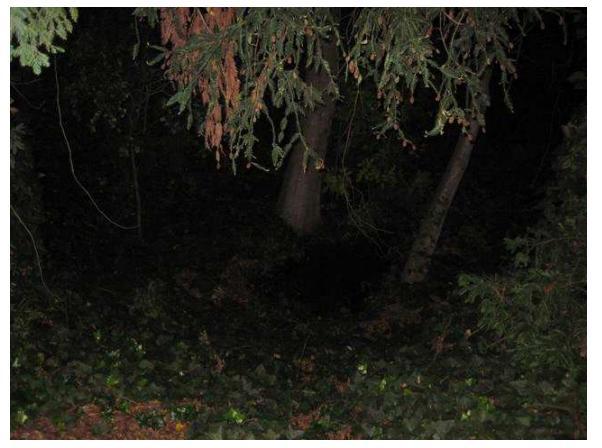
## Unknown H (outfall)

Surcharged, stagnant condition at outfall during dry weather

Clear/channelize creek to prevent surcharging.

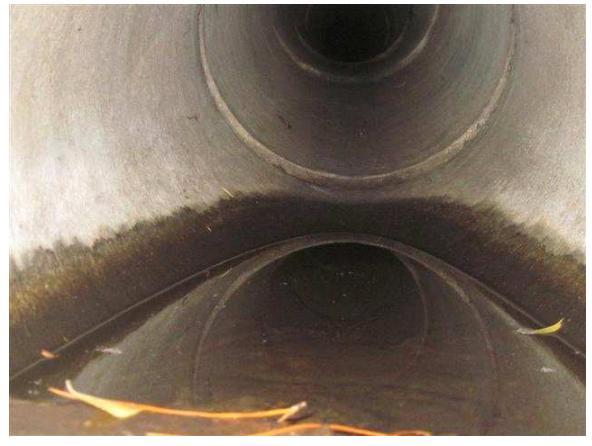
Upstream pipe with backup caused by mortar dam at inlet

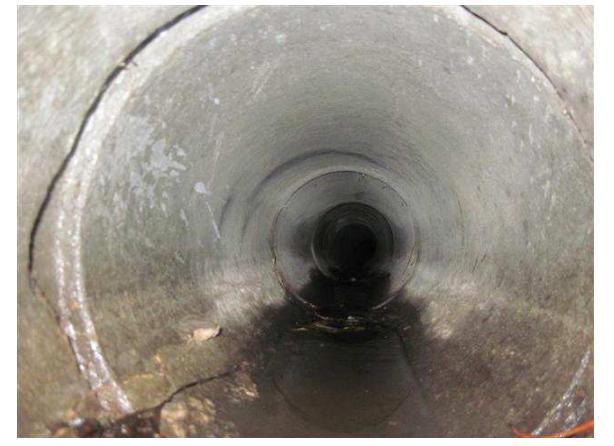
## C3C-501

Downstream pipe with cracks

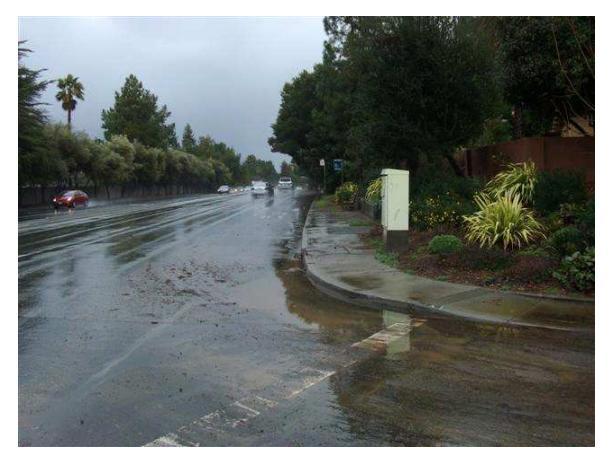
Area view with evidence of ponding at east corner of intersection

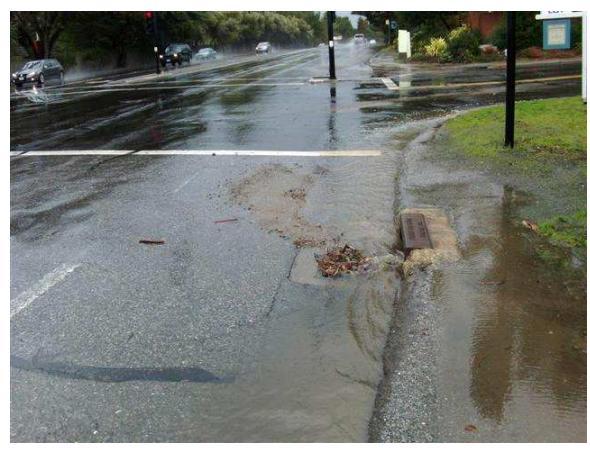
Does not receive flow from H2C-218; receives flow from both Summerhill and El Monte, but both gutters have low slopes which form puddles on either side of catch basin.

Area view with ponding due to shallow slope

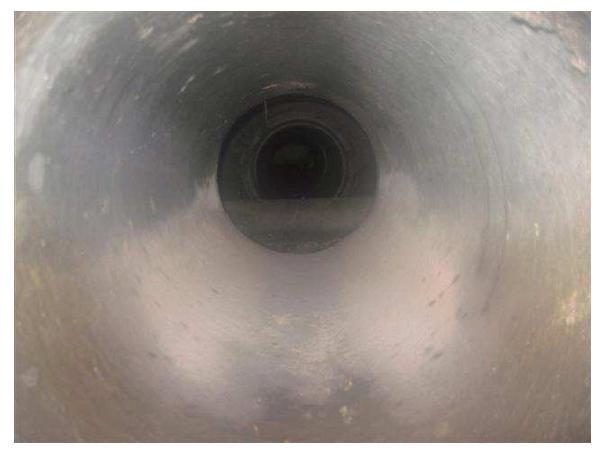
Pipe defect between H2C-216 and H2D-217 with obstruction at invert

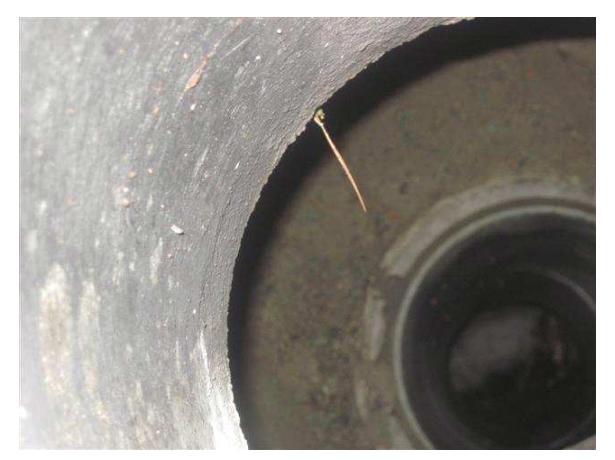
Pipe defect between H2C-216 and H2D-217

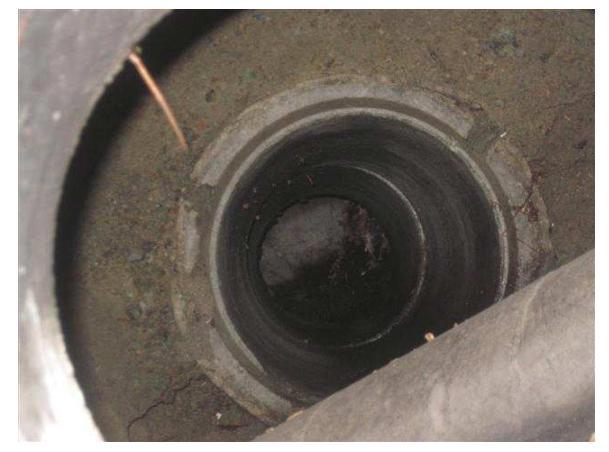
Pipe defect between H2C-216 and H2D-217

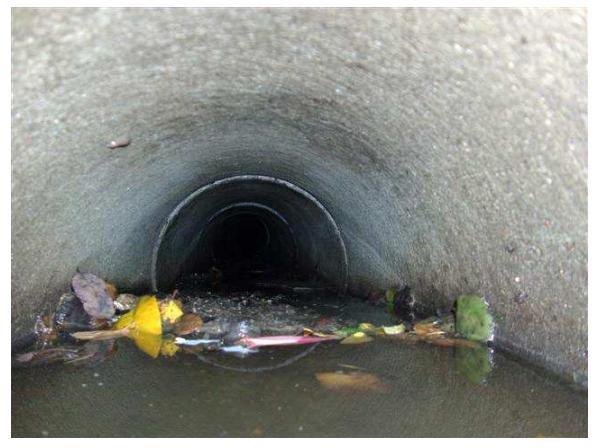
Downstream pipe with debris backing up flow

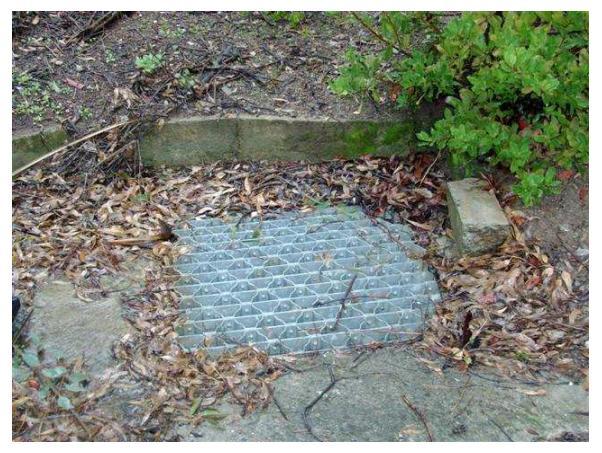
Downstream of Unknown A; sheet flow along easement does not enter catch basin due to cross-slope and berm.

Grating showing susceptibility to plugging

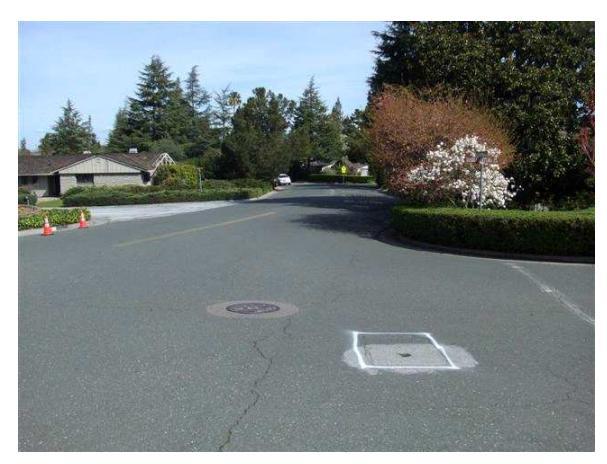
Area view, looking northeast with access hatch outlined in white

Remove asphalt patch and open hatch to exercize gate. Set gate to optimize flow model.
