**Project:** Summerhill Avenue at South El Monte Ave  
**Project Identifier:** AD\_PA\_1000

**Issue:** Southeast corner of intersection floods during rain, also rocks, debris and other obstructions affect general drainage

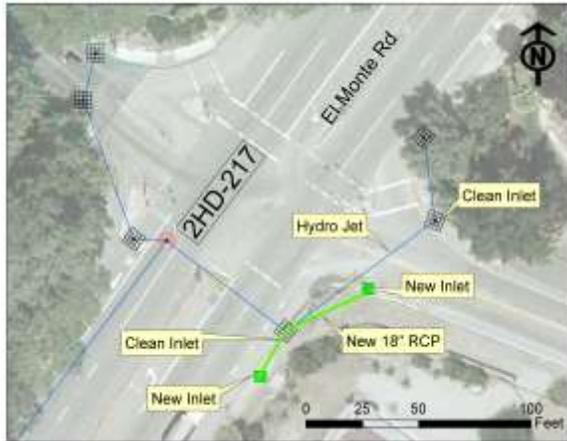
*Plan View*

The intersection of El Monte Road and Summerhill Ave has experienced drainage problems during past storms. There is a significant amount of debris and sediment along the roadway and in the drainage system from nearby hills and development.

1. CCTV to investigate line between CB H2C-216 and H2D-217
2. Construct 2 additional CB inlets at the southeast corner of the intersection on both Summerhill Avenue and South El Monte Avenue. Improvements to consist of ~200 LF of 18" RCP and 2 CB connections

Additional inlets on the SE corner of the intersection, where the debris is greatest, will improve roadway conditions.

Regular cleaning and maintenance of the system should also be performed to assure the system functions optimally during storm events.

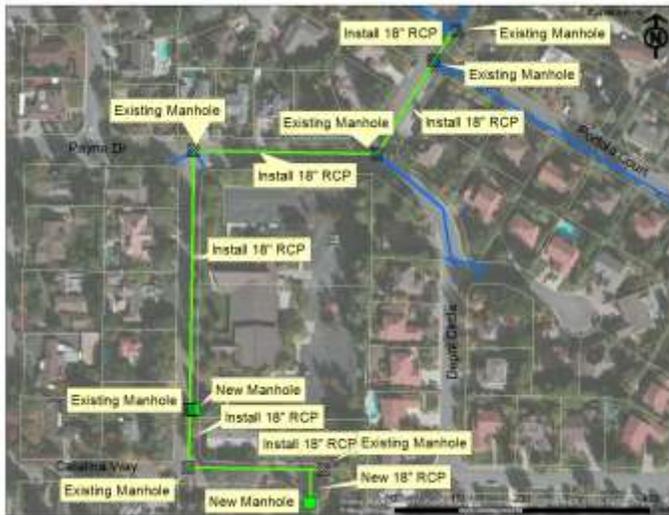
*Plan View*

**Issue:** Continually Blocked CB

Catalina Court has poor drainage with ponding in front of 110 Catalina Court during rain events. The City has removed debris, including balls, on numerous occasions. Manhole C2D-314 has a 12 inch inlet from the south towards 110 Catalina that appears to be abandoned and no longer in use.

Catch basin C2C-315 was observed to have some debris buildup in the sump of the basin due to a protruding outlet pipe. The outlet pipe causes debris to collect and impedes flow thru the outlet.

1. Reshape catch basins on Catalina Ct
2. Install a new CB (if needed)
3. Upsize pipe on Catalina Ct to 18-inch RCP
4. Replace bubble system with 18-inch underground system on Catalina

Installing a catch basin on the south side of the street will eliminate ponding in front of 110 Catalina and the neighboring homes. Catch basin C2C-315 should also have the outlet pipe re-formed to make a smoother transition from basin to outlet pipe

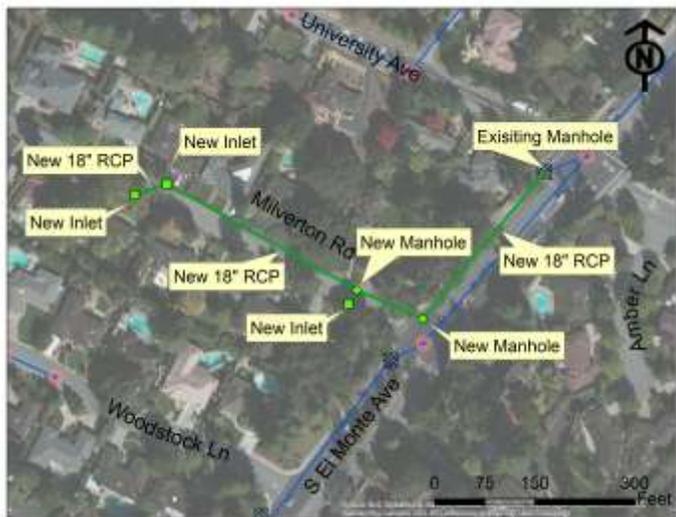
*Plan View*

**Project:** Milverton Road  
**Project Identifier:** AD\_PA\_1002  
**Issue:** Poorly functioning drywells cause flooding

Milverton Rd, approximately 515 feet NW of S El Monte Rd, has experienced drainage problems. Drywells exist, but function poorly.

New inlets at the low point in Milverton Rd will improve roadway conditions by draining the street and carrying the runoff to the existing city SD system.

1. Add new 18" RCP line along Milverton Rd. Top of system is approximately half way between S El Monte Ave and the bend in Milverton Rd. Tie into existing system at MH G2D-608 (S El Monte Ave at University Ave).
2. Construct 3 new inlets on Milverton Rd at the low point where flooding occurs. Drywells should be removed. Improvements consist of 772 LF of 18" RCP, 2 new MH connections, and 1 MH connection to an existing line.

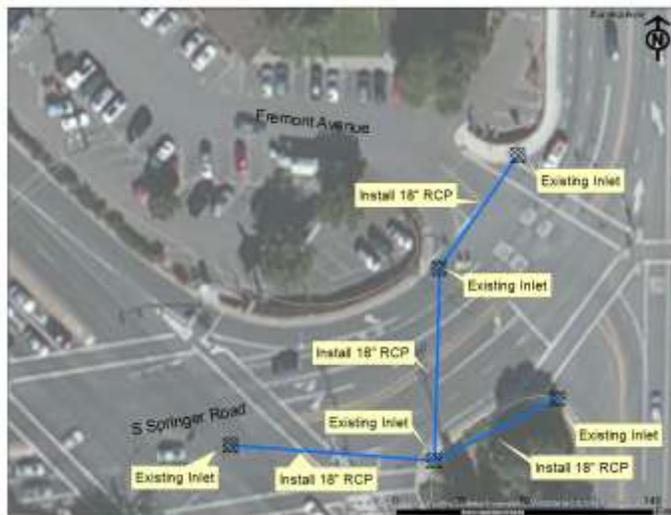
*Plan View*

**Issue:** Water pooling

Springer Rd is connected to Fremont Avenue. Not much information is known about this problem area, but it was brought to attention by the City of Los Altos and O&M staff for pooling of water.

The proposed improvements were analyzed with the City’s hydraulic model to determine impacts. This project is determined as a moderate priority due to ponding between 6” and 12” from a 10 year storm.

1. Replace 370 ft. 18” RCP line along Marilyn Drive and tie into existing system
2. Replace 5 MH along S Springer Rd. This includes MH I4F-118, I4F-401, I4F-402, I4F-403, and I4F-404.

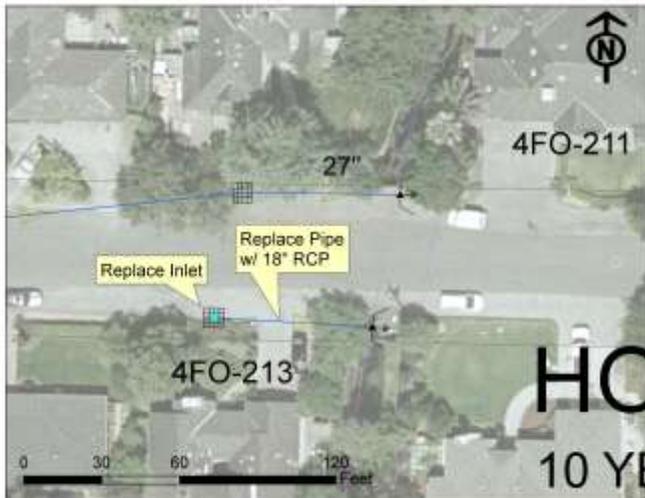
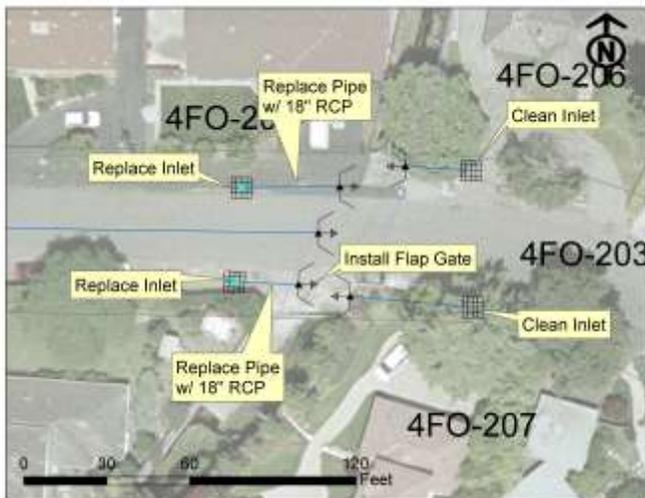
*Plan View*

**Issue:** CBs plug during rainy season, CBs full of sediment, CBF4F-204 discharges in upstream direction of Hale Creek. CMP protruding into basins

Sunshine Drive has experienced drainage problems during past storm events. CB and outlet pipes have limited conveyance due to debris and pipes in poor condition. There also appears to be a backwater issue from the Hale Creek.

1. Reconstruct CBs F4F-21- and F4F-201 by removing corrugated metal pipe section protruding into basin.
2. Replace CMP pipes as needed.
3. Hydro jet pipes
4. Install flap gate on CB F4F-204
5. Routine maintenance during rainy season

CMP sections in poor condition should be replaced with RCP. Flap gates should be installed to prevent backflows. The system should be cleaned and maintained on a regular basis.

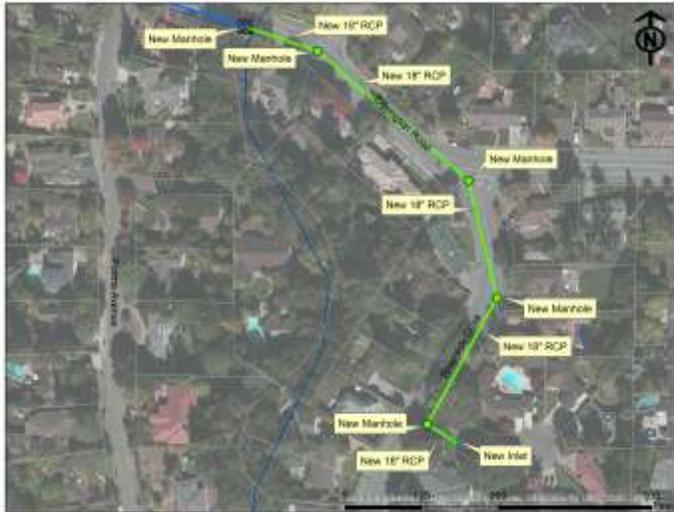
*Plan View*

**Issue:** Water pooling

Oakwood Ct is connected to Riverside Drive and Covington Rd. Not much information is known about this problem area, but it was brought to attention by the City of Los Altos and O&M staff for pooling of water.

The proposed improvements were analyzed with the City’s hydraulic model to determine impacts. This project is determined as a moderate priority due to ponding between 6” and 12” from a 10 year storm.

1. Add 50 ft. of new 18” RCP line along Oakwood Ct. Add 433 ft. of new 18” RCP line along Riverside Drive. Add 450 ft. of new 18” RCP line along Covington Road and tie into existing system at inlet H40-221 (Covington Road between Parma Ave and Riverside Dr).
2. Construct 1 new inlet on Oakwood Ct. Improvements consist of 933 LF of 18” RCP, 4 new CB connections, 4 new MH connections, and 1 MH connection to an existing line.

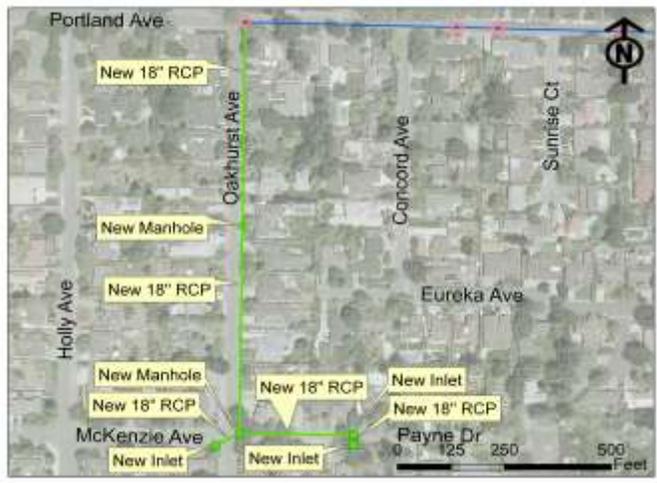
*Plan View*

**Project Summary:**  
 Payne Drive, approximately 270 feet E of Oakhurst Ave, has experienced drainage problems. There is a low spot in the street without a formal drainage system. The corner of McKenzie and Oakhurst is also a low spot that experiences drainage problems.

New inlets at the low point on Payne Dr and at McKenzie and Oakhurst will improve drainage conditions by conveying runoff to the existing city SD system on Portland Ave.

1. Add new 18” RCP line along Payne Dr and Oakhurst Ave. Upstream inlets are approximately 3-4 lots east of Oakhurst Ave on the north leg of Payne Dr, and on the SW corner of McKenzie Ave and Oakhurst Ave. Tie into existing system at MH I5D-502 (Portland Ave at Oakhurst Ave).
2. Construct 2 new inlets on Payne Dr at the low point where flooding occurs. Construct 1 new inlet on the SW corner of McKenzie Ave and Oakhurst Ave. Improvements consist of 1,370 LF of 18” RCP, 3 new CB connections, 2 new MH connections, and 1 MH connection to an existing line.

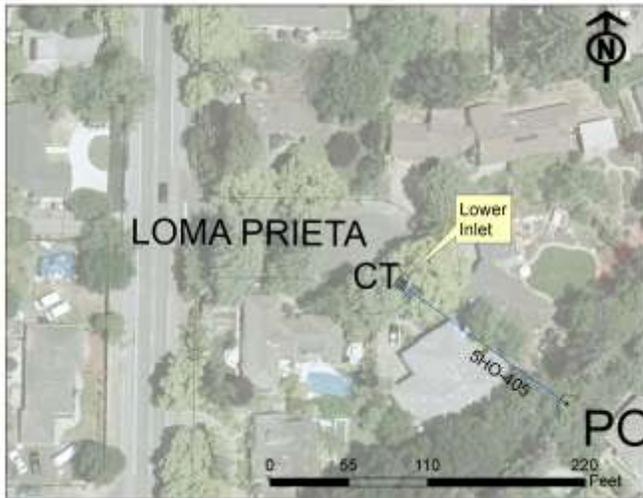
*Plan View*

**Issue:** The storm inlet is too high resulting in poor drainage

Loma Prieta Court experiences significant ponding after most storm events. The existing inlet in the court is not at the lowest point. Driveway entrances were graded lower causing standing water.

Lowering the existing CB and minor gutter grading should improve drainage. Alternatively, additional inlets can be added to existing low spots in the court and connected to the existing CB.

1. Lower inlet grading of CB H5F-404 below the surrounding gutters

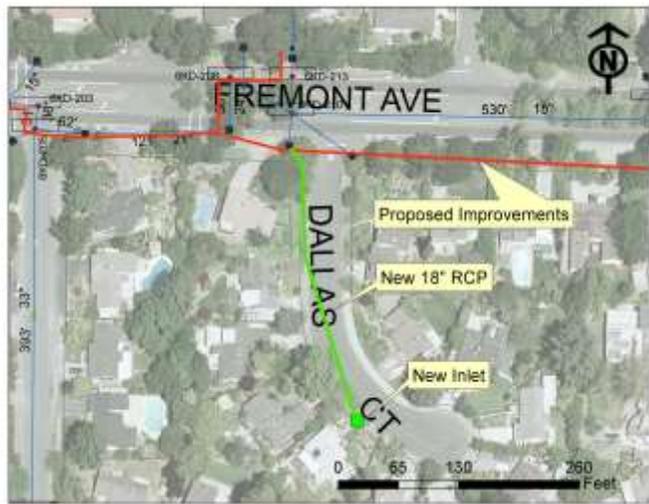
*Plan View*

There have been drainage issues in Dallas Court. The existing drywell percolation rate is not adequate.

Replace the drywell with a CB and connect to the existing system on Fremont Ave. Add additional inlets if needed.

1. Restore MH . K6F-225
2. Install new CB and connect to MH K6f-226 in Fremont Ave.

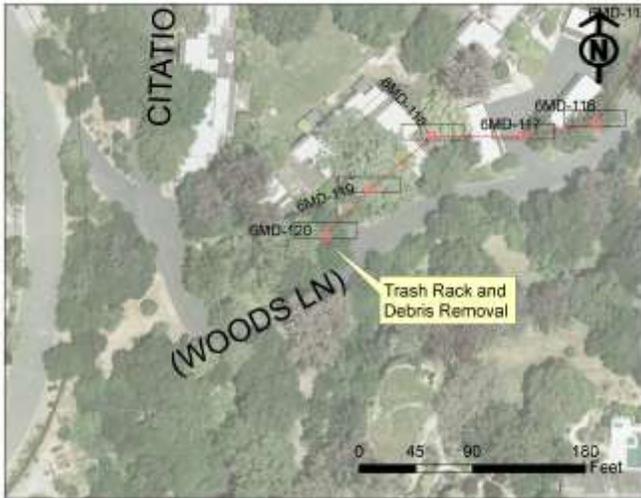
*Plan View*

**Issue:** The City has indicated that logs and debris are clogging the creek in the area

There has been past drainage issues near Woods Lane and Citation Drive. Debris from upstream limits the conveyance in the existing 36-inch pipeline. There is an existing drop structure upstream of the culvert inlet.

1. Install 36" trash rack at check dam or inlet to storm water pipe
2. Routine maintenance along creek and pipe junction

Installing a trash rack at the check dam or inlet to the 36-inch culvert will reduce debris flowing down stream. This device will need routine inspection and maintenance to assure the system functions optimally during storm events.

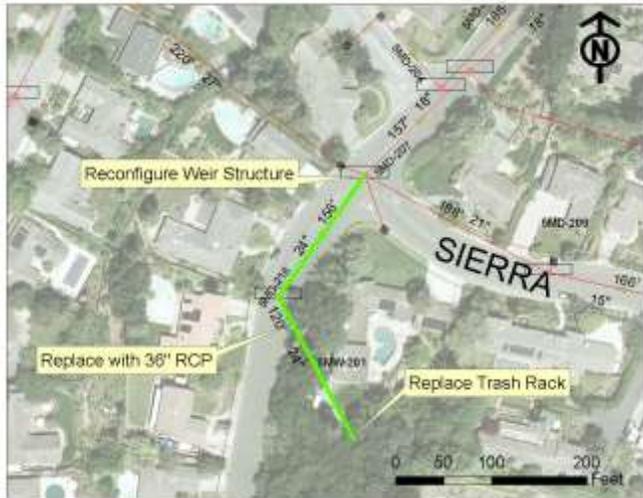
*Plan View*

**Issue:** Trash rack behind residence gets blocked with debris. Gate structure M5D-207 is paved over

The drainage system along Stonehaven Drive upstream of Sierra Ventura has experienced significant drainage problems during storm events. The existing ditch enters the City drainage pipe network at a concrete headwall. There appears to be significant sediment and debris issues. The adjacent landowner has attempted to provide some additional flood protection.

We recommend replacing the headwall and culvert. A 36-inch RCP line to the existing junction box in Stonehaven is required. The new headwall should be higher and include an engineered trash rack. The ditch channel should be improved to prevent erosion.

1. Improve creek channel approach to SD headwall and inlet
2. Remove asphalt over gate structure and bring hatch to grade
3. Continue routine maintenance and cleaning of trash racks behind home and exercise gate structure

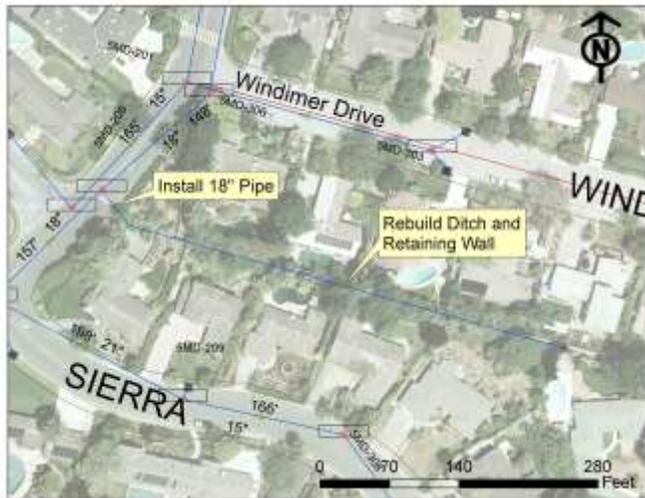
*Plan View*

**Issue:** Drainage ditch in easement fills with debris causing overflow into adjacent properties

The ditch between Windimer and Sierra Ventura Drive fills with debris causing flooding and overflow into the backyards of adjacent properties.

The upstream portion of the ditch has a cage-wrapped retaining wall that provides adequate conveyance in the ditch. The downstream portion of the ditch contains some home-made retaining walls that are collapsing into the ditch causing blockage.

1. Install gabion rock wall throughout the entire length of the ditch
2. Rebuild ditch with constant slope
3. Repair fence
4. Replace pipe between ditch and MH with 18" RCP.

We suggest lining the entire ditch with a gabion rock wall. This will help stabilize the neighboring properties and will limit debris from the surrounding hill.

The existing concrete channel should be repaired and reshaped as needed. A constant pitched slope will help reduce standing water and overflows.

The pipe from the ditch to the manhole in Stovehaven should be replaced with an 18-inch RCP line. The inlet structure should include a trash rack to prevent large debris from entering the storm drain network.

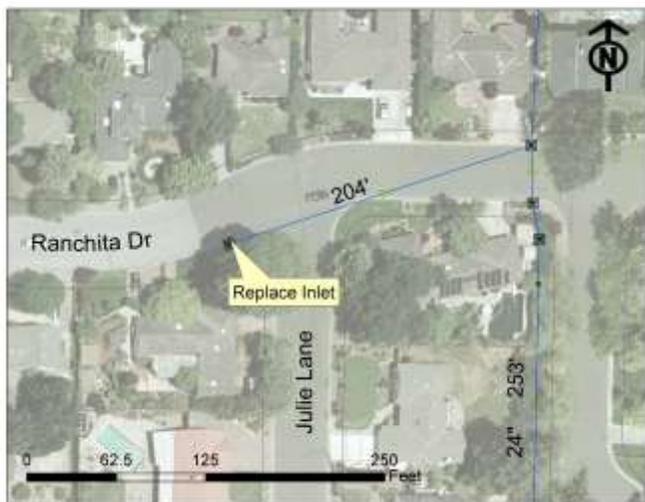
*Plan View*

**Issue:** No sump in CB. Flooding east of Julie and Ranchita, drainage issues due to a crowned road

The area near Ranchita Drive and Julie Lane has experienced drainage problems. There is one existing inlet on the SE corner that regularly clogs with debris. The roadway grading limits drainage to the inlet.

Replace the existing inlet with a CB that includes a sump to collect debris. Regular cleaning of CB should be conducted. Adding an additional CB east of the existing inlet could also improve drainage.

1. Replace inlet CB J6C-225

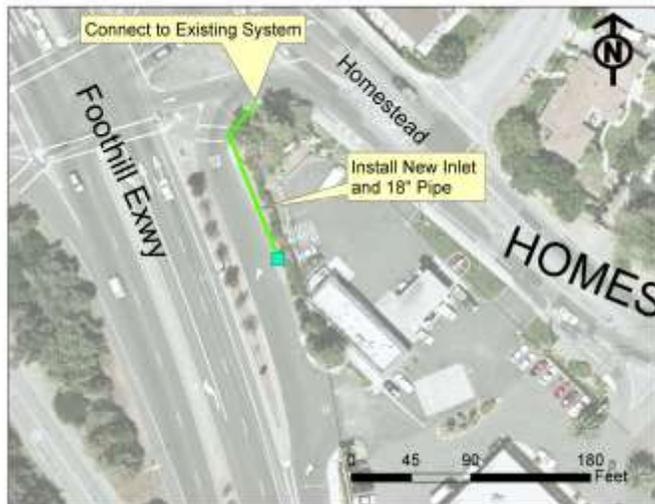
*Plan View*

**Issue:** Poor drainage on offramp.

The offramp from northbound Foothill Expressway to Homestead Road routinely floods. There is a significant sag in the roadway and no storm drain system.

Install an inlet and catch basin at the sag point in the roadway. Connect to undocumented system at corner on Homestead Road.

1. Install a new catch basin alongside the Foothill Expressway offramp, near the Chevron station.
