## AGENDA REPORT

**SUBJECT:** 482 University Avenue – Halsey House

State of California The Resources Agency  
 DEPARTMENT OF PARKS AND RECREATION  
**PRIMARY RECORD**

Page 1 of 3 \*Resource Name or #: (Assigned by recorder) Halsey House

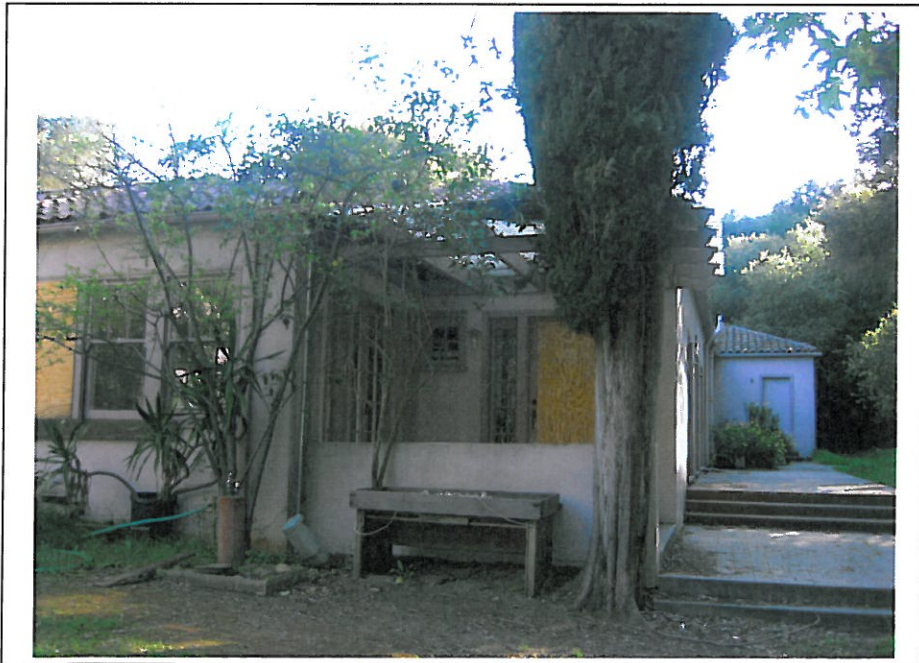
P5b. **Description of Photo:**  
Primary Entrance (north corner)  
March 2009
