City of Los Altos
Blach School Neighborhood
Traffic Study
December 2010

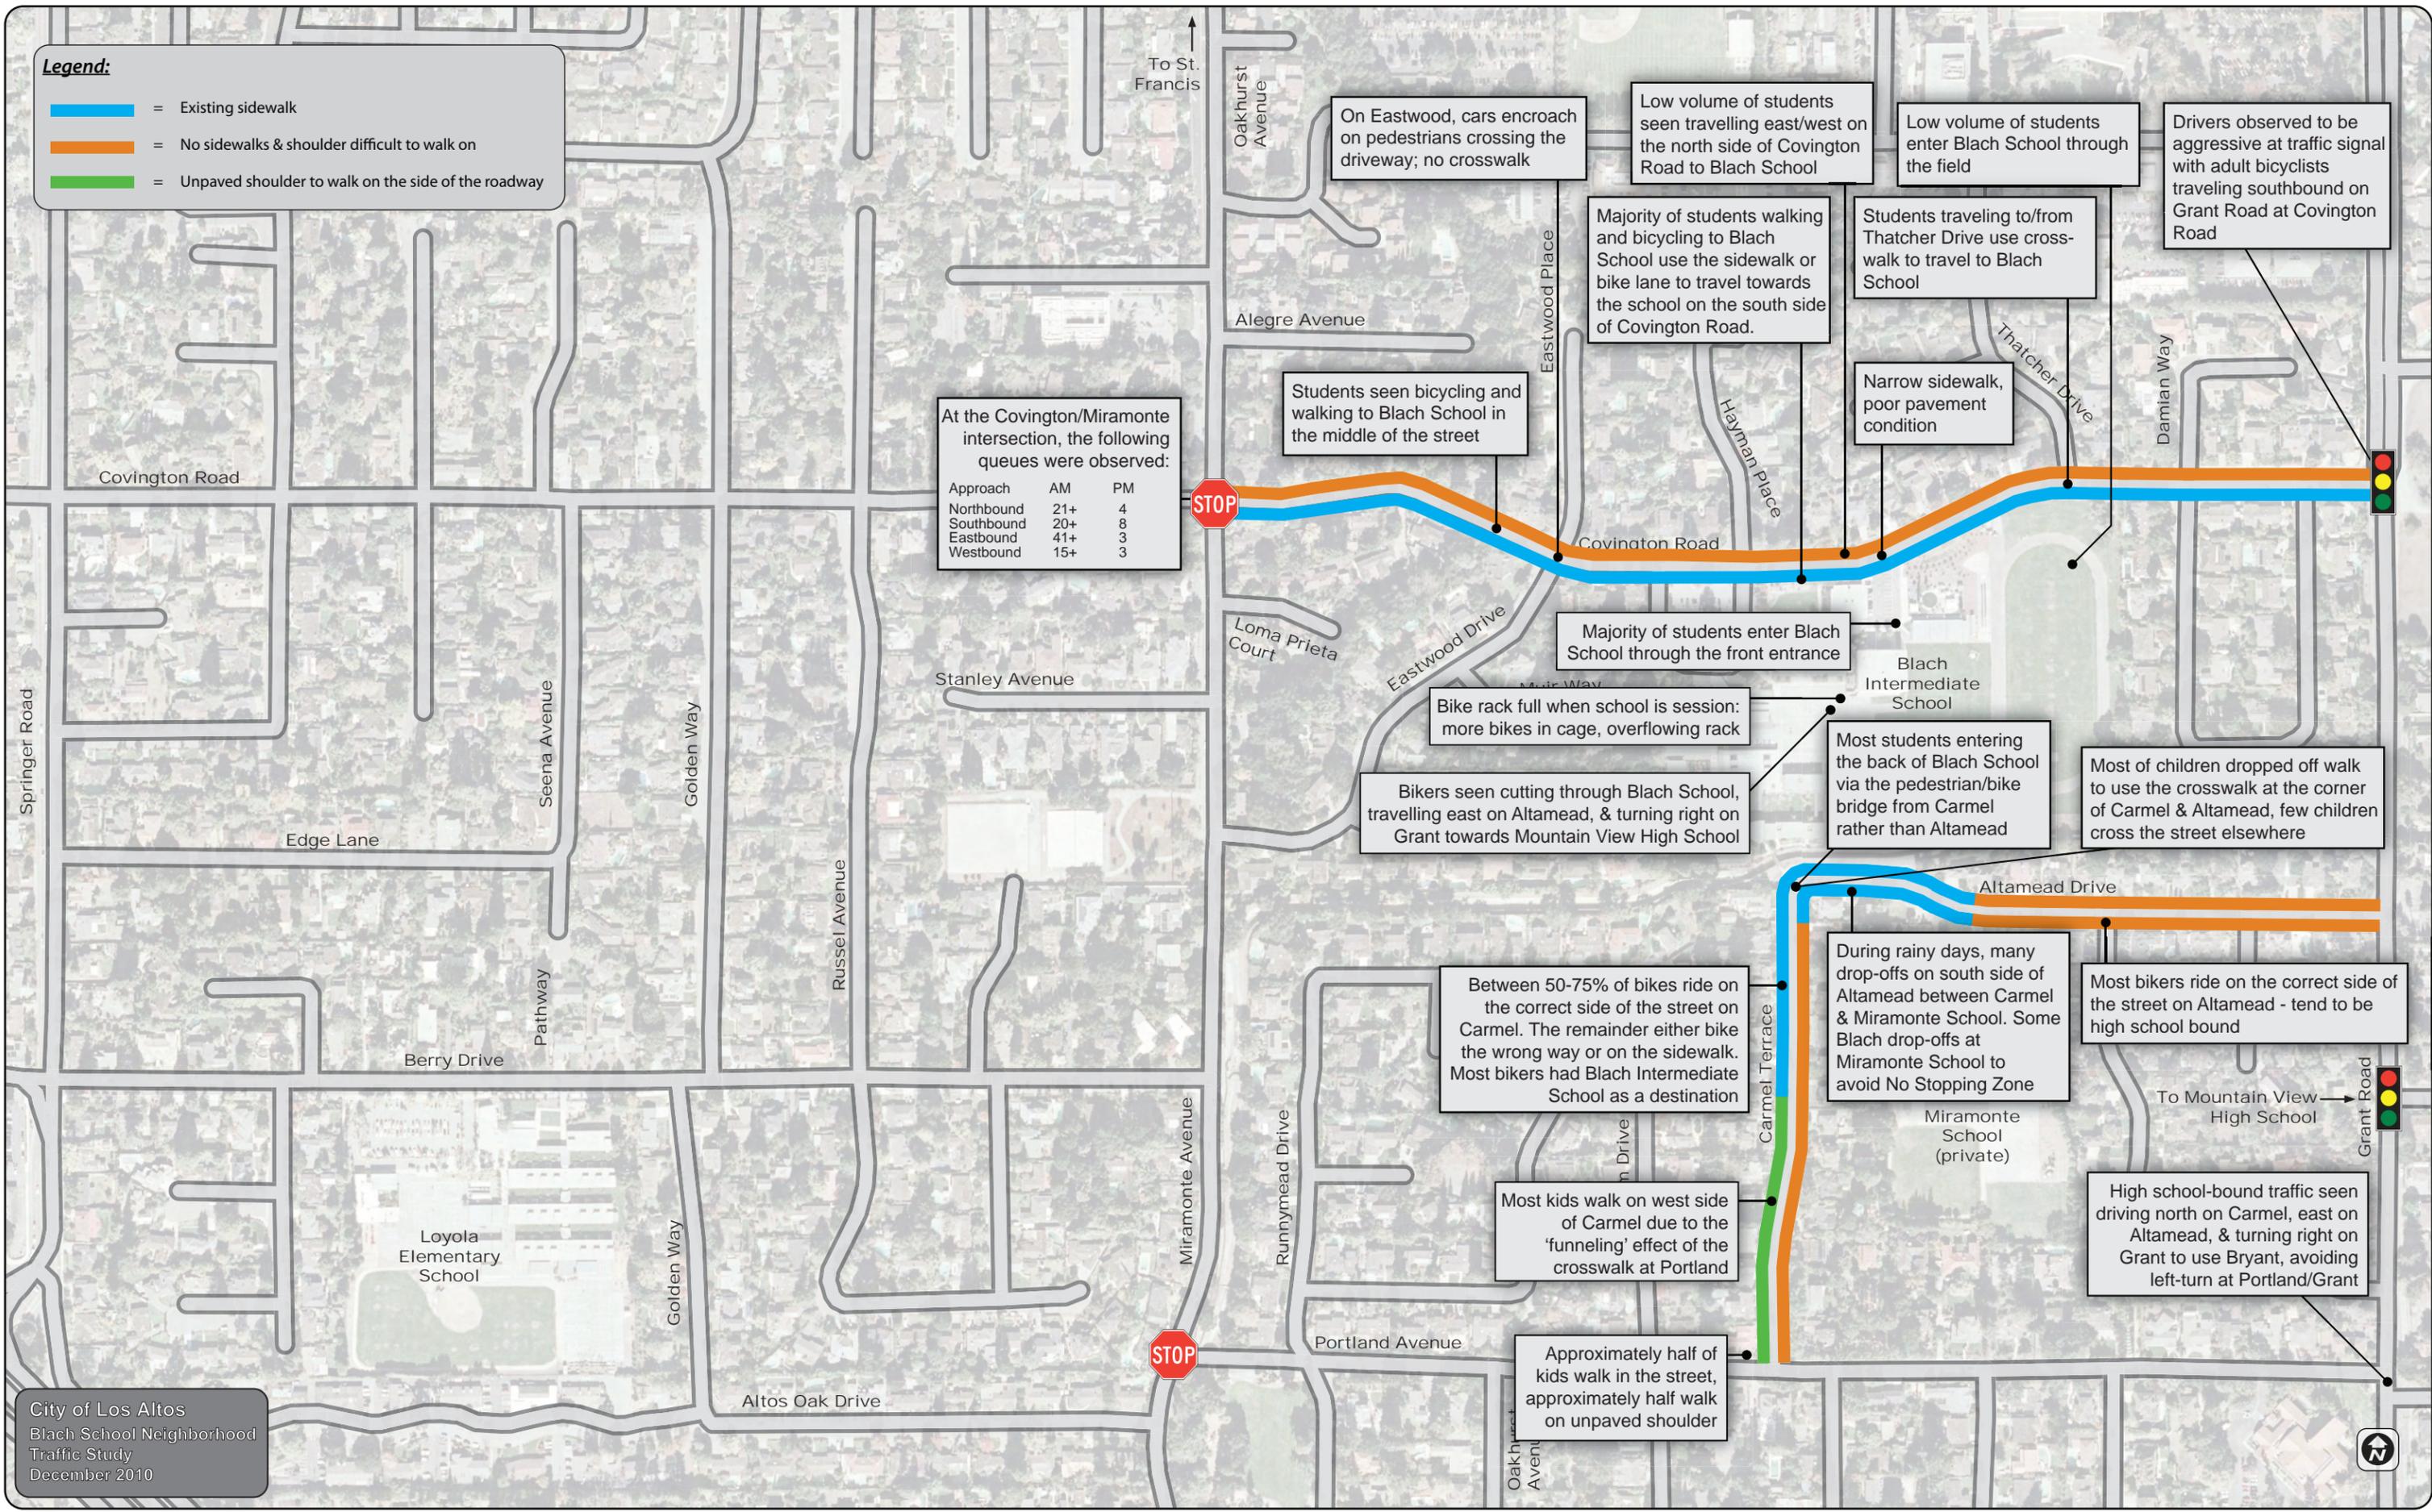
Legend:

- = Existing sidewalk
- = No sidewalks & shoulder difficult to walk on
- = Unpaved shoulder to walk on the side of the roadway
