# Phase I Environmental Site Assessment Report

Hillview Avenue Property  
97 Hillview Avenue  
Los Altos, California

September 25, 2017 | Project No. 403132001

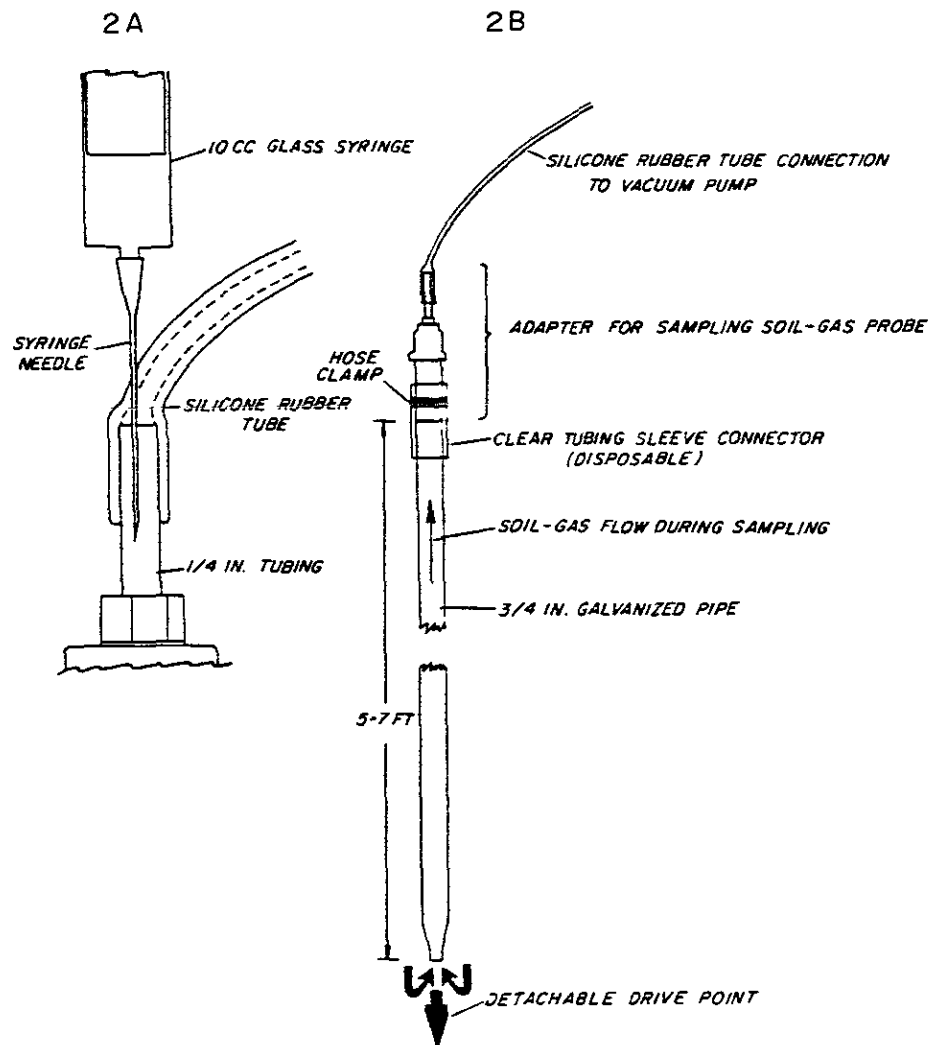
Figure 2. Soil gas sampling apparatus: (a) Close-up view of syringe sampling through the evacuation line, (b) gas flow through a soil gas probe

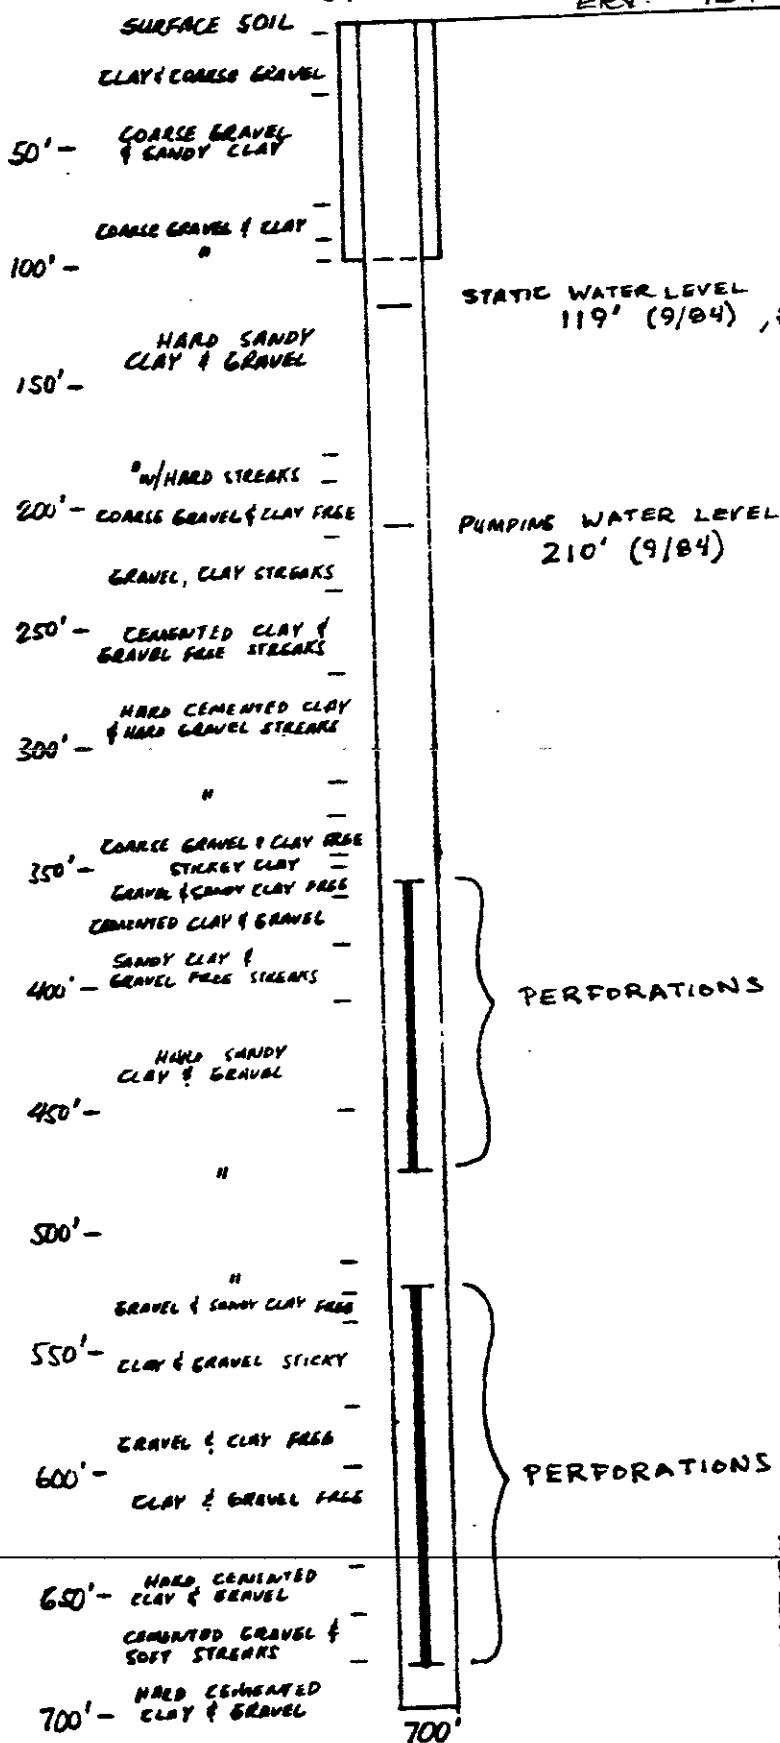
STATIC WATER LEVEL  
119' (9/84), Elev. = +38'

PUMPING WATER LEVEL  
210' (9/84)

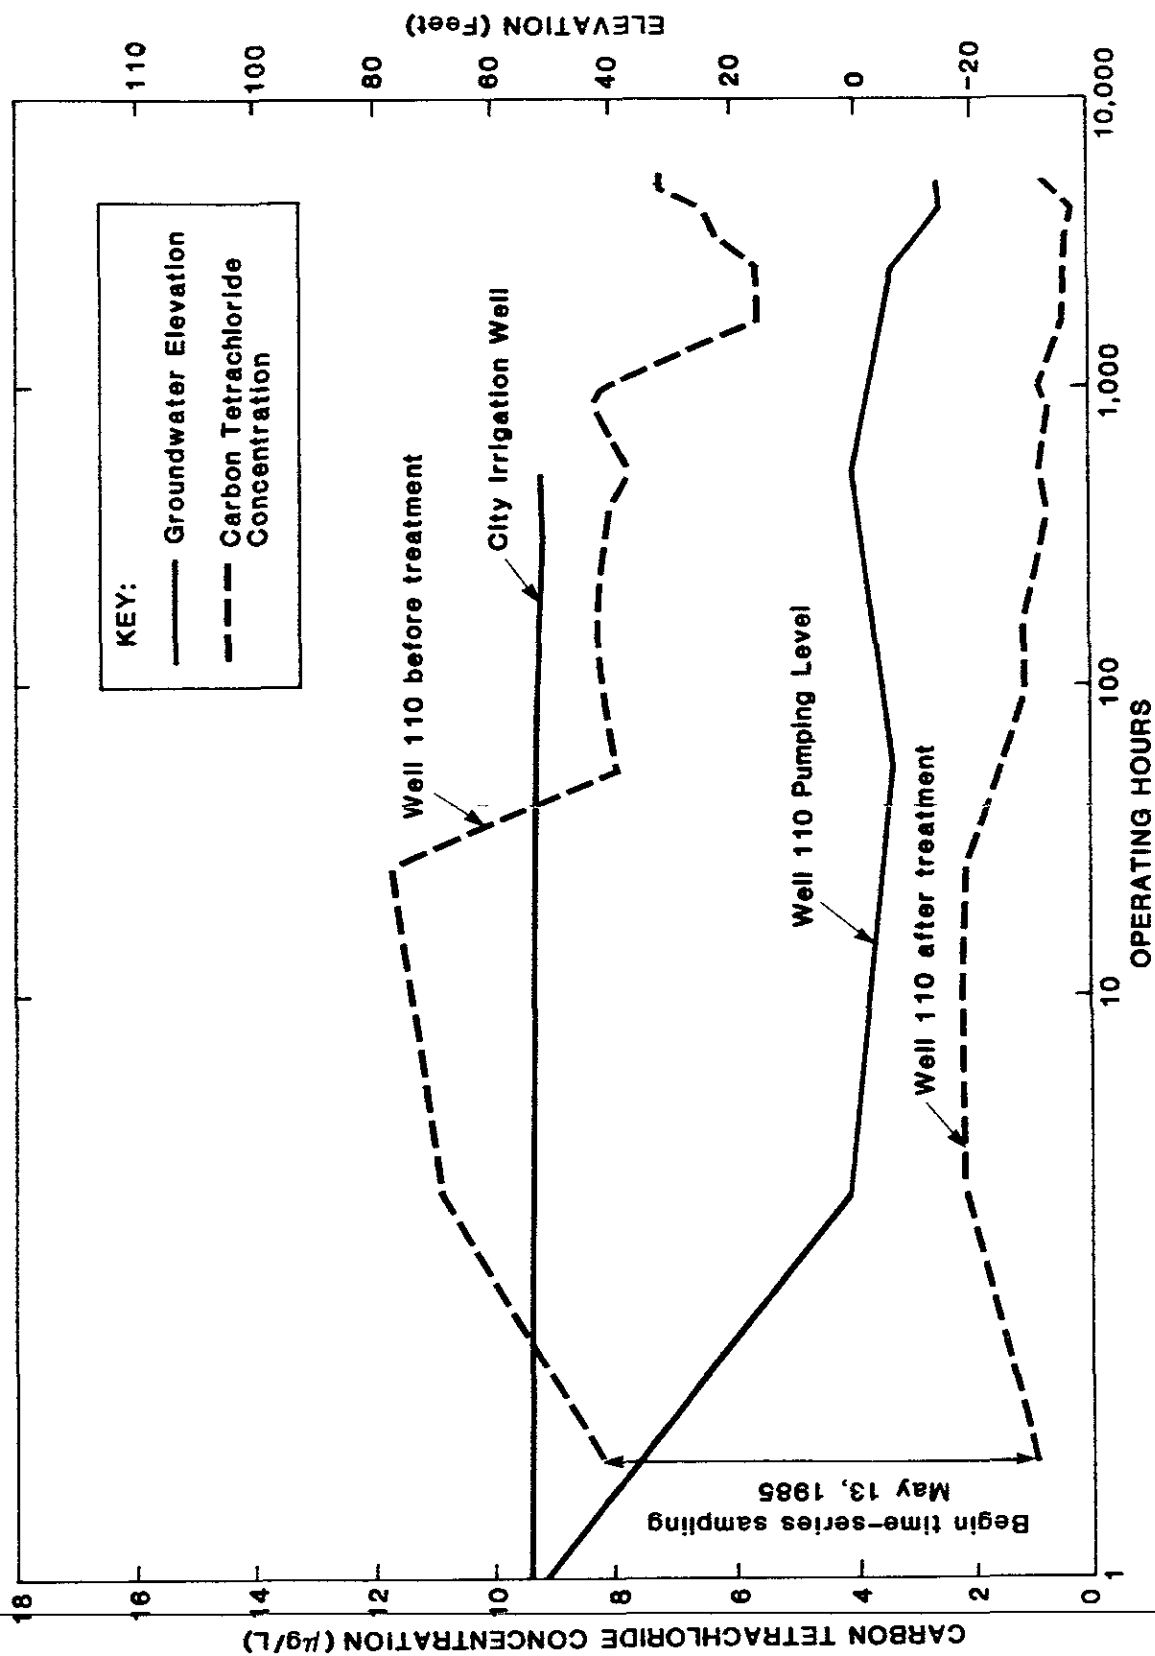
Figure 4  
**CARBON TETRACHLORIDE  
 CONCENTRATION VS. TIME - CWS WELL 110**  
 Los Altos, California  
 Dames & Moore

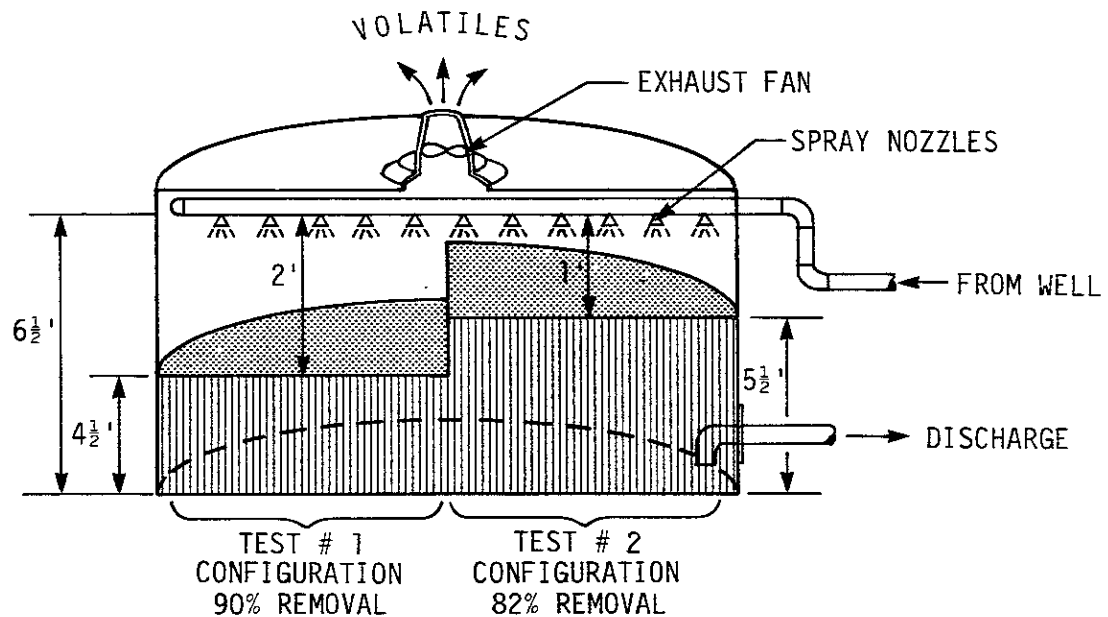
<u>Test 1</u>	<u>Test 2</u>
Tank depth	6.5 ft.	6.5 ft.
Water depth in tank	4.5 ft.	5.5 ft.
Spray exposure	2.0 ft.	1.0 ft.
Carbon tet conc. (initial)	6.2 ug/L	10.5 ug/L
Carbon tet conc. after spray	0.6 ug/L	1.9 ug/L
% carbon tet removal	90%	82%

These results indicate greater than 80% removal of carbon tetrachloride during the least favorable operating conditions; i.e. highest carbon tet concentration with least spray exposure (highest water level). Increasing the spray exposure by decreasing the water depth in the tank, increases the carbon tet removal. Ideal conditions would be to maintain the water level in the tank at less than 4.5 feet to maximize water/air exposure and carbon tet removal.
