DATE: January 20, 2016

TO: Design Review Commission
FROM: Sierra Davis, Assistant Planner
SUBJECT: 15-SC-36 – 614 University Avenue

PROJECT DESCRIPTION

This is a design review application for a new two-story house. The project includes 3,172 square feet on the first story, 2,189 square feet on the second story (street level) and a 1,755 square-foot basement. The following table summarizes the project's technical details:

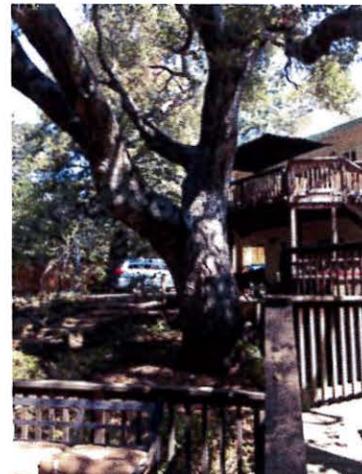
Photo 1: Coast live oak

The coast live oak is in good to fair condition considering its age and size.

In conclusion the coast live oak is in good to fair condition with no significant health or structural problems other than being old and large. The maximum encroachment distance into the root zone on one side would be 22.5 feet. Alternative construction techniques such as post or pier construction would limit the influence on the root area and could allow for greater encroachment.

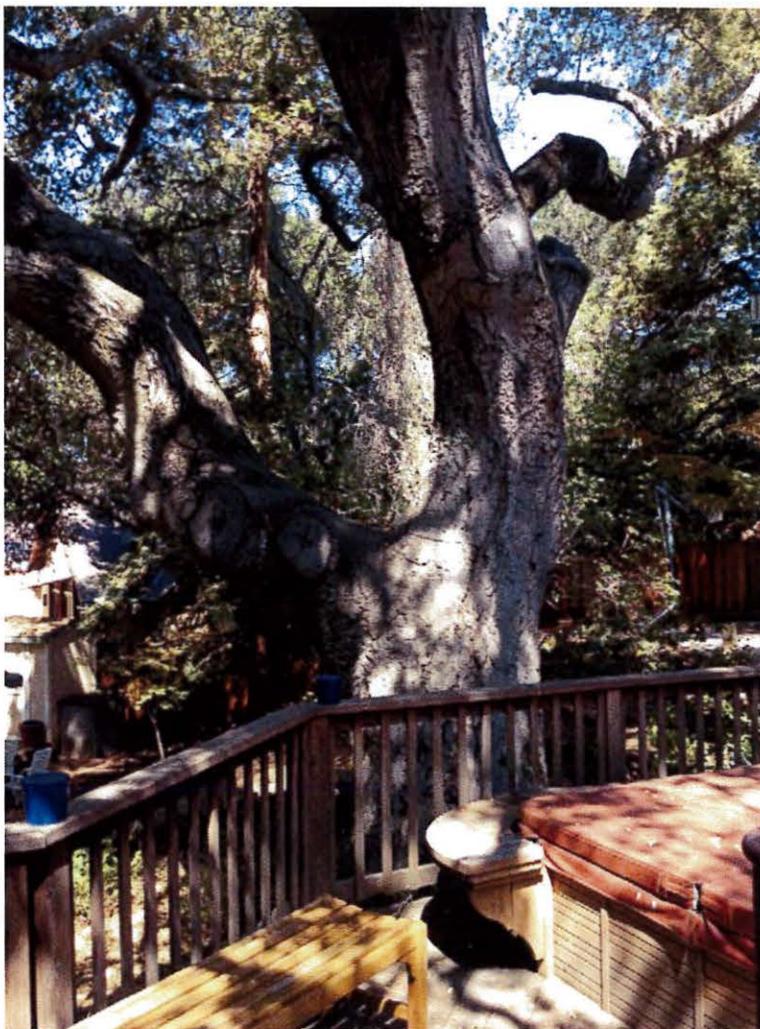
Photo 2: Coast live oak from the deck

The house is located to the east of the tree and there is a deck extending south and west around the tree. There is a pathway down to the lower yard on the north side of the tree and the grade appears to have been raised. A rock wall creates a tree well on the north side at the pathway and the south side of the root area is under the deck.

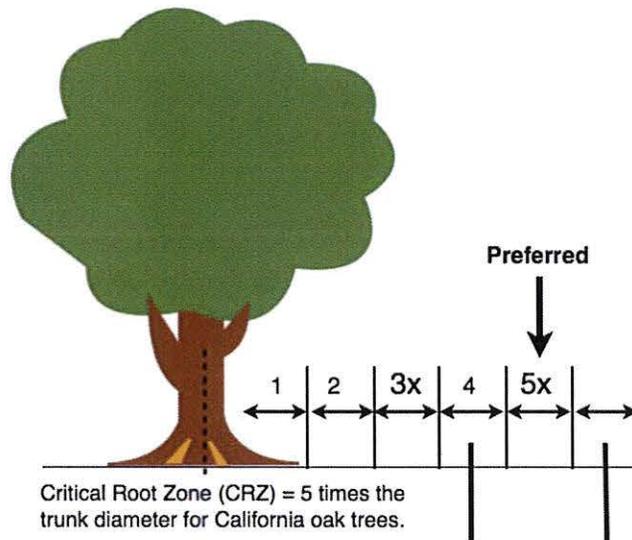
The recommended maximum encroachment distance into the root zone of oaks on one side is five times the trunk diameter (Coate, B.)(Costello, L., Hagan, B., Jones, K. 2011)(Figure 3).

Figure 3: The image above depicts the preferred Critical Root Zone distance for oaks.

The critical root zone (CRZ) is the area of soil around the trunk of a tree where roots are located that provide stability and uptake of water and nutrients required for the tree's survival. The CRZ is the minimum distance from the trunk that trenching or root cutting can occur and will be defined by the trunk diameter as a distance of three times the DBH in feet, and preferably, five times (Smiley, E.T., Fraedrich, B. and Hendrickson, N. 2007). For example if the tree is two feet in diameter, the minimum CRZ distance would be six to ten feet from the stem on one side of the tree.
