TO: Design Review Commission
FROM: Zachary Dahl, Planning Services Manager, Current Planning
SUBJECT: 16-SC-19 – 841 Santa Rita Avenue

This is a design review application for a new 4,144 square-foot one-story house. The following table summarizes the project's technical details:

Site: 841 Santa Rita, Los Altos, CA

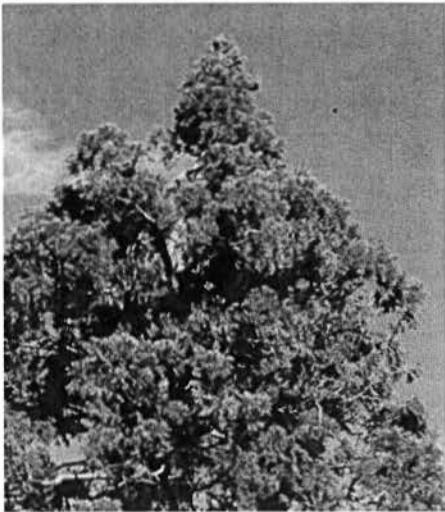
Giant sequoia tree #14 received a condition rating of 45 making it a poor tree. The tree has Botryosphaeria canker disease and is in decline because of the disease. The disease has caused an extensive amount of dieback within the canopy. Also the top of the tree has failed. This tree should be removed as it is a hazard to the property. The following tree protection plan will help reduce impacts from the planned construction.

Showing tree #14 in decline.
