TO: Design Review Commission
FROM: Sean K. Gallegos, Assistant Planner
SUBJECT: 16-SC-04 – 516 Van Buren Street

Approve design review application 16-SC-04 subject to the listed findings and conditions

16-SC-04—516 Van Buren Street

Fir and Cedar Tree Assessments and Protection Zone Recommendations

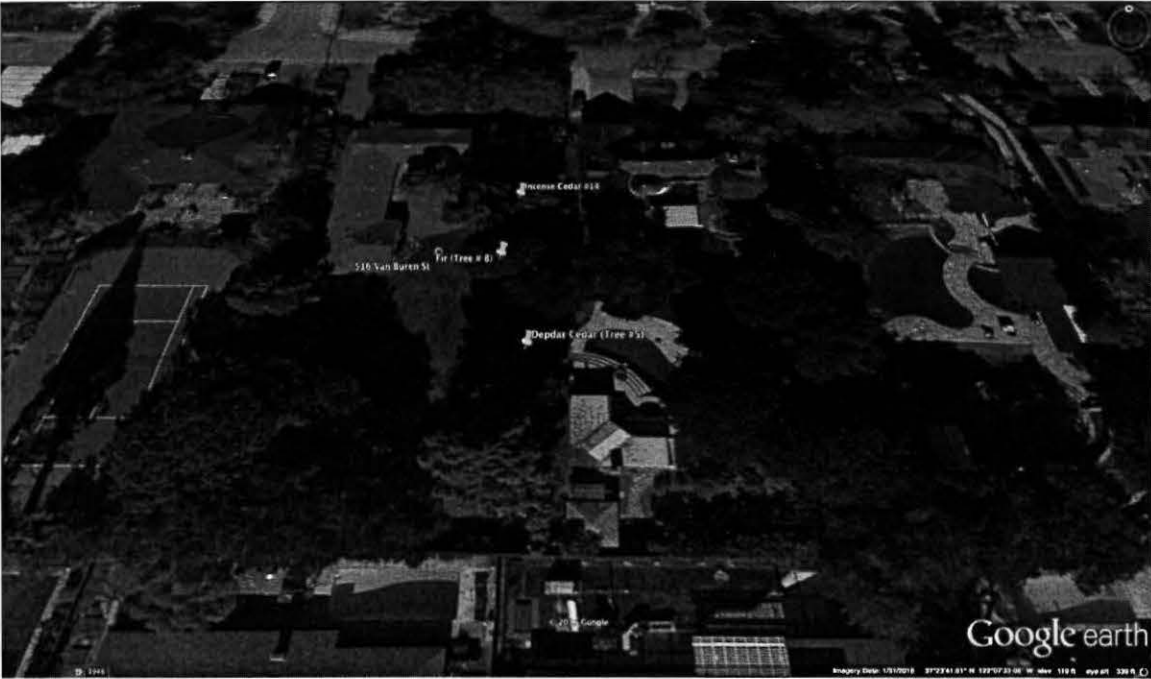
APPENDIX A: SITE OVERVIEW

Yellow pins indicates location of Incense Cedar, Fir, and Cedar tree.

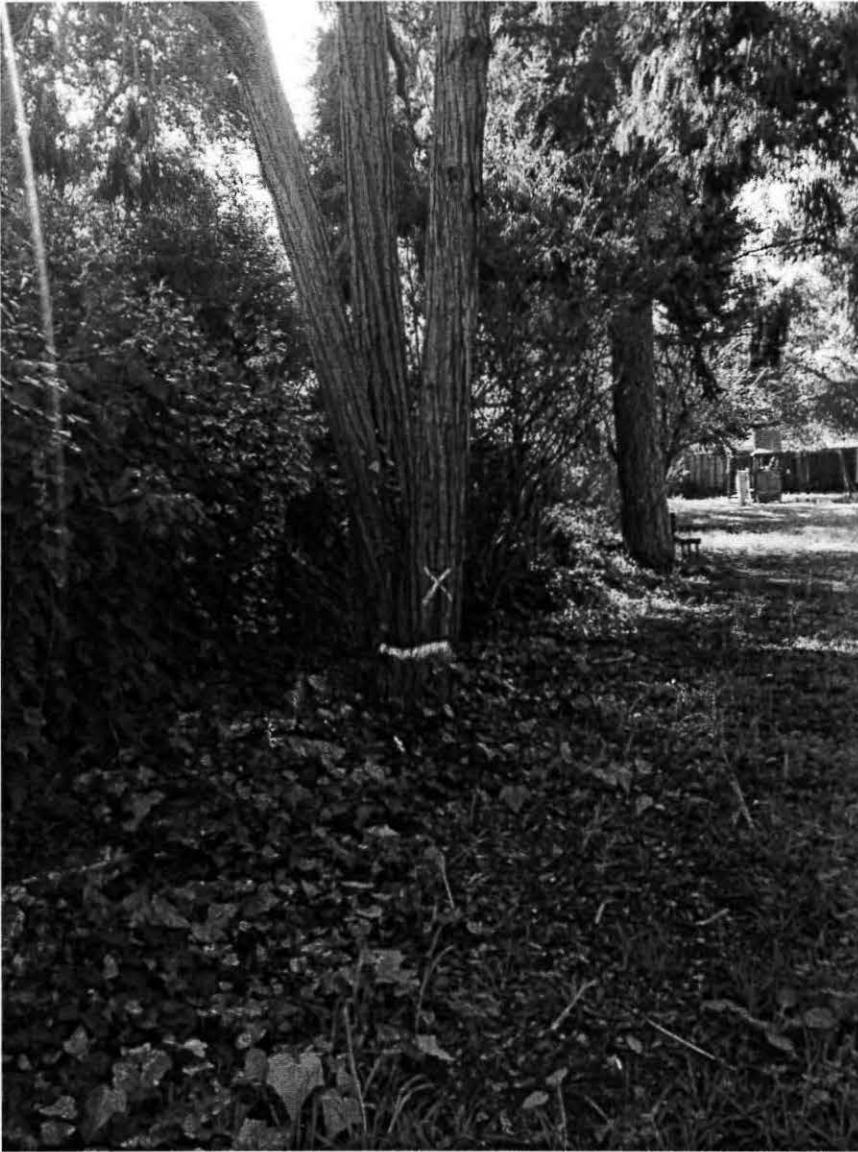
APPENDIX B: TREE PHOTOGRAPHS

Tree #14, an Incense Cedar (*Calocedrus decurrens*) is located in the back yard on the east side of the property.

The Incense Cedar tree is approximately 50 feet tall with a trunk diameter of 41 inches. The average canopy spread is about 30 feet and live crown ratio is 80 percent.

Tree size and density is normal and twig growth is average in length. And the Critical Root Zone (CRZ), for a tree this size is 13 feet from the base of main stem. Best practice is not to sever any roots within the CRZ.

The tree appears to be in good health. (Appendix B)

Photo of tree #14, Incense Cedar.

TREE PROTECTION FENCING SHOULD BE IN PLACE AROUND THESE TREES DURING THE ENTIRE CONSTRUCTION PERIOD TO GUARD AGAINST SOIL COMPACTION AND ABIOTIC DAMAGE.

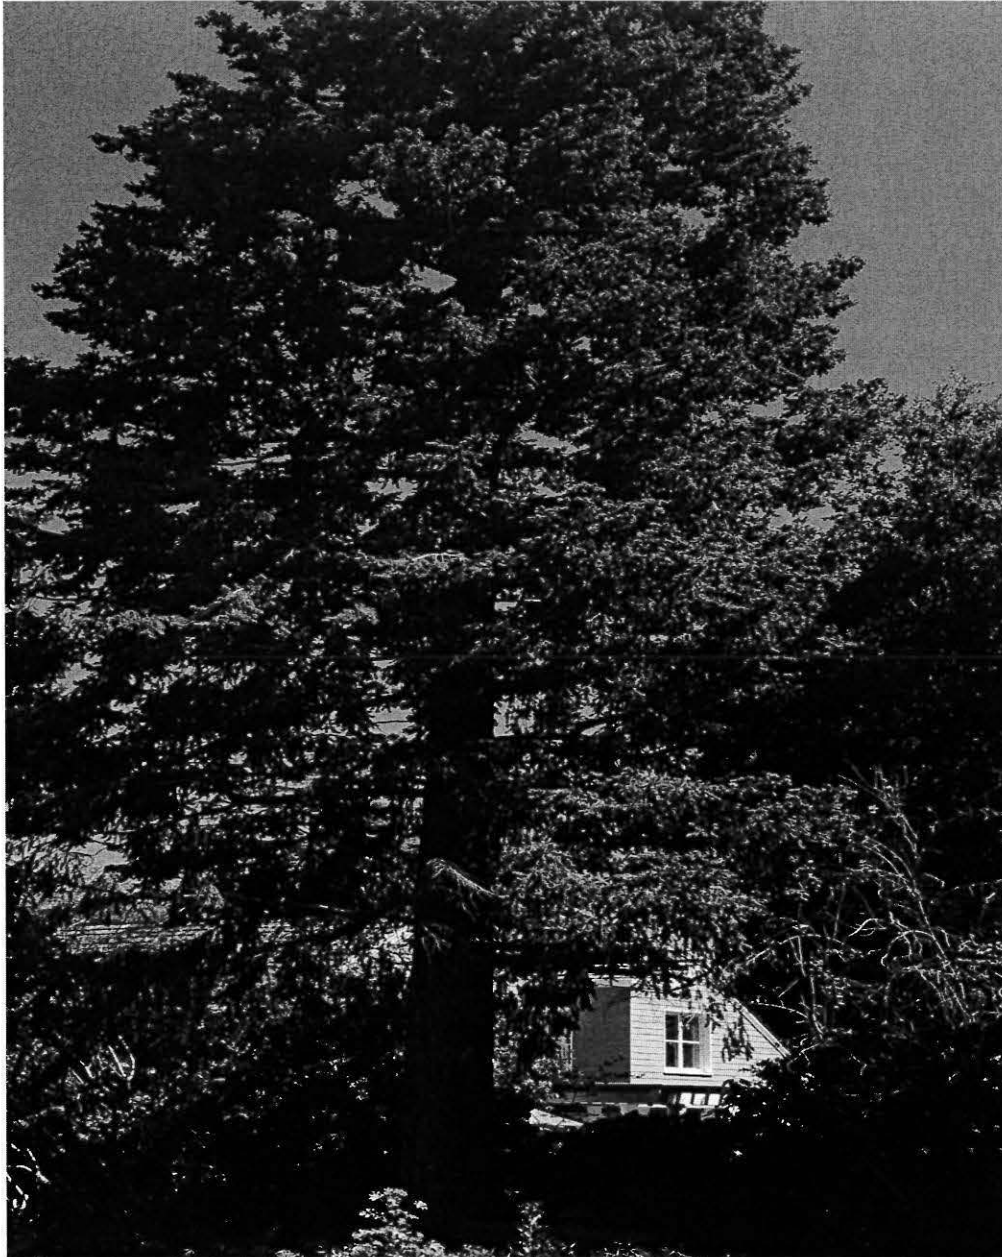
B1:

Tree #8, a Douglas Fir (*Pseudotsuga menziesii*) is located in the back yard on the east side of the property.

The Fir tree is approximately 60 feet tall with a trunk diameter of 30 inches. The average canopy spread is about 30 feet and live crown ratio is 80 percent.

The tree appears to be in good health. (Appendix B1)

Photo of tree #8, Douglas Fir.

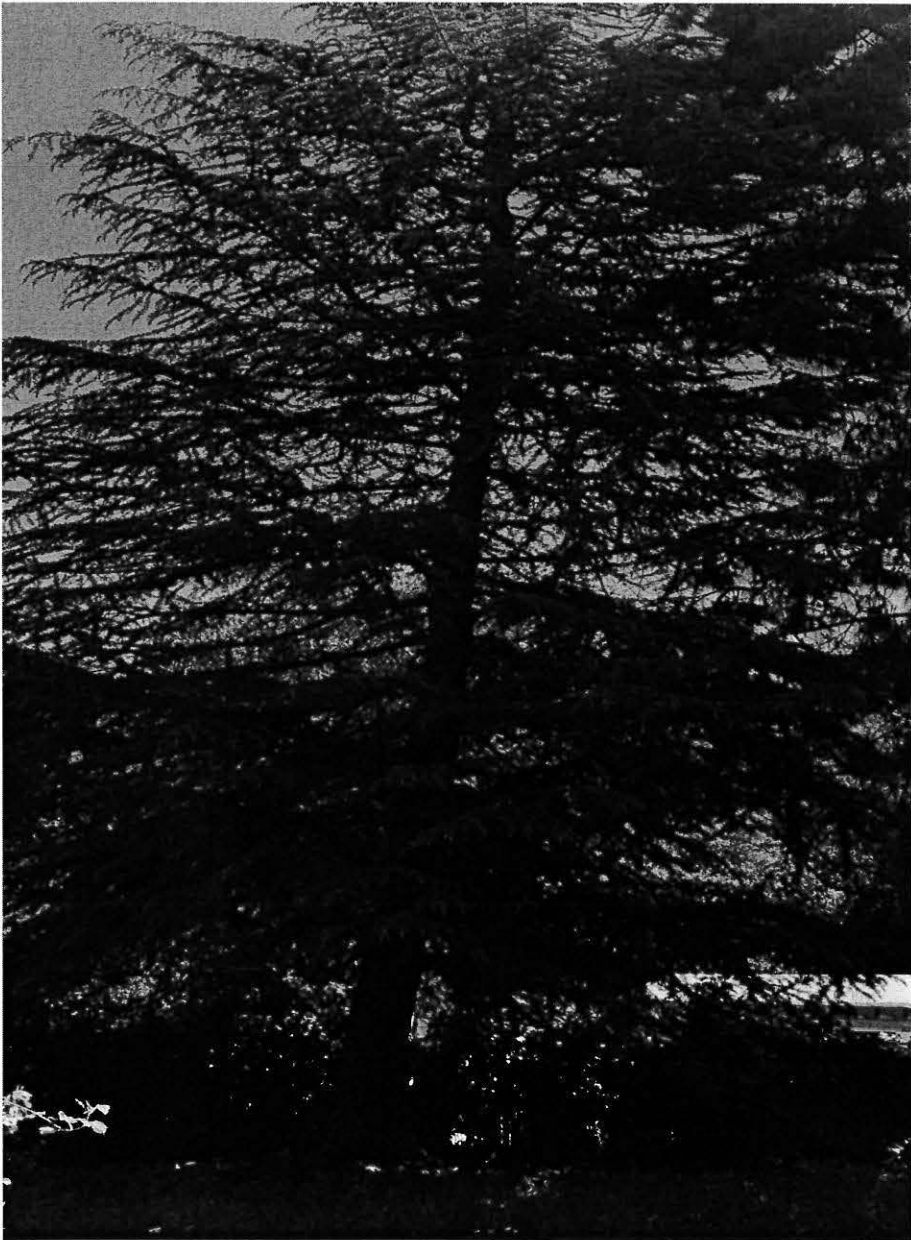
B2:

Tree #5, a Deodar Cedar (*Cedrus deodara*) is located in the back yard on the east side of the property. (Appendix A: Site Overview).

Photo of tree #5, Cedar.
