**TO:** Design Review Commission  
**FROM:** Zachary Dahl, Planning Services Manger – Current Planning  
**SUBJECT:** 17-SC-25 – 167 Garland Way

Approve design review application 17-SC-25 subject to the listed findings and conditions

This is a design review application for a new one-story house that exceeds 20 feet in height. The project includes a 4,757 square-foot one-story house with a maximum height of 22 feet. The following table summarizes the project’s technical details:

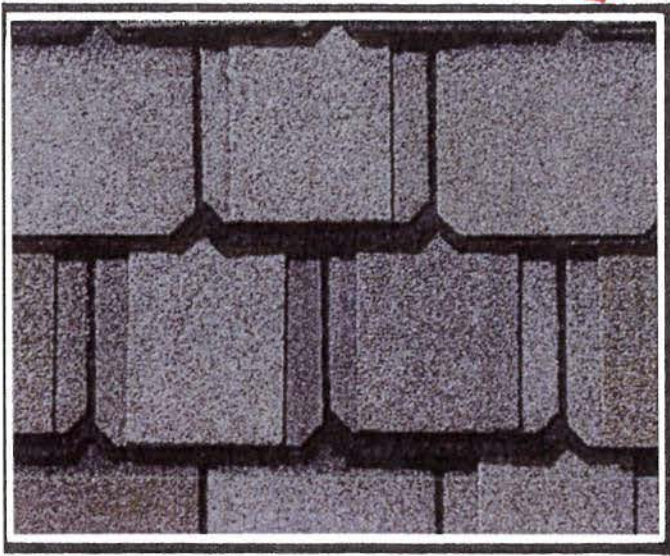
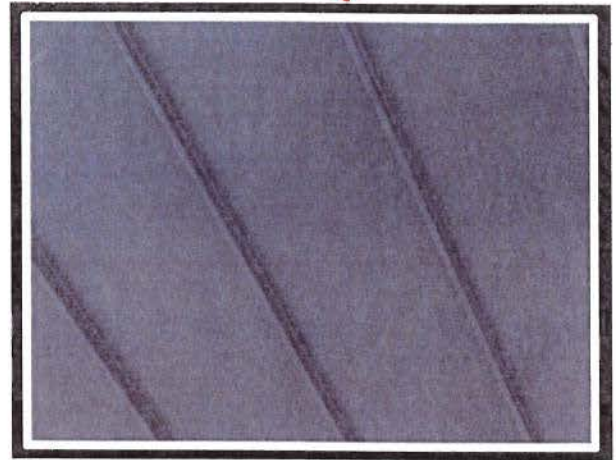
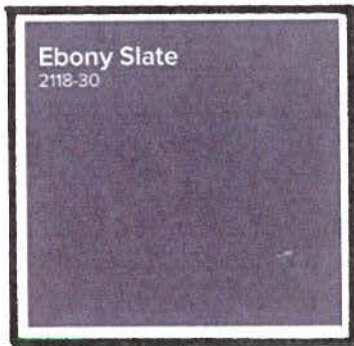
CLASSIC METAL  
ROOFING SYSTEMS  
'VERMONT SLATE'

CERTAINTEED  
'GRAND MANOR'  
STONEGATE GRAY  
ASPHALT SHINGLE ROOF

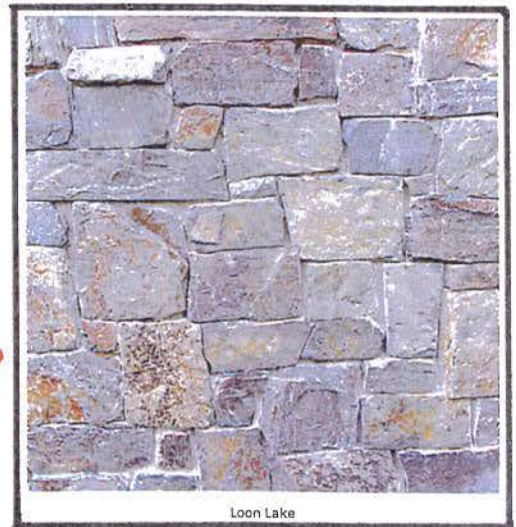
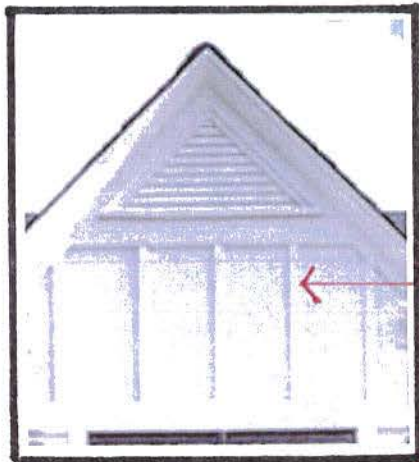
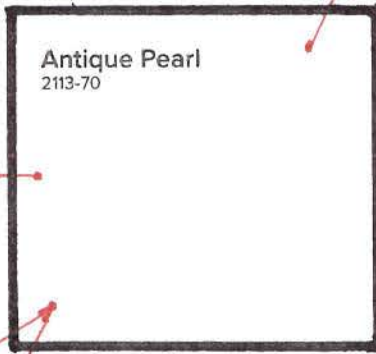
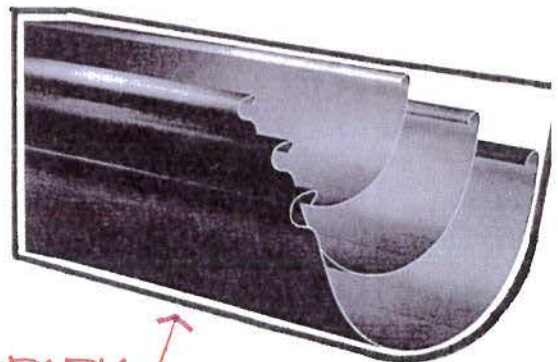
PENINSULA BUILDING  
SUPPLY, NATURAL STONE  
THIN VENEER 'LOON LAKE'

'BENJAMIN MOORE'  
'EBONY SLATE'  
2118-30  
ENTRY DOOR

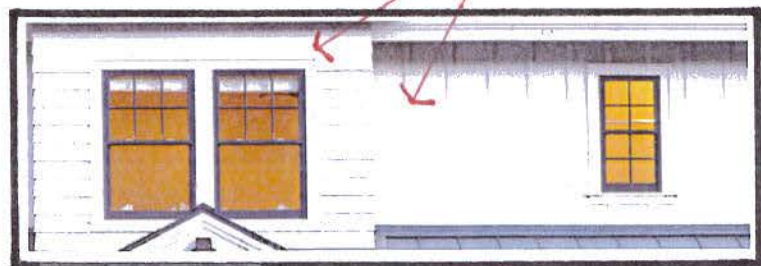
DARK  
ANODIZED 1/2  $\phi$   
GUTTERS  
BENJAMIN MOORE  
'ANTIQUE PEARL' 2113-70  
ALL SPECIFIED AREAS

ALL EXT. WOOD TO BE  
CLEAR (CVR) FINGER JNT  
PAINT PRIMED CEDAR
