TO: Design Review Commission
FROM: Sean K. Gallegos, Associate Planner
SUBJECT: SC20-0012 – 148 Doud Drive

PROJECT DESCRIPTION

This is a design review application for a new two-story house. The project includes 2,411 square feet on the first story and 1,464 square feet on the second story. The following table summarizes the project's technical details:

**Tree Inventory, Assessment,
and
Protection Report**

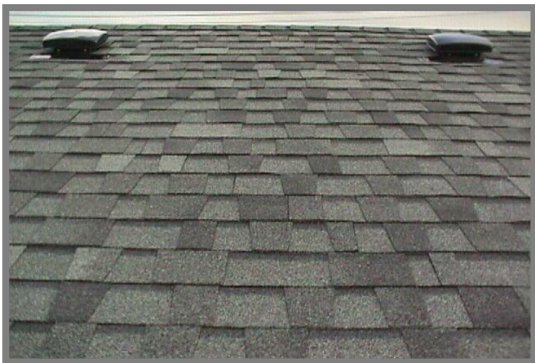
ROOFING
40 YO COMP

GENERAL PLAN DESIGNATION: Single-Family, Residential
ZONING: R1-10
PARCEL SIZE: 11,250 square feet
MATERIALS: Composition shingle roof, Hardie lap siding, fiberglass windows, and wood trim and details

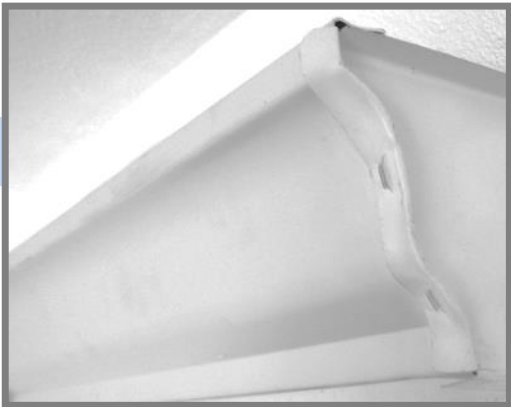
GUTTERS
OGEE PROFILE
ROUND DOWNSPOUTS

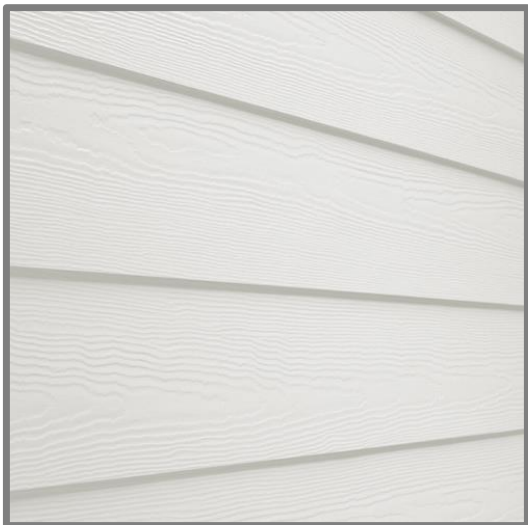
EXTERIOR WALLS
HARDIE PLANK
LAP SIDING
WITH
VERT CORNER TRIM

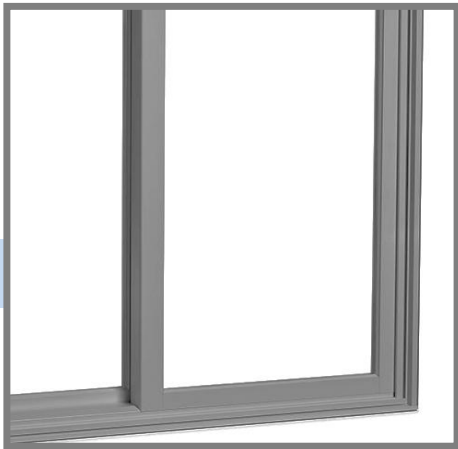
WINDOWS
DUAL GLAZED VINYL
BY ANDERSON
WINDOWS OR
EQUIVALENT VALUE

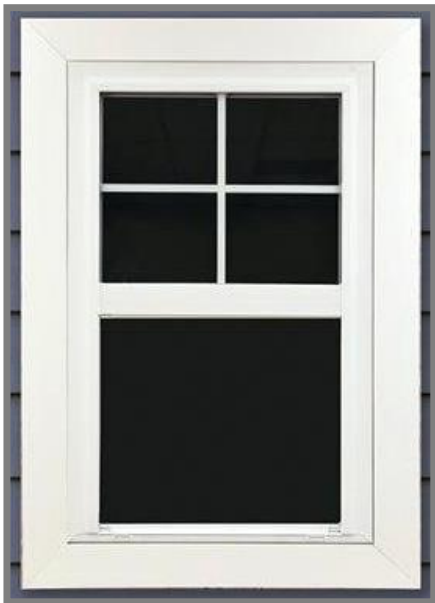
WINDOW TRIM
2X4 & 2X3 WHERE
SHOWN

2X4 WITH APRON AT
FIRST FLOOR

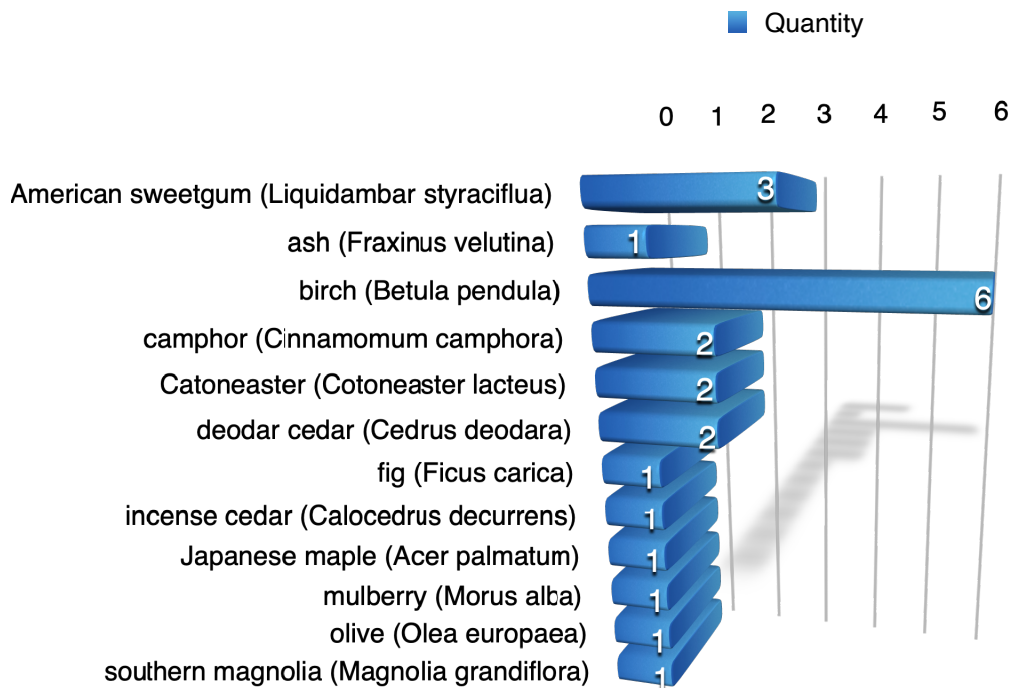
Chart 1: Species Distribution

The inventory contains all the trees with trunk diameters greater than four inches (Chart 1). There are 22 trees and shrubs comprised of 12 different species. Eleven of the twenty-two are considered protected by the ordinance with trunks greater than 15 inches in diameter.

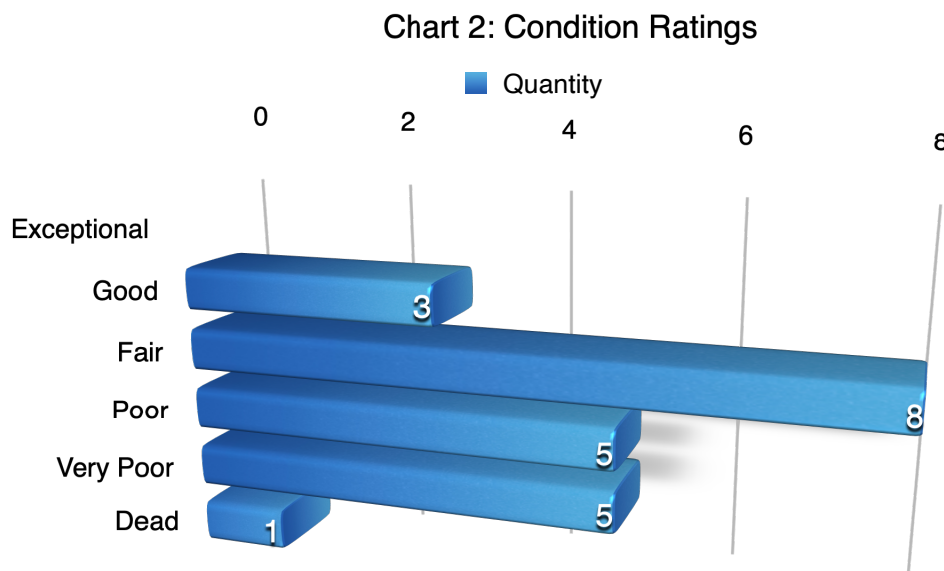
Three trees are in good condition, eight fair, five poor, five very poor, and one is dead (Chart 2). Trees in very poor condition include are all the birch in front, some of which are topped under the high voltage lines.

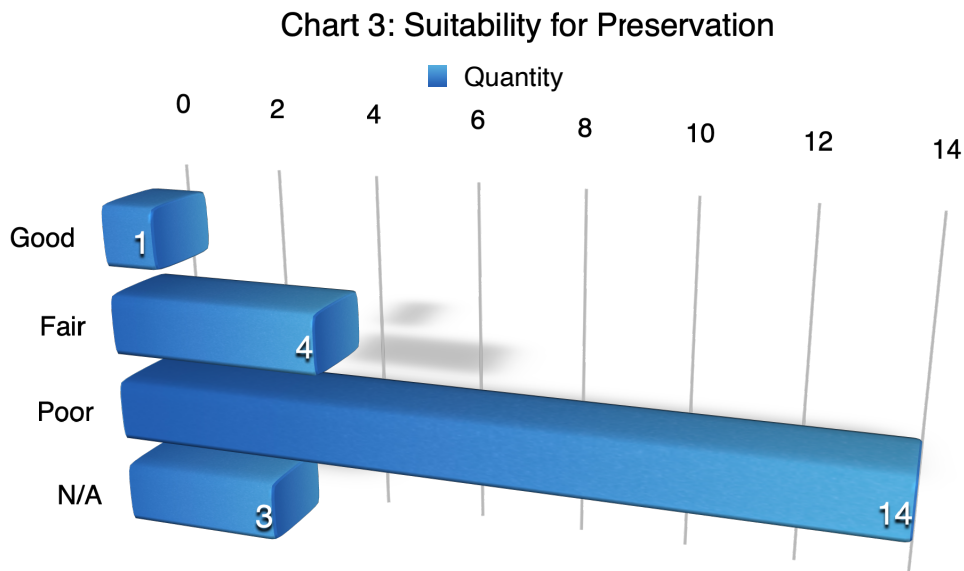
Fourteen trees are poorly suited for retention in a development setting and include all the birch, the ash under the high voltage lines, and several small specimens or shrubs in poor condition (Chart 3). Deodar cedar #17 has the best suitability because it is large and far enough from construction to potentially survive for many more years. Three trees originate on the adjacent site and are labeled as N/A for purposes of this report. Four trees have fair suitability.

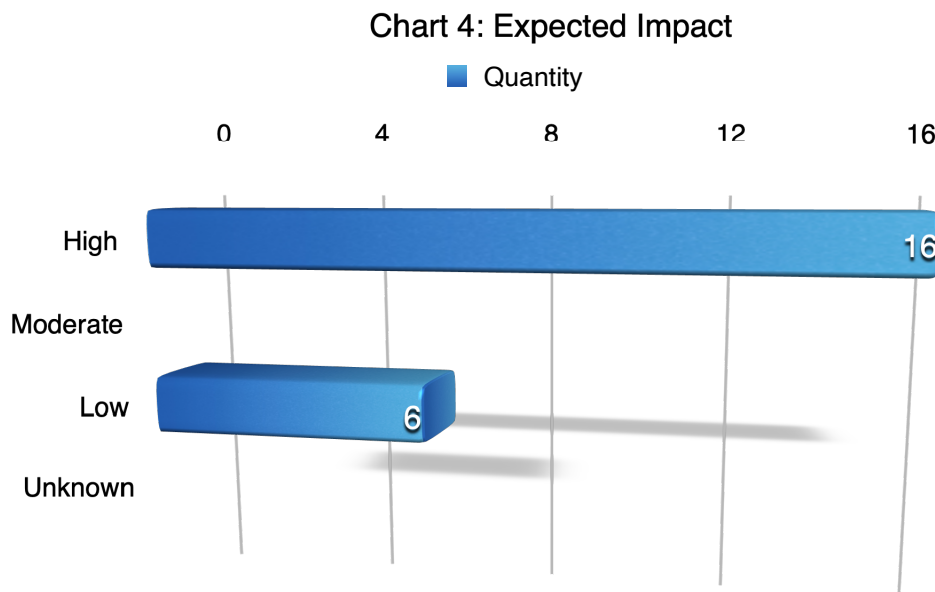
There are sixteen trees that will be highly impacted and require removal (Chart 4). Seven of the sixteen are protected by the ordinance (trunks greater than 15 inches in diameter) with one of those being dead and one being a small Japanese maple with combined stems adding to more than 15 inches. Six trees are to be retained with three of those originating on the adjacent property and three located in the back corner (deodar cedar #17 and camphors #18 and #19).

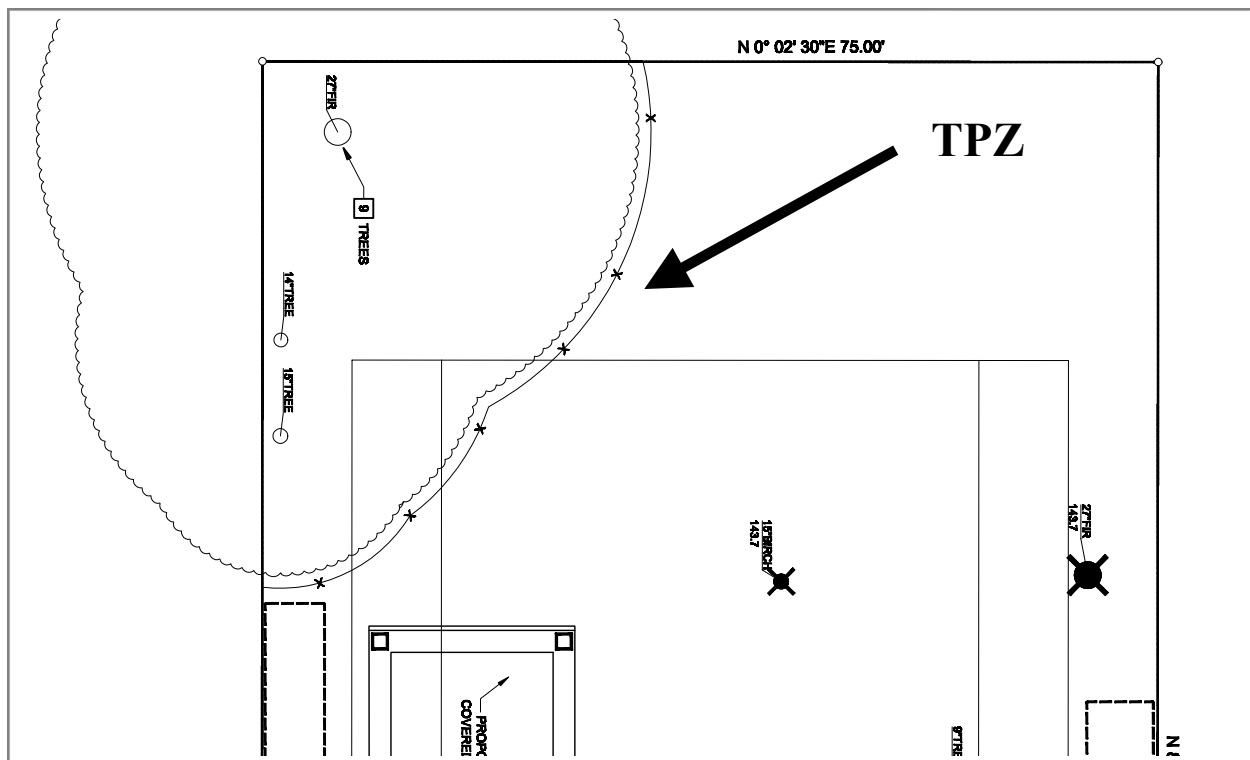
There are three trees to be retained and protected on the property with are deodar cedar #17 and camphors #18 and #19. All three of these trees are located in the back corner of the property and will be protected as a group. There are no proposed improvements in this area and fence can be placed around them. The Tree Protection Zone should extend 19 feet into the site and be connected to the existing neighbor fence.

SNAPSHOT OF LANDSCAPE PLAN WITH TREE PROTECTION FENCE AROUND #17, #18, AND #19

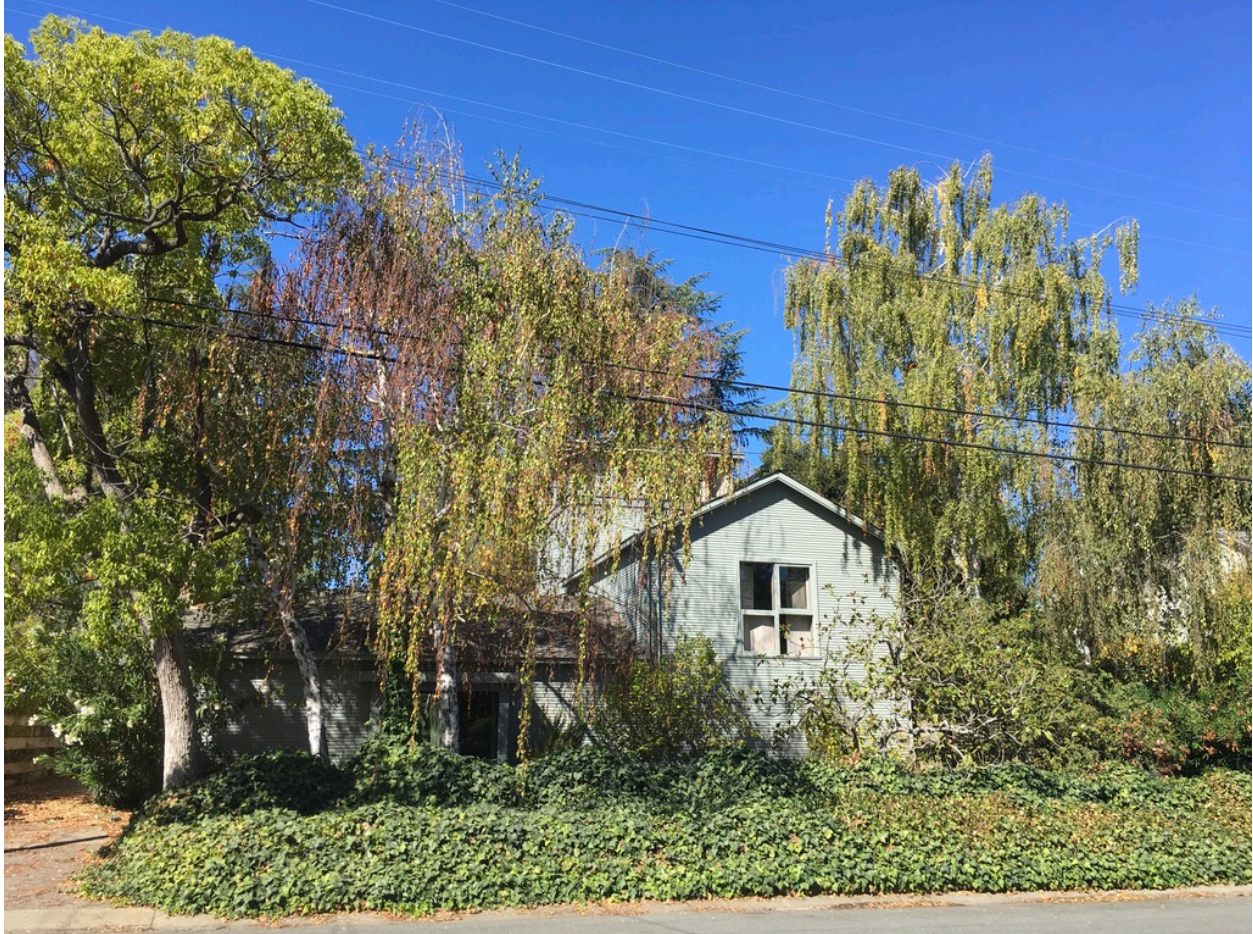
C1: Ash and birch in front (1-4)

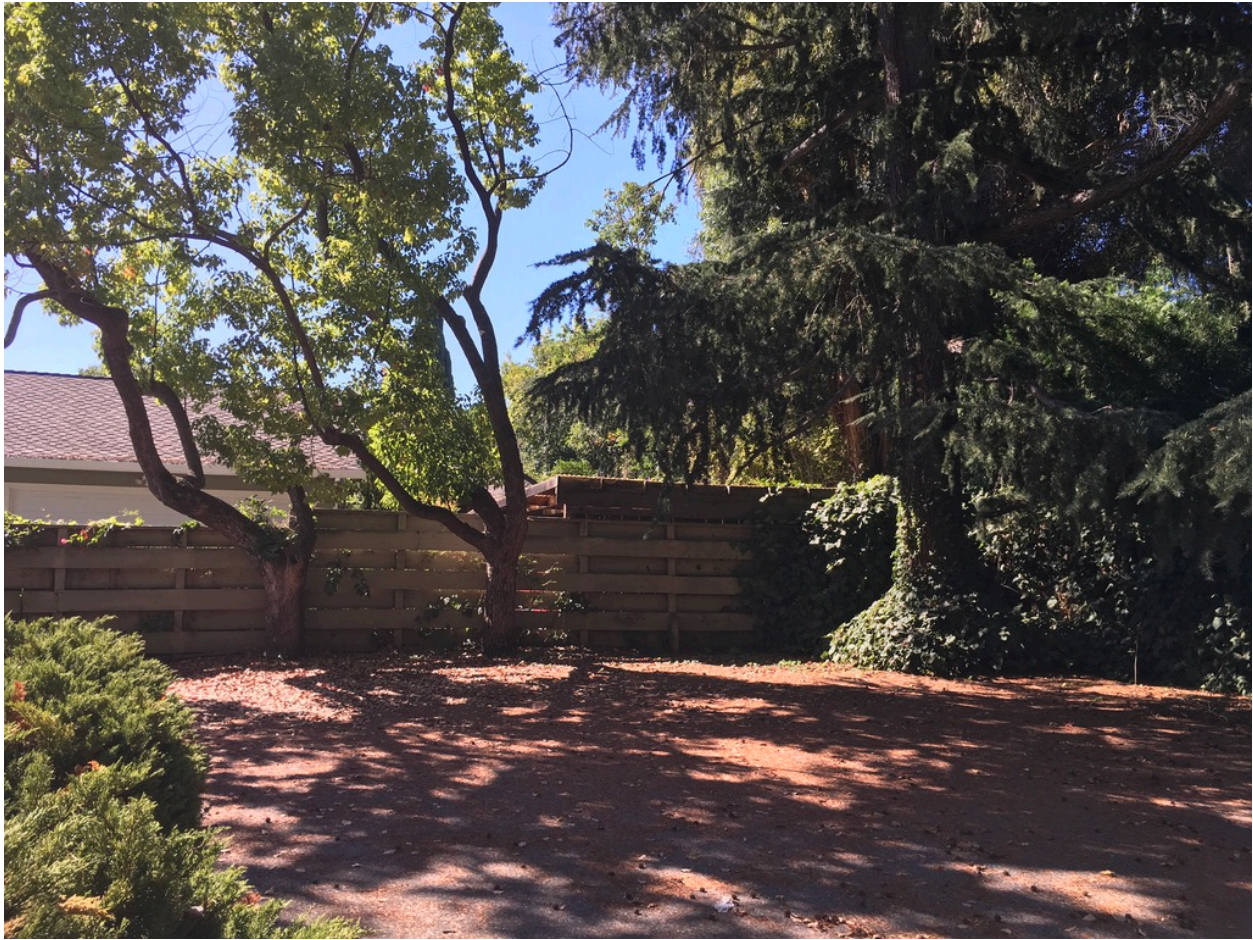
C2: Deodar cedar and camphors in back (17-19)

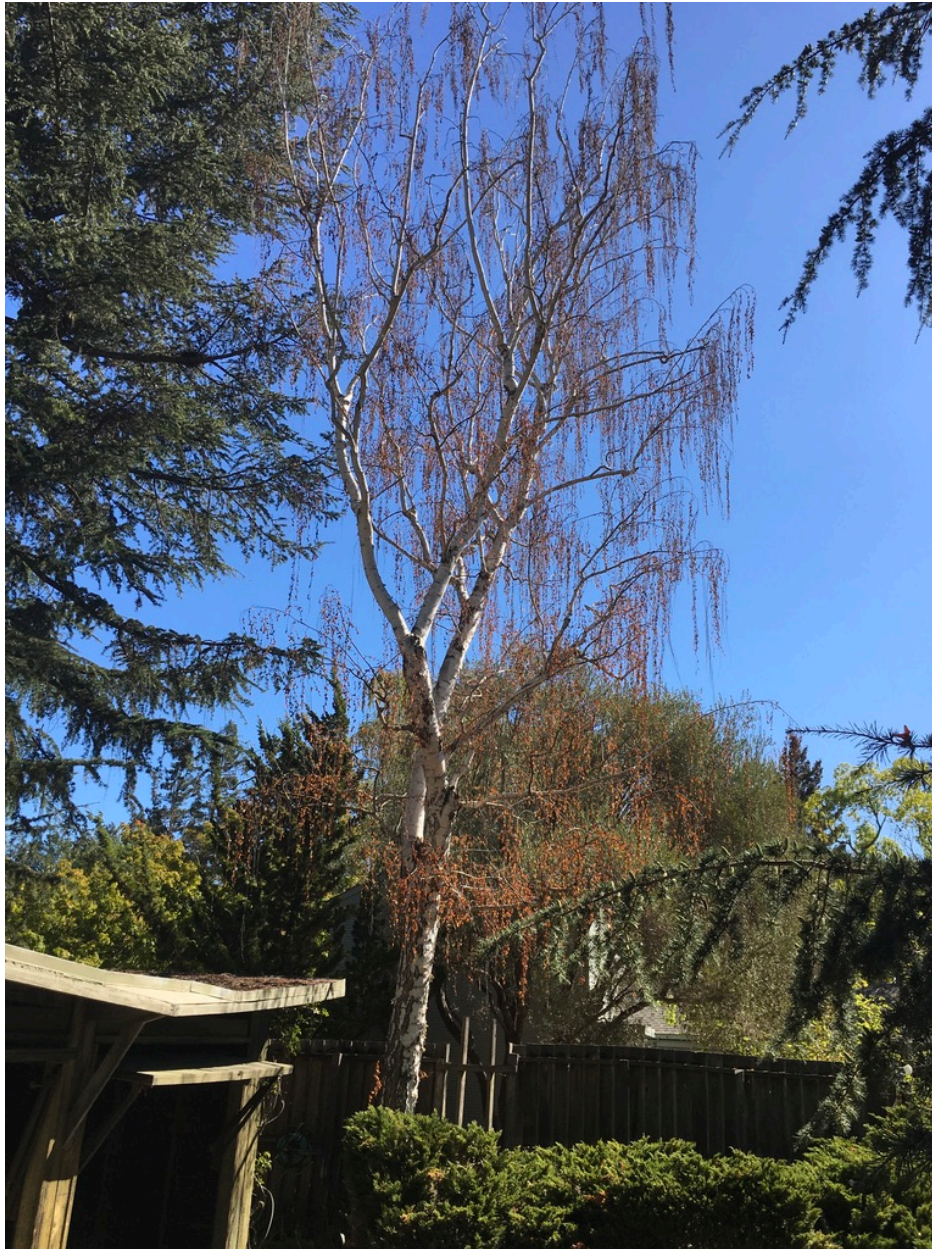
C3: Dead birch #13

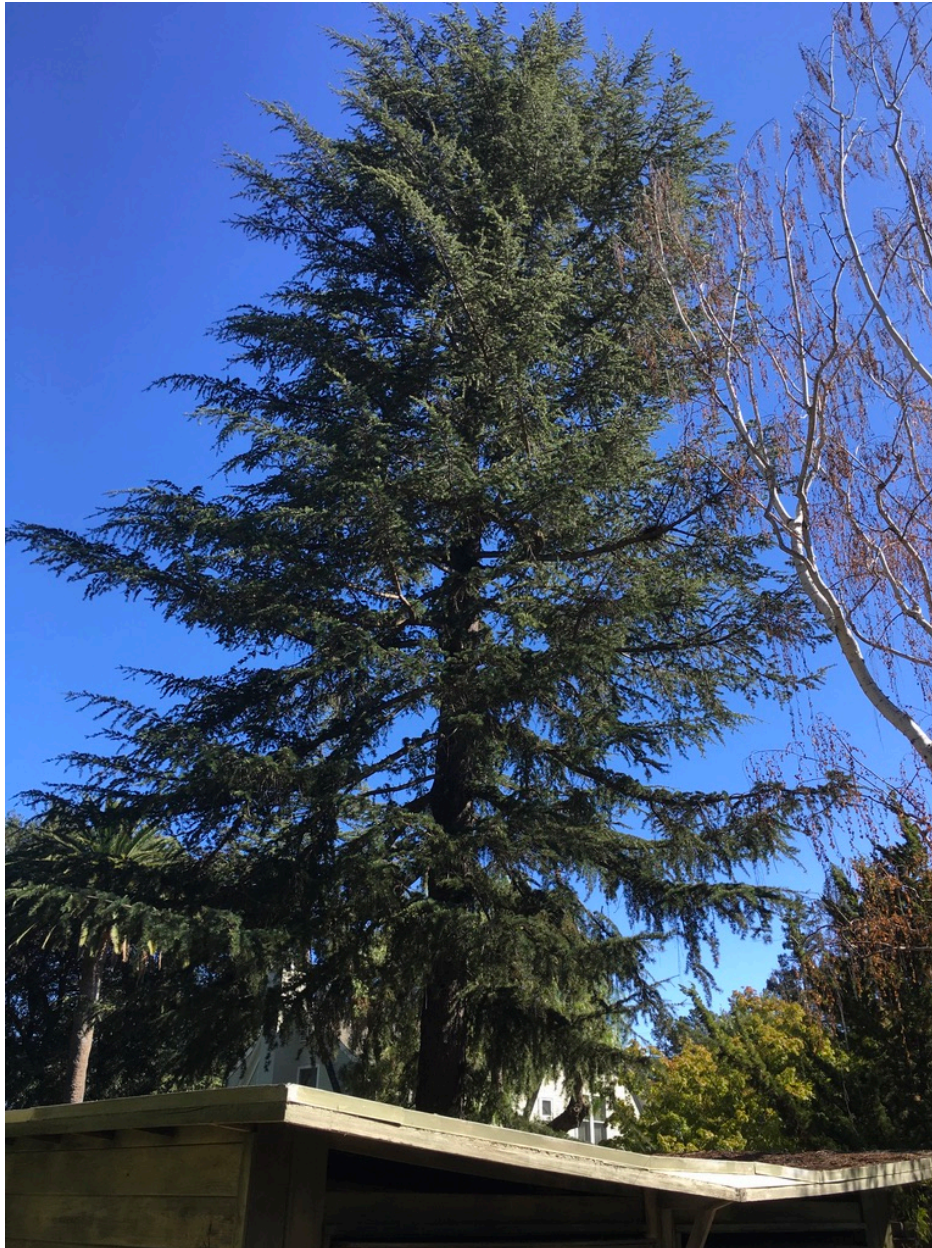
C4: Cedar requested for removal #12

The arborist report recommended the elimination of a deodar cedar tree (no. 12) due to being in poor condition. In reviewing the arborist report, staff found the deodar cedar tree was recommended for removal due to conflicting with proposed improvements. In reviewing the project plans, staff did not find the deodar cedar tree (no. 12) conflicted with proposed improvements due to being 26 feet from the new two-story house. Staff recommends condition no. 3b to preserve tree no. 12.

Nine trees to be removed are not large enough to qualify for protection under the ordinance. Of the remaining seven protected but requested for removal three are in poor, very poor, or dead condition. The most significant protected tree requested for removal is deodar cedar #12 which is located close to proposed improvements and the property boundary.

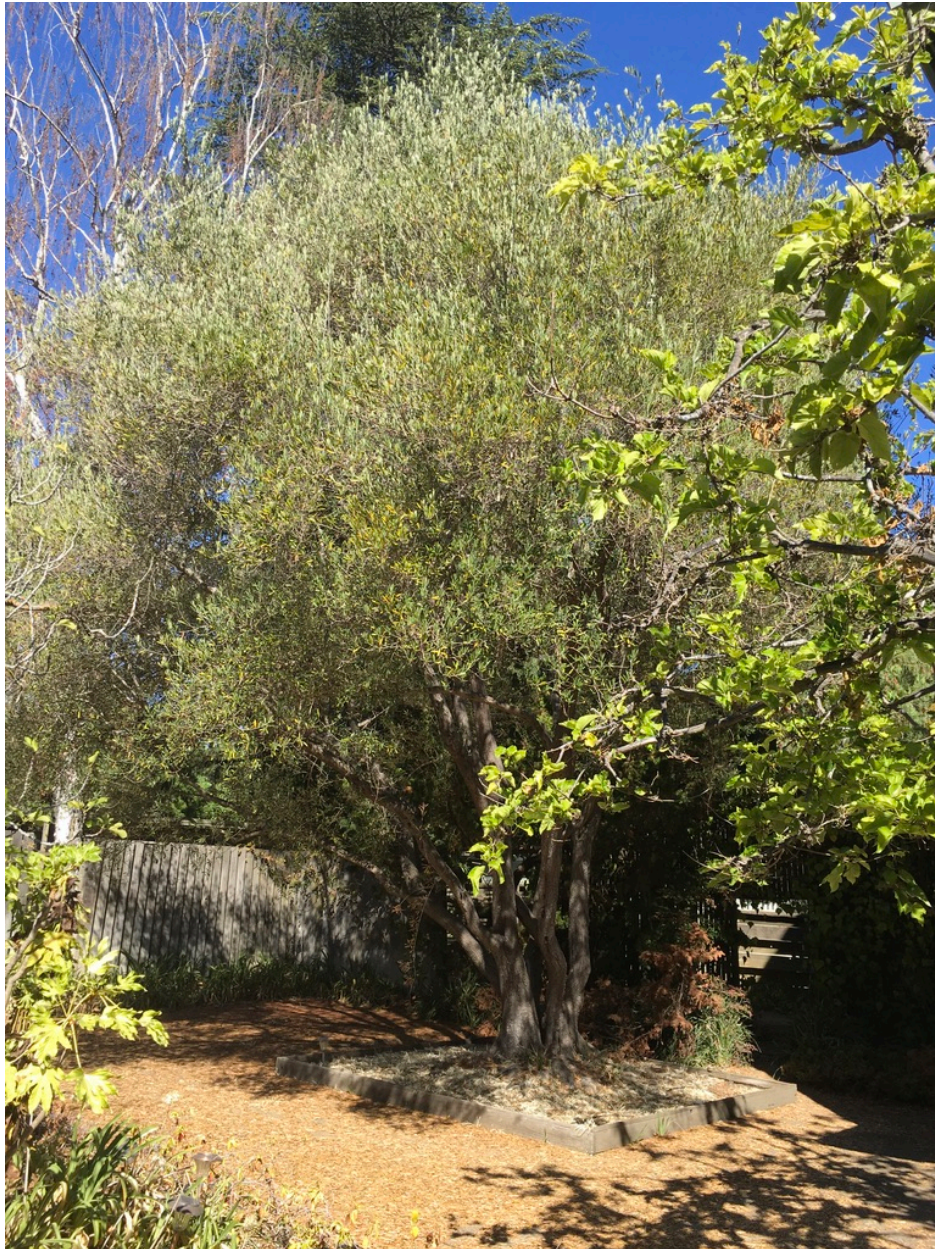
C5: Olive in the courtyard #21

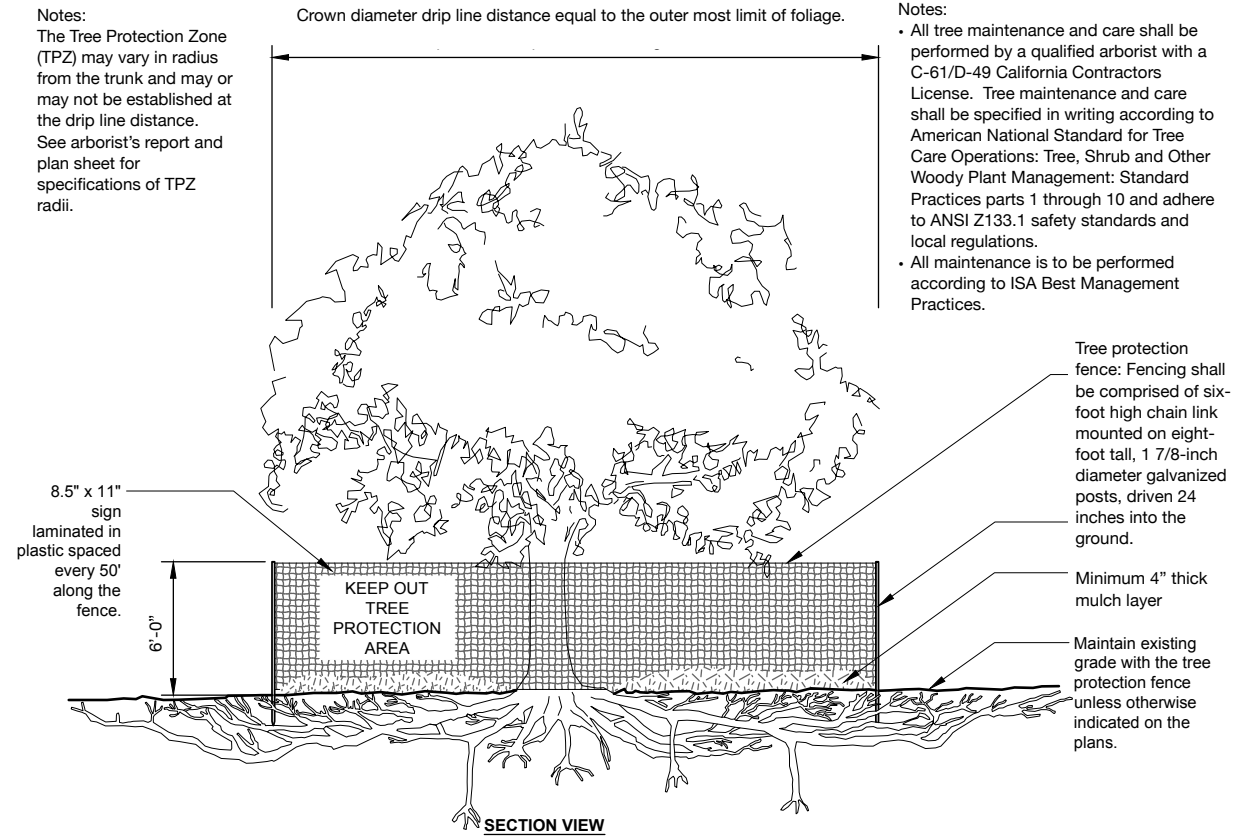
Plan Sheet Detail S-X

TREE PROTECTION

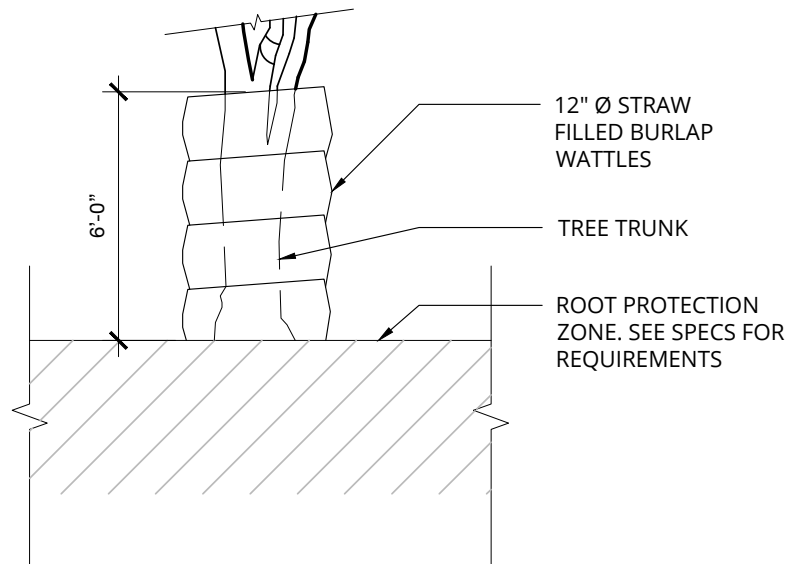
Plan Sheet Detail S-Y

SECTION VIEW
