**Tier 1 Report of**

**Facility Condition Assessment**

**For  
City of Los Altos  
Black Gymnasium  
1120 Covington Road  
Los Altos,  
California 94024-5005**

**Date of Report: October 14, 2016**

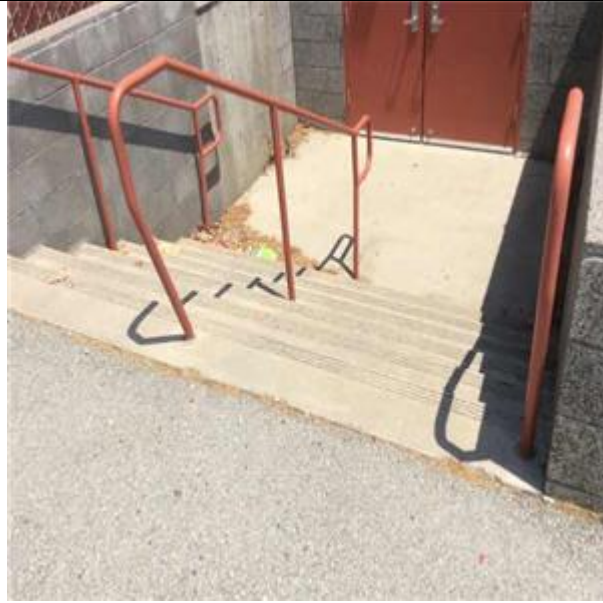
The stairs were observed to be in good condition and no actions are anticipated during the study period.

B1015 Exterior Stairs and Fire Escapes:- View of Exterior Stair(s) - Concrete Construction

ID	Type	Recommendation	Priority	Year	Expenditures
153823	B1010	ADA Modifications to Exterior Stairs	Priority 1	2016	\$100
153824	B1010	ADA Modifications to Ramp	Priority 1	2016	\$20,000

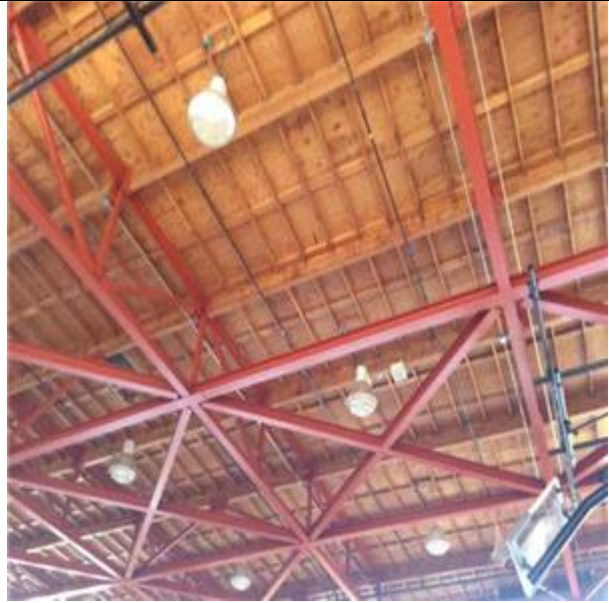
The roof structure assembly was observed to be in good condition and no actions are anticipated within the study period.

B1021 Flat Roof Construction:- View of Roof Construction - Structural Steel Beams and Joist with Timber Roof Deck

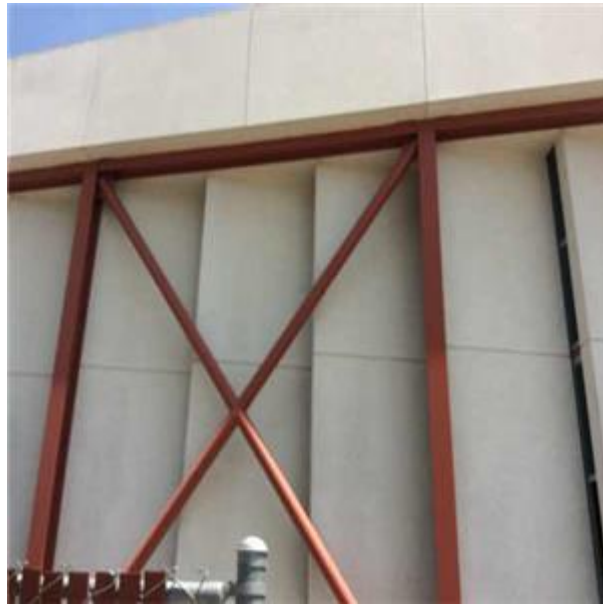
The structural steel frame was observed to be in good condition and no actions are anticipated within the study period.

B1031 Steel Frame Structure:- View of Structural Steel Columns and Beams Frame

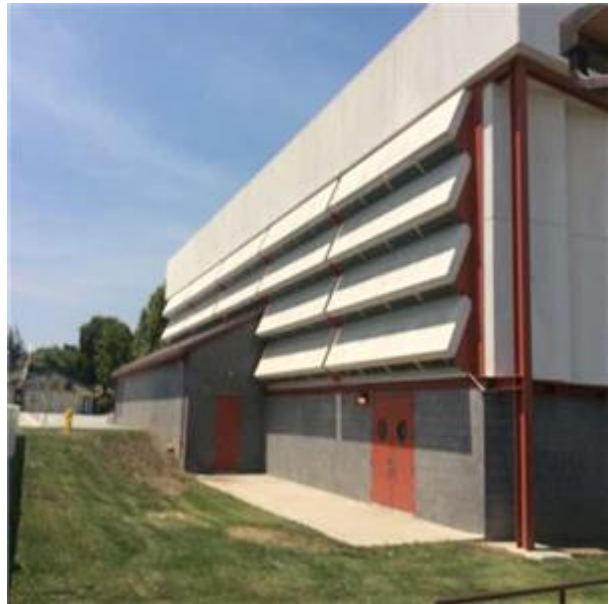
The EIFS was observed to be in good condition and no actions are anticipated during the study period.

B2011 Exterior Wall Construction:- View of EIFS (Synthetic Stucco) Wall Panels - Standard

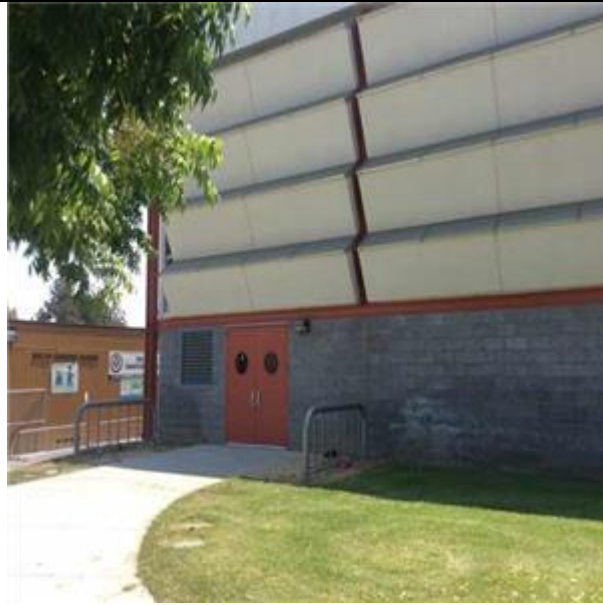
The CMUs were observed to be in good condition and no actions are anticipated during the study period.

B2011 Exterior Wall Construction:- View of Exposed CMU Walls

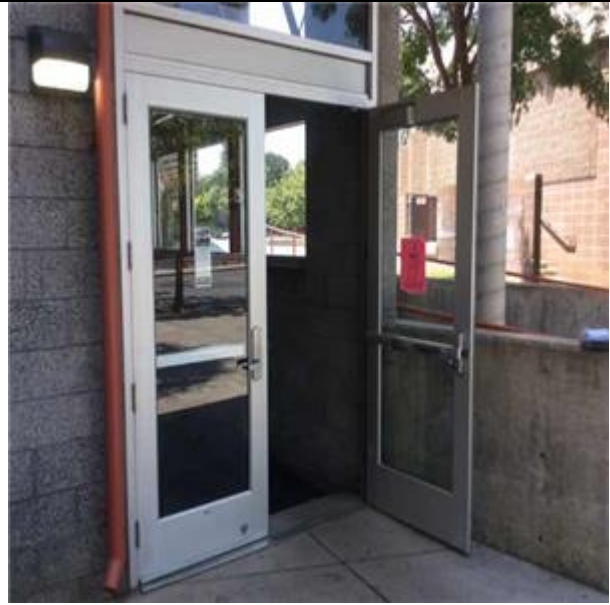
The double aluminum door was observed to be in fair to good condition and no actions are anticipated during the study period.

B2031 Glazed Doors & Entrances:- View of Double Aluminum Glazed Doors

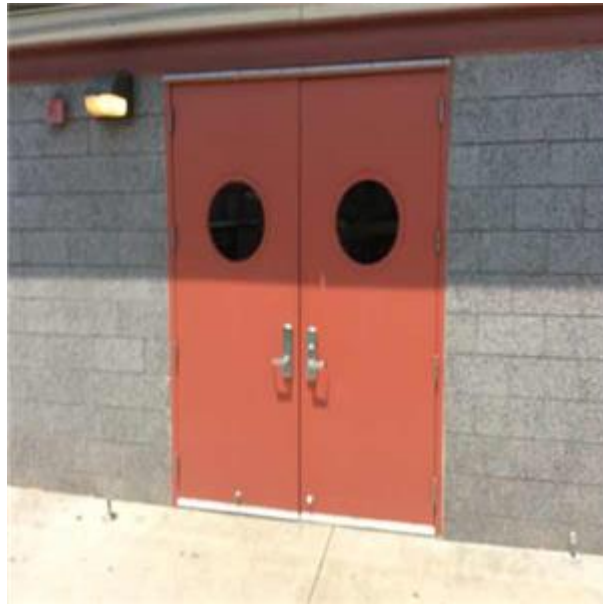
The exterior hollow metal doors were observed to be in good condition and no actions are anticipated aside from painting as part of routine maintenance.

B2039 Other Doors & Entrances:- View of Double HM Doors

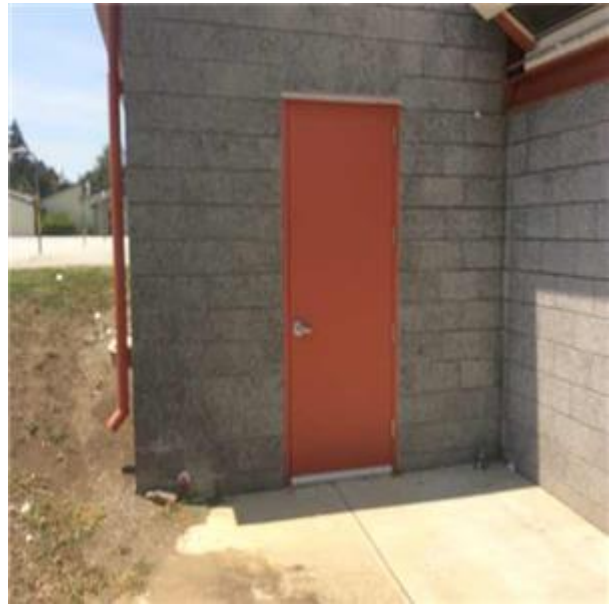
The single hollow metal door was observed to be in good condition and no actions are anticipated within the study period aside from painting as part of routine maintenance.

B2039 Other Doors & Entrances:- View of Single HM Doors

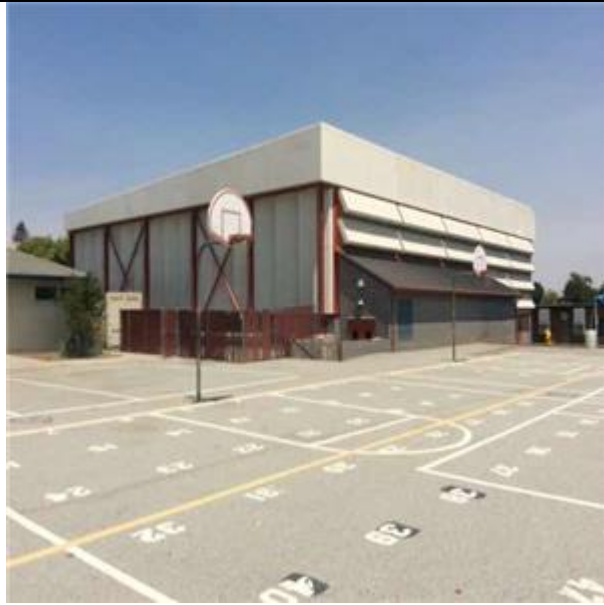
The standing seam metal roof was observed to be in good condition and no actions are anticipated within the study period.

B3011 Roof Finishes:- View of Standing Seam Metal Roof Panels

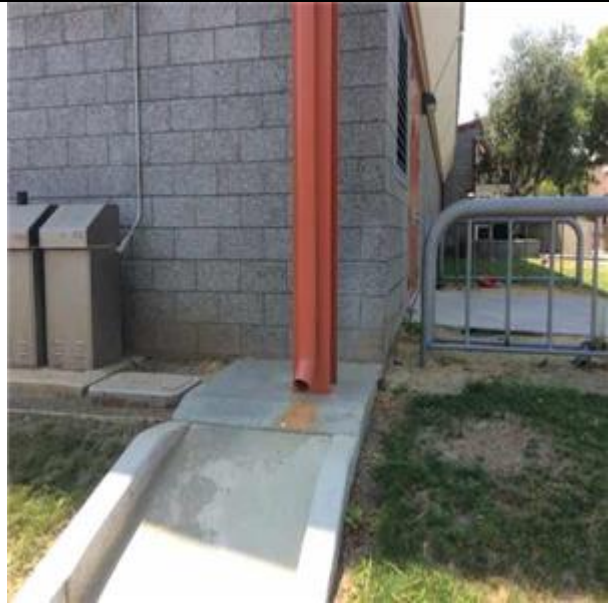
The downspouts were observed to be in good condition and no actions are anticipated during the study period.

B3016 Gutters and Downspouts:- View of Galvanized Steel Perimeter Gutters & Downspout

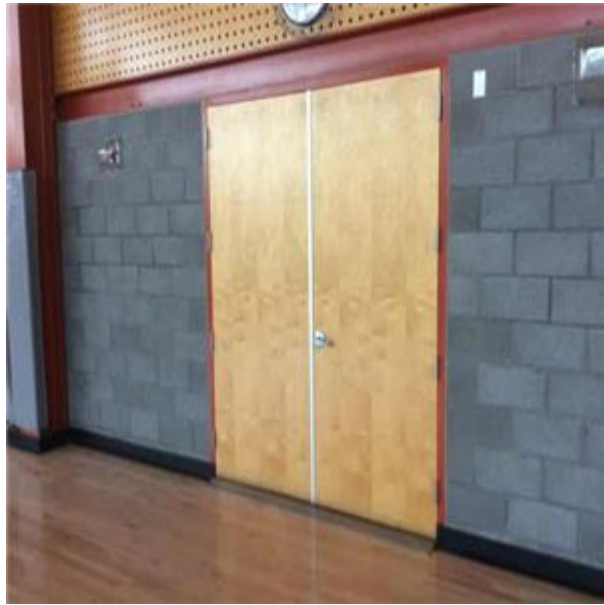
The double wood door was observed to be in fair to good condition with no signs of significant damage or deterioration and no actions are anticipated within the study period aside from painting as part of routine maintenance.

C1021 Interior Doors:- View of Interior Double Wood Door(s)

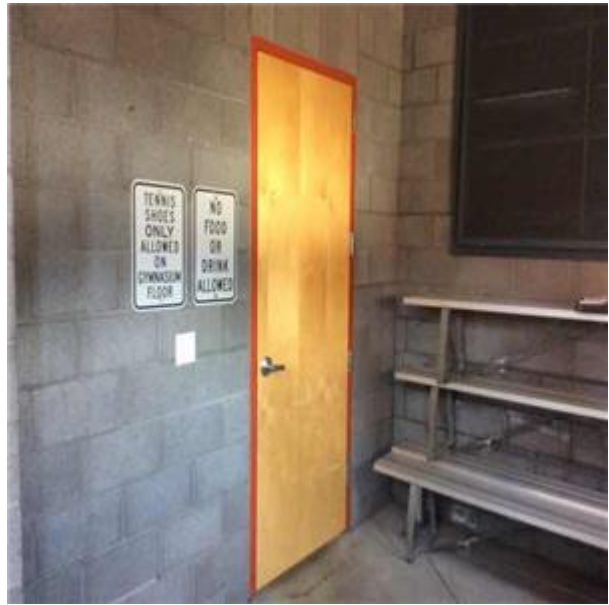
The wood door was observed to be in fair to good condition with no signs of significant damage or deterioration and no actions are anticipated within the study period aside from painting as part of routine maintenance.

C1021 Interior Doors:- View of Interior Single Door Door(s)

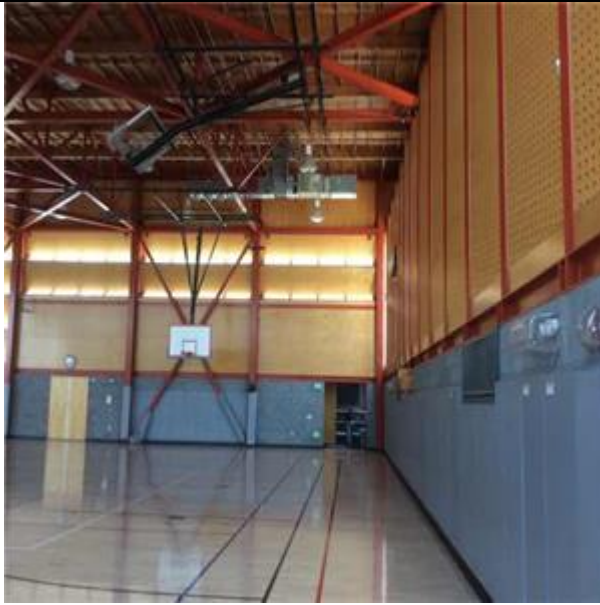
The flooring was observed to be in good condition and no actions are anticipated during the study period.

C3024 Flooring:- View of Wood Flooring – Premium

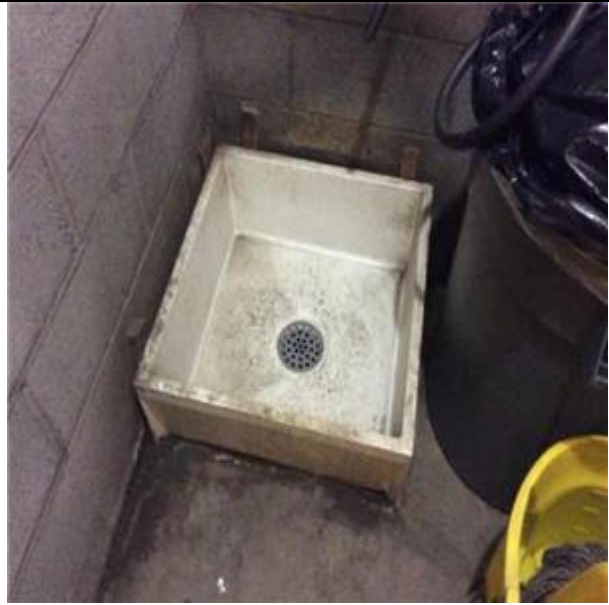
The service sink was observed to be in good condition with no serious deficiencies noted. We anticipate that the faucet may fail during the study period and may need to be rebuilt or replaced. This work has not been included in this study as we anticipate it will be carried out on an as-needed basis as part of routine maintenance

D2014 Sinks:- View of Service Sink Floor Mounted

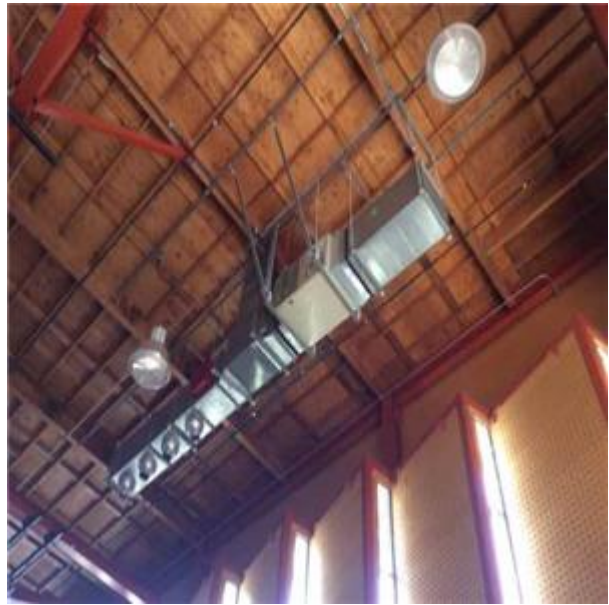
The furnaces were not accessible at the time of the survey but based on age are expected to be in good condition and no actions are anticipated.

D3021 Boilers:- View of Furnace – Gas

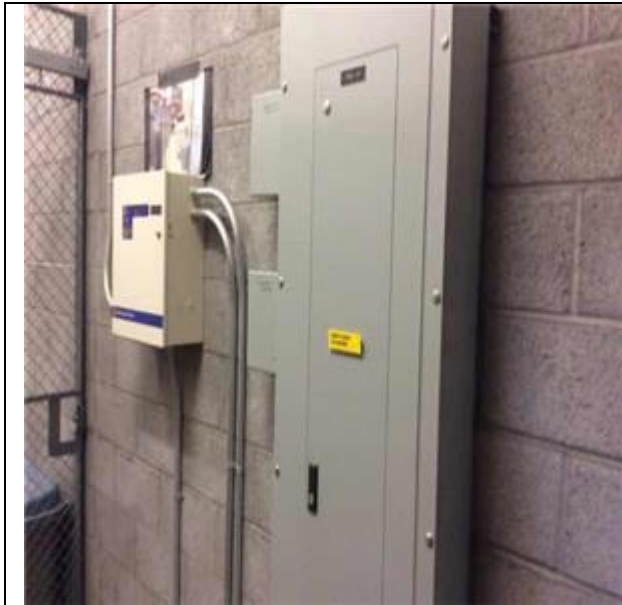
The distribution panelboard was observed to be in good condition with no actions anticipated within the study period.

D5012 Low Tension Service & Dist:- View of Panelboard -  
120/240volts, 60 to 2000amp

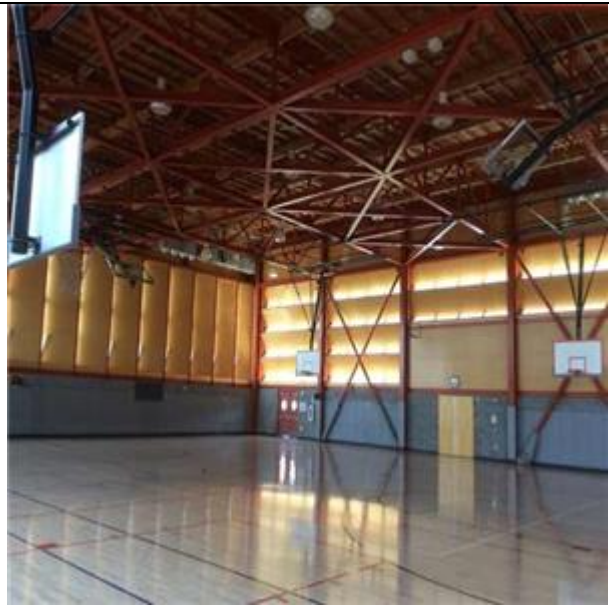
The light fixtures were observed to be in good condition and no actions are anticipated within the study period.

D5022 Lighting Equipment:- View of H.I.D High Bay Fixture(s)
