**Tier 1 Report of
Facility Condition Assessment**

**For
City of Los Altos
Caretaker House
482 University Ave
Los Altos,
California 94022-3518**

Date of Report: October 11, 2016

Faithful+Gould, Inc.

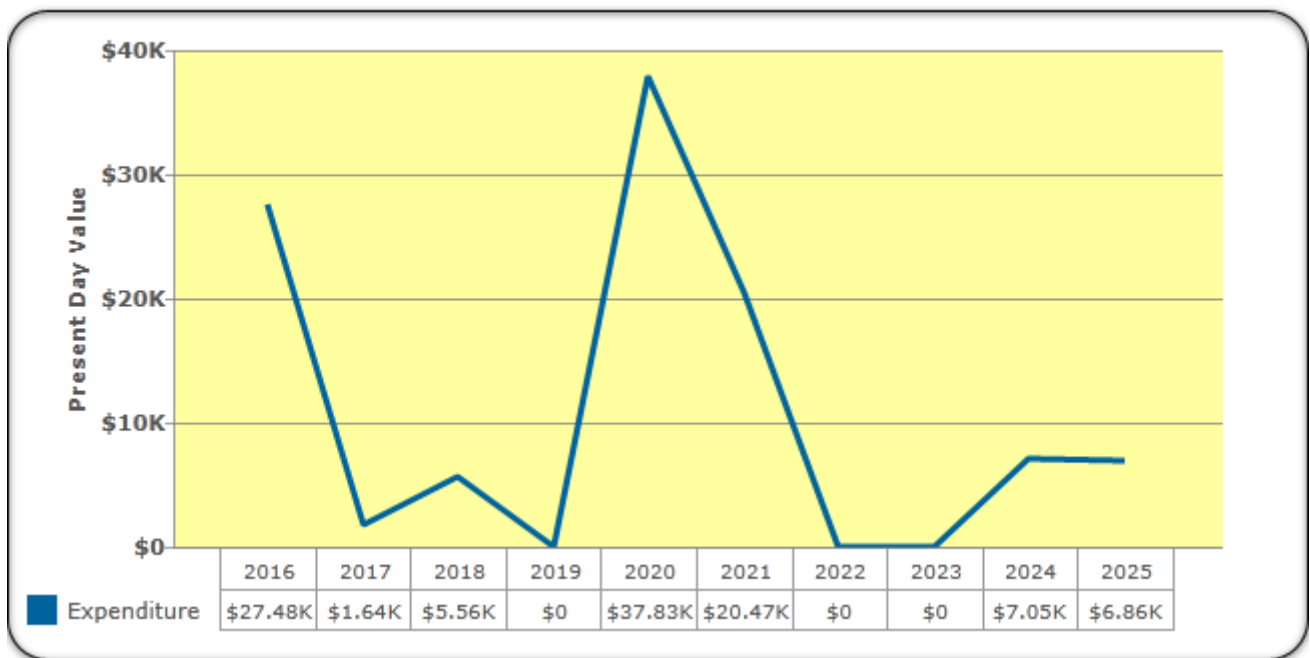
Expenditure Forecast Over Study Period

The building expenditure summary section provides an executive overview of the findings from the assessment. The chart below provides a summary of yearly anticipated expenditures over the study period for the Caretaker House building. In addition, we have scheduled key findings highlighting items greater than \$5,000 and their anticipated failure year. Further details of these expenditures are included within each respective report section and within the expenditure forecast, in Appendix A of this report. The results illustrate a total anticipated expenditure over the study period of approximately \$106,887.

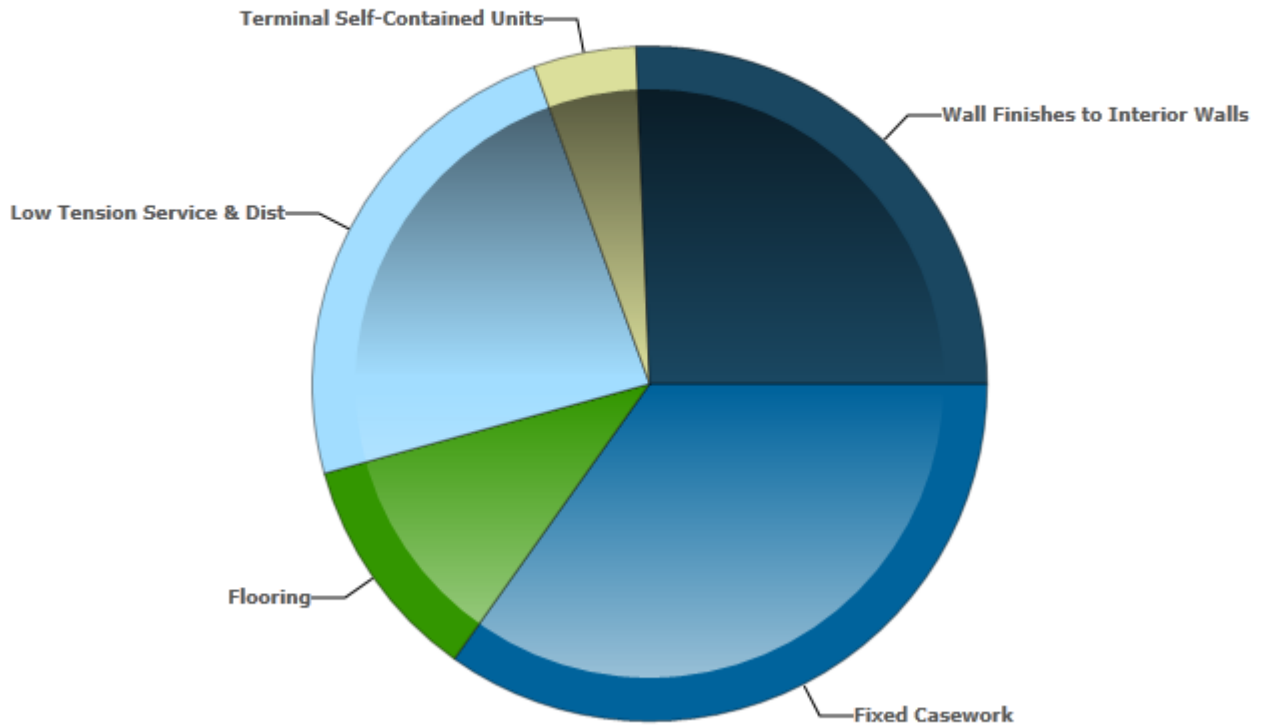
Distribution of Immediate Needs by Building System

Building System	Estimated Cost	Percentage of Total Cost
Fixed Casework	\$9,570	34.8%
Flooring	\$2,993	10.9%
Low Tension Service & Dist	\$6,519	23.7%
Terminal Self-Contained Units	\$1,350	4.9%
Wall Finishes to Interior Walls	\$7,047	25.6%
Total	\$27,479	100%

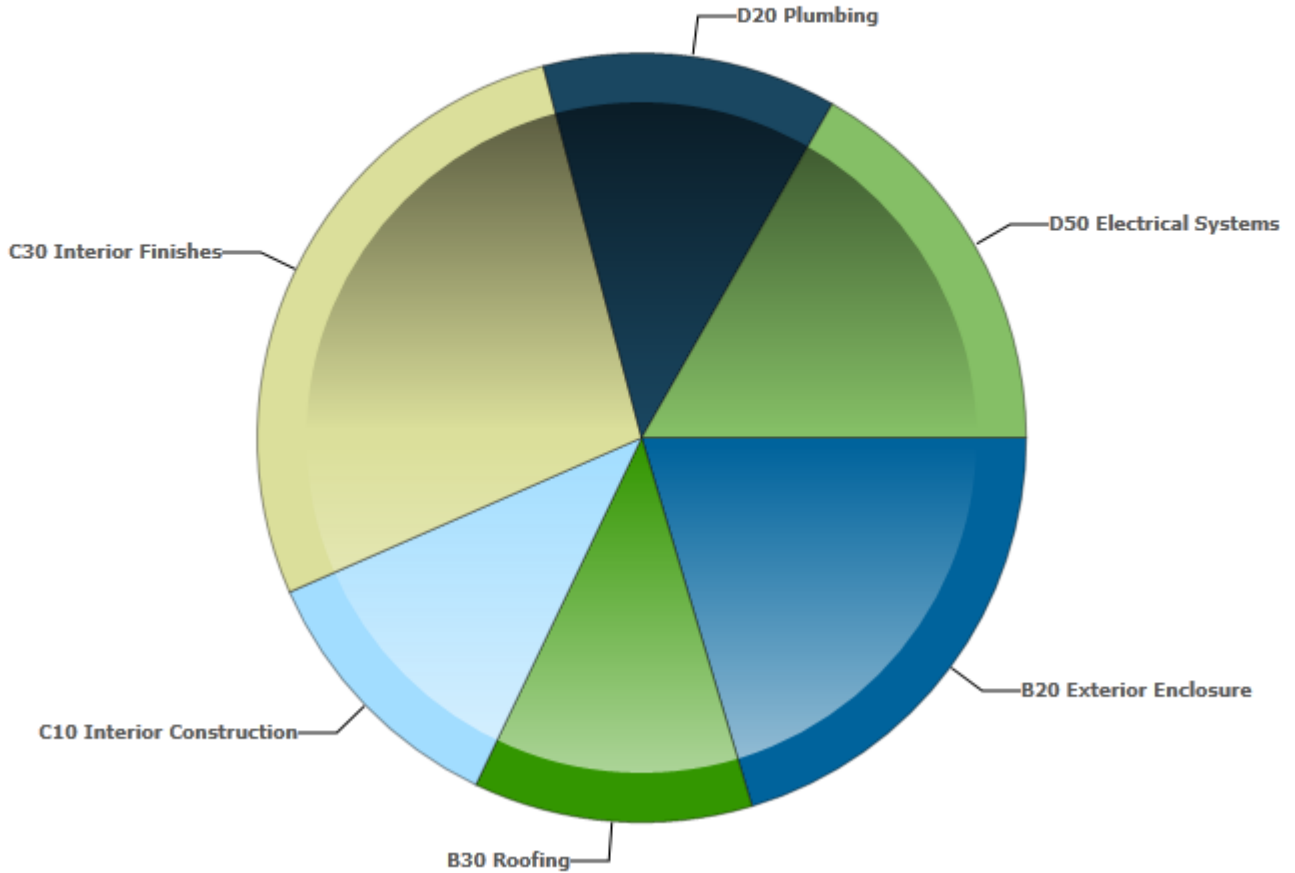
Distribution of Capital Needs by Building System

Building System	Estimated Cost	Percentage of Total Cost
B20 Exterior Enclosure	\$16,172	20.4%
B30 Roofing	\$9,316	11.7%
C10 Interior Construction	\$8,997	11.3%
C30 Interior Finishes	\$21,798	27.5%
D20 Plumbing	\$9,828	12.4%
D50 Electrical Systems	\$13,296	16.7%
Total	\$79,408	100%

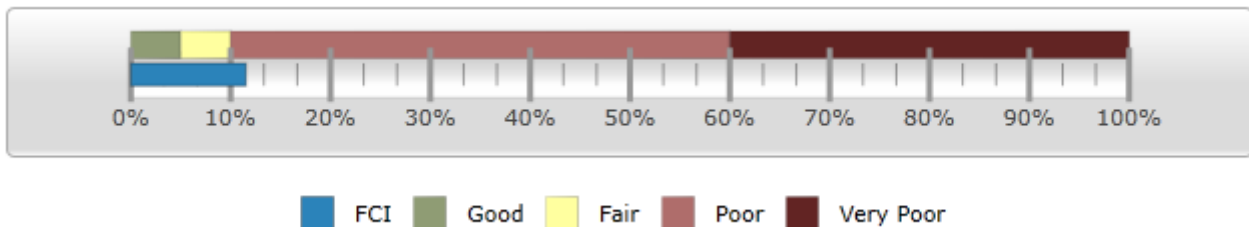
The chart below indicates the current FCNI ratio of the Caretaker House building.

Caretaker House, FCNI: 11.54%

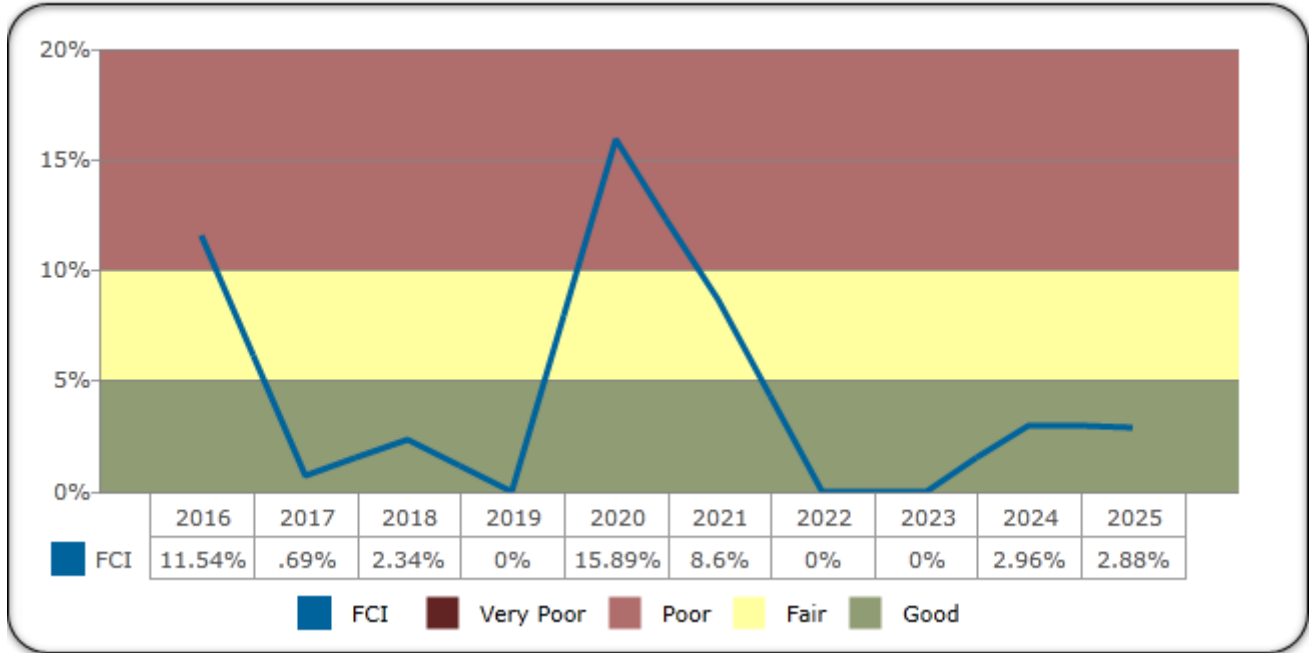
Year by Year Effects of FCI Over the Study Period

The chart below indicates the effects of the FCNI ratio per year, assuming the required funds and expenditures **ARE** made to address the identified actions each year.

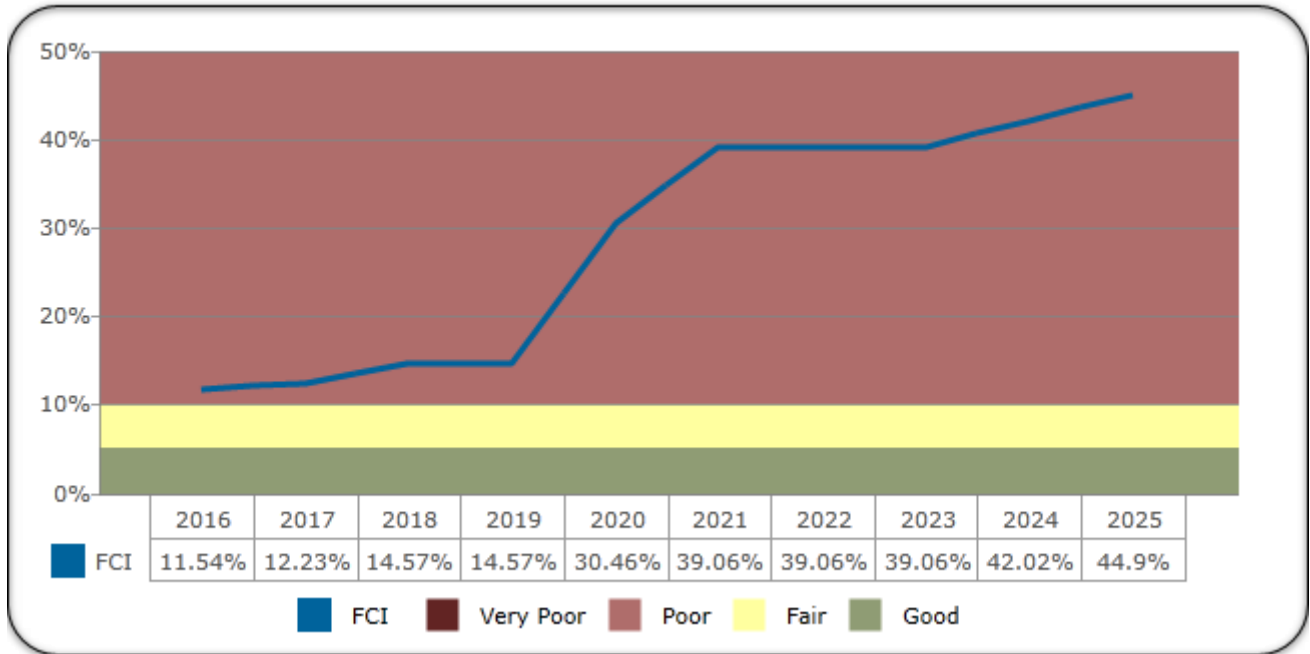
Cumulative Effects of FCI over the Study Period

The Chart below indicates the cumulative effects of the FCNI ratio over the study period assuming the required funds and expenditures are **NOT** provided to address the identified works and deferred maintenance each year.

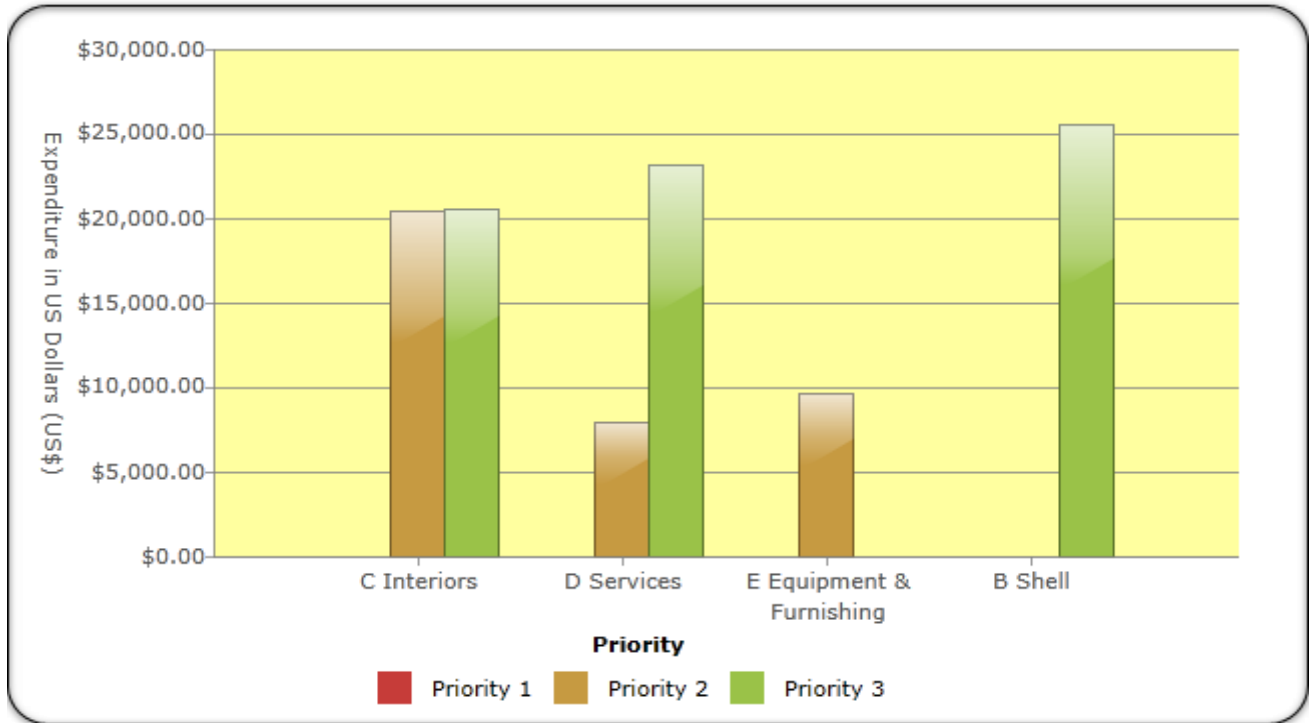
Planning Horizon Needs by System and Priority

The chart below illustrates the breakdown of expenditure according the priority coding providing an opportunity to strategically plan and effectively direct funding to the highest priority.

Building System	Priority 1	Priority 2	Priority 3	Total
B Shell	\$0	\$0	\$25,488	\$25,488
C Interiors	\$0	\$20,363	\$20,473	\$40,836
D Services	\$0	\$7,869	\$23,125	\$30,993
E Equipment & Furnishing	\$0	\$9,570	\$0	\$9,570
Totals	\$0	\$37,801	\$69,085	\$106,887

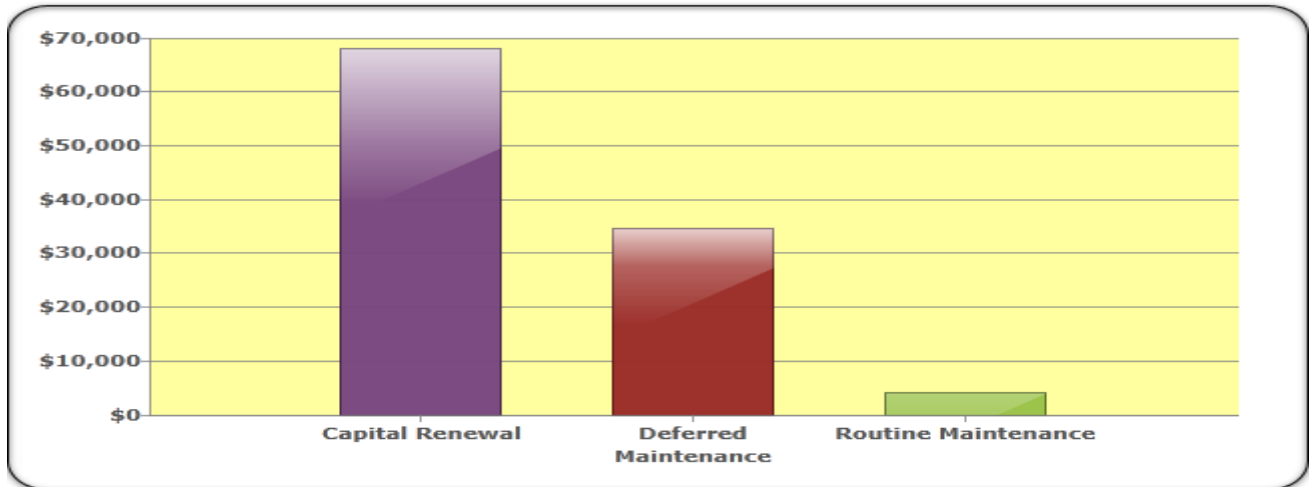
Planning Horizon Needs by Category

The chart below illustrates the breakdown of expenditure according to the Plan Type or deficiency categories providing an opportunity to strategically plan and effectively direct funding.

Building System	Total Cost
Deferred Maintenance	\$34,525
Capital Renewal	\$68,128
Routine Maintenance	\$4,233
Total	\$106,887

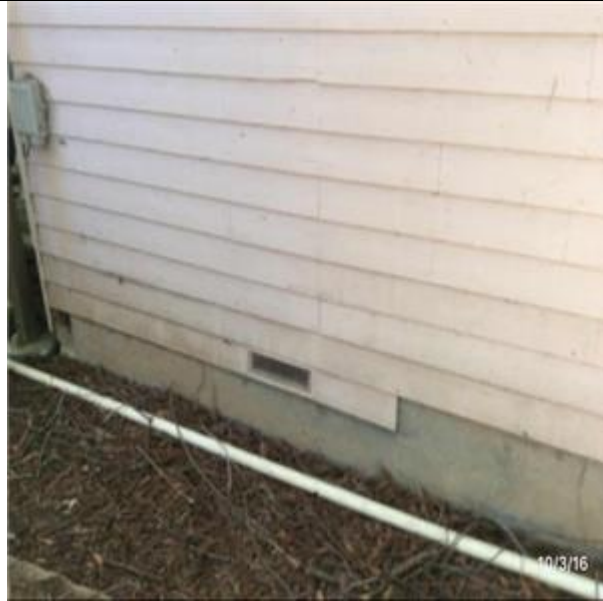
The exterior wall construction is supported by reinforced concrete spread footings around the perimeter of the foundation wall. The compressive strength of the concrete is unknown.

The concrete footings are partially visible due to their location at the exterior wall construction. There is no observed deterioration to the foundation wall constructions that they are supporting, therefore we assume both the footings and concrete foundation wall to be in fair to good condition and free from defects. We do not anticipate a requirement for replacement during the study period.

A1011 Wall Foundations:- View of Reinforced Concrete Strip Footing

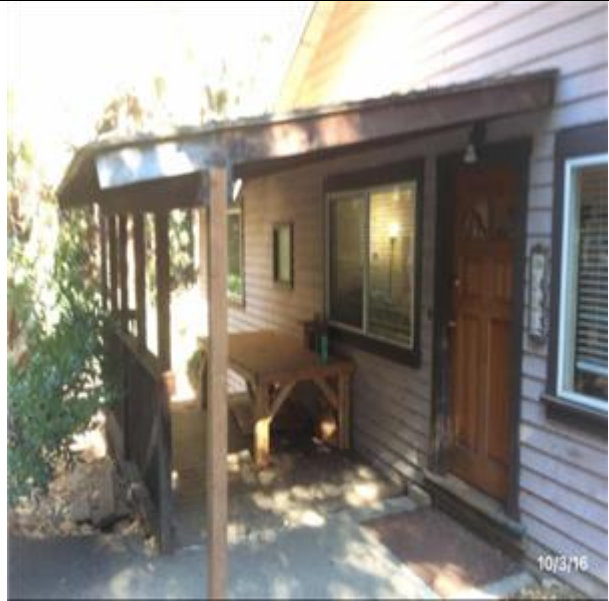
The canopy appeared in good condition. No signs of weathering were noted; therefore, no actions are anticipated during the study period outside of routine maintenance.

B1023 Canopies:- View of Canopies - Wood Joists Supporting Exterior Grade Plywood

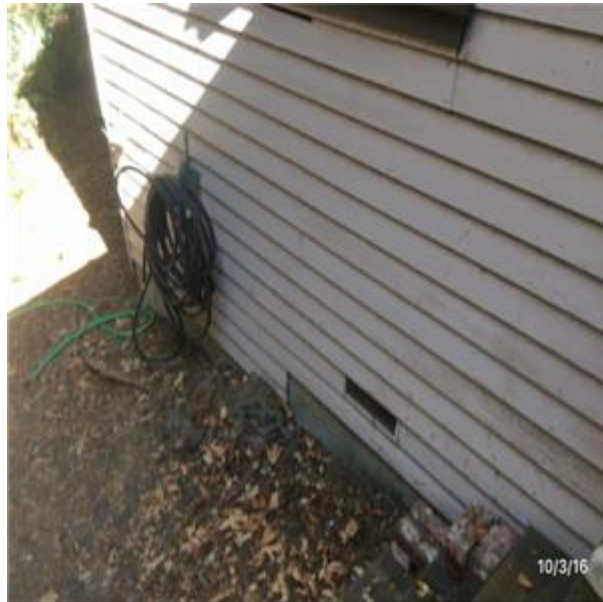
The exterior walls are constructed of stained vertical wood board and battens which are supported by wood studs.

The exterior wall construction was observed to be in fair condition. The wood siding has been regularly painted. We recommend repainting of the surface of the wood panels during the term in the study period to maintain the appearance of the building and also the wood itself.

B2011 Exterior Wall Construction:- View of Wood Clapperboard Siding

ID	Type	Recommendation	Priority	Year	Expenditures
153635	B2010	Repaint Exterior Wall Surfaces	Priority 3	2018	\$957
153636	B2020	Replace Wood Window Units - Casement, Double Hung, Vent or Sliding	Priority 3	2020	\$9,431
153637	B2030	Replace Exterior Single Wood Door	Priority 3	2020	\$5,784

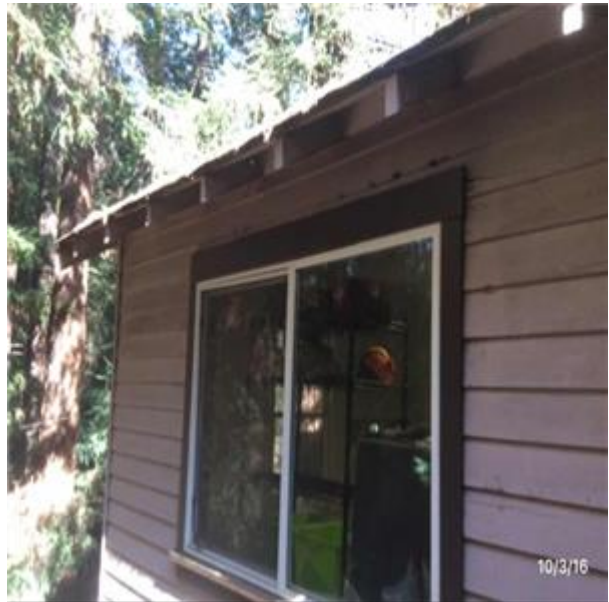
The steel windows were observed to be in fair condition and based on an EUL of thirty years for this type of window we do not anticipate replacement during the study period. The wood windows at the building, however, were observed to be in poor condition. We were not able to confirm their operation. We have assumed the windows to be original based on the current condition, which would put the windows well past their useful life. We recommend replacing the windows early in study period in order to maintain the appearance and security of the building as well as prevent water penetration.

B2021 Windows:- View of Steel Window Units - Casement, Double Hung, Vent or Sliding

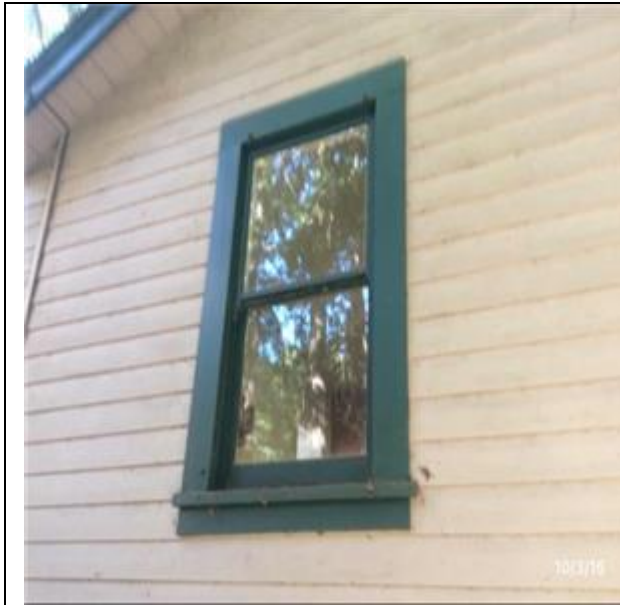
B2021 Windows:- View of Wood Window Units - Casement, Double Hung, Vent or Sliding

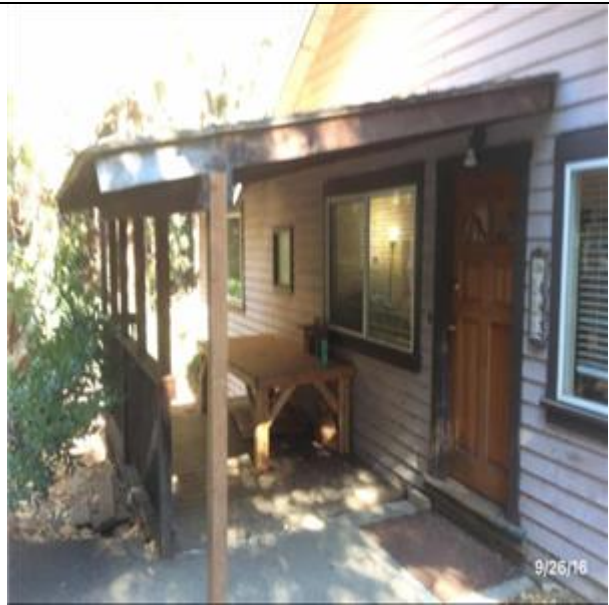
The building contained three single exterior wood doors with a painted stain finishes.

The doors appeared to be in a poor to fair condition with no major signs of damage or deterioration, however, based on a EUL of thirty years we anticipate replacement during the study period. The new door surface finish and door frames will require repainting later in the study period. The cost of this work has been included within the amount to undertake the repainting of the exterior walls.

B2039 Other Doors & Entrances:- View of Exterior Single Wood Door

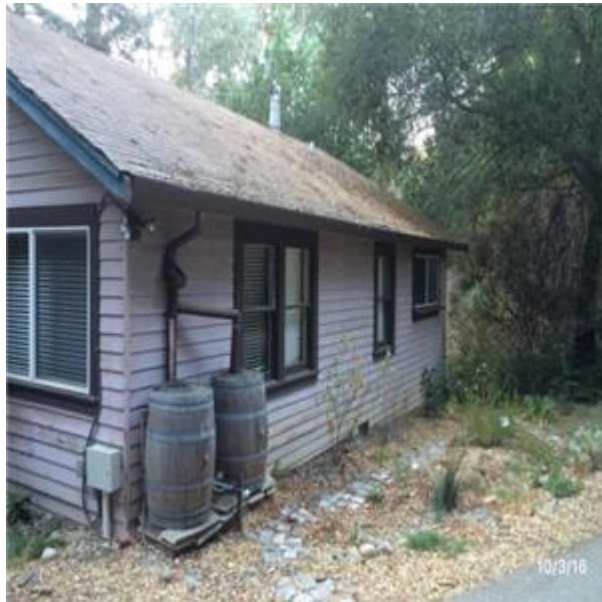
The asphalt shingle covering appeared to be in fair condition, with no roof leaks reported. We are unaware of when the roof was installed, we assume it to be more than twenty years of age. Due to the observed condition we have extended the RUL, however, we believe that the covering will need to be replaced in the study period in order to maintain the condition of the building. We anticipate the gutters and downspouts will not need replacing during the study period.

B3011 Roof Finishes:- View of Asphalt Shingle Roof

ID	Type	Recommendation	Priority	Year	Expenditures
153638	B3010	Replace Asphalt Shingle Roof	Priority 3	2020	\$9,316

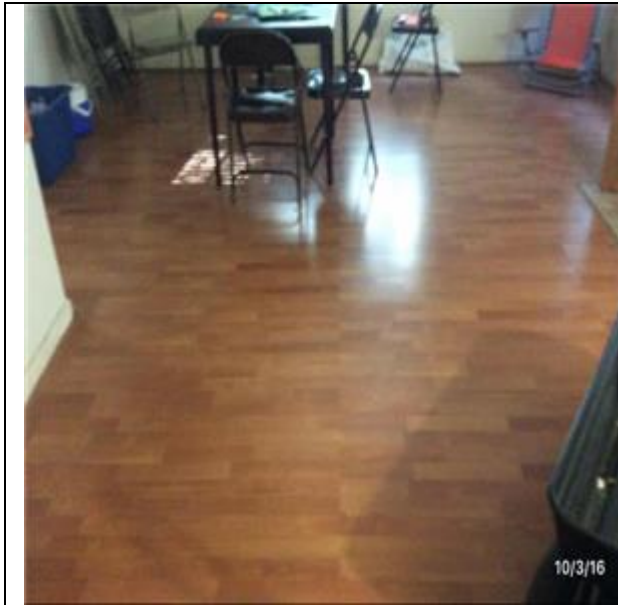
The floor finishes appeared in poor condition throughout the building. We are unaware of the age of the laminate wood floor, however we assume it to be more than fifteen years of age, therefore based on the typical EUL of twenty years for this type of covering and current observed condition, we anticipate replacement early in the study period. The vinyl sheet at the restroom is well past its useful life. We recommend replacement in the study period.

C3024 Flooring:- View of Laminate Wood Floors

ID	Type	Recommendation	Priority	Year	Expenditures
153640	C3010	Replace Painted Finish - Standard	Priority 2	2016	\$7,047
153641	C3010	Replace Painted Finish - Standard	Priority 2	2024	\$7,047
153642	C3020	Replace Vinyl Sheet	Priority 2	2016	\$2,993
153643	C3020	Replace Laminate Wood Floors	Priority 3	2021	\$11,476
153644	C3030	Repaint Wood Ceiling	Priority 2	2017	\$1,638
153645	C3030	Repaint Wood Ceiling	Priority 2	2025	\$1,638

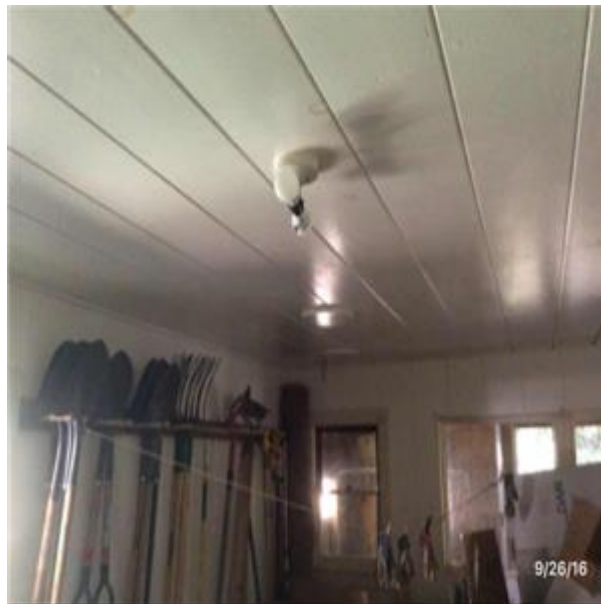
The interior wood ceilings were observed to be in fair condition. We anticipate the repainting of the interior surfaces early in the study period to maintain appearances, at the same time as the interior wall finishes.

C3031 Ceiling Finishes:- View of Wood Ceiling Painted

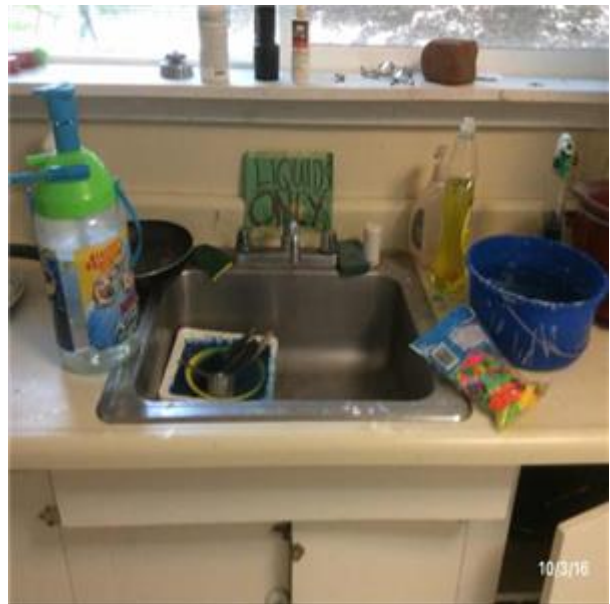
The building contained a single bowl kitchen sink in hall kitchen. The stainless steel sink had metal non-metering dual handle (lever) faucet.

The counter top stainless sink was observed to be in fair condition. The sink drained properly and appeared not to have any damage in the stainless steel finish; however, it is assumed to be installed in 1990 and based on a typical EUL of twenty years we recommend that it is considered for replacement during the study period.

We anticipate that the faucet may fail during the study period and therefore to maintain function they may need to be replaced. This work has not been included in this study as we anticipate it will be carried out on an as-needed basis as part of routine maintenance.

D2014 Sinks:- View of Countertop Single Bowl Kitchen Sink

ID	Type	Recommendation	Priority	Year	Expenditures
153646	D2010	Replace Countertop Single Bowl Kitchen Sink	Priority 3	2018	\$1,453
153647	D2010	Replace Wall Hung Lavatories	Priority 3	2025	\$2,643
153648	D2010	Replace Floor Mounted Water Closets	Priority 3	2025	\$2,583
153649	D2020	Replace Domestic Hot Water Heater - Gas	Priority 3	2018	\$3,149

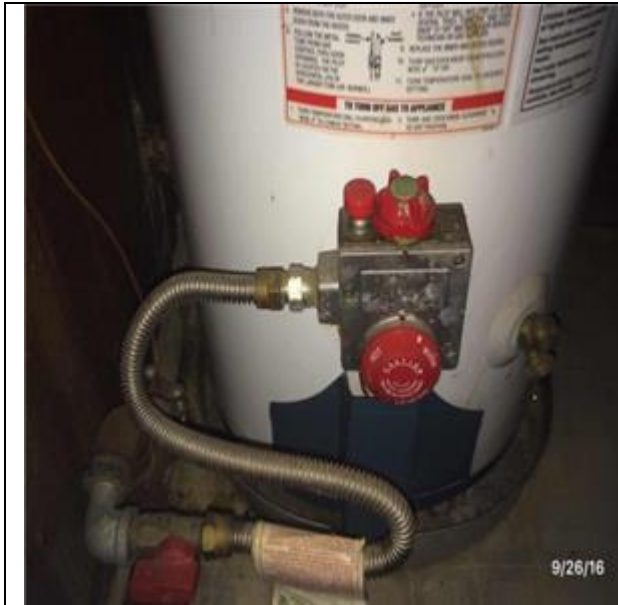
The domestic water heater appeared in fair condition and functioned without issue. The EUL for this equipment is fifteen years which puts the RUL at the beginning of the study period; therefore, we anticipate replacement during the study period.

D2022 Hot Water Service:- View of Domestic Hot Water Heater - Gas

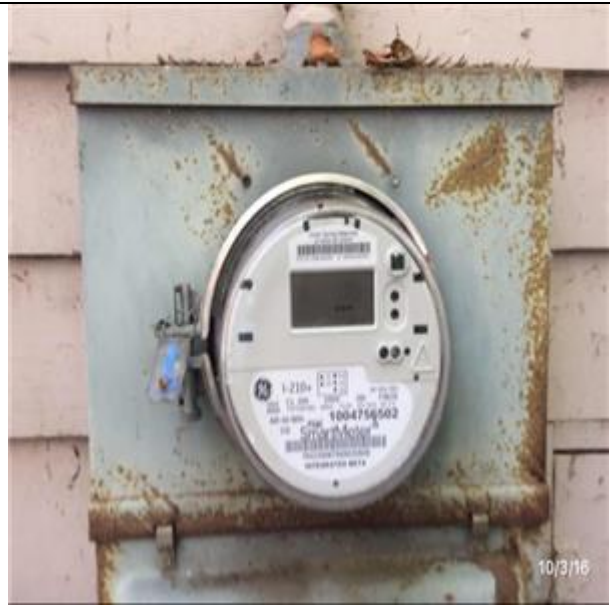
The panels appeared to be in fair condition due to their age. There were no signs of deterioration at the panels. The typical EUL for electrical switchboard such as this is thirty years; therefore replacement will be necessary during the study period. We do recommend further evaluation of the branch panels via an infrared electrical inspection which will highlight if high temperatures, excessive electrical resistance, failing components, ground faults and short circuiting issues exist.

D5012 Low Tension Service & Dist:- View of Panelboard - 120/240volts, 60 to 2000amp

ID	Type	Recommendation	Priority	Year	Expenditures
153651	D5010	Replace Panelboard - 120/240volts, 60 to 2000amp	Priority 2	2016	\$6,519
153652	D5020	Replace Fluorescent Light Fixtures	Priority 3	2020	\$2,809
153653	D5020	Replace Wiring Systems (Inc. Receptacles & Switches)	Priority 3	2020	\$10,487
