**Tier 1 Report of  
Facility Condition Assessment**

**For  
City of Los Altos  
Egan Gymnasium  
100 W Portola Ave  
Los Altos,  
California 94022-1210**

**Date of Report: October 12, 2016**

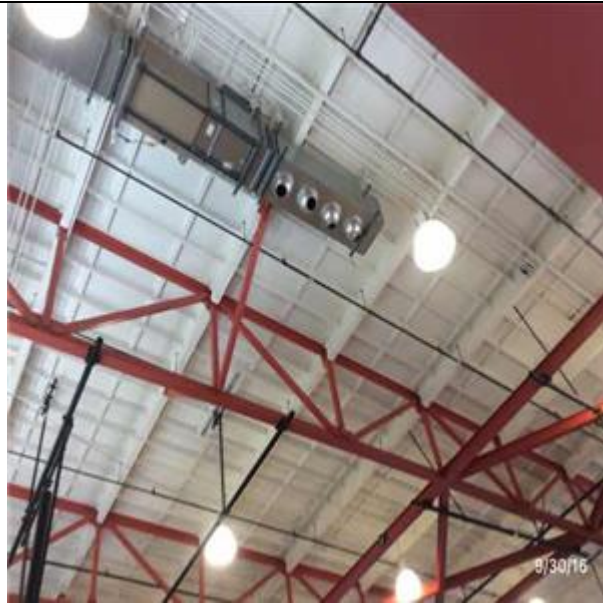
The roof structure assembly was observed to be in good condition and no actions are anticipated within the study period.

B1021 Flat Roof Construction:- View of Roof Construction - Structural Steel Beams and Joist with Timber Roof Deck

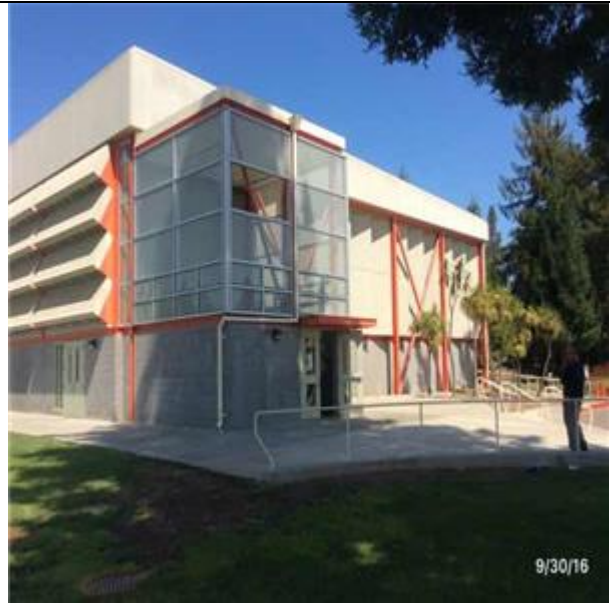
The structural steel frame was observed to be in good condition and no actions are anticipated within the study period.

B1031 Steel Frame Structure:- View of Structural Steel Columns and Beams Frame

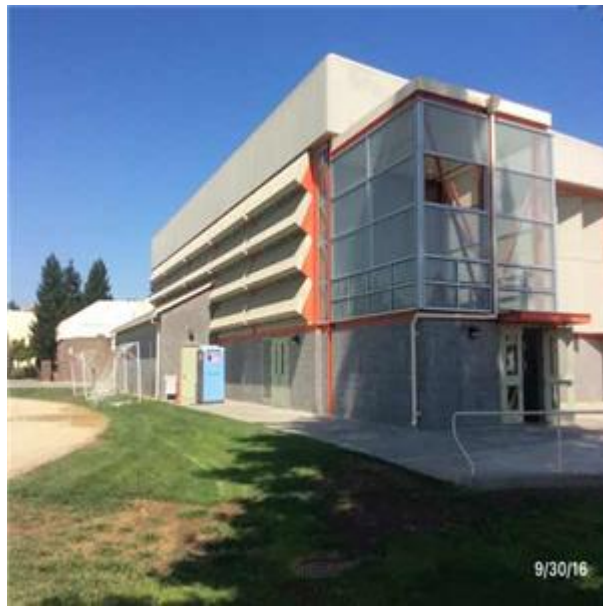
The EIFS was observed to be in good condition and no actions are anticipated during the study period.

B2011 Exterior Wall Construction:- View of EIFS (Synthetic Stucco) Wall Panels - Standard

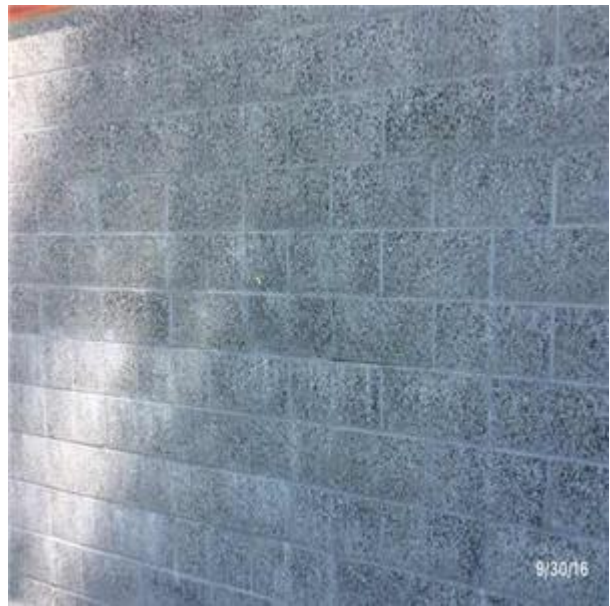
The CMUs were observed to be in good condition and no actions are anticipated during the study period.

B2011 Exterior Wall Construction:- View of Exposed CMU Walls

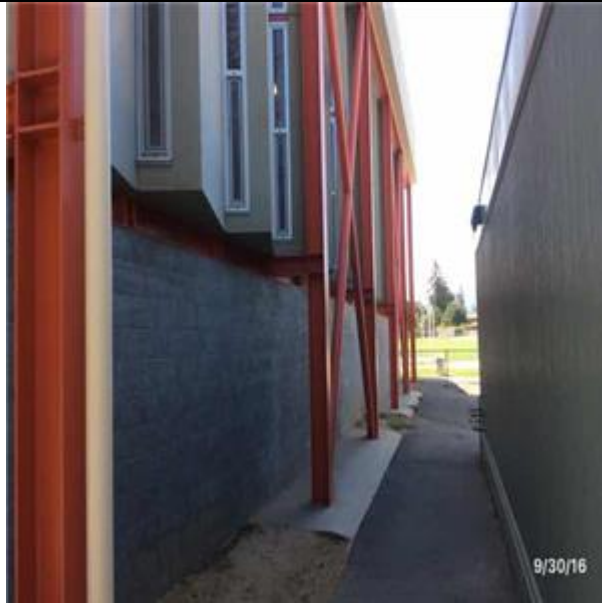
The aluminum windows were observed to be in good condition and no actions are anticipated within the study period.

B2021 Windows:- View of Aluminum Window Units - Fixed or Single Hung

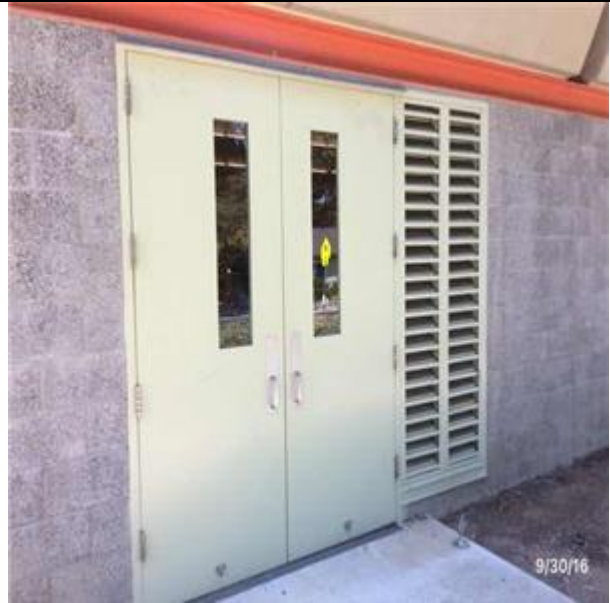
The double hollow metal door was observed to be in fair to good condition with no signs of significant damage or deterioration and no actions are anticipated within the study period aside from painting as part of routine maintenance.

B2039 Other Doors & Entrances:- View of Double HM Doors

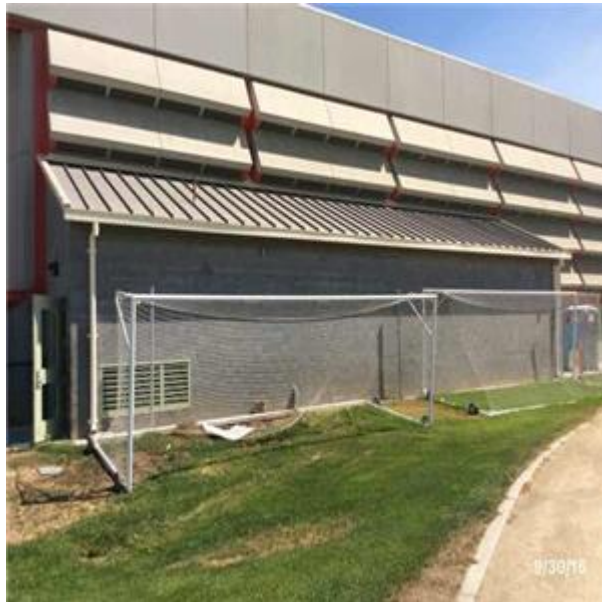
The standing seam metal roof was observed to be in good condition and no actions are anticipated within the study period.

B3011 Roof Finishes:- View of Standing Seam Metal Roof Panels

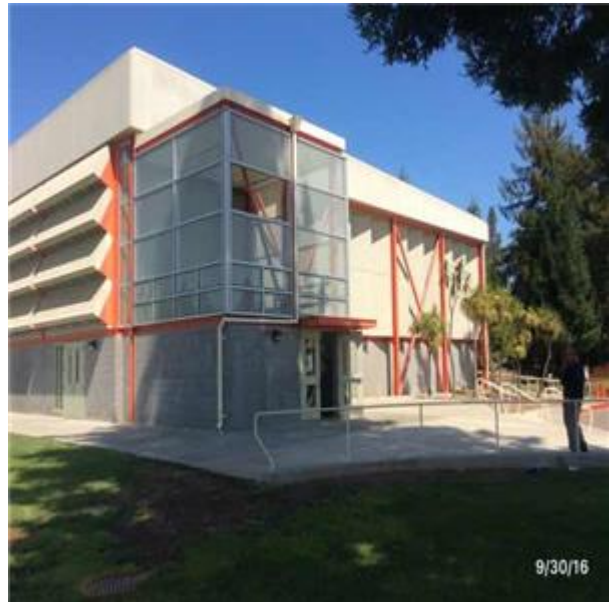
The downspouts were observed to be in good condition and no actions are anticipated during the study period.

B3016 Gutters and Downspouts:- View of Galvanized Steel Perimeter Gutters & Downspout

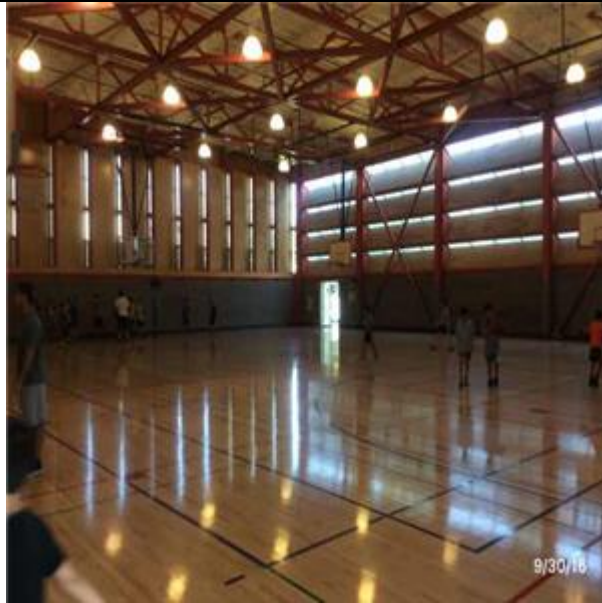
The flooring was observed to be in good condition and no actions are anticipated during the study period.

C3024 Flooring:- View of Wood Flooring – Premium

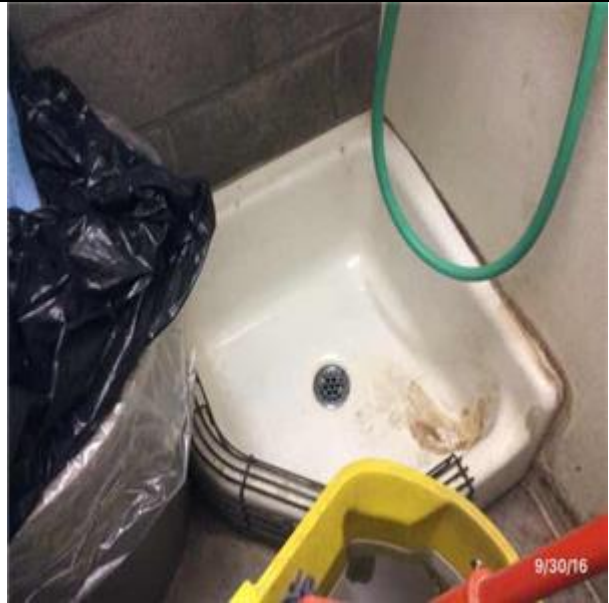
The service sink was observed to be in good condition with no serious deficiencies noted. We anticipate that the faucet may fail during the study period and may need to be rebuilt or replaced. This work has not been included in this study as we anticipate it will be carried out on an as-needed basis as part of routine maintenance

D2014 Sinks:- View of Service Sink Floor Mounted

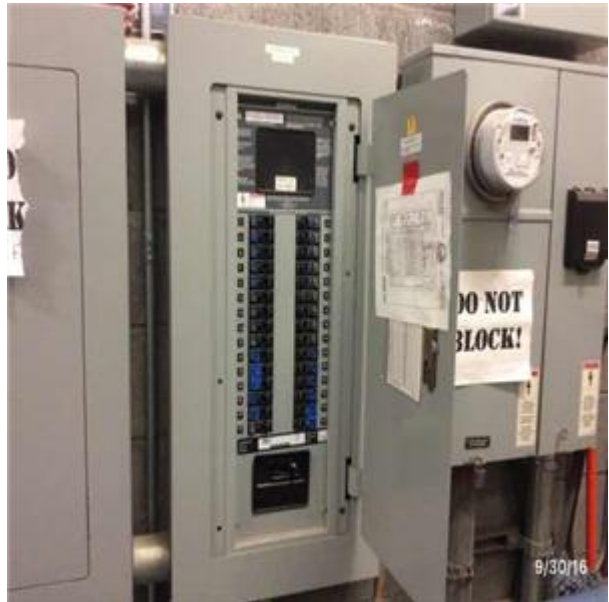
The distribution panelboards were observed to be in good condition with no actions anticipated within the study period.

D5012 Low Tension Service & Dist:- View of Panelboard -  
120/240volts, 60 to 2000amp

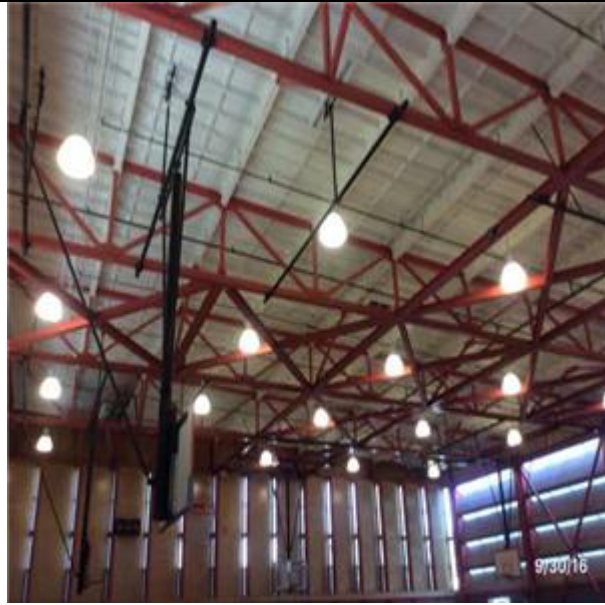
The light fixtures were observed to be in good condition and no actions are anticipated within the study period.

D5022 Lighting Equipment:- View of H.I.D High Bay Fixture(s)
