Tier 1 Report of
Facility Condition Assessment

For
City of Los Altos
Fire Station
10 Almond Ave
Los Altos,
California 94022-2201

Date of Report: October 03, 2016

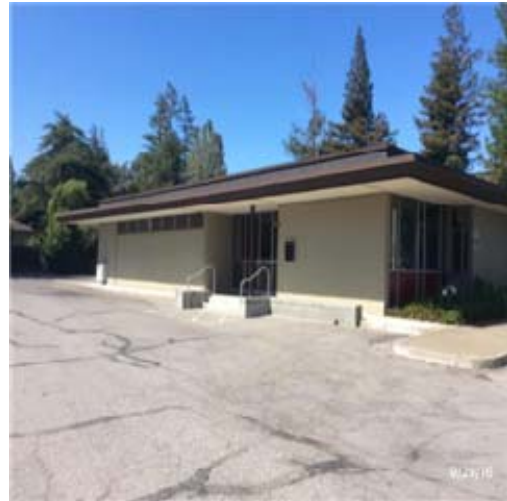
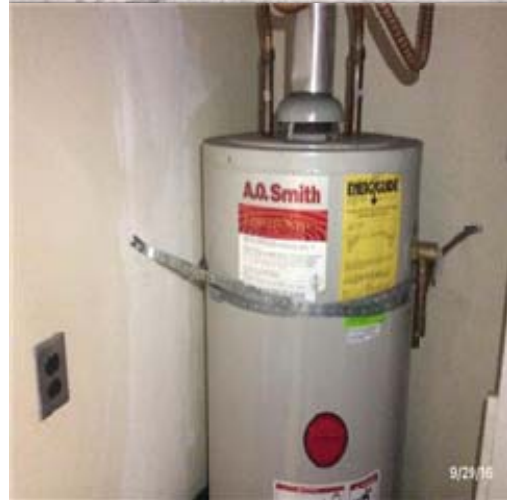
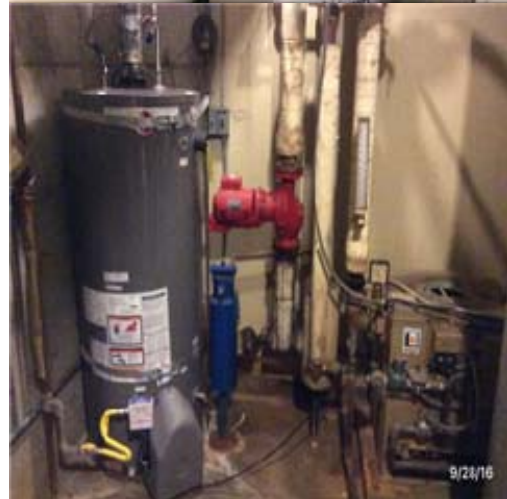
The site is predominantly asphalt surfacing. There is an asphalt pavement driveway and parking adjacent the building, along with concrete sidewalks around the site. There is a concrete surface patio and equipment yard to the rear of the property. There is landscaping along the road frontage and to the two side of the building along the site boundary. There is predominately grass with certain large trees and shrubs.

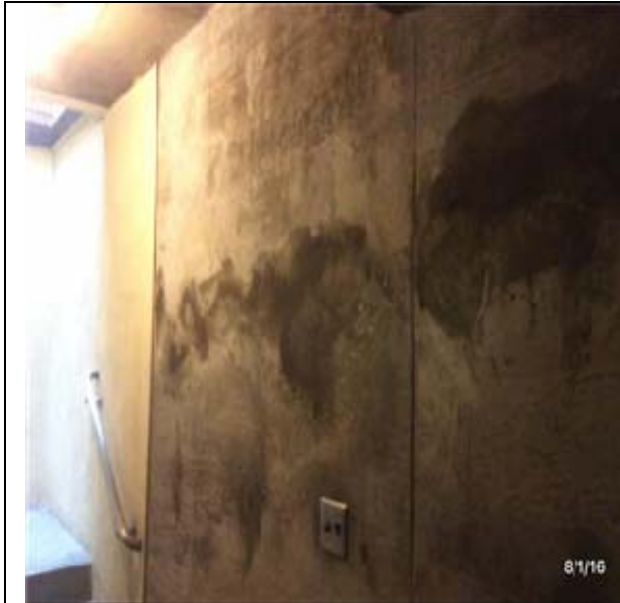
The wall constructions appeared to be in fair to good condition on the areas below grade viewed from the interior of the building. We believe the basement construction will last beyond the study period.

A2021 Basement Wall Construction:- View of Basement Construction

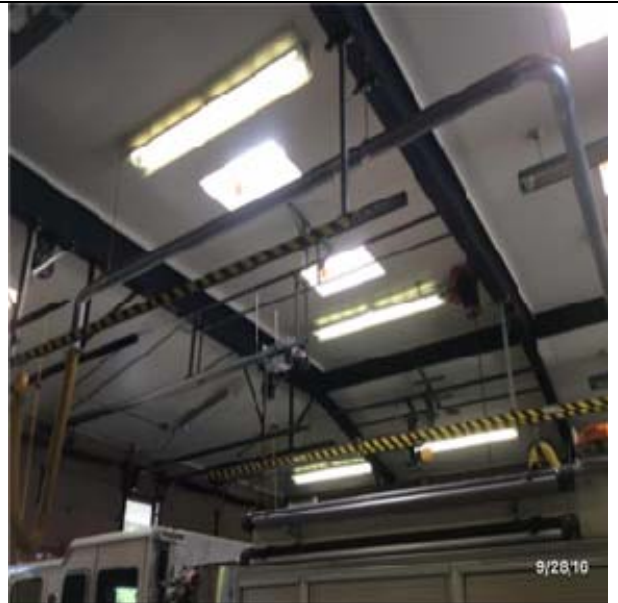
The roof constructions appeared in fair condition with no signs or reports of water ingress; therefore, no actions are anticipated during the study period.

B1022 Pitched Roof Construction:- View of Steel Beams and Rafters

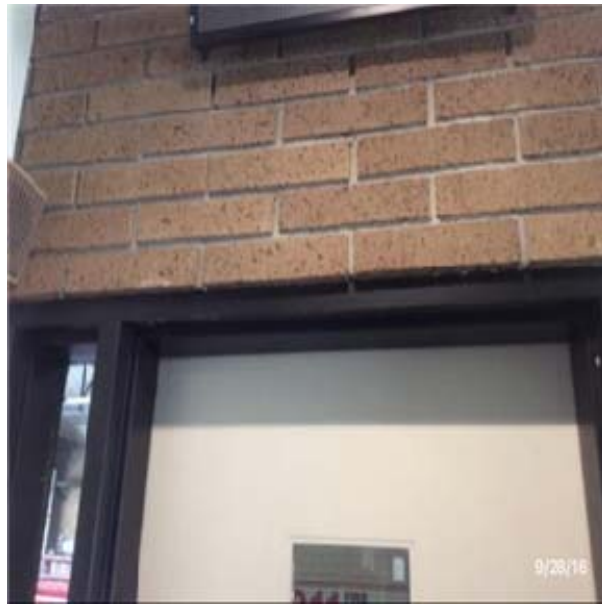
The exterior masonry wall construction appeared to be in fair condition with no obvious bulging or cracking present, therefore no actions will be generated during the study period that relate to the replacement or repair of the masonry wall construction. The majority of the exterior wall is wood cladding which appeared to be in fair condition with no apparent defects, therefore no actions will be generated during the study period.

B2011 Exterior Wall Construction:- View of Veneer Brick

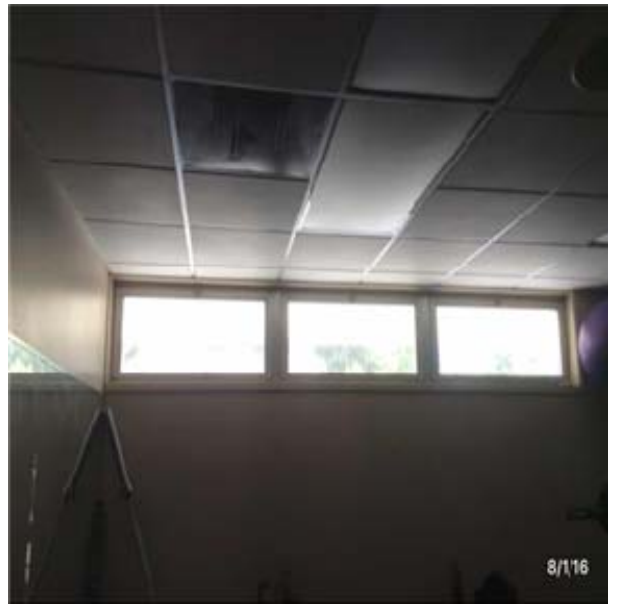
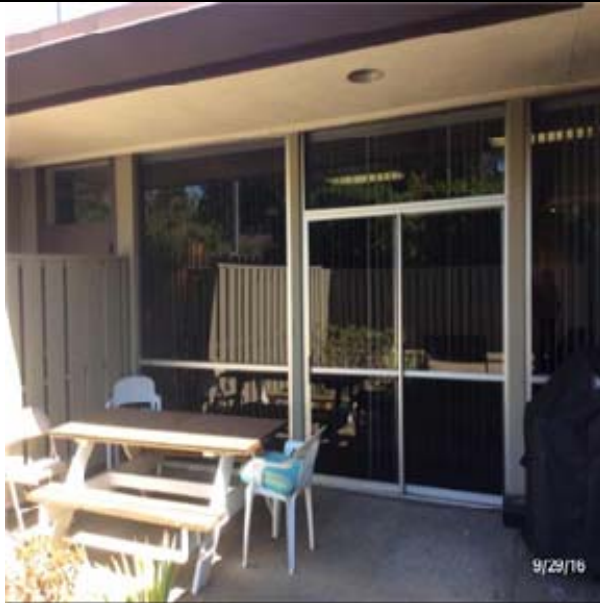
The window systems appeared to be in poor - fair condition. We noted some deterioration of frame and/or glass which would require actions and the frames are over their EUL of thirty years, therefore we recommend replacement during the study period.

B2021 Windows:- View of Aluminum Window Units - Fixed or Single Hung

ID	Type	Recommendation	Priority	Year	Expenditures
151819	B2010	Paint exterior	Priority 2	2018	\$3,700
151820	B2020	Replace Aluminum Window Units - Fixed or Single Hung	Priority 3	2021	\$90,431
151821	B2030	Replace Single Aluminum Glazed Doors	Priority 2	2016	\$6,652

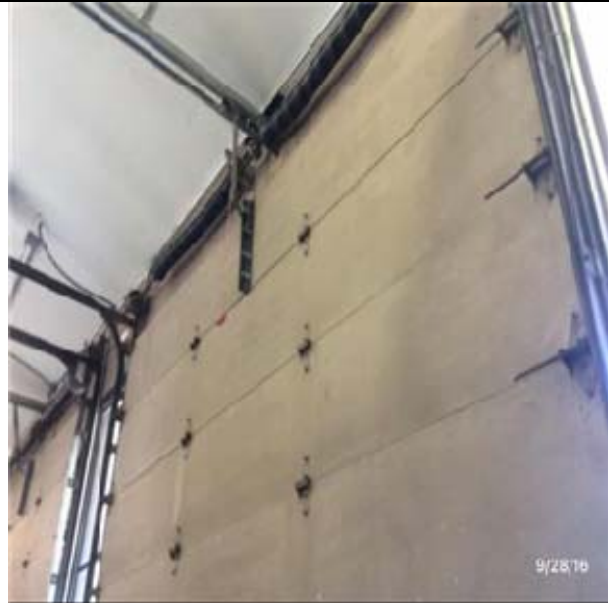
The overhead doors appeared to be in fair condition and operated properly. No replacement actions are anticipated during the study period.

B2034 Overhead Doors:- View of Rolling Overhead Doors, Electric

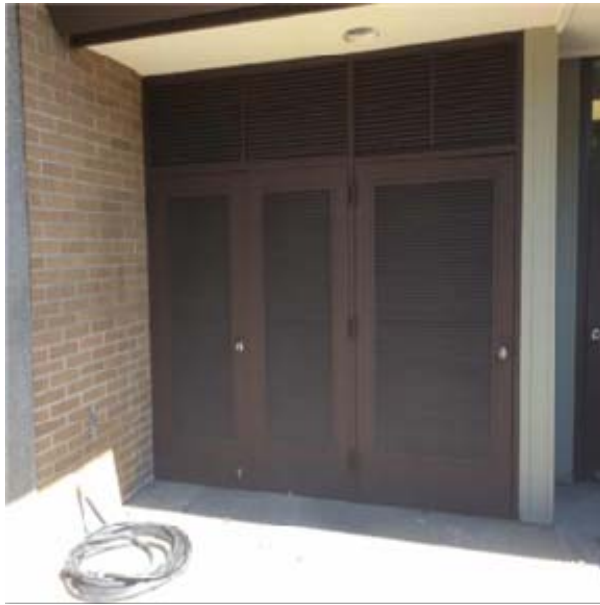
The hollow metal doors appeared to be in fair condition with no major signs of damage or deterioration. There were no issues with these doors therefore no actions will be generated during the study period. The new door surface finish and door frames will require repainting later in the study period. The cost of this work has been included within the amount to undertake the repainting of the exterior walls.

B2039 Other Doors & Entrances:- View of Single HM Louvered Doors

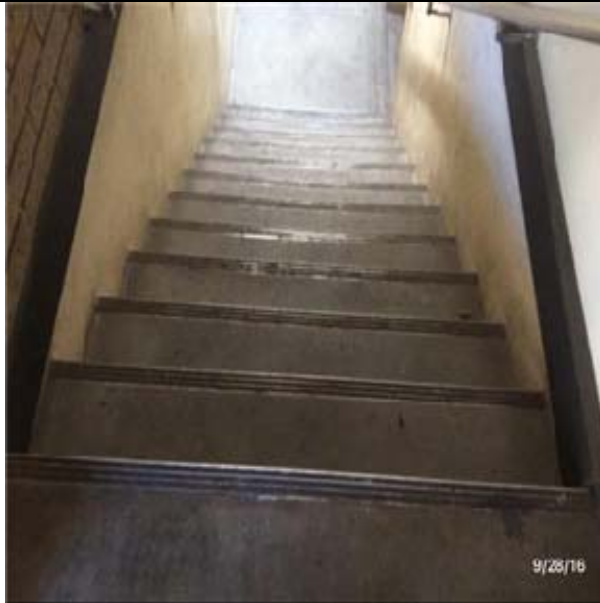
The stairs are in good to fair condition. Therefore no repair or replacement actions will be generated during the study period.

C2011 Regular Stairs:- View of Regular Stairs –
Concrete Construction

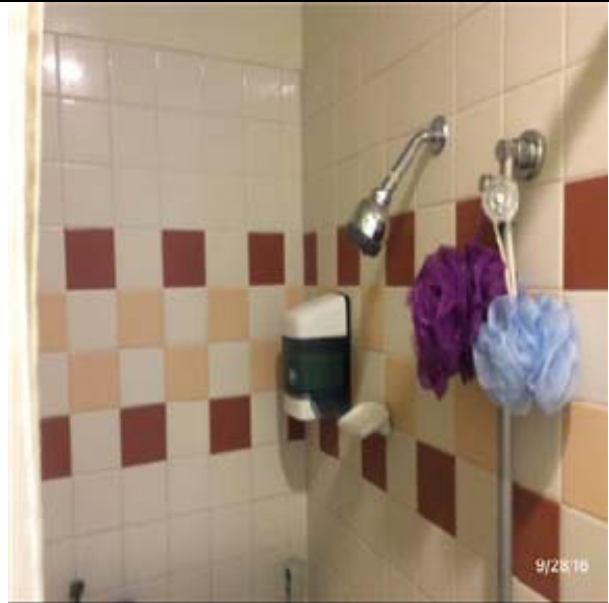
The ceramic wall finishes to the various restrooms were observed to be in fair condition. The ceramic tile has an EUL of thirty years. We did not observe any broken or loose tiles or missing grout; therefore we do not anticipate replacement during the study period.

C3012 Wall Finishes to Interior Walls:- View of Ceramic
Wall Tiles

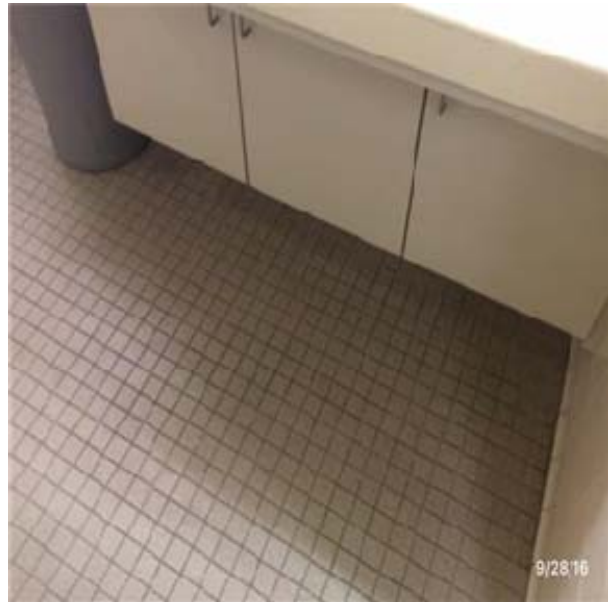
C3024 Flooring:- View of Ceramic Tile

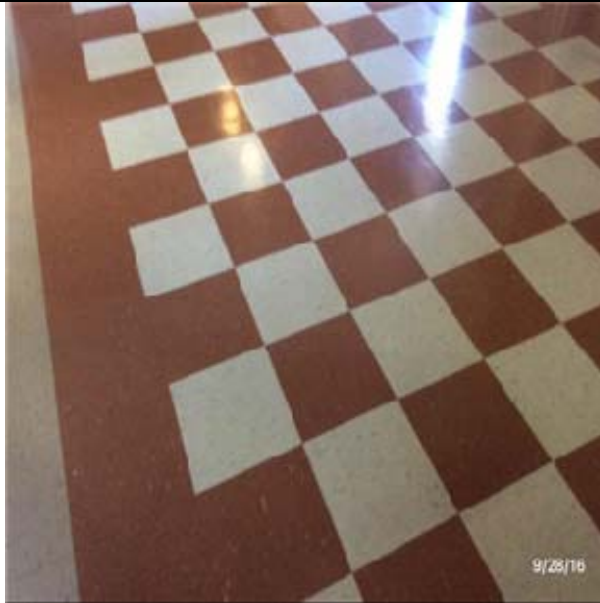
C3024 Flooring:- View of Vinyl Composite Tile (VCT)

ID	Type	Recommendation	Priority	Year	Expenditures
151825	C3010	Replace Painted Finish - Standard	Priority 2	2016	\$40,575
151826	C3010	Replace Painted Finish - Standard	Priority 2	2024	\$40,575
151827	C3020	Replace Vinyl Composite Tile (VCT)	Priority 3	2017	\$3,596
151828	C3020	Replace Broadloom Standard without Padding	Priority 2	2016	\$30,306
151829	C3020	Replace Epoxy Floor Coating	Priority 2	2016	\$79,660
151830	C3030	Replace Acoustic Ceiling System - Standard	Priority 3	2019	\$25,205

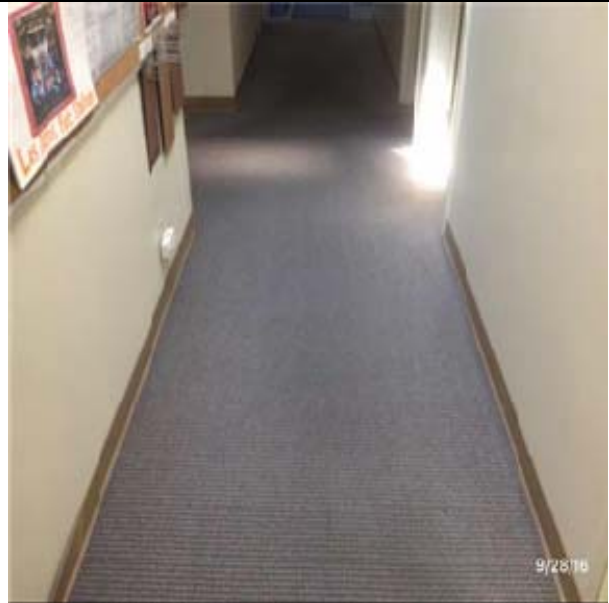
The carpet is in fair condition. We are unaware of the age of the carpeting, however we assume it to be more than fifteen years of age, therefore based on the typical EUL of ten years for this type of covering and current observed condition, we anticipate replacement early in the study period.

C3025 Carpeting:- View of Broadloom Standard without Padding

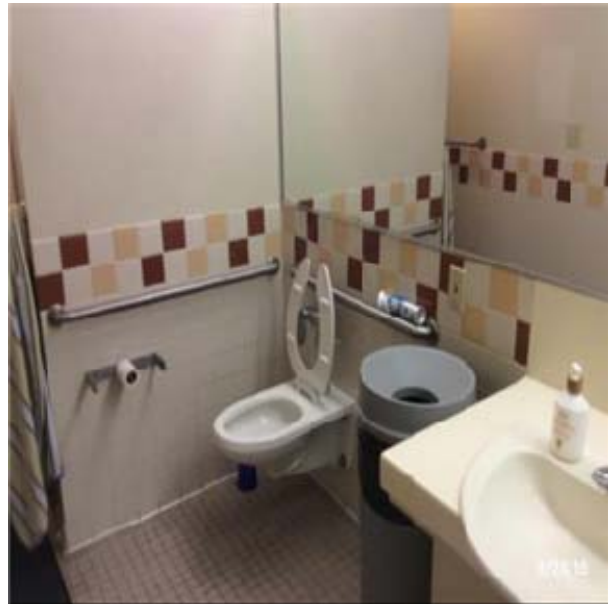
The water closets were observed to be in fair condition for the type and use of the building. The water closets flushed properly and did not have any cracks in the china therefore no replacement actions will be generated during the study period.

D2011 Water Closets:- View of Wall Mounted Water Closets

We anticipate that the flush valves may fail during the study period and therefore to maintain function they may need to be rebuilt or in some cases replaced. This work has not been included in this study as we anticipate it will be carried out on an as-needed basis as part of routine maintenance.

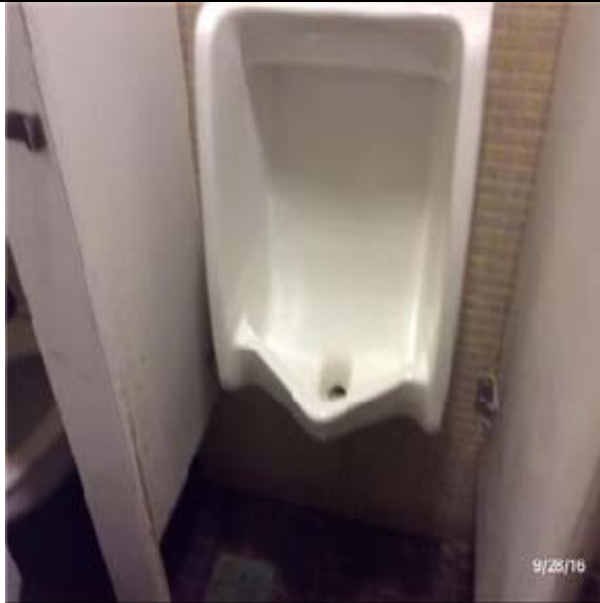
The urinal was observed to be in fair condition. The urinal flushed properly and did not have any cracks in the china, therefore no actions will be generated during the study period. We anticipate that the flush valve may fail during the study period and therefore to maintain function they may need to be rebuilt or in some cases replaced. This work has not been included in this study as we anticipate it will be carried out on an as-needed basis as part of routine maintenance.

D2012 Urinals:- View of Wall Hung Urinals

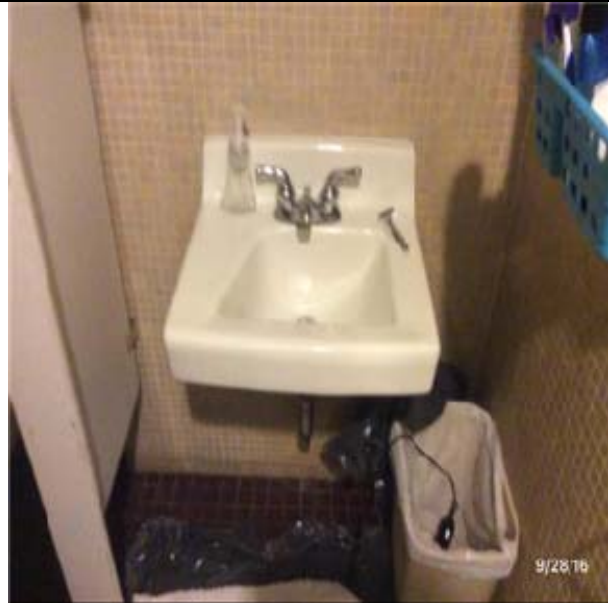
D2013 Lavatories:- View of Wall Hung Lavatories

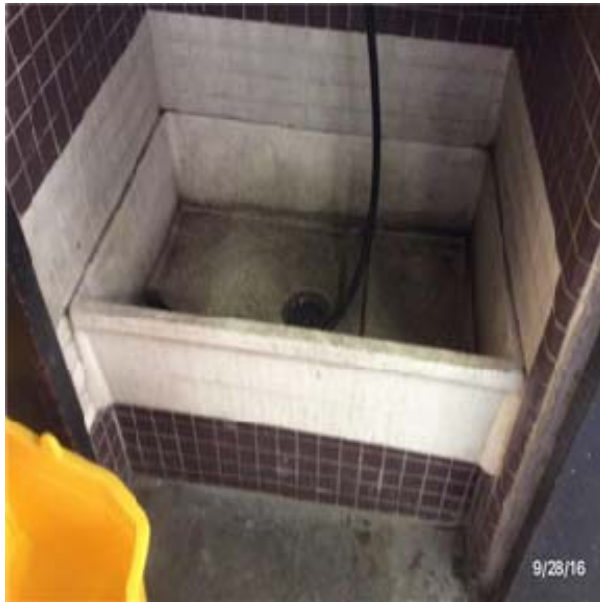
D2014 Sinks:- View of Service Sink Floor Mounted

- + D Services: Replace Unit Heater - Gas Fired Suspended - 100 MBH at an estimated cost of \$20,694 in year 2016
- + D Services: Replace Service Sink Floor Mounted at an estimated cost of \$7,749 in year 2019

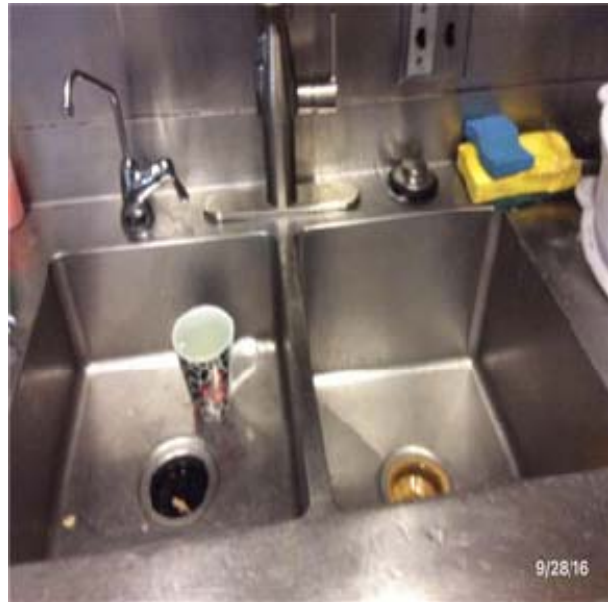
D2014 Sinks:- View of Sink - Integral with countertop (Stainless)

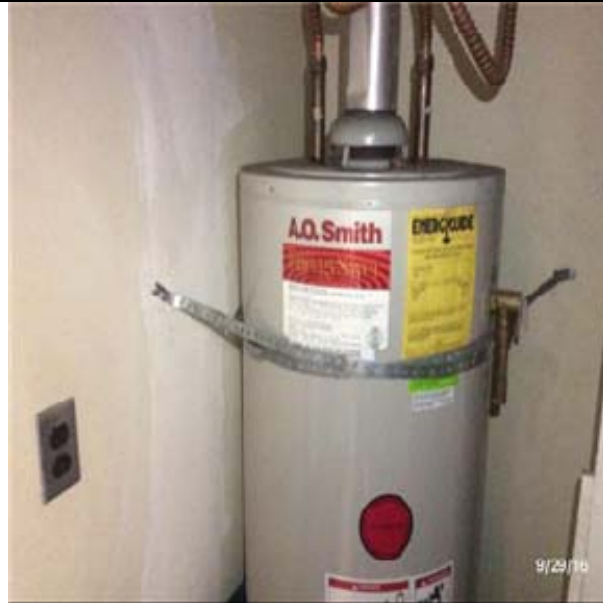
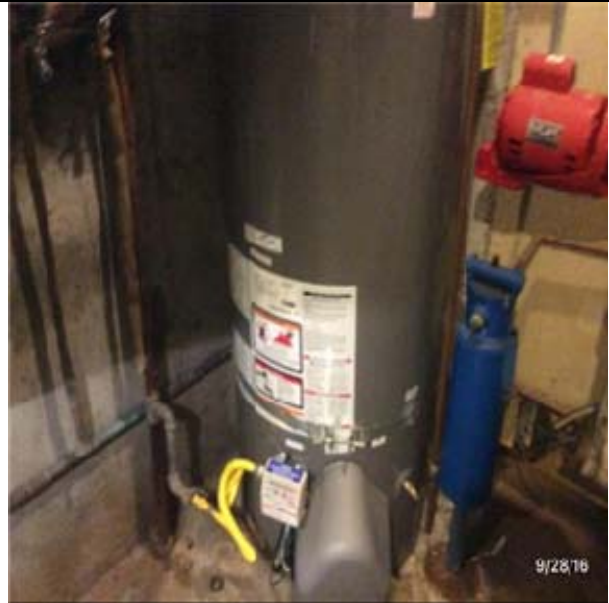
D2022 Hot Water Service:- View of Domestic Hot Water Heater - Gas

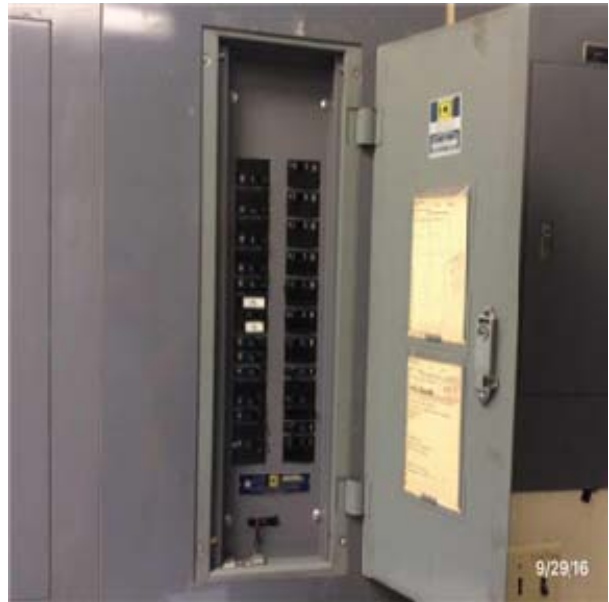
D5012 Low Tension Service & Dist:- View of Panelboard - 120/208volts, 400 to 1200amp

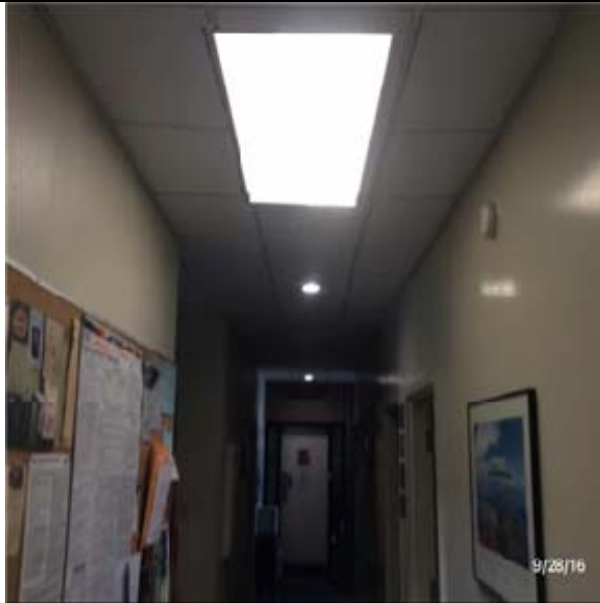
D5022 Lighting Equipment:- View of Interior Light Fixtures - Fluorescent

- + D Services: Replace Interior Light Fixtures - Fluorescent at an estimated cost of \$85,012 in year 2019
- + D Services: Replace Split-System (Air Cooled Condenser Chiller Unit) at an estimated cost of \$20,418 in year 2025

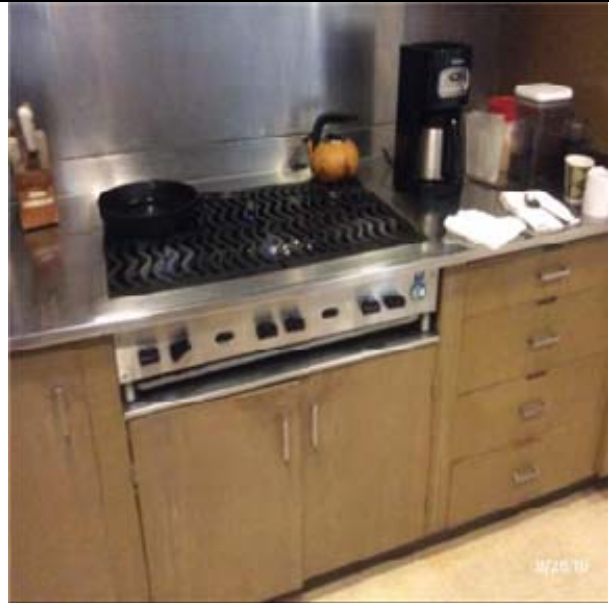
E1095 Unit Kitchens:- View of Floor Mounted Base Cabinets - Standard

- + E Equipment & Furnishing: ADA - Provide Accessible Public Counter at an estimated cost of \$5,600 in year 2016
- + E Equipment & Furnishing: Replace Floor Mounted Base Cabinets - Standard at an estimated cost of \$32,391 in year 2019

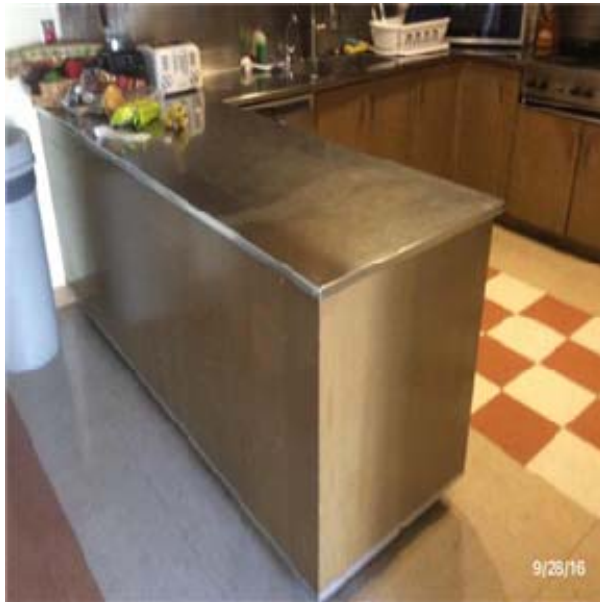
E1095 Unit Kitchens:- View of Unit Kitchens - Counter Top - Stainless Steel

- + E Equipment & Furnishing: Replace Unit Kitchens - Wall Mounted Cabinets - Standard at an estimated cost of \$13,496 in year 2019
- + E Equipment & Furnishing: Replace Unit Kitchens - Counter Top - Stainless Steel at an estimated cost of \$6,478 in year 2019
