Tier 1 Report of  
Facility Condition Assessment

For  
City of Los Altos  
Halsey House  
482 University Ave  
Los Altos,  
California 94022-3518

Date of Report: October 18, 2016

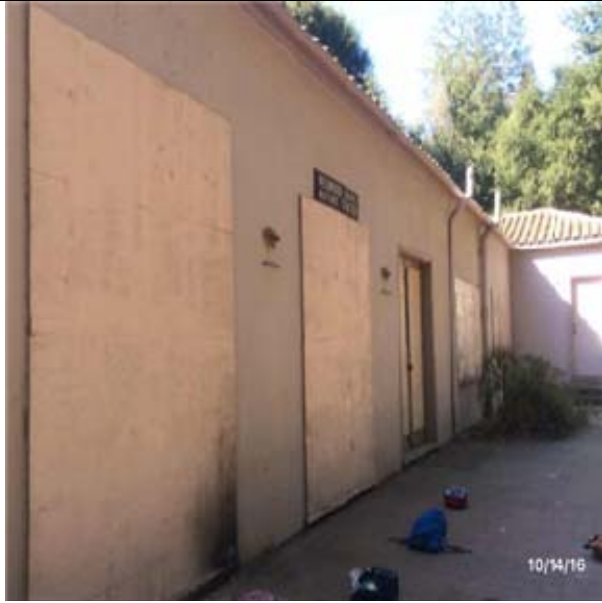
The exterior wood frame structure appeared to be in poor condition with certain areas of **water** penetration and damage to the stucco finish. There is also localized **water** penetration around the masonry chimney structure. We anticipate repairs and or replacement will be necessary during the study period.

B2011 Exterior Wall Construction:- View of Stucco over Stud Walls

ID	Type	Recommendation	Priority	Year	Expenditures
157233	B2010	Replace Stucco over Stud Walls	Priority 2	2016	\$167,096
157234	B2020	Replace Wood Window Units - Fixed or Single Hung	Priority 2	2016	\$56,584
157235	B2030	Replace Double Wood Glazed Doors	Priority 2	2016	\$30,996
157236	B2030	Replace Single Wood Doors	Priority 2	2016	\$15,424

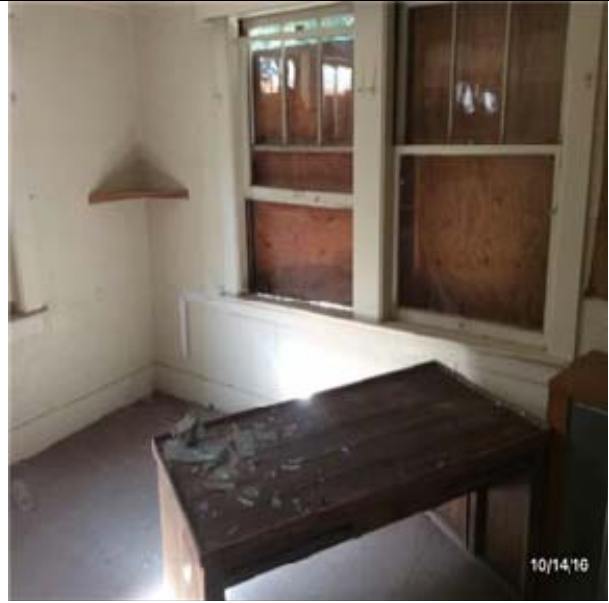
The windows appeared to be in poor condition due to heavy vandalism and are boarded up. From our limited observation of the windows not vandalized we noted some deterioration of frame and/or glass which would require actions and the frames are over their EUL of thirty years, therefore we recommend replacement of all windows during the study period.

B2021 Windows:- View of Wood Window Units - Fixed or Single Hung

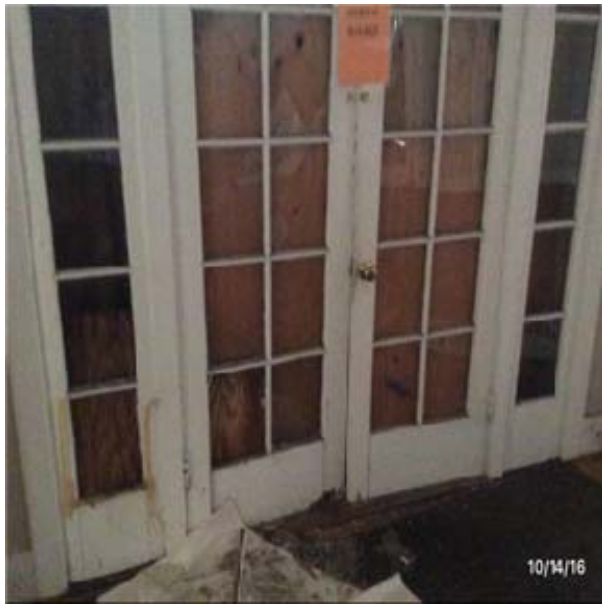
The doors appeared to be in poor condition due to heavy vandalism and have been boarded up. Those doors not vandalized are over their EUL of thirty years, therefore we recommend replacement of all doors during the study period.

B2039 Other Doors & Entrances:- View of Double Wood Glazed Doors

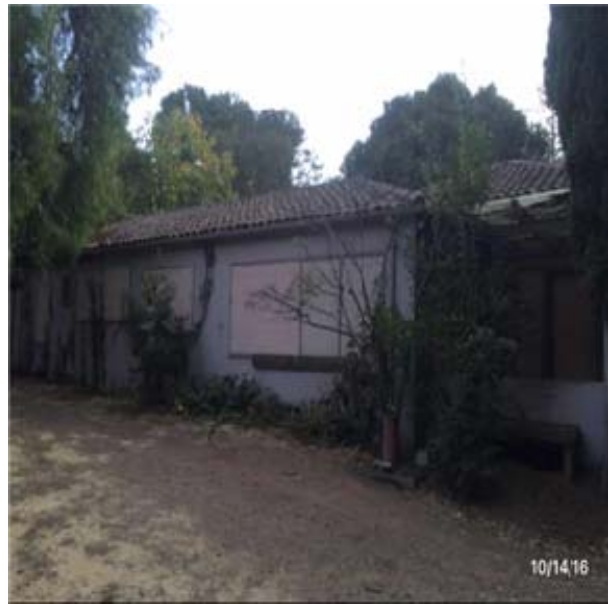
The clay roof tile covering appeared to be in fair to poor condition, with certain roof leaks observed. We assume it to be original, with an EUL of fifty years we anticipate replacement in the study period along with the associated rainwater gutters and downspouts.

B3011 Roof Finishes:- View of Clay Roof Tile

ID	Type	Recommendation	Priority	Year	Expenditures
157237	B3010	Replace Gutters and Downspouts	Priority 2	2016	\$7,056
157238	B3010	Replace Clay Roof Tile	Priority 2	2016	\$88,988

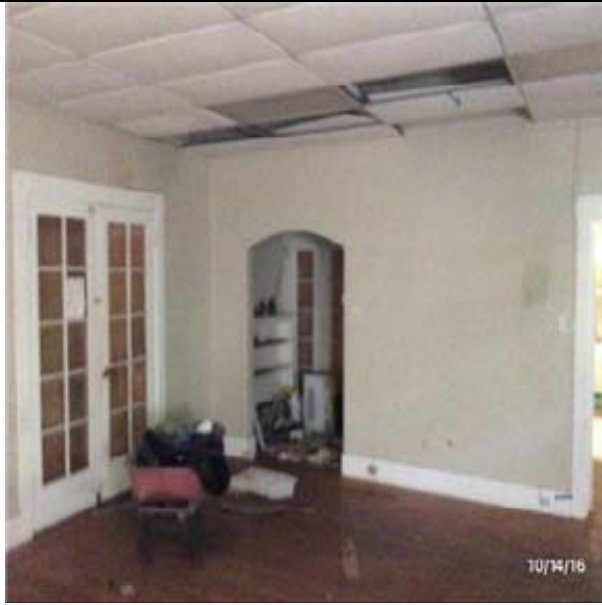
The wood flooring was observed to be in fair to poor condition with certain localized damage due to water penetration. We anticipate replacement during the study period.

C3024 Flooring:- View of Wood Flooring

ID	Type	Recommendation	Priority	Year	Expenditures
157241	C3020	Replace Wood Flooring	Priority 2	2016	\$104,420
157242	C3030	Replace Plaster Ceilings	Priority 2	2016	\$56,771
