**Tier 1 Report of**

**Facility Condition Assessment**

**J Gilbert Smith House (History House)**

**Date of Report: October 10, 2016**

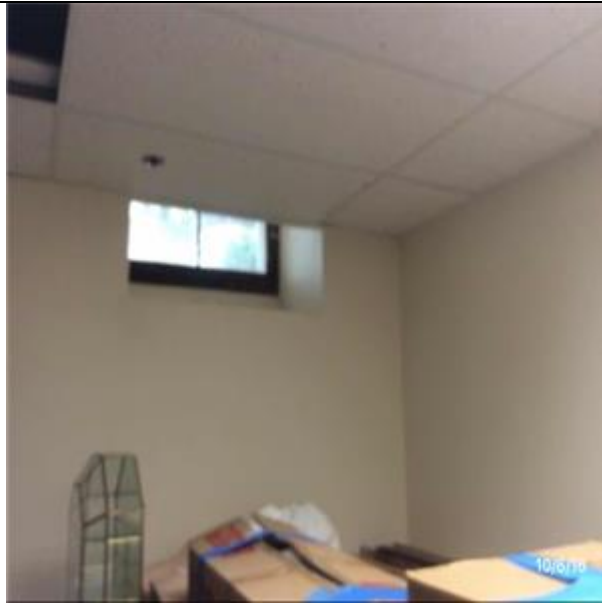
The basement wall construction was observed to be in fair to good condition. There were no signs of undue settling, major cracks or excessive water ingress noted. We do not anticipate a requirement for replacement during the study period.

A1011 Wall Foundations:- View of Foundation Wall and Footings up to 12FT - Full Basement

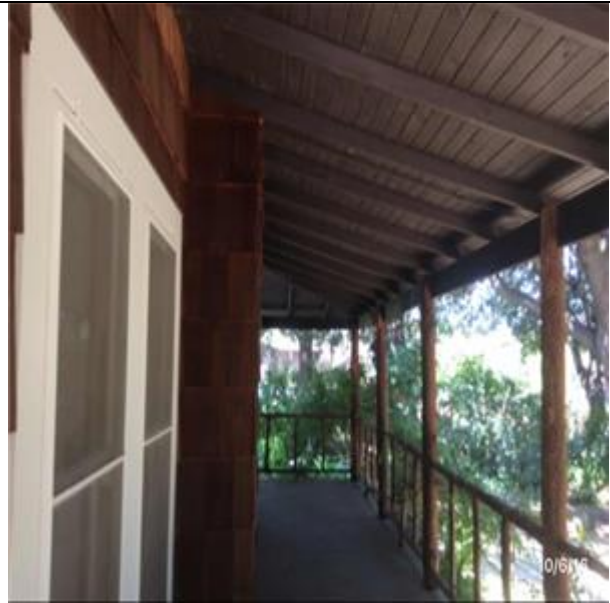
The porch appeared in fair condition. No signs of weathering were noted; therefore, no actions are anticipated during the study period outside of routine maintenance.

B1023 Canopies:- View of Canopies - Wood Joists Supporting Wood Deck to Porch

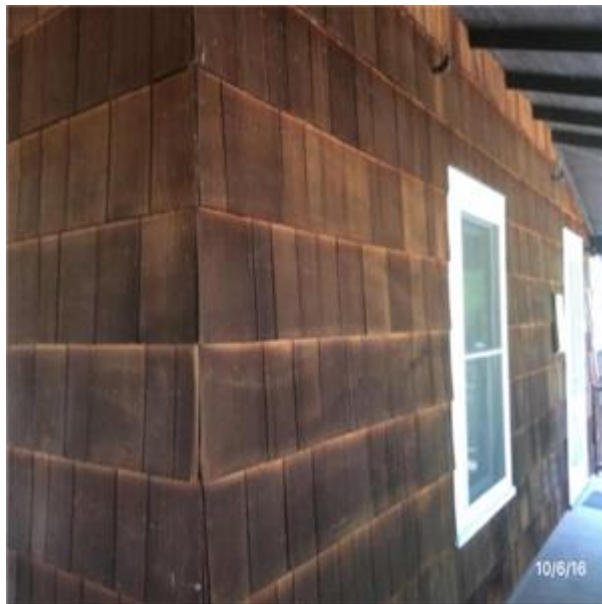
The exterior wall construction was observed to be in fair condition. We assume the wood shingle siding is not original, however we are not certain as to the age of the current wood shingle siding. Based on the appearance and the durability of redwood shingles we do not anticipate replacement during the study period.

B2011 Exterior Wall Construction:- View of Wood Shingle Siding

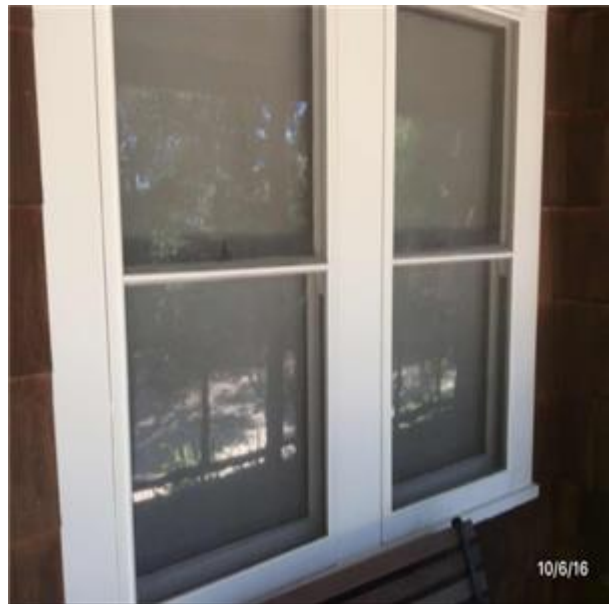
The windows were observed to be in fair condition, however given the historical importance of the building we do not anticipate replacement during the study period. We have included to paint the exterior wood finishes during the study period to maintain the building appearance.

B2021 Windows:- View of Wood Window Units - Casement, Double Hung, Vent or Sliding

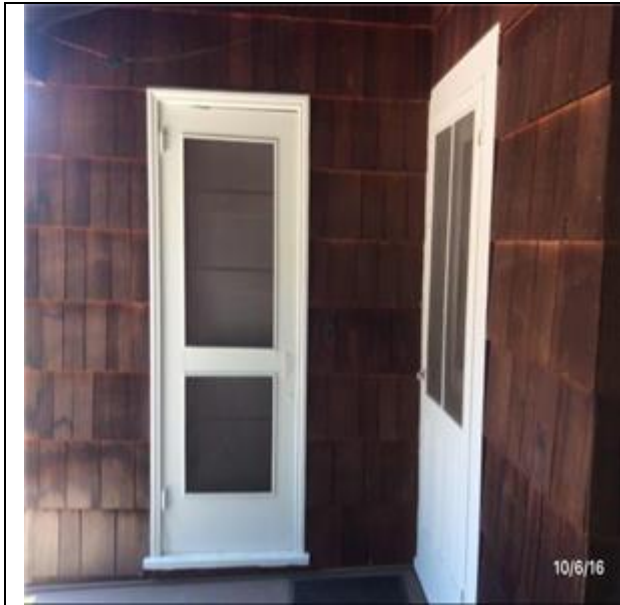
The doors appeared to be in a fair condition with no major signs of damage or deterioration, given the historical context of the doors we do not anticipate replacement during the study period. The doors, screens and door frames will require repainting later in the study to maintain the appearance of the building and integrity of the wood.

B2039 Other Doors & Entrances:- View of Exterior Single Wood Door

ID	Type	Recommendation	Priority	Year	Expenditures
153355	B2030	Paint Exterior Doors	Priority 1	2016	\$2,132

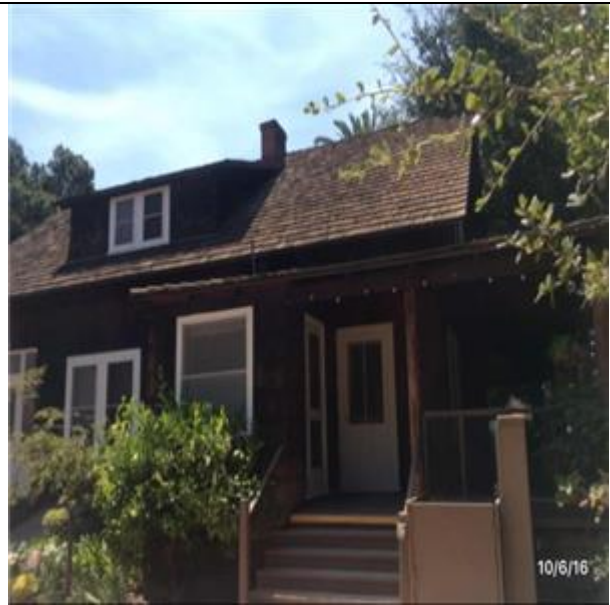
The wood shake covering appeared to be in fair condition, with no roof leaks reported. We are unaware of when the roof coverings were installed, we assume them to be installed at the time of the upgrade in 1993, therefore we anticipate replacement during the study period.

B3011 Roof Finishes:- View of Wood Shake Roof

ID	Type	Recommendation	Priority	Year	Expenditures
153356	B3010	Replace Wood Shake Roof	Priority 3	2021	\$26,391

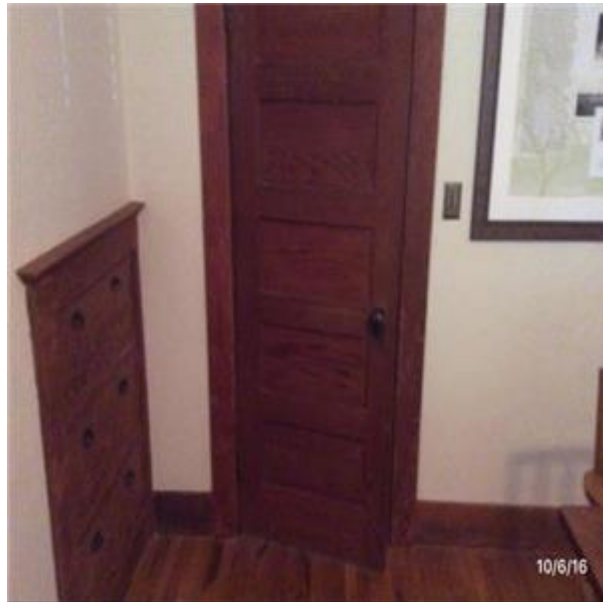
All the wood doors at the building were observed to be in fair condition. We have assumed the doors to be original, however given the historical context, the doors will not need replacing during the study period. The door surface finish and door frames will require painting or varnishing later in the study period. The cost of this work has been included within the amount to undertake the repainting of the interior walls.

C1021 Interior Doors:- View of Interior Single Wood Door(s)

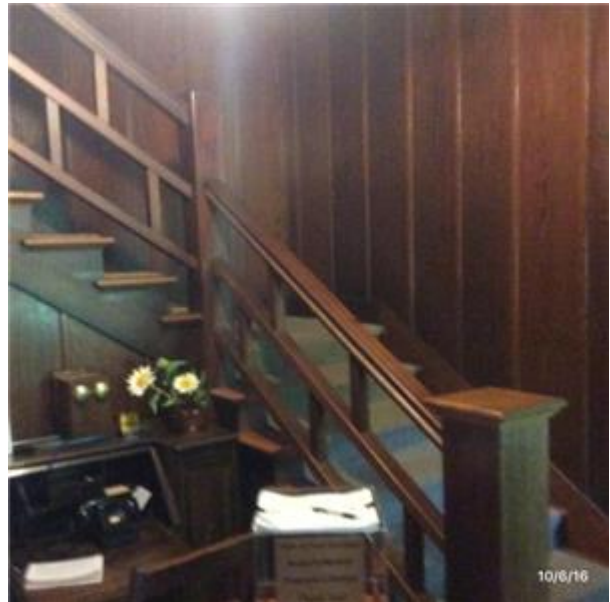
The stairs appeared to be in fair to good condition given their age. Despite the age, we do not anticipate replacement during the study period given the historical context.

C2011 Regular Stairs:- View of Regular Stairs - Wood Construction to Stage

ID	Type	Recommendation	Priority	Year	Expenditures
153357	C2010	ADA - Install or Modify Handrails	Priority 2	2016	\$5,600

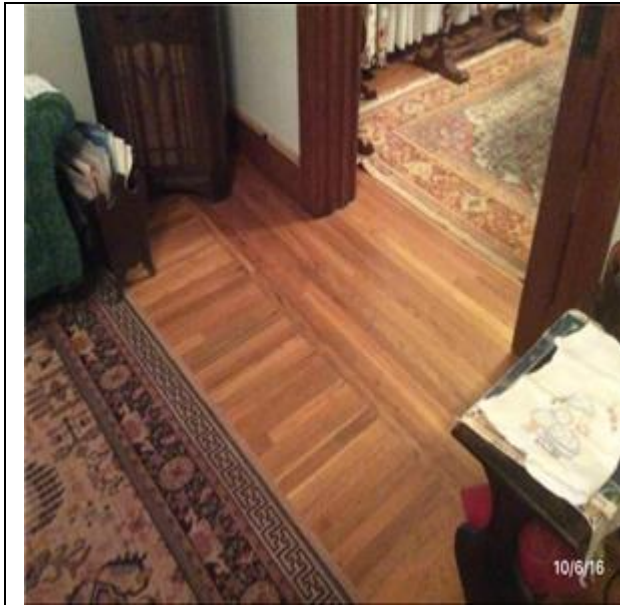
The floor finishes appeared in fair condition throughout the building. There is redwood floor throughout which is in good condition having been refurbished recently. We do not anticipate replacement during the study period. The vinyl sheet at the kitchen is in a fair condition, however given the historical context, we do not anticipate replacement during the study period.

C3024 Flooring:- View of Wood Flooring – Redwood

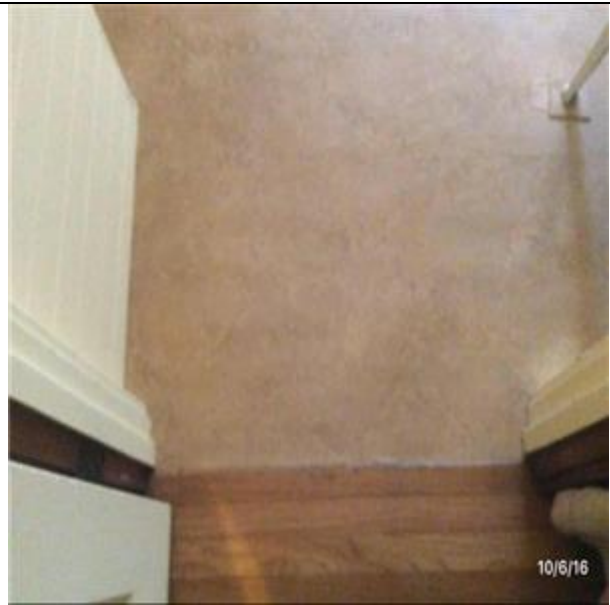
C3024 Flooring:- View of Vinyl Sheet

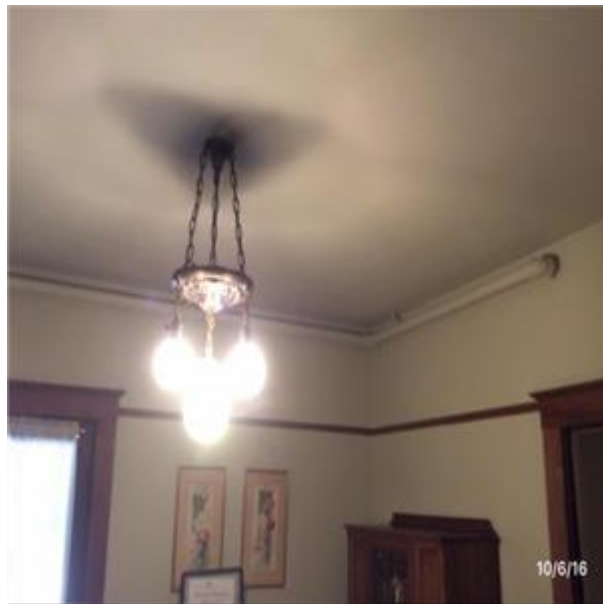
The plaster ceilings are assumed to be original, however given the historical context we do not anticipate replacement. We are uncertain as to the age of the wood ceilings, however, they were observed to be in a fair to good condition, therefore we do not anticipate replacement during the study period. We do anticipate the painted and varnished surface will need to be repainted mid-term in the study period to maintain the appearance of the building and integrity of the wood. The suspended ceilings at the basement are assumed to be installed as part of the refurbishment, based on the typical EUL of twenty years for this type of ceiling and current observed condition, we anticipate replacement during the study period.

C3031 Ceiling Finishes:- View of Plaster Ceilings

ID	Type	Recommendation	Priority	Year	Expenditures
153358	C3010	Replace Painted or Varnish Finish - Standard	Priority 3	2019	\$11,551
153359	C3030	Replace Acoustic Ceiling System - Standard	Priority 3	2021	\$5,069
153360	C3030	Paint Ceilings	Priority 3	2019	\$2,025
153361	C3030	Paint Wood Ceiling	Priority 2	2018	\$340

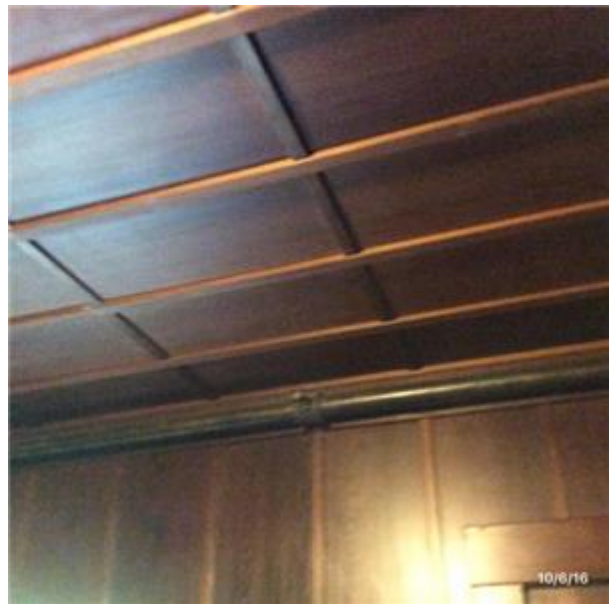
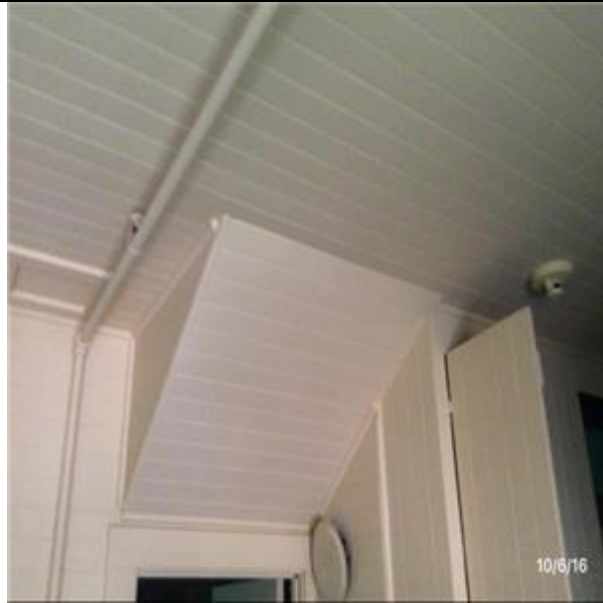
C3031 Ceiling Finishes:- View of Wood Ceiling Painted and Stained

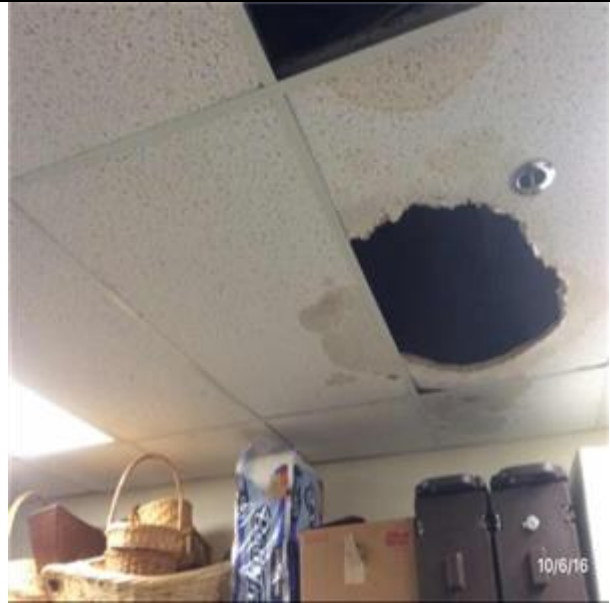
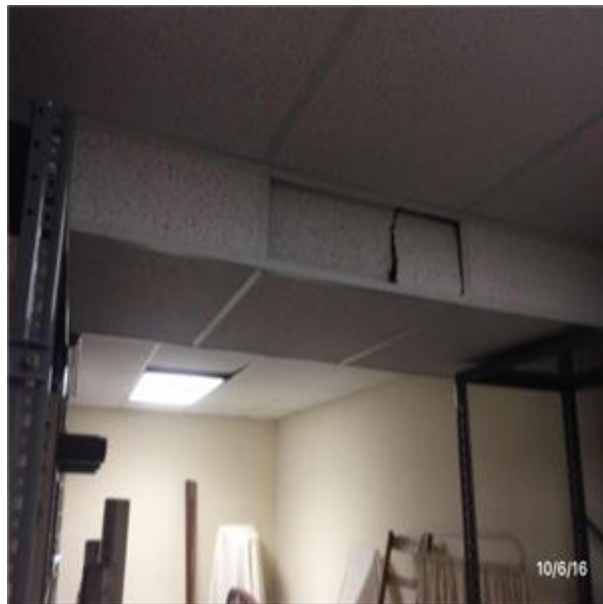
C3032 Suspended Ceilings:- View of Acoustic Ceiling System - Standard

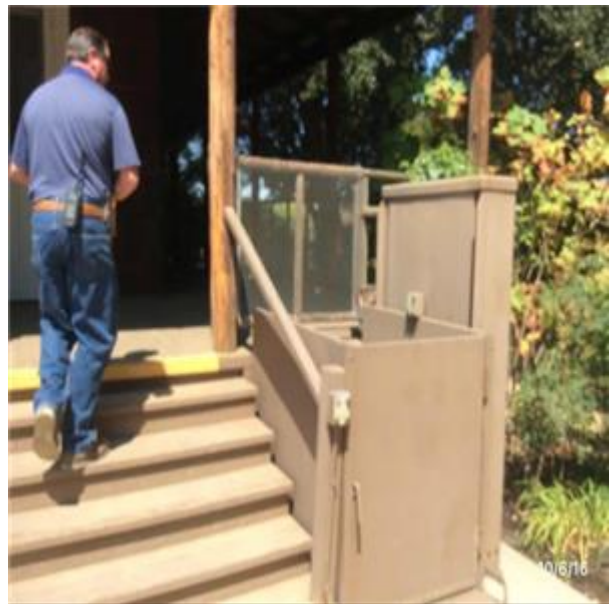
The wheel chair lifts appeared to be in fair condition. The equipment was operational at the time of the assessment and no issues were reported to us, however, based on a EUL of twenty five years the lift will need replacement during the study period.

D1094 Conveyors:- View of Wheelchair lift

ID	Type	Recommendation	Priority	Year	Expenditures
153362	D1090	Replace Wheelchair lift	Priority 2	2018	\$9,779
153363	D1090	ADA - Modify or Replace Lift	Priority 1	2016	\$1,680

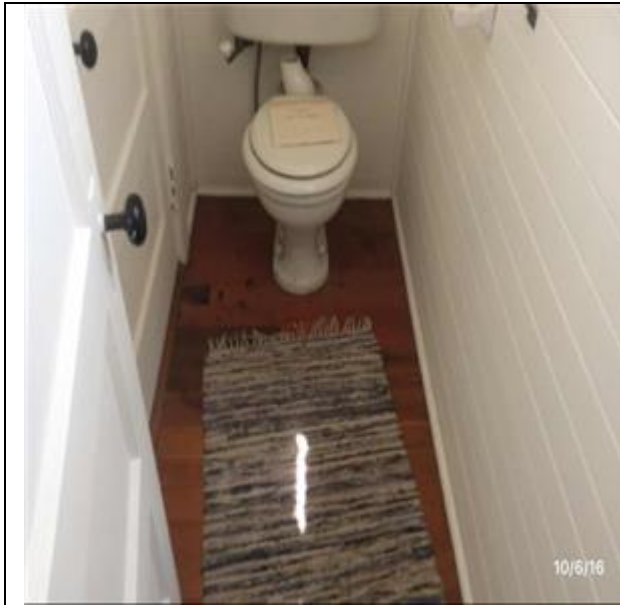
There are is one floor mounted vitreous china water closets and lavatory, with a traditional tank type units and manual flush valves. All the plumbing fixtures are for historical context only and are no longer operational. The water closet has caused localized flooding in the basement in the past.

The water closets and lavatories where observed to be in fair condition, however as they are no longer in operation and are used for exhibition purposes only we do not anticipate replacement during the study period.

D2011 Water Closets:- View of Floor Mounted Water Closets

ID	Type	Recommendation	Priority	Year	Expenditures
153364	D2010	ADA - Replace or modify Grab Bars, fixtures and mirrors	Priority 1	2016	\$2,968

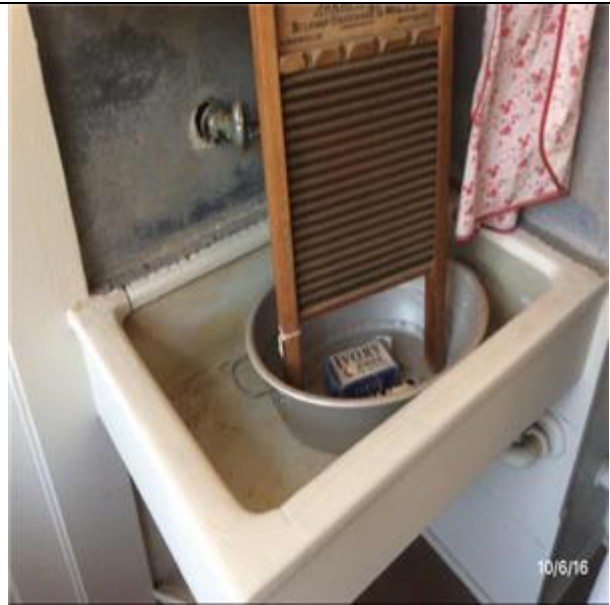
The counter top enameled metal sinks were observed to be in fair condition. As with the plumbing fixtures these are no longer used and are for exhibit purposes only, therefore we do not anticipate replacement during the study period.

D2014 Sinks:- View of Countertop Single Bowl Kitchen Sink

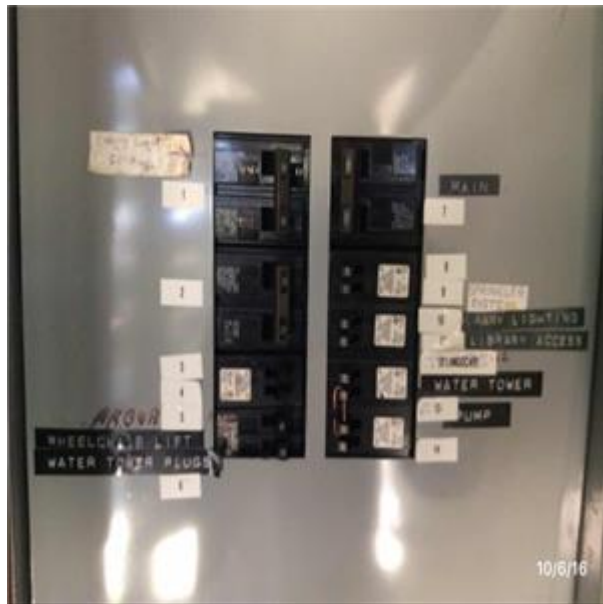
The panel appeared to be in a good condition due to its age. There was no sign of deterioration at the panels. The typical EUL for electrical Panelboard such as this is thirty years; therefore replacement will not be necessary during the study period. We do recommend further evaluation of the branch panels via an infrared electrical inspection which will highlight if high temperatures, excessive electrical resistance, failing components, ground faults and short circuiting issues exist.

D5012 Low Tension Service & Dist:- View of Panelboard -  
120/240volts, 60 to 2000amp

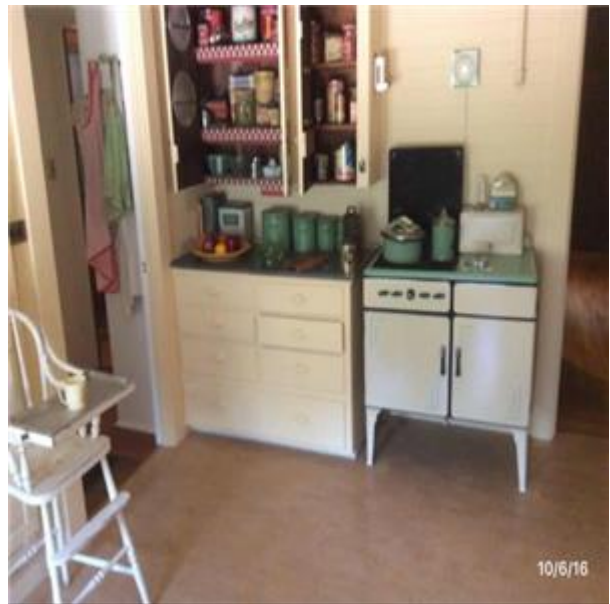
E2012 Fixed Casework:- View of Floor mounted Base Cabinets

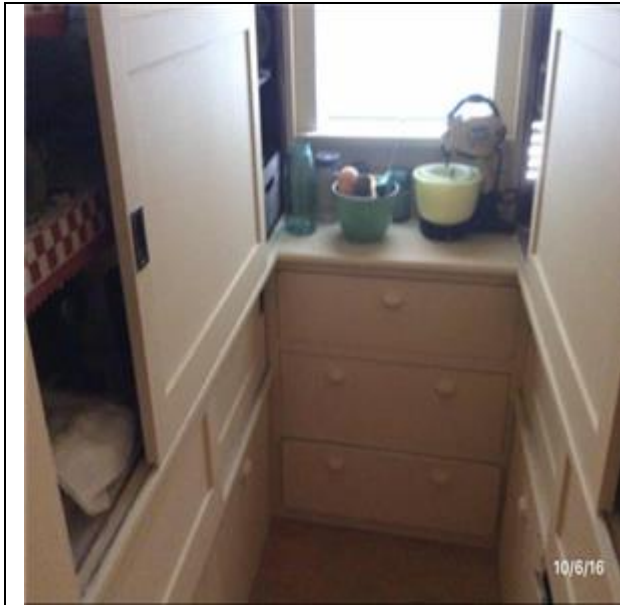
E2012 Fixed Casework:- View of Wall Mounted Cabinets

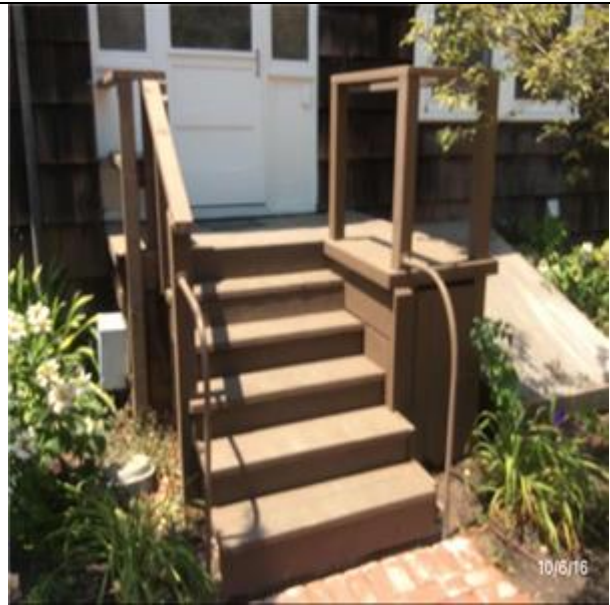
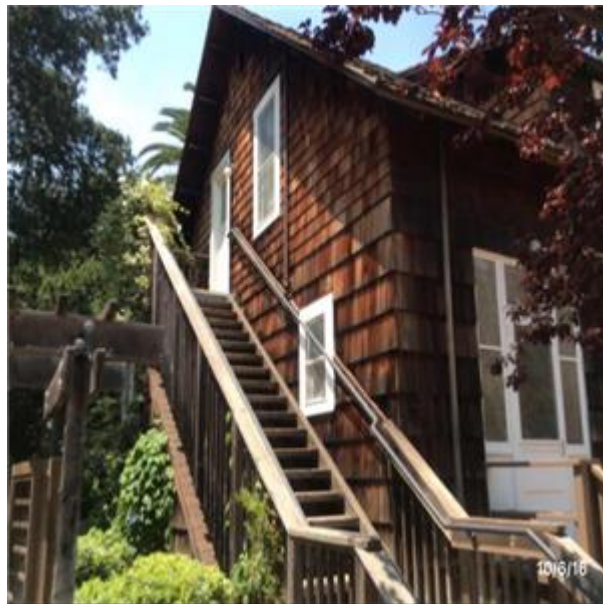
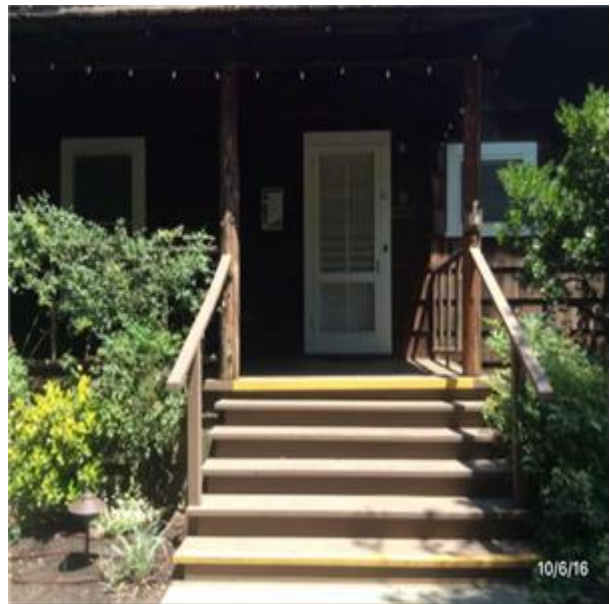
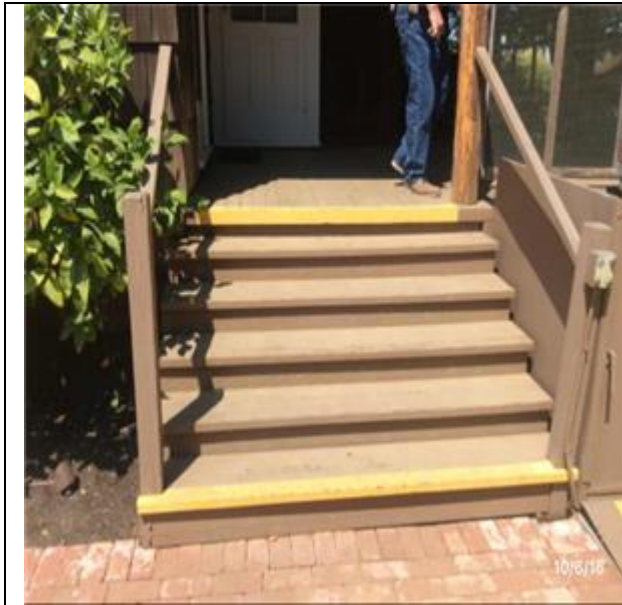
G2033 Exterior Steps:- View of Exterior Wood Steps
