**Tier 1 Report of
Facility Condition Assessment**

**For
City of Los Altos
Fire Station
765 Fremont Ave
Los Altos,
California 94024-5408**

Date of Report: October 11, 2016

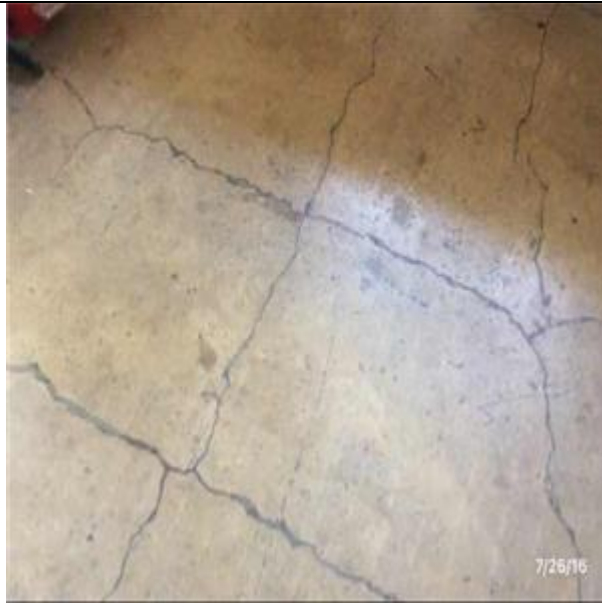
The structural slab is showing time-related stress cracking. It is recommended that large cracks be tuck pointed with a high strength grout early in the study period to prevent further deterioration.

A1031 Standard Slab on Grade:- View of Slab-on-Grade Reinforced Concrete

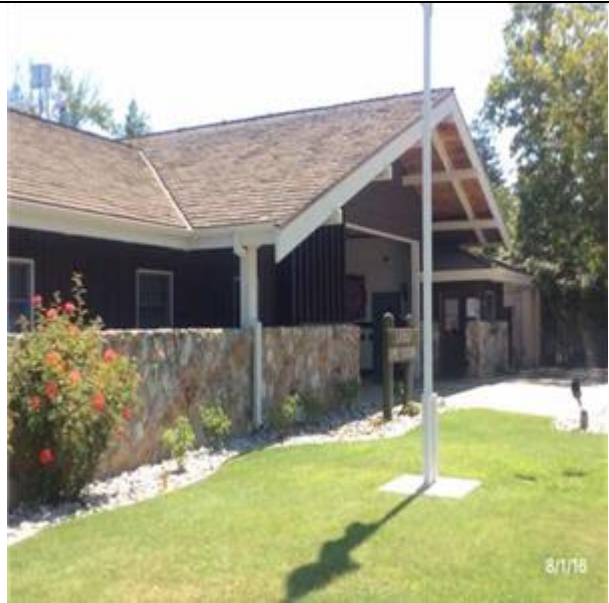
The stone veneer was observed to be in fair to good condition and no actions are anticipated during the study period.

B2011 Exterior Wall Construction:- View of Veneer – Stone

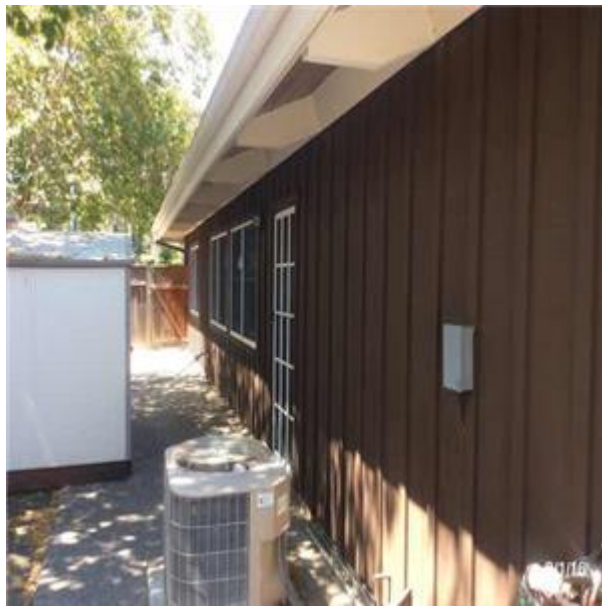
The exterior wall construction was observed to be in fair to good condition with no appreciable deterioration present and no actions are anticipated during the study period.

B2011 Exterior Wall Construction:- View of Wood Clapboard Siding

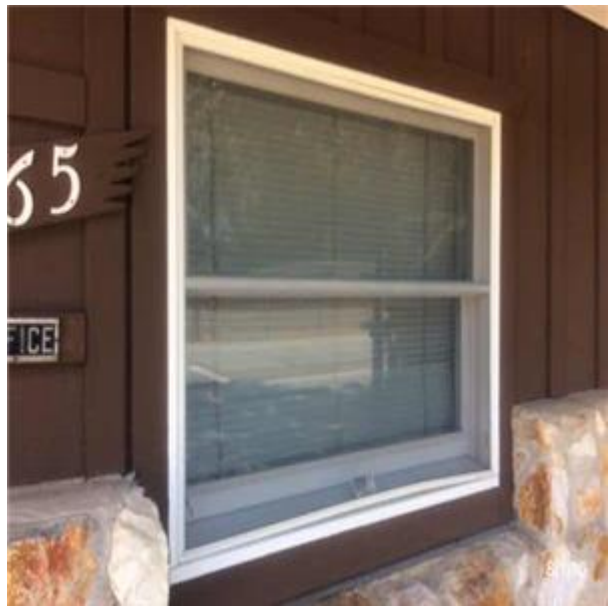
The window units were observed to be in fair to good condition and no actions are anticipated during the study period.

B2021 Windows:- View of UPVC Window Units - Casement, Double Hung, Vent or Sliding

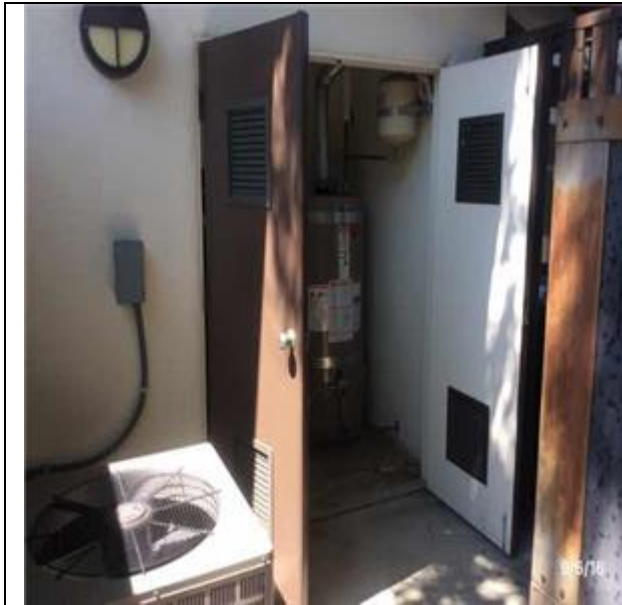
The double wood door was observed to be in fair to good condition and no actions are anticipated during the study period aside from ADA modifications.

B2032 Solid Exterior Doors:- View of Double Solid Core Wood Doors

ID	Type	Recommendation	Priority	Year	Expenditures
153551	B2030	Modifications to Exterior Door	Priority 1	2016	\$6,250

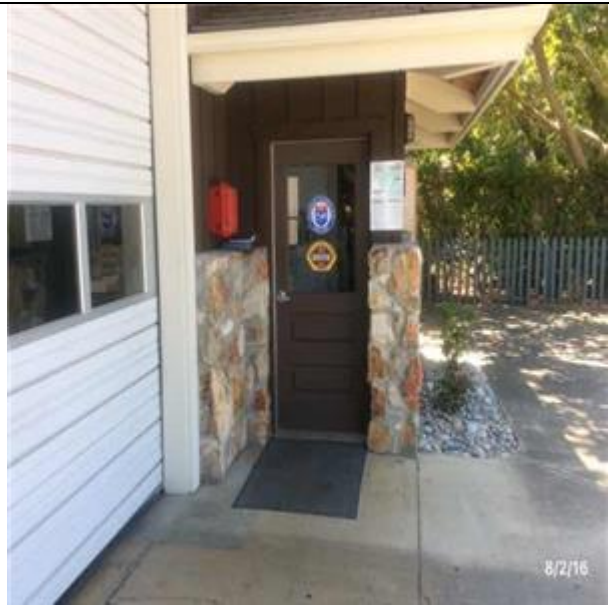
The single solid core doors were observed to be in fair to good condition and no actions are anticipated during the study period aside from painting as part of routine maintenance.

B2032 Solid Exterior Doors:- View of Single Solid Core Wood Doors

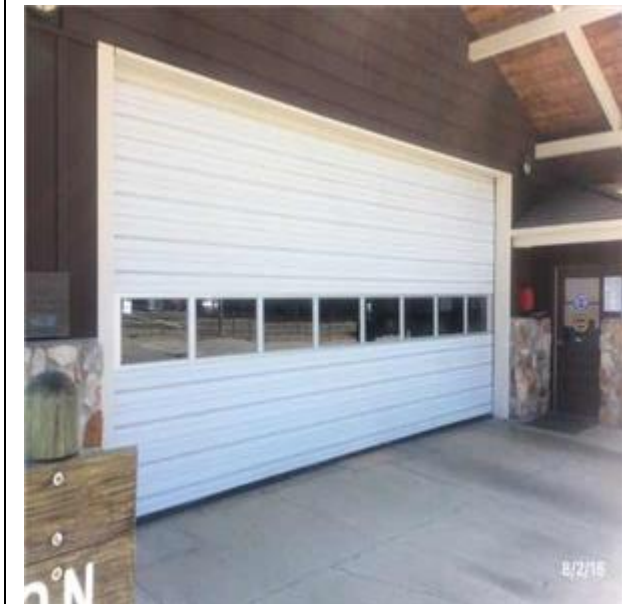
The overhead doors were observed to be in fair to good condition with no reported operational issues. No actions are anticipated during the study period.

B2034 Overhead Doors:- View of Rolling Overhead Doors, Electric

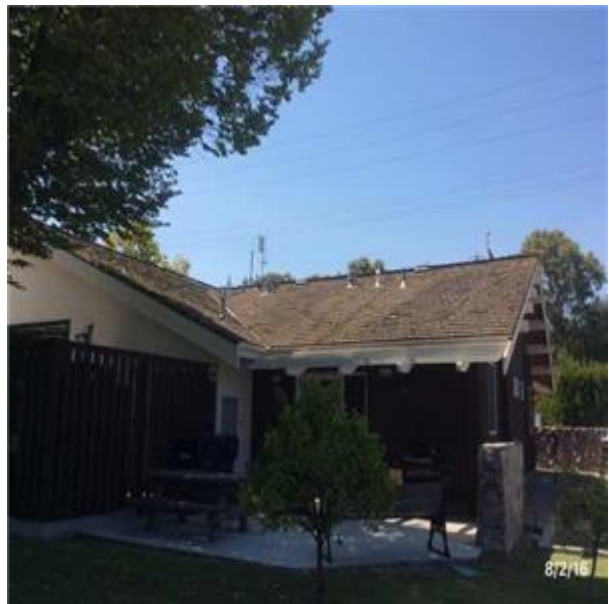
The wood shake roof was observed to be in fair condition. Based on EUL and appearance, Replacement is anticipated mid-term in the study period.

B3011 Roof Finishes:- View of Wood Shake Roof

ID	Type	Recommendation	Priority	Year	Expenditures
153552	B3010	Replace Wood Shake Roof	Priority 3	2020	\$47,937

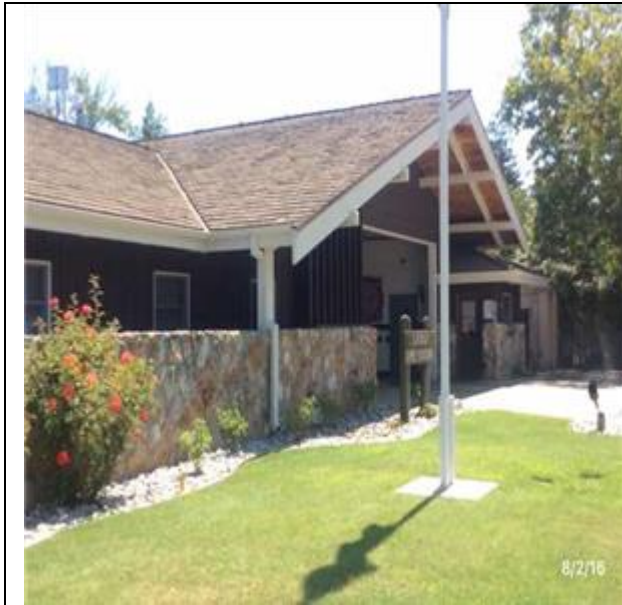
The gutters and downspouts were observed to be in fair to good condition and no actions are anticipated during the study period.

B3016 Gutters and Downspouts:- View of Galvanized Steel Perimeter Gutters & Downspout

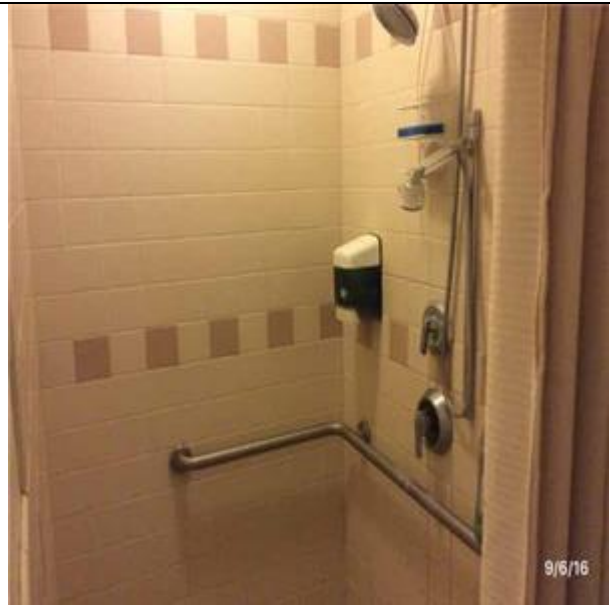
The ceramic tile wainscot at the restrooms / showers was observed to be in good condition and no actions are anticipated within the study period.

C3012 Wall Finishes to Interior Walls:- View of Ceramic Wall Tiles

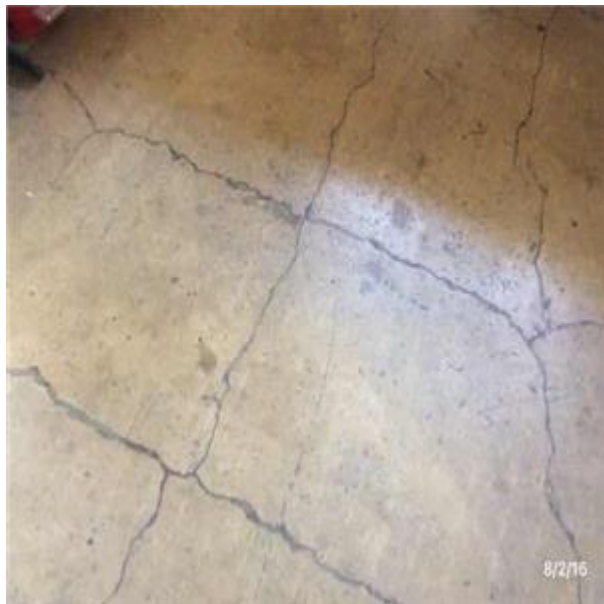
The concrete sealer was observed to be in fair condition. Resealing of the concrete should be anticipated early in the study period.

C3023 Hardeners and Sealers:- View of Seal Floor Coating

ID	Type	Recommendation	Priority	Year	Expenditures
153553	C3010	Replace Painted Finish - Standard	Priority 3	2020	\$11,136
153554	C3020	Replace Seal Floor Coating	Priority 3	2018	\$7,815
153555	C3020	Replace Broadloom Standard without Padding	Priority 3	2018	\$8,760

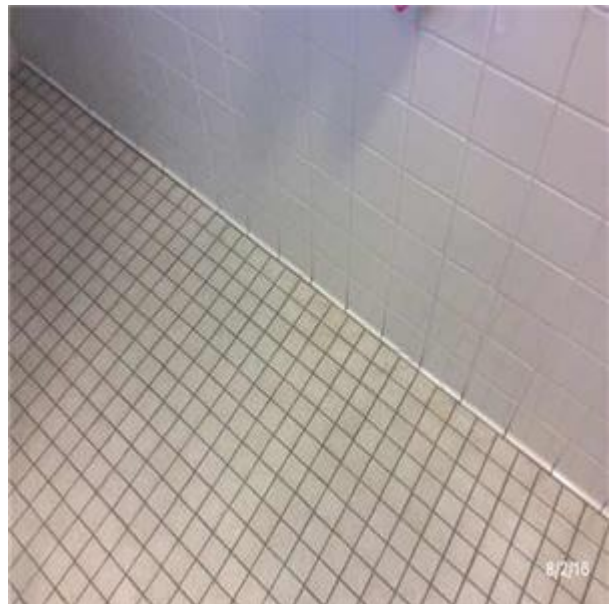
The ceramic tile flooring was observed to be in good condition and no actions are anticipated within the study period.

C3024 Flooring:- View of Ceramic Tile

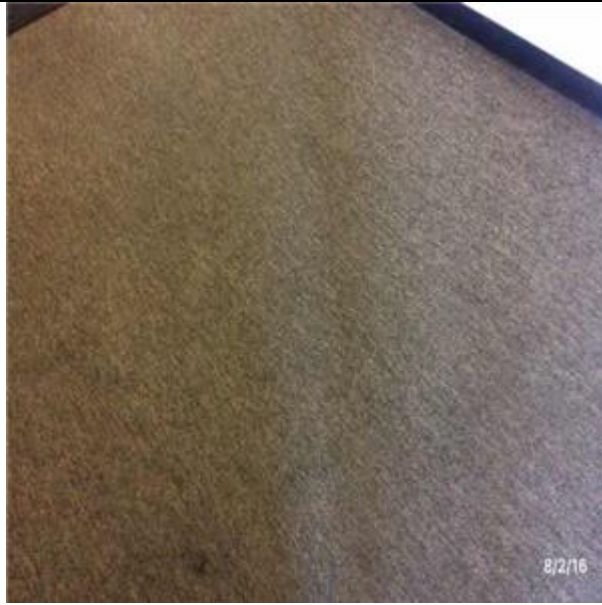
The carpet was observed to be in poor to fair condition and replacement should be anticipated early in the study period.

C3025 Carpeting:- View of Broadloom Standard without Padding

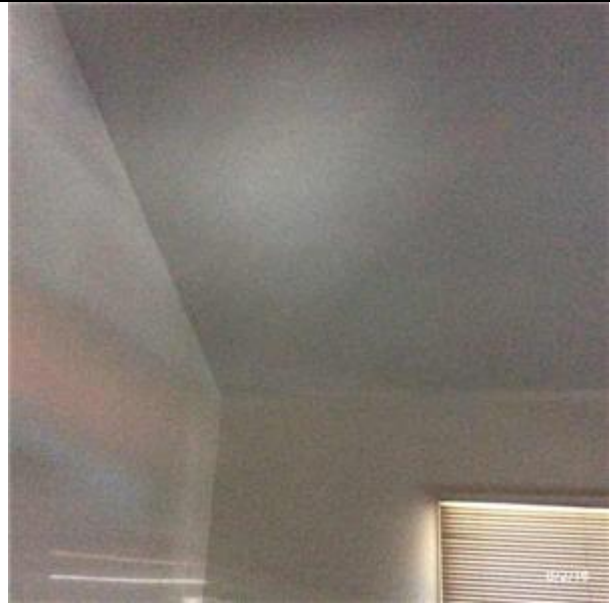
The GWB ceilings were observed to be in fair to good condition and no actions are anticipated within the study period.

C3031 Ceiling Finishes:- View of Gypsum Wall Board Ceilings

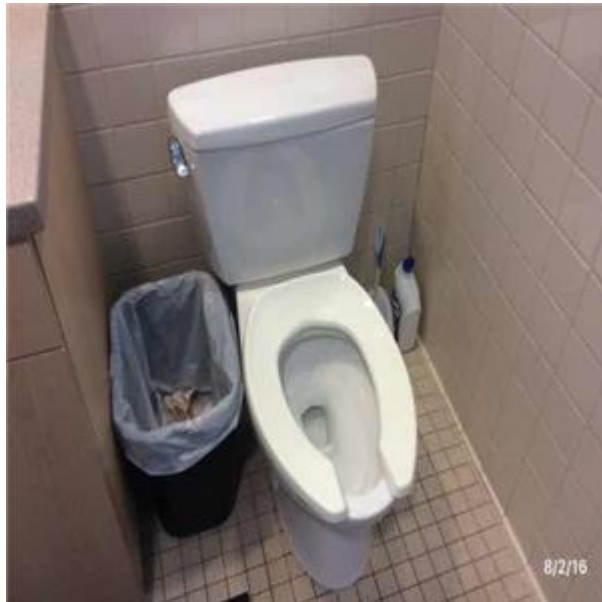
The water closets were observed to be in fair to good condition. The water closets flushed properly and did not have any cracks in the china and no actions are anticipated during the study period. It is expected that the flush valves may fail during the study period and may need to be rebuilt or in some cases replaced. This work has not been included in this study as we anticipate it will be carried out on an as-needed basis as part of routine maintenance.

D2011 Water Closets:- View of Floor Mounted Water Closets

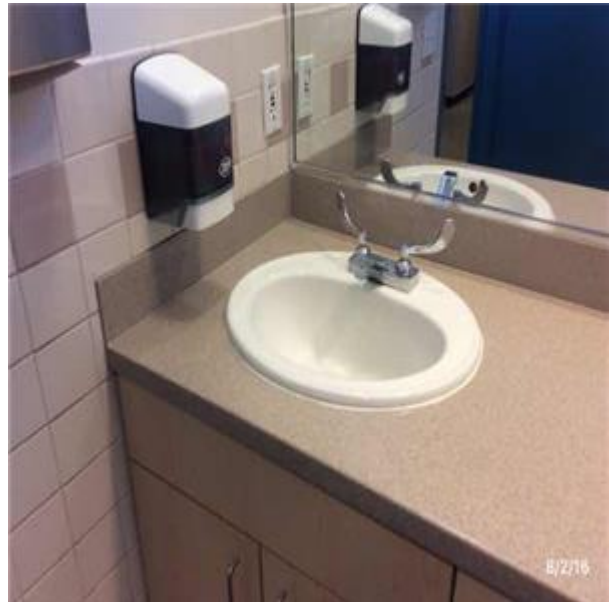
The lavatories were observed to be in fair to good condition. The lavatories drained properly with no deficiencies noted and no actions are anticipated during the study period.

D2013 Lavatories:- View of Vanity Top Lavatories

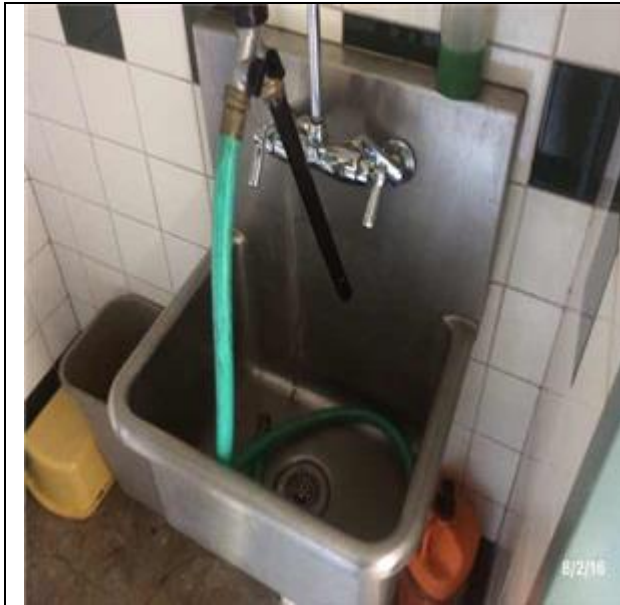
The service sink was observed to be in fair condition with no serious deficiencies noted and no actions are anticipated during the study period.

D2014 Sinks:- View of Service Sink Wall Mounted

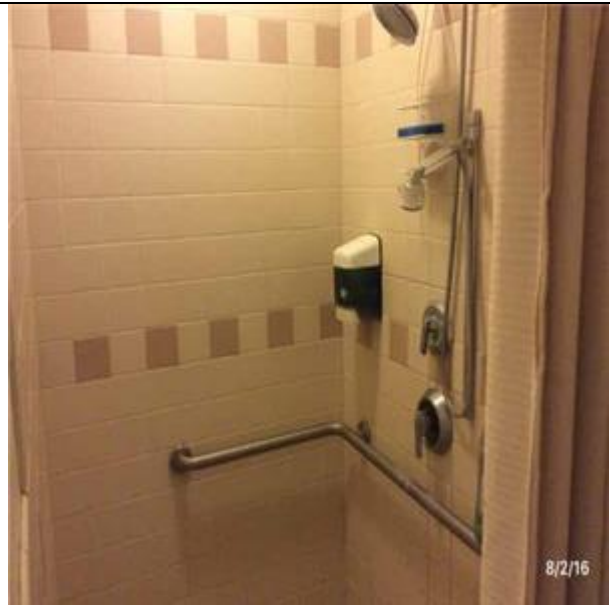
The ceramic tile shower stalls were observed to be in fair to good condition with no noted deficiencies and no actions will be generated within the study period.

D2017 Showers:- View of Shower - Three Wall Ceramic Tile

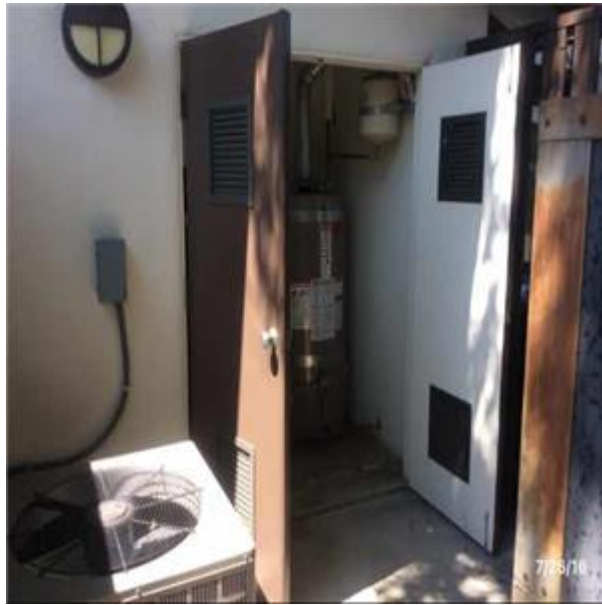
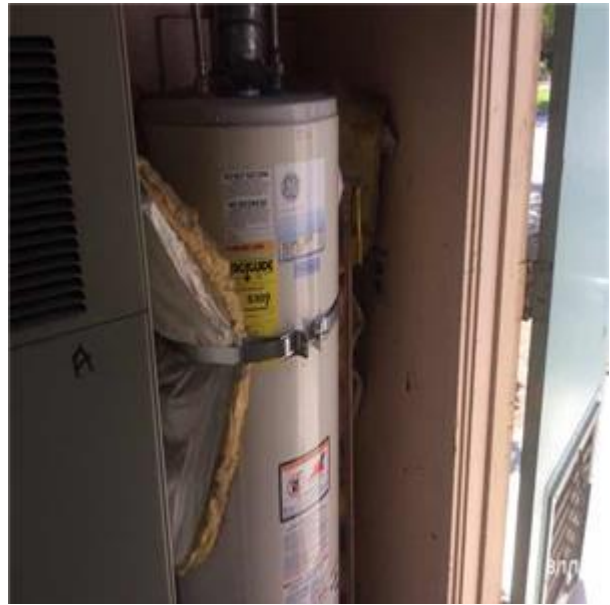
The water heater was observed to be in fair to good condition. Based on EUL, replacement is anticipated late in the study period.

D2022 Hot Water Service:- View of Domestic Hot Water Heater - Gas

ID	Type	Recommendation	Priority	Year	Expenditures
153556	D2020	Replace Domestic Hot Water Heater - Gas	Priority 3	2025	\$3,352

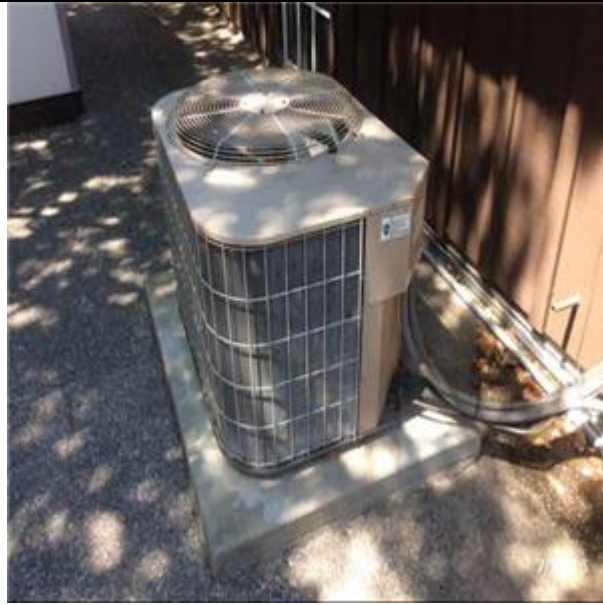
The condensing units appeared to be in fair to good condition. Based on the estimated date in service, replacement is not anticipated during the study period.

D3032 Direct Expansion Systems:- View of Split-System
(Outdoor Unit Only - Compressor and Condenser)

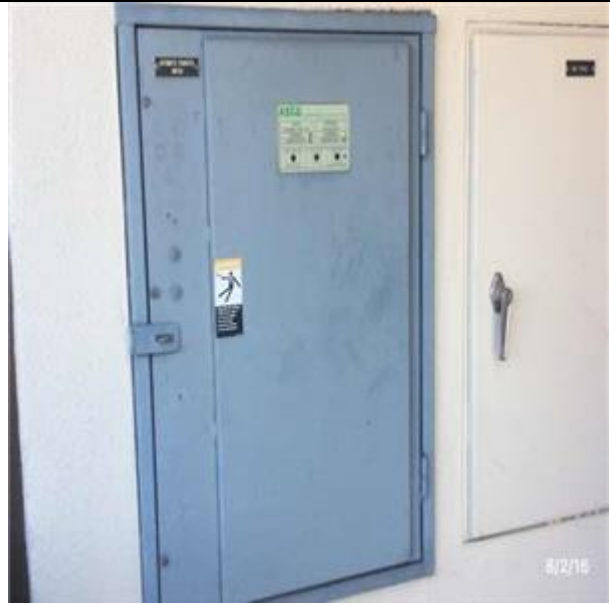
The emergency generator and transfer switch were observed to be in poor to fair condition and based on EUL, replacement is recommended early in the study period.

D5012 Low Tension Service & Dist:- View of Emergency
Generator Transfer Switch

ID	Type	Recommendation	Priority	Year	Expenditures
153580	D5010	Replace Emergency Generator Transfer Switch	Priority 3	2018	\$8,610

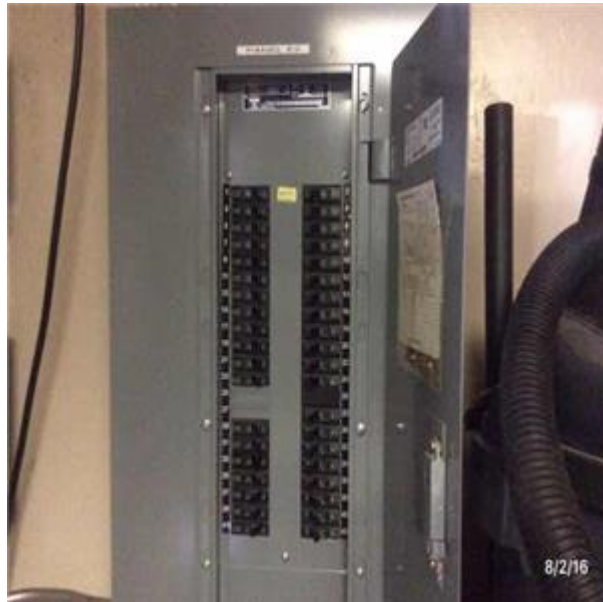
The main distribution panel and subpanel were observed to be in fair to good condition and no actions are anticipated during the study period.

D5012 Low Tension Service & Dist:- View of Panelboard -
120/240volts, 60 to 2000amp

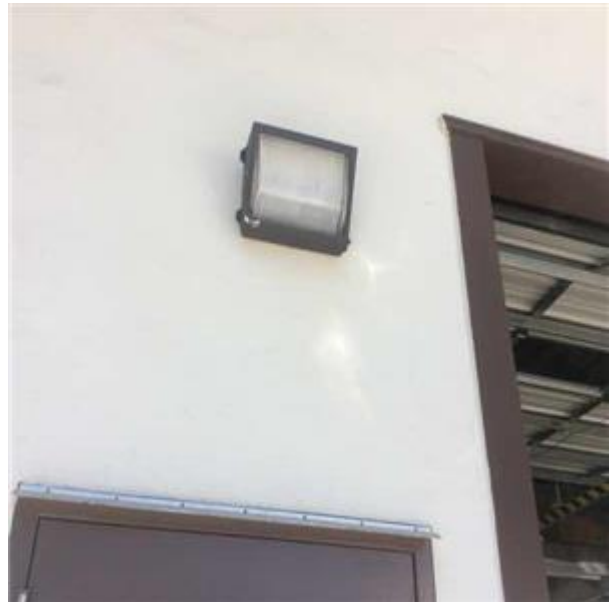
The wall packs were observed to be in fair to good condition and no actions are anticipated during the study period.

D5022 Lighting Equipment:- View of Exterior Wall Pack Light
Fixtures

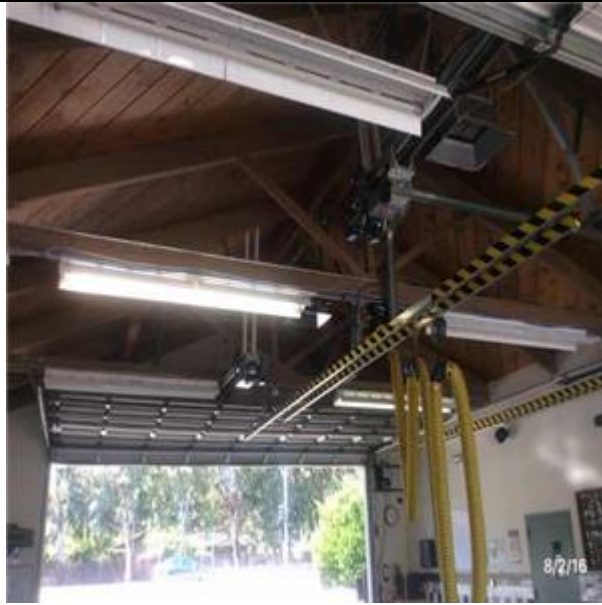
The fluorescent fixtures were observed to be in fair to good condition and no actions are anticipated during the study period.

D5022 Lighting Equipment:- View of Interior Light Fixtures -
Fluorescent

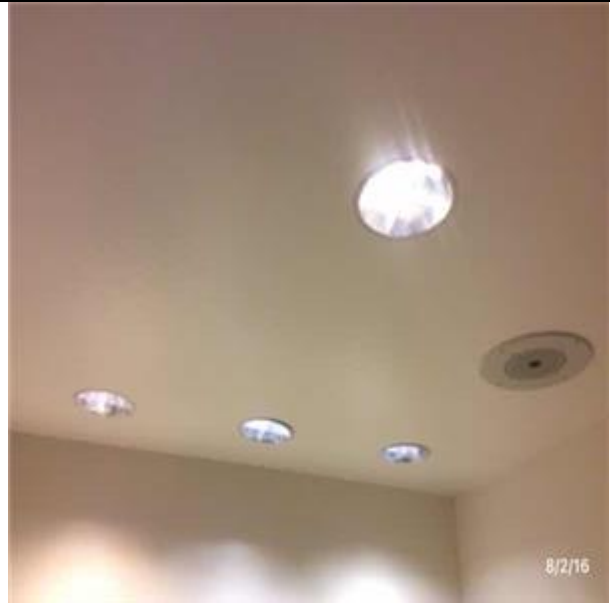
The recessed can fixtures were observed to be in fair to good condition and no actions are anticipated during the study period.

D5022 Lighting Equipment:- View of Recessed Can Light
Fixtures

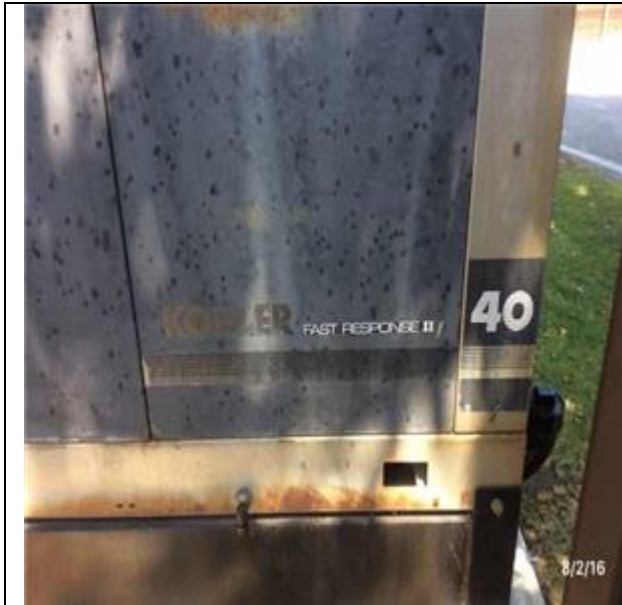
G4092 Site Emergency Power Generation:- View of Generator
Sets, Diesel Engine - 50 kW

ID	Type	Recommendation	Priority	Year	Expenditures
153560	G4090	Replace Generator Sets, Diesel Engine - 50 kW	Priority 1	2018	\$58,130
