**Tier 1 Report of
Facility Condition Assessment**

**For
City of Los Altos
Main Library
13 S. San Antonio Road
Los Altos,
California 94022-3000**

Date of Report: October 13, 2016

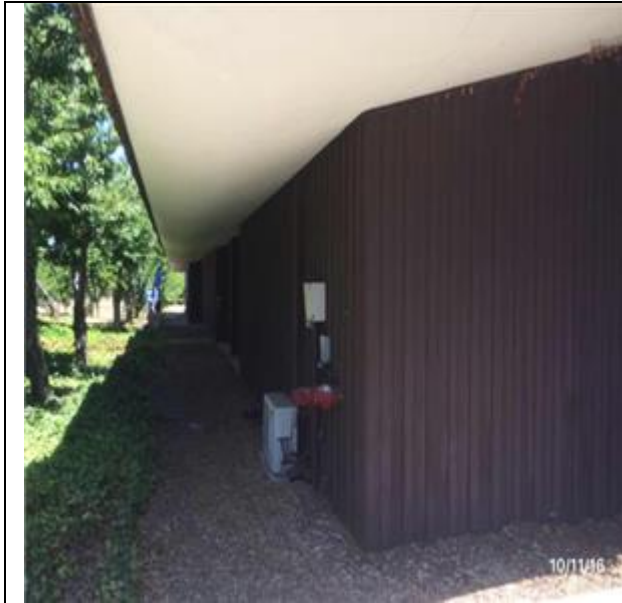
The exterior wall construction was observed to be in fair condition. We do not anticipate replacement during the study period. The wood cladding has been regularly painted. We recommend repainting of the surface of the wood during the term in the study period to maintain the appearance of the building and also the wood itself.

B2011 Exterior Wall Construction:- View of Wood Clapboard Siding

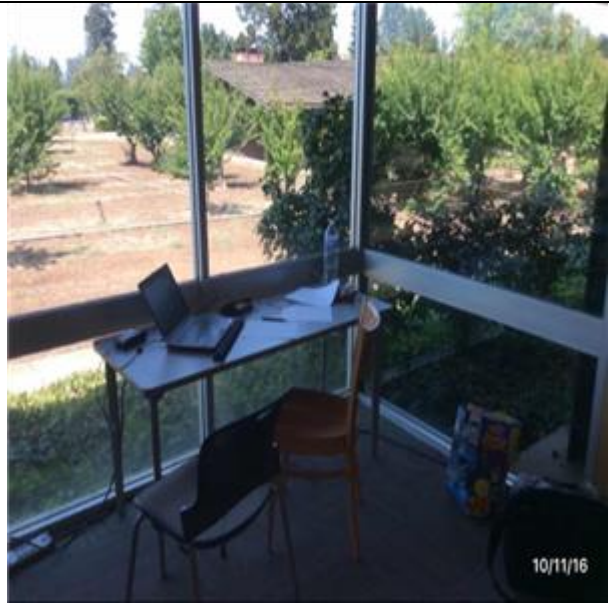
The window systems appeared to be in fair condition. Based on a EUL of thirty years we do not anticipate replacement during the study period.

B2021 Windows:- View of Aluminum Window Units - Fixed or Single Hung

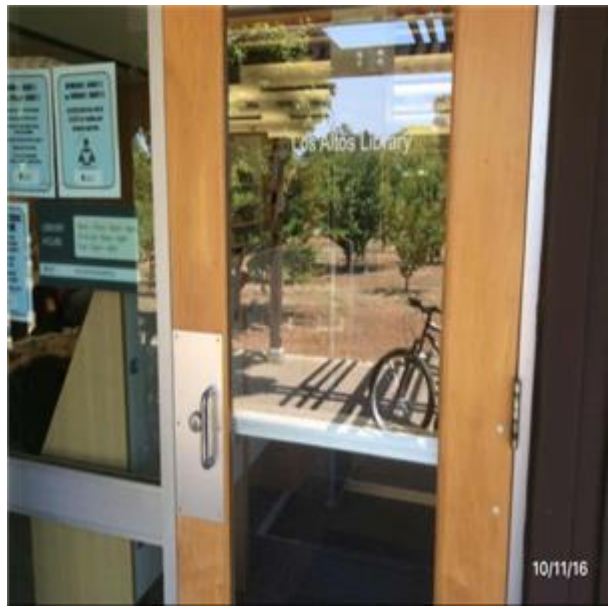
The doors were observed to be in fair condition and are assumed to be replaced in 1993 as part of the expansion to the building. The typical EUL for this type of equipment is thirty years and no actions are anticipated during the study period aside from painting and ADA modifications.

B2031 Glazed Doors & Entrances:- View of Single Wood Glazed Doors

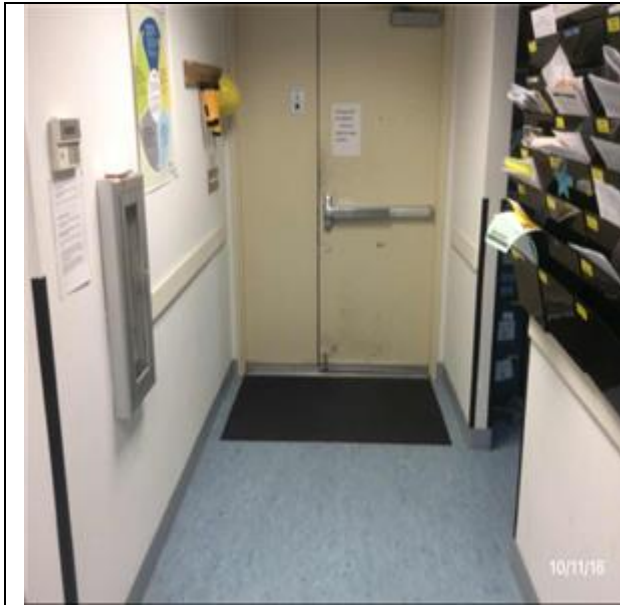
B2039 Other Doors & Entrances:- View of Single Hollow Metal Doors

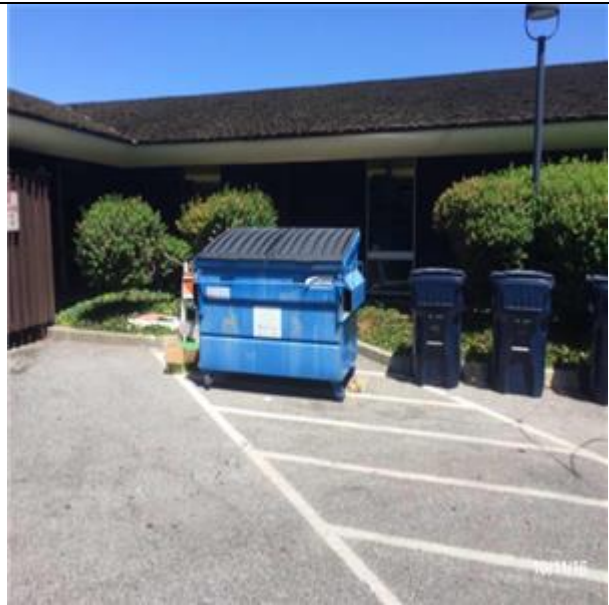
The wood shake roof was observed to be in fair condition with no issues reported by maintenance, however we did observe staining to the acoustic suspended ceiling tiles, but we are uncertain if this was from roof leaks or leaking HVAC equipment. Based on the EUL of twenty years and observed condition, replacement can be anticipated towards the mid-term of the study period.

B3011 Roof Finishes:- View of Wood Shake Roof

ID	Type	Recommendation	Priority	Year	Expenditures
154860	B3010	Replace Wood Shake Roof	Priority 3	2021	\$167,976

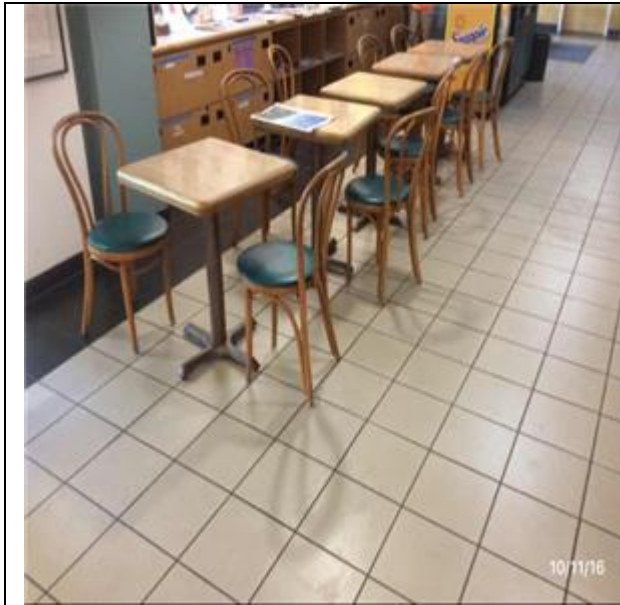
The floor finishes appeared in fair condition throughout the building. The ceramic tile at the restrooms was in fair condition given its age. The ceramic tile has a EUL of thirty years. We did not observe any broken or loose tiles or missing grout; therefore, we expect the ceramic tile to last beyond the study period. The vinyl sheet has a EUL of eighteen years; therefore we have included for replacement during the study period.

C3024 Flooring:- View of Ceramic Tile

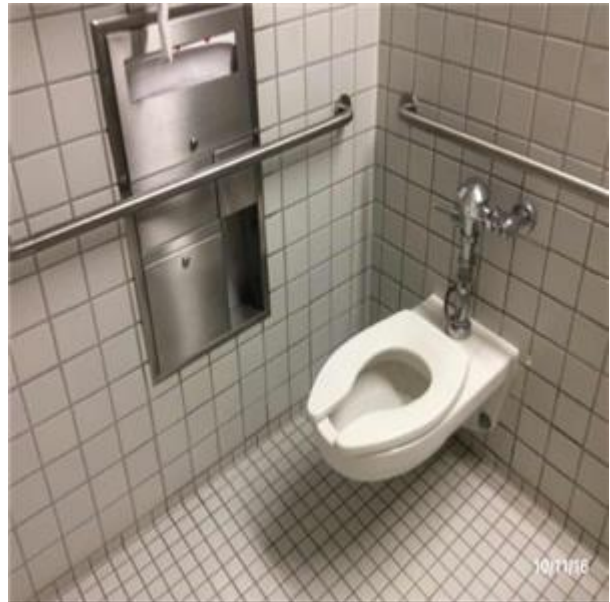
The water closets were observed to be in fair to good condition. The water closets flushed properly and did not have any cracks in the china therefore no actions will be generated during the study period. We anticipate that the flush valves may fail during the study period and therefore to maintain function they may need to be rebuilt or in some cases replaced. This work has not been included in this study as we anticipate it will be carried out on an as-needed basis as part of routine maintenance.

D2011 Water Closets:- View of Wall Mounted Water Closets

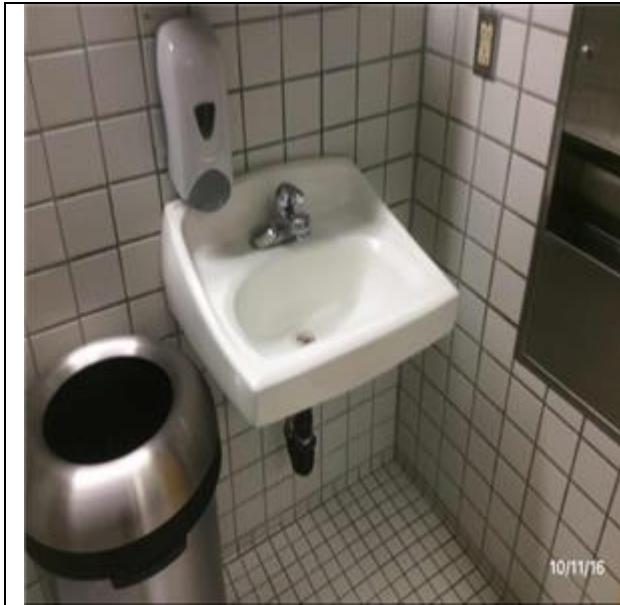
The lavatories appear to be in fair to good condition; the lavatories drained properly and did not have any cracks in the china therefore no actions will be generated, as we anticipate that they are suitable to last beyond the study period. We anticipate that the faucets may fail during the study period and therefore to maintain function they may need to be replaced. These works have not been included in the study period, as they are to be undertaken as part of routine maintenance.

D2013 Lavatories:- View of Wall Hung Lavatories

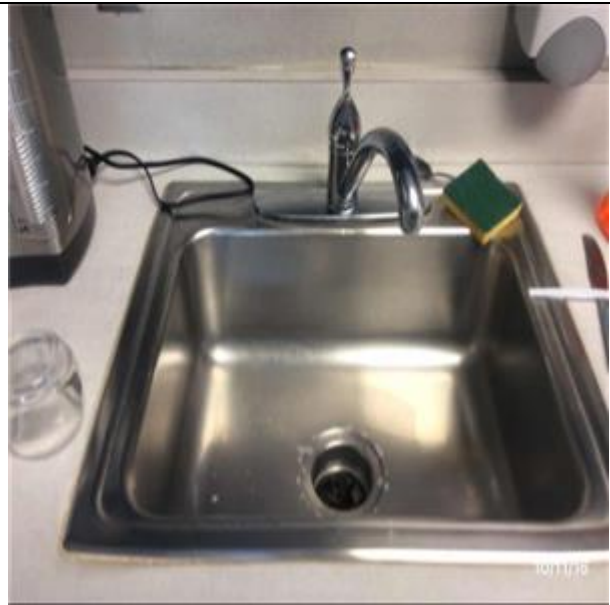
The kitchen countertop single bowl kitchen sink and Janitor's service sink were observed to be in fair condition and with no issues reported; therefore, based on the RUL, no action is necessary during the study period.

D2014 Sinks:- View of Countertop Single Bowl Kitchen Sinks

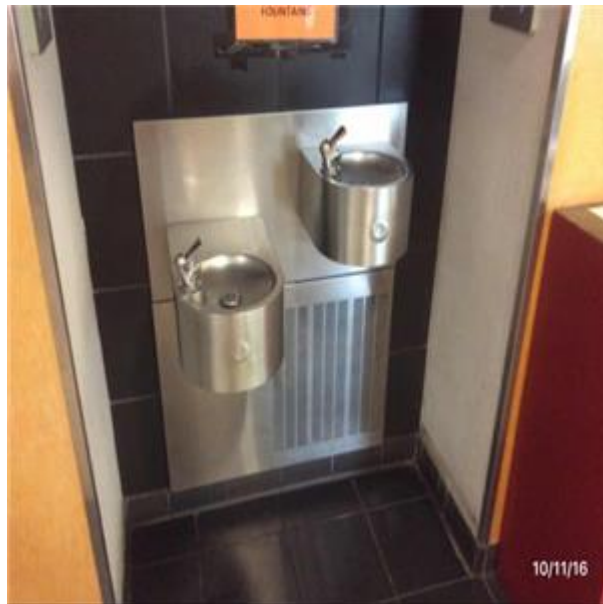
The facility contains two stainless steel wall mounted single level drinking fountain that is believed to have been installed as part of the original construction. The maintenance staff reported that the chillers to the units no longer work.

The drinking fountains were observed to be operational but in poor condition. Replacement is recommended early in the study period with the applicable ADA modifications.

D2018 Drinking Fountains and Coolers:- View of Wall Mounted Standard Drinking Fountain (Single)

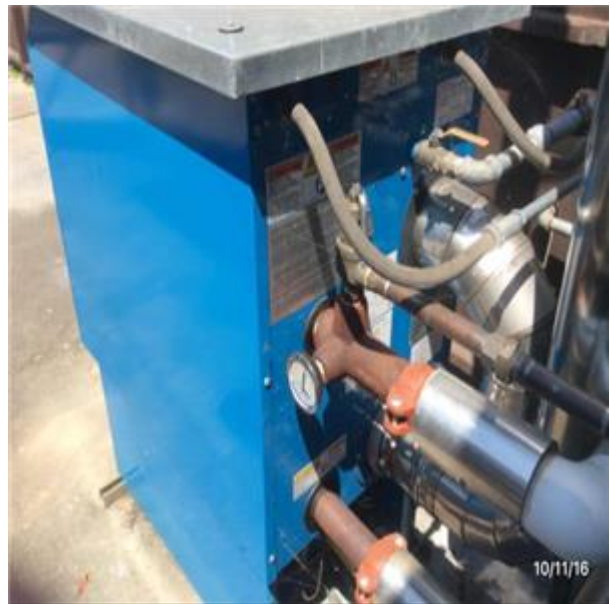
The gas fired boiler was observed to be in fair condition the typical EUL is thirty five years; therefore replacement is not anticipated within the study period.

D3021 Boilers:- View of Furnace – Gas

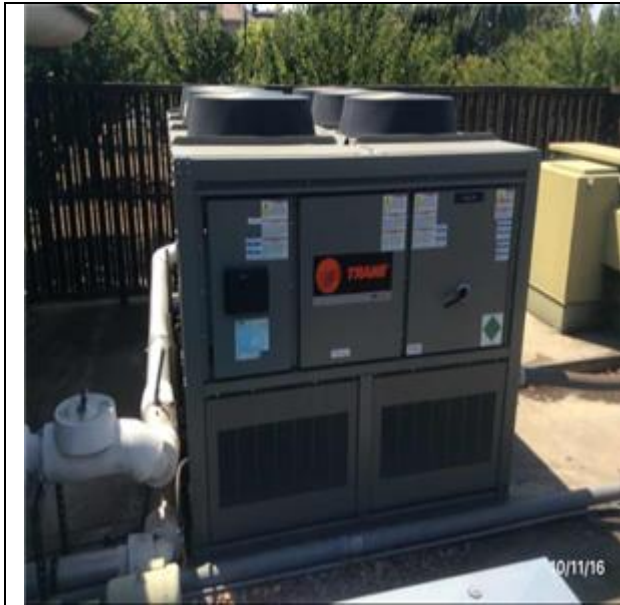
D3052 Package Units:- View of Packaged Outdoor - Cooling Only

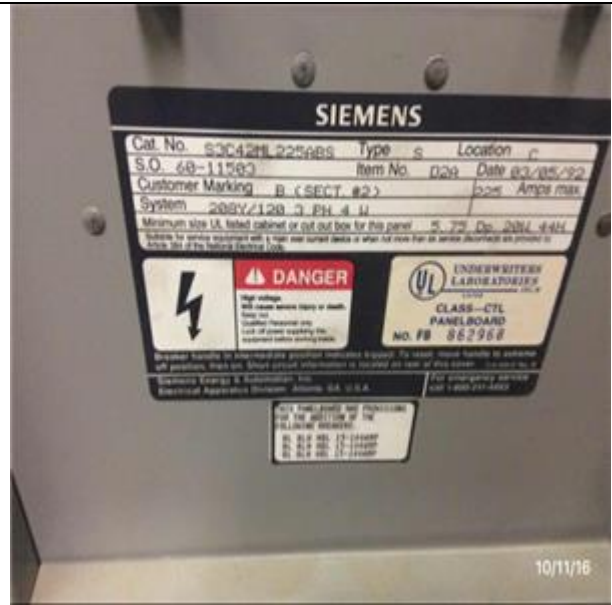
D5012 Low Tension Service & Dist:- View of Panelboard - 120/208volts, 225amp

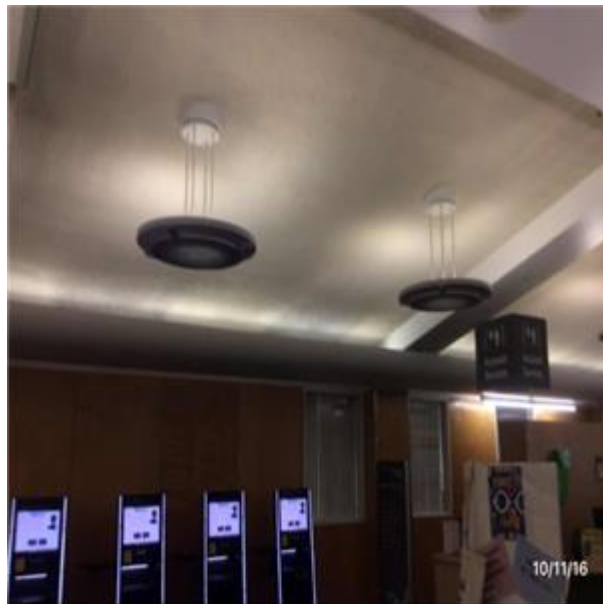
D5022 Lighting Equipment:- View of Feature Light Fixtures to Lobby

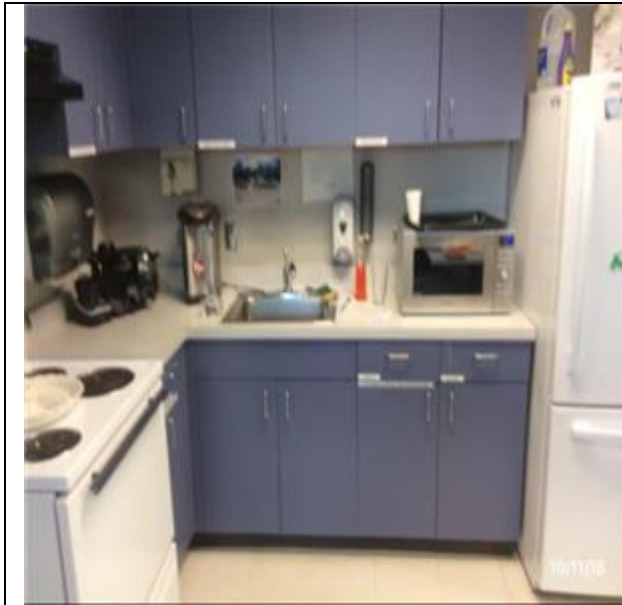
E2012 Fixed Casework:- View of Fixed Casework - Counter
Top - Laminated
