Tier 1 Report of

Facility Condition Assessment

For
City of Los Altos
Marymead Park - Restroom
1221 Fremont Ave
Los Altos,
California 94024

Date of Report: September 28, 2016

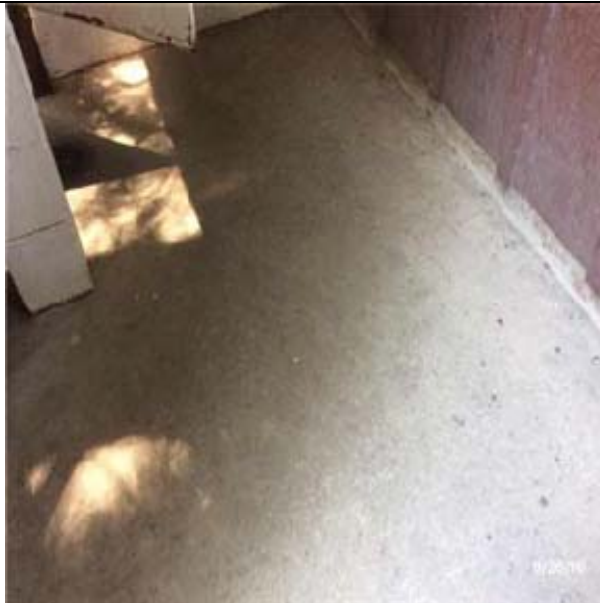
The slab-on-grade was observed to be in fair condition with no signs of undue settling or cracks noted. Replacement is not anticipated during the study period.

A1031 Standard Slab on Grade:- View of Slab-on-Grade Reinforced Concrete

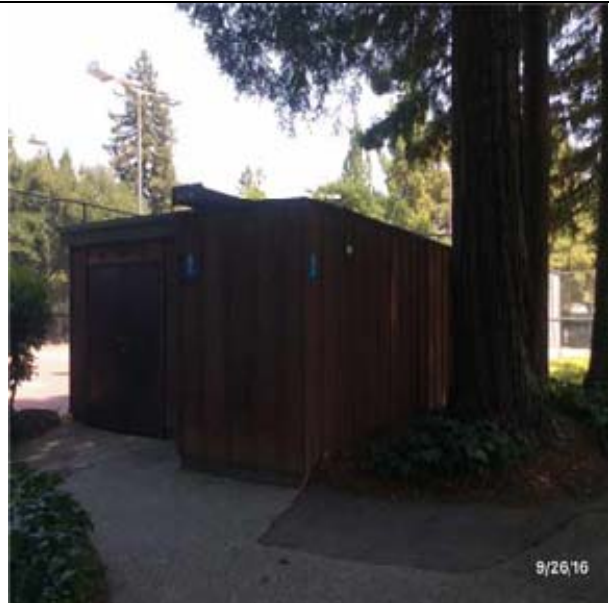
The wall construction was observed to be in fair condition and well maintained with no instances of deterioration, cracking or damage observed. No actions will be generated during the study period for works associated with the structural wood frame structure.

B2011 Exterior Wall Construction:- View of Wood Clapboard Siding

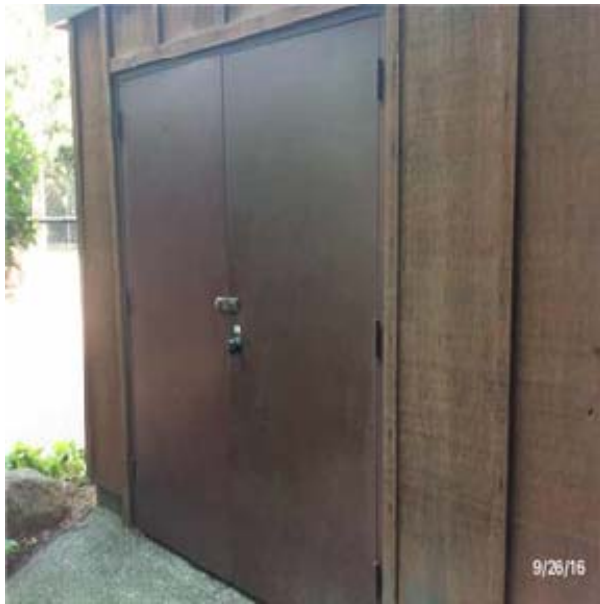
The double hollow metal door was observed to be in fair to good condition exhibiting minimal scratching or denting. No actions are anticipated during the study period aside from re-painting as part of routine maintenance.

B2039 Other Doors & Entrances:- View of Double HM Doors

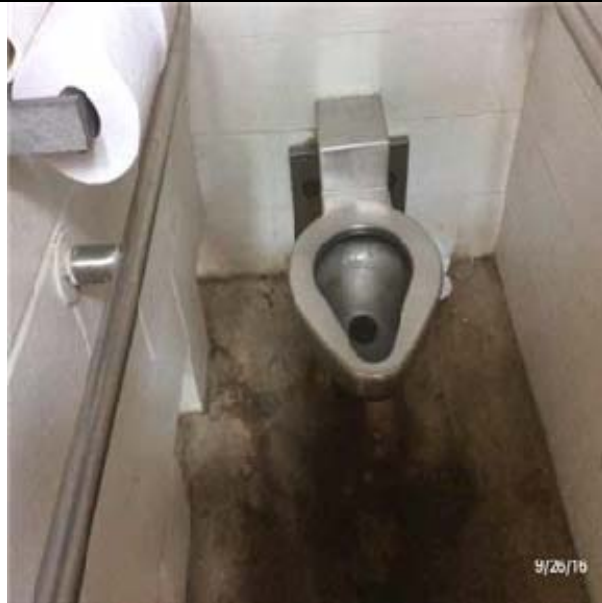
The water closets were observed to be in fair to good condition with minimal signs of scratching or denting and no actions are anticipated during the study period with normal routine maintenance, aside from ADA modifications,

D2011 Water Closets:- View of Wall Mounted Water Closets

ID	Type	Recommendation	Priority	Year	Expenditures
150965	D2010	ADA Modifications to Water Closets	Priority 1	2016	\$2,000
150966	D2010	ADA Modifications to Lavatories	Priority 1	2016	\$5,000

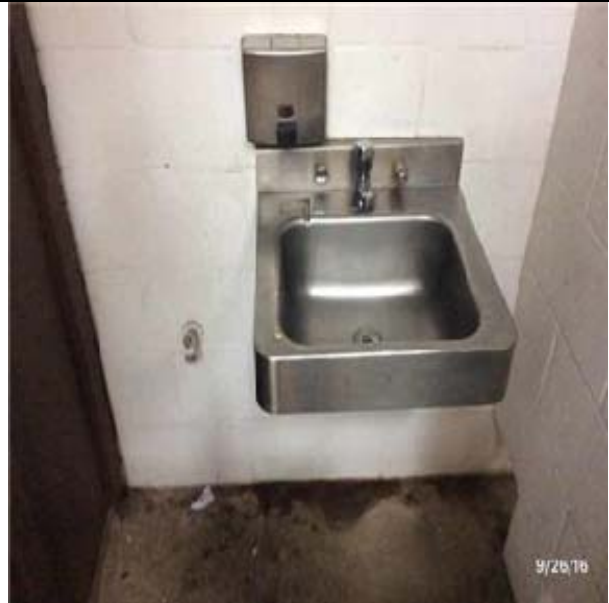
The stainless steel sinks were observed to be in fair to good condition and no actions are anticipated during the study period aside from ADA modifications.

D2013 Lavatories:- View of Wall Hung Lavatories

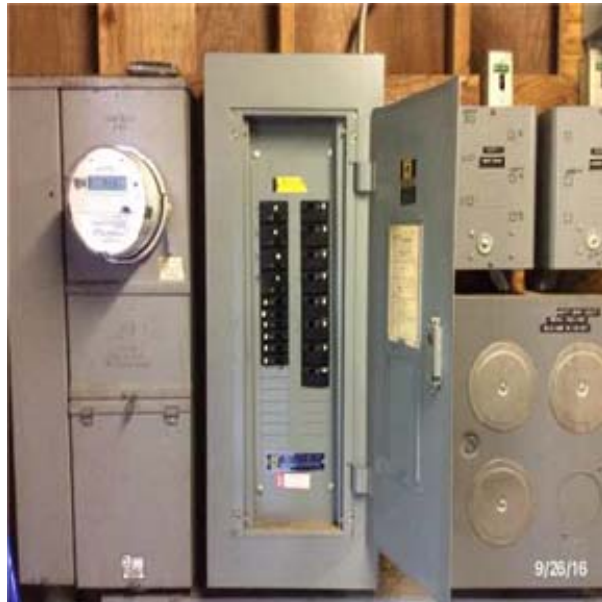
The electric service distribution panel appears to have been replaced at some point after the initial 1960 installation as it was observed to be in fair to good condition. No actions are anticipated during the study period.

D5012 Low Tension Service & Dist:- View of Panelboard -
120/240volts, 60 to 2000amp

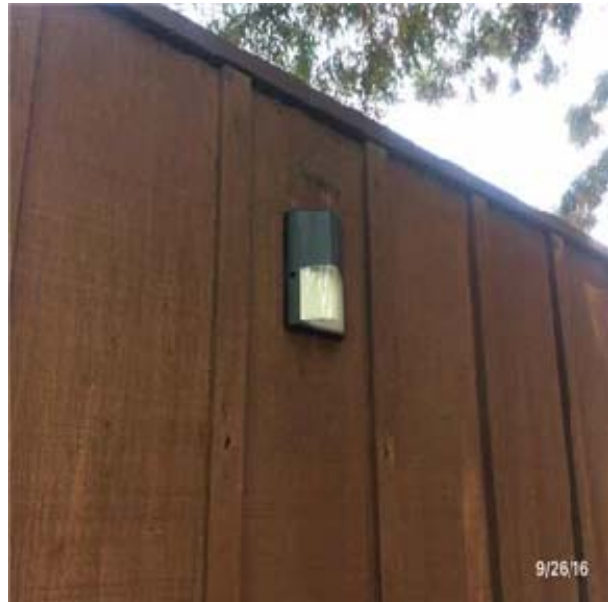
The fluorescent fixtures were observed to be in fair condition. Although RUL has been extended for interior and exterior lights, replacement of both types can be anticipated later in the study period.

D5022 Lighting Equipment:- View of Exterior Wall Pack
Light Fixtures

ID	Type	Recommendation	Priority	Year	Expenditures
150967	D5020	Replace Interior Light Fixtures - Fluorescent	Priority 3	2024	\$3,385
150968	D5020	Replace Exterior Wall Pack Light Fixtures	Priority 3	2024	\$1,808

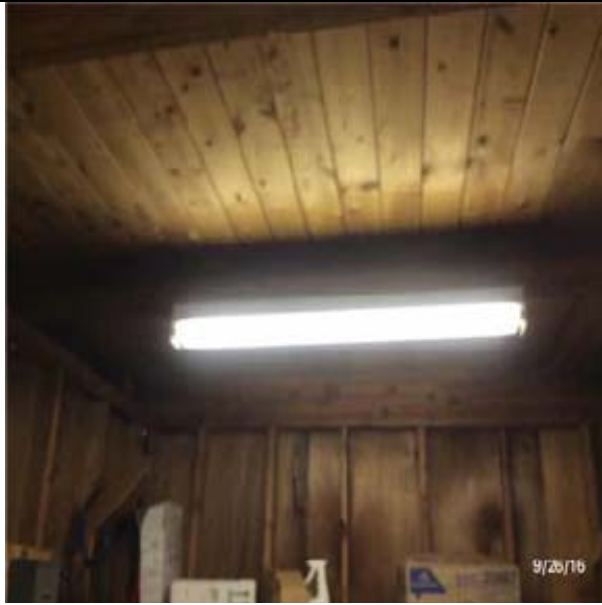
D5022 Lighting Equipment:- View of Interior Light Fixtures -
Fluorescent
