Facility Condition Assessment Services

Facility Condition Assessment

**For
City of Los Altos
Municipal Service Center - Admin
707 Fremont Ave
Los Altos,
California 94024-5408**

Date of Report: October 10, 2016

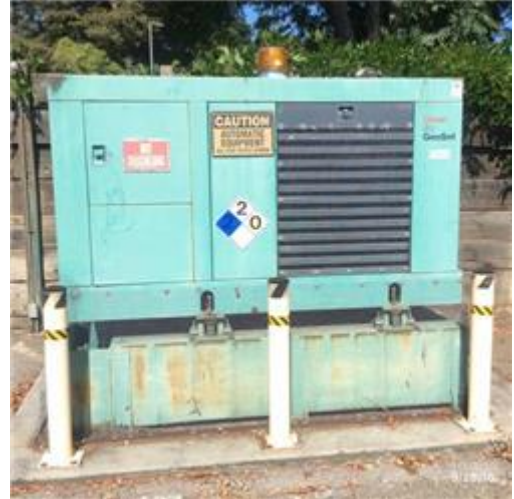
There is a diesel powered emergency generator set present at the facility with an estimated capacity of 80 Kw.

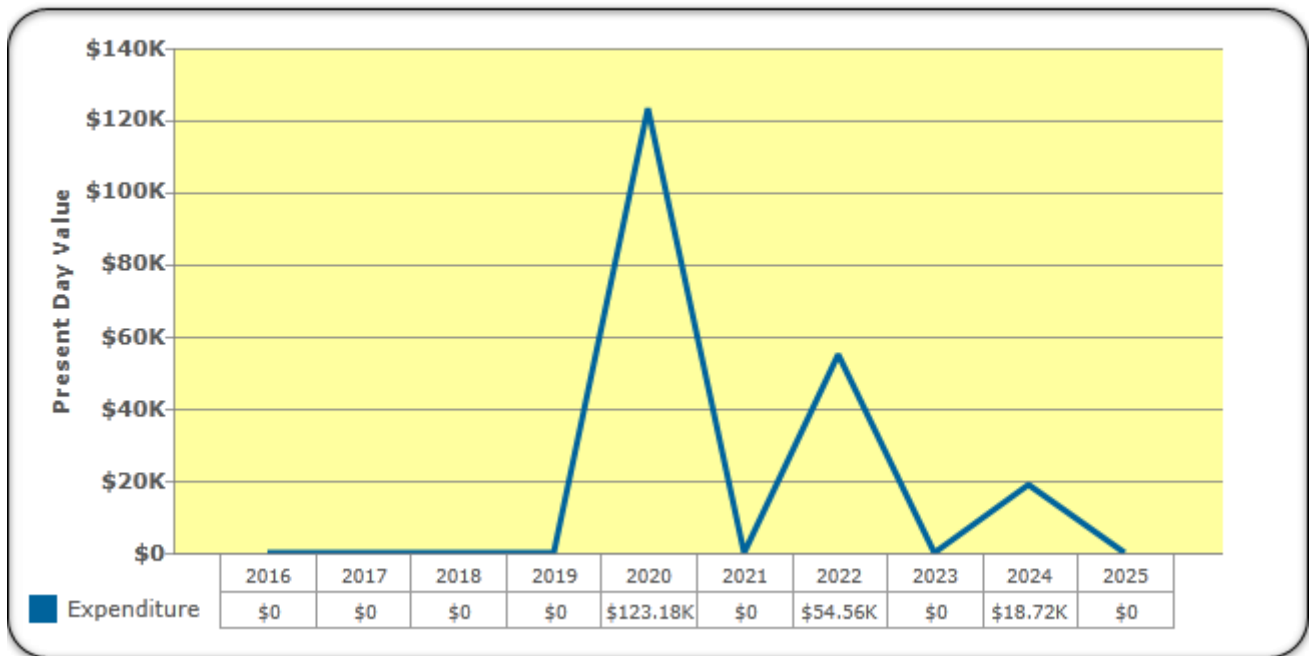
Expenditure Forecast Over Study Period

The building expenditure summary section provides an executive overview of the findings from the assessment. The chart below provides a summary of yearly anticipated expenditures over the study period for the Municipal Service Center - Admin building. In addition, we have scheduled key findings highlighting items greater than \$5,000 and their anticipated failure year. Further details of these expenditures are included within each respective report section and within the expenditure forecast, in Appendix A of this report. The results illustrate a total anticipated expenditure over the study period of approximately \$196,466.

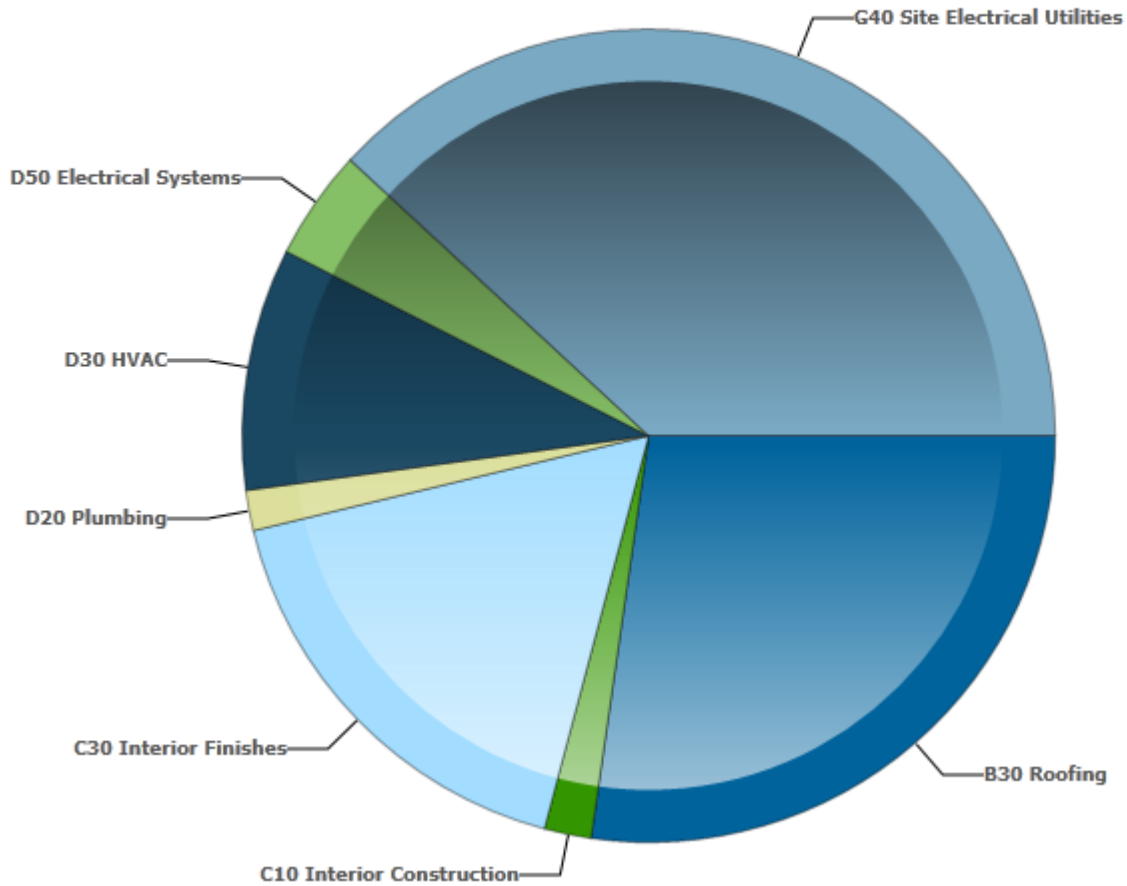
Distribution of Capital Needs by Building System

Building System	Estimated Cost	Percentage of Total Cost
B30 Roofing	\$53,569	27.3%
C10 Interior Construction	\$3,666	1.9%
C30 Interior Finishes	\$33,634	17.1%
D20 Plumbing	\$3,149	1.6%
D30 HVAC	\$18,934	9.6%
D50 Electrical Systems	\$8,610	4.4%
G40 Site Electrical Utilities	\$74,904	38.1%
Total	\$196,466	100%

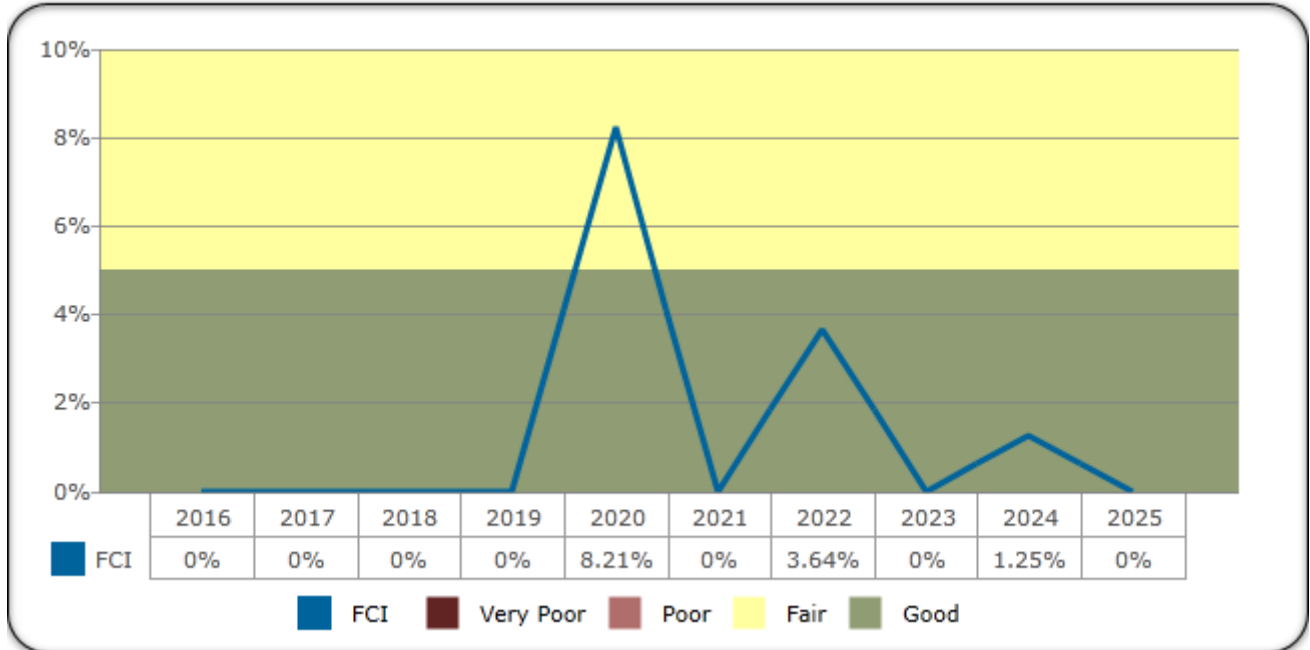
Year by Year Effects of FCI Over the Study Period

The chart below indicates the effects of the FCNI ratio per year, assuming the required funds and expenditures **ARE** made to address the identified actions each year.

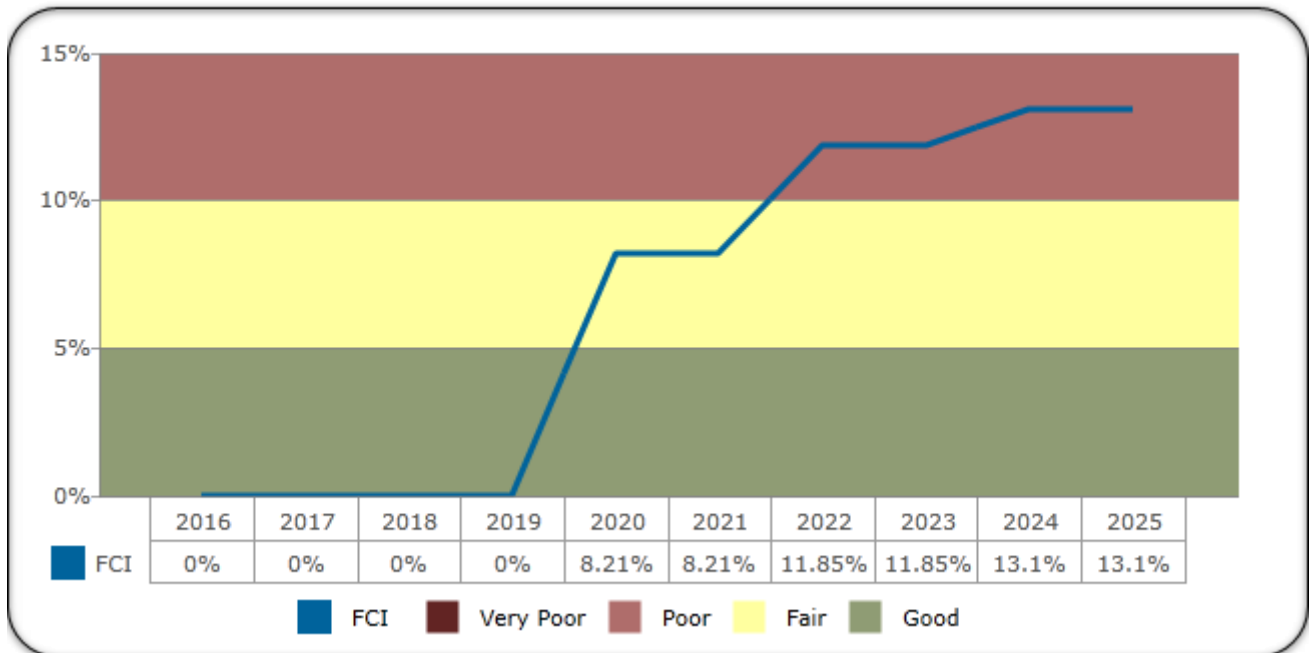
Cumulative Effects of FCI over the Study Period

The Chart below indicates the cumulative effects of the FCNI ratio over the study period assuming the required funds and expenditures are **NOT** provided to address the identified works and deferred maintenance each year.

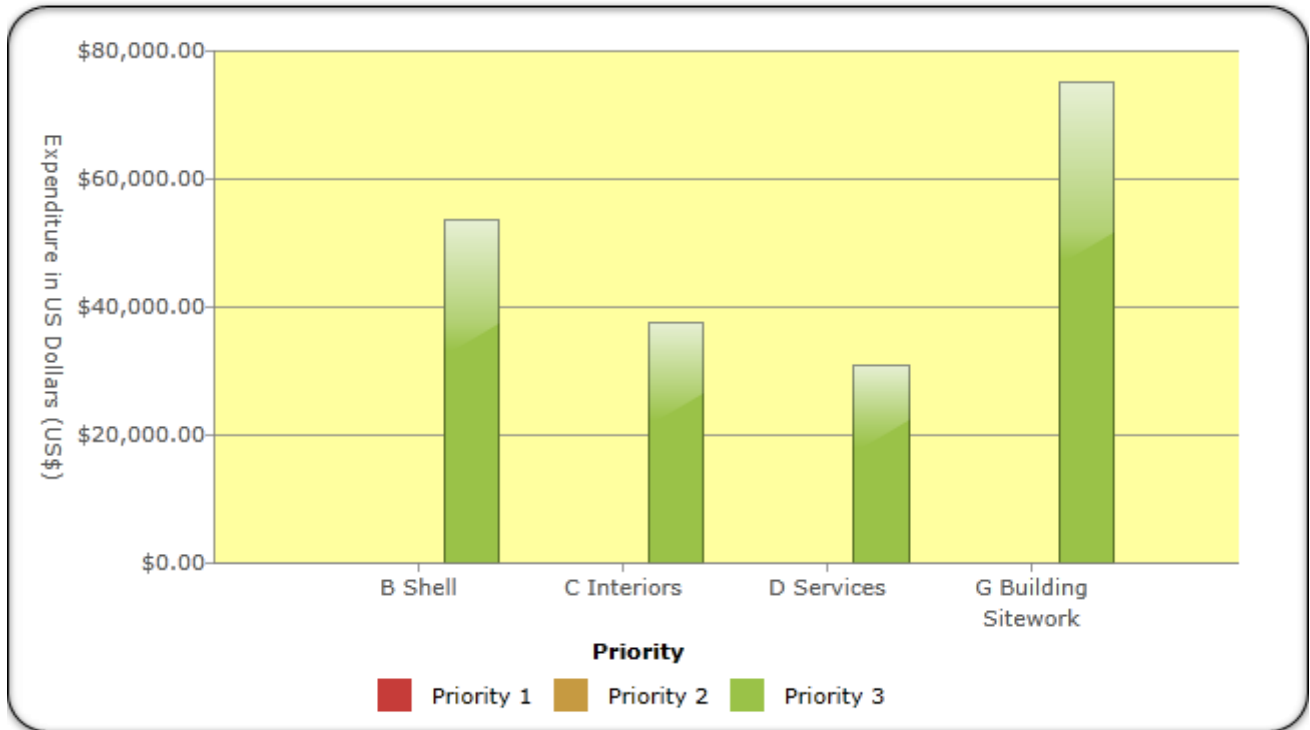
Planning Horizon Needs by System and Priority

The chart below illustrates the breakdown of expenditure according the priority coding providing an opportunity to strategically plan and effectively direct funding to the highest priority.

Building System	Priority 1	Priority 2	Priority 3	Total
B Shell	\$0	\$0	\$53,569	\$53,569
C Interiors	\$0	\$0	\$37,300	\$37,300
D Services	\$0	\$0	\$30,694	\$30,694
G Building Sitework	\$0	\$0	\$74,904	\$74,904
Totals	\$0	\$0	\$196,466	\$196,466

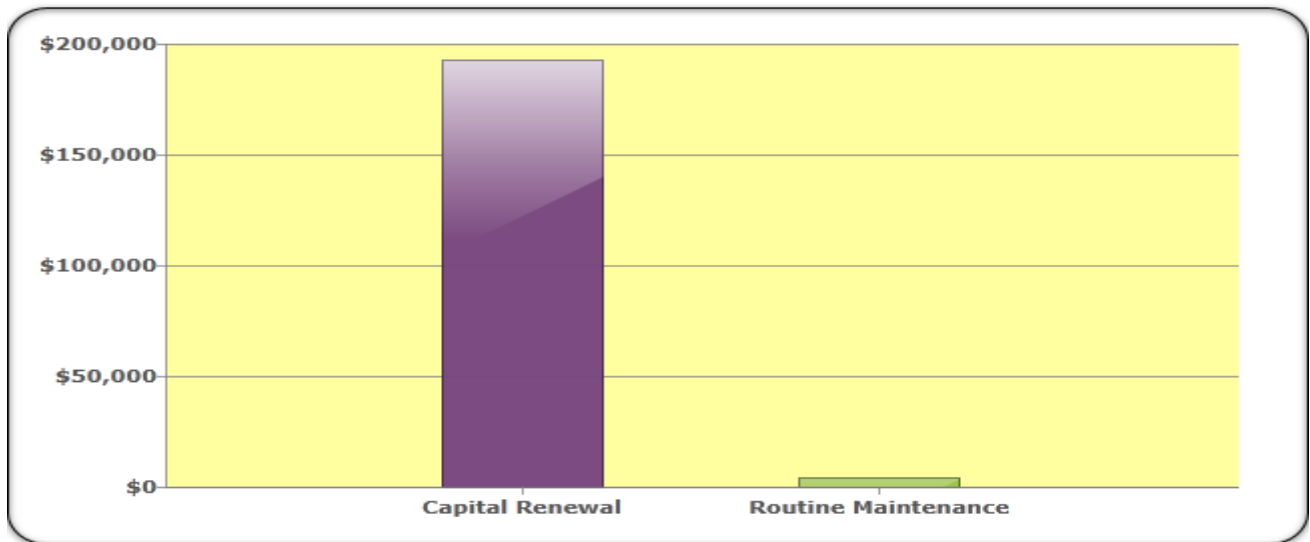
Planning Horizon Needs by Category

The chart below illustrates the breakdown of expenditure according to the Plan Type or deficiency categories providing an opportunity to strategically plan and effectively direct funding.

Building System	Total Cost
Capital Renewal	\$192,800
Routine Maintenance	\$3,666
Total	\$196,466

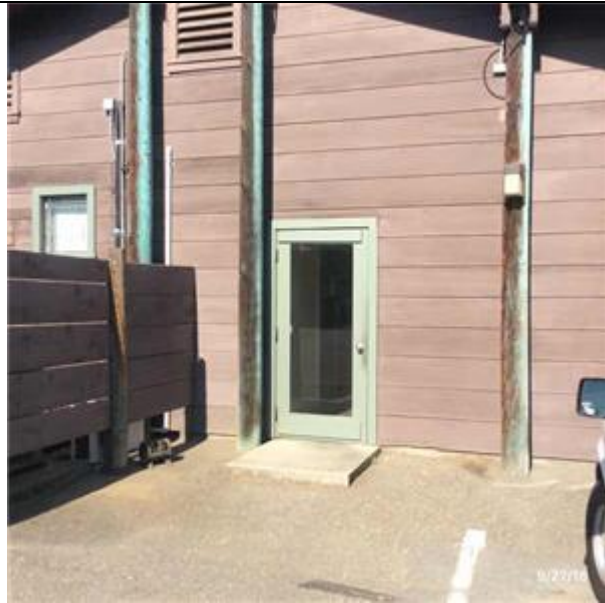
The exterior wall construction was observed to be in fair to good condition with no appreciable deterioration present and no actions are anticipated during the study period.

B2011 Exterior Wall Construction:- View of Wood Clapboard Siding

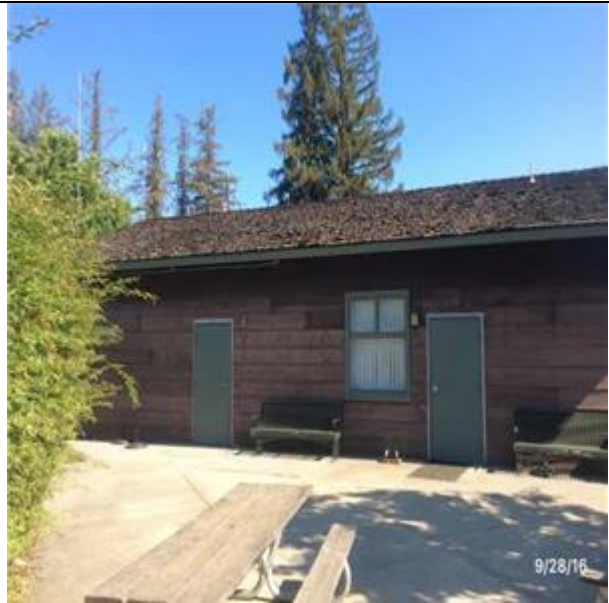
The exterior windows were observed to be well maintained in fair to good condition and no repair or replacement actions are anticipated during the study period.

B2021 Windows:- View of Wood Window Units - Fixed or Single Hung

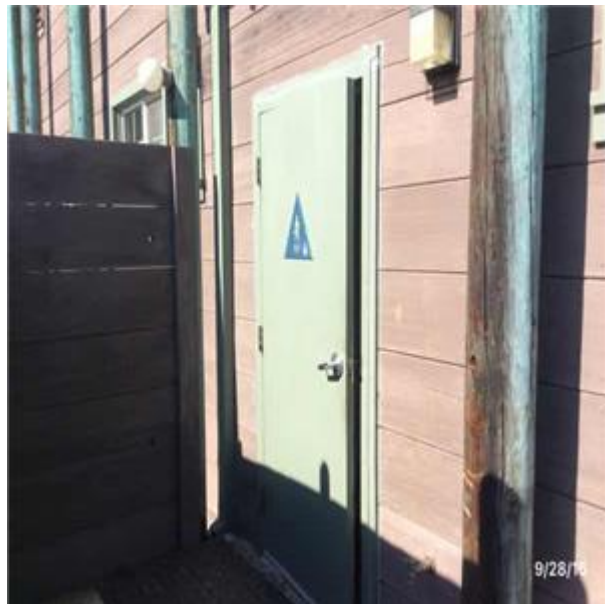
The single hollow metal doors were observed to be in fair to good condition and no actions are anticipated during the study period aside from painting as part of routine maintenance.

B2039 Other Doors & Entrances:- View of Single HM Doors

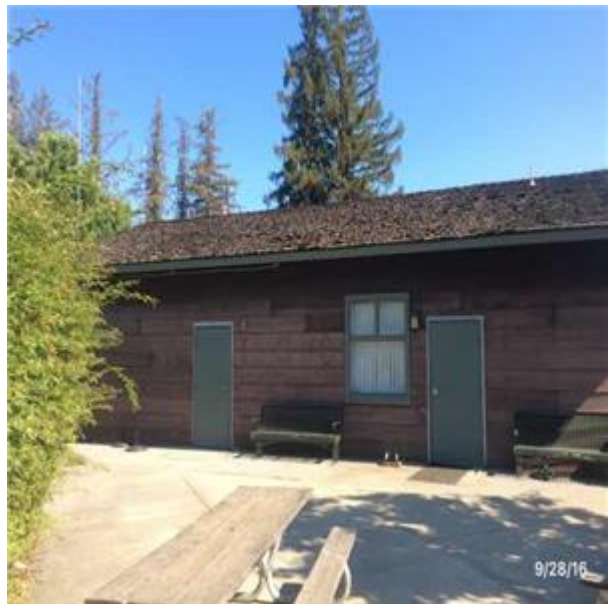
The wood shake roof covering was observed to be showing signs of deterioration. Roof replacement is anticipated mid-term in the study period

B3011 Roof Finishes:- View of Wood Shake Roof

ID	Type	Recommendation	Priority	Year	Expenditures
153329	B3010	Replace Wood Shake Roof	Priority 3	2022	\$53,569

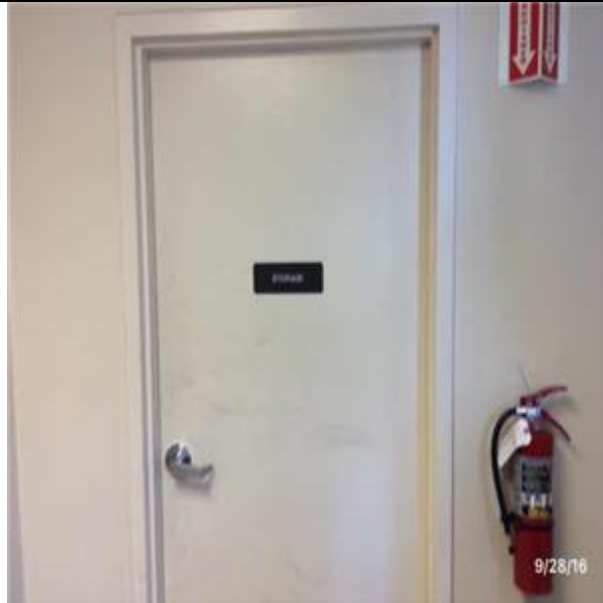
The wood doors were observed to be in fair to good condition with no signs of significant damage or deterioration and no actions are anticipated within the study period aside from painting as part of routine maintenance.

C1021 Interior Doors:- View of Interior Single Wood Door(s)

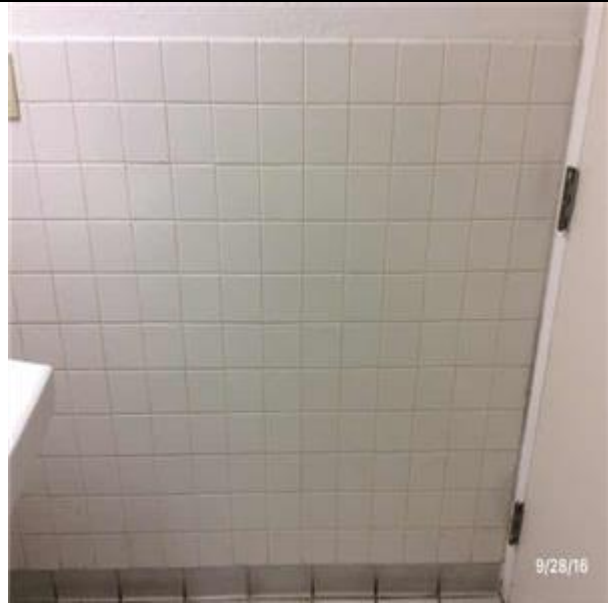
The ceramic wall tile was installed as part of a 1995 remodeling and was observed to be in good condition. No repair or replacement actions are anticipated during the study period.

C3012 Wall Finishes to Interior Walls:- View of Ceramic Wall Tiles

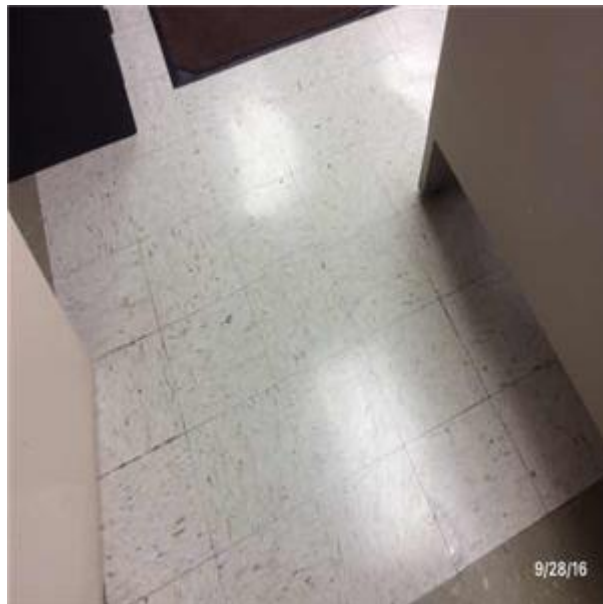
The VCT was observed to be in fair to good condition and no actions are anticipated within the study period.

C3024 Flooring:- View of Vinyl Composite Tile (VCT)

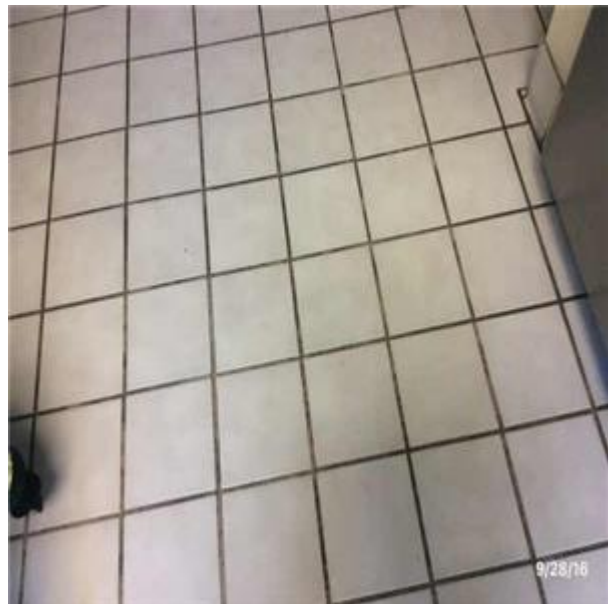
The ceramic floor tile was generally found to be in fair to good condition and no actions are anticipated within the study period.

C3024 Flooring:- View of Ceramic Tile

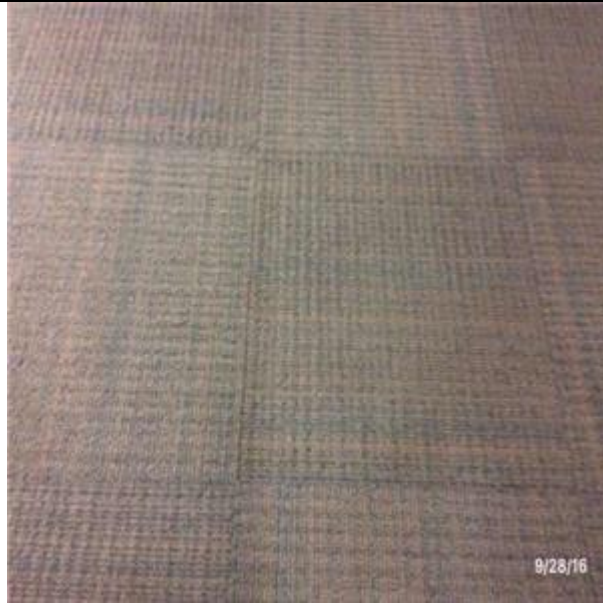
The carpet tiles appeared to be in fair to good condition. Based on EUL and observed condition, replacement can be anticipated later in the study period.

C3025 Carpeting:- View of Carpet Tiles – Standard

ID	Type	Recommendation	Priority	Year	Expenditures
153331	C3010	Replace Painted Finish - Standard	Priority 3	2020	\$18,059
153332	C3020	Replace Carpet Tiles - Standard	Priority 3	2024	\$15,575

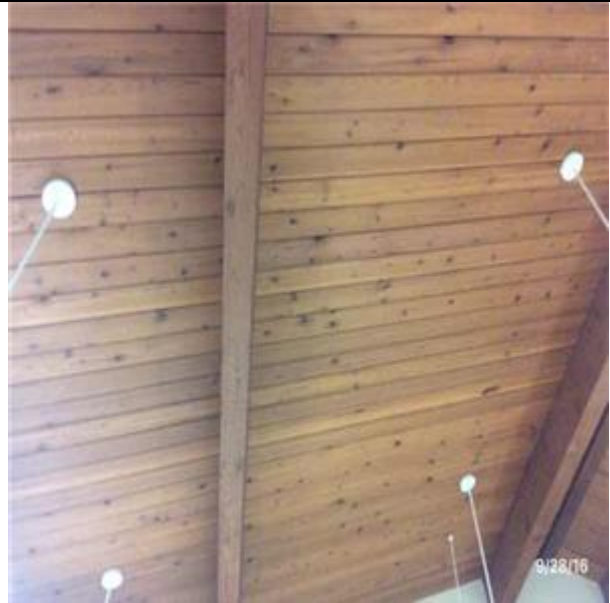
The conference area ceiling was observed to be in good condition and no actions are anticipated within the study period.

C3031 Ceiling Finishes:- View of Wood Ceiling - Painted or Stained

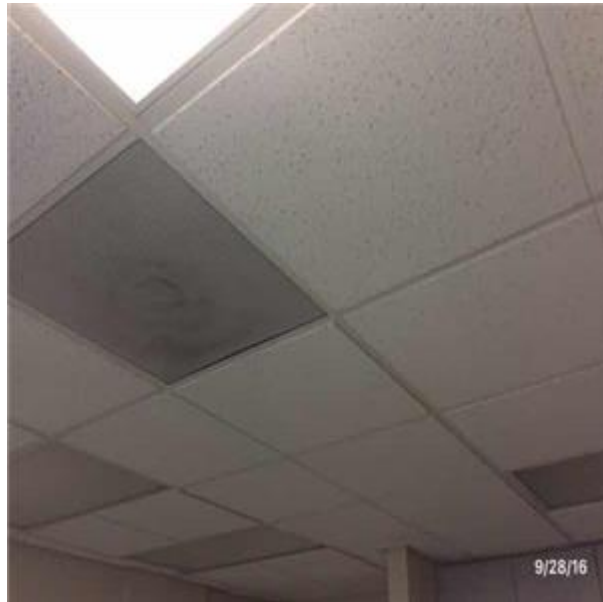
The acoustic tile ceiling was observed to be in fair to good condition and no actions are generated during the study period.

C3032 Suspended Ceilings:- View of Acoustic Ceiling System
- Standard

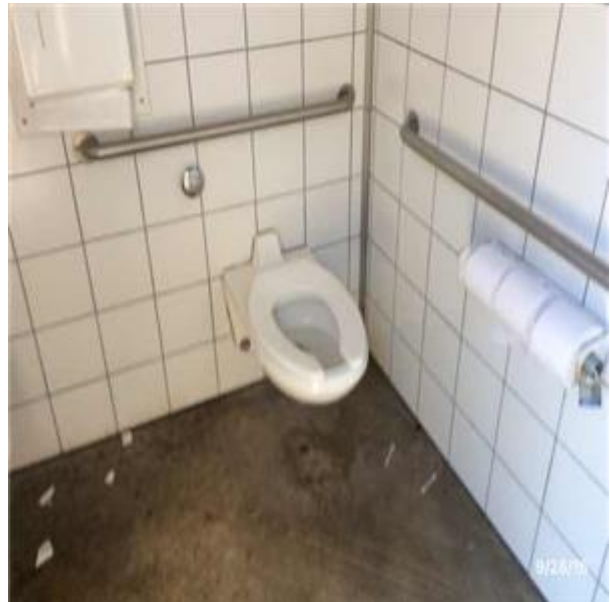
The water closets were observed to be in fair to good condition. The water closets flushed properly and did not have any cracks in the china and no actions are anticipated during the study period. It is expected that the flush valves may fail during the study period and may need to be rebuilt or in some cases replaced. This work has not been included in this study as we anticipate it will be carried out on an as-needed basis as part of routine maintenance.

D2011 Water Closets:- View of Wall Mounted Water Closets

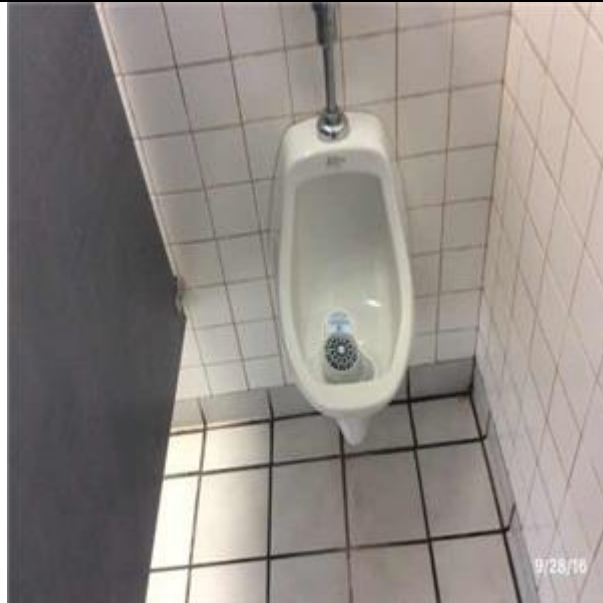
The urinal was observed to be in fair to good condition. The urinal flushed properly and did not have any cracks in the china and no actions are anticipated during the study period. It is expected that the flush valves may fail during the study period and may need to be rebuilt or in some cases replaced. This work has not been included in this study as we anticipate it will be carried out on an as-needed basis as part of routine maintenance.

D2012 Urinals:- View of Wall Hung Urinals

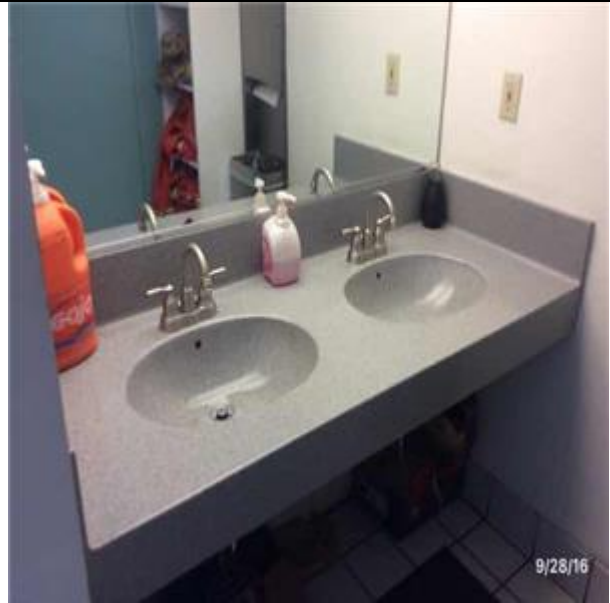
The lavatories were observed to be in fair to good condition having been installed during the 1995 remodeling project. The lavatories drained properly with no deficiencies noted and no actions are anticipated during the study period.

D2013 Lavatories:- View of Vanity Top Lavatories

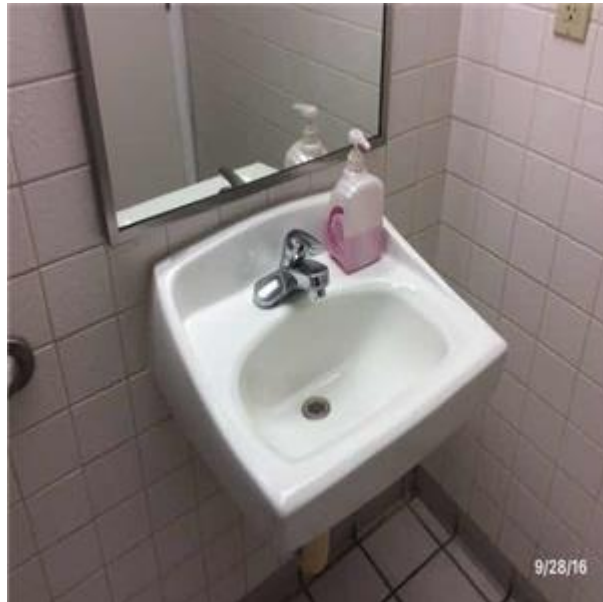
The lavatory drained properly with no noted deficiencies to the china or faucet. No actions are anticipated during the study period.

D2013 Lavatories:- View of Wall Hung Lavatories

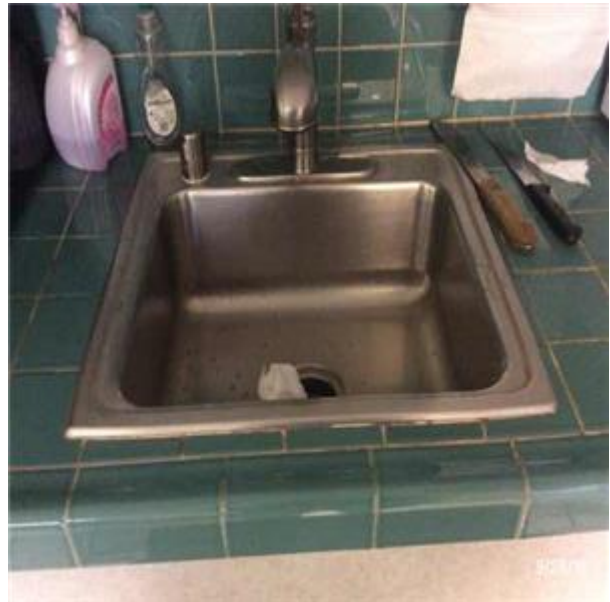
The counter top stainless sink was observed to be in good condition and no deficiencies were noted to the sink or the faucet. No repair or replacement actions are anticipated within the study period.

D2014 Sinks:- View of Countertop Single Bowl Kitchen Sink

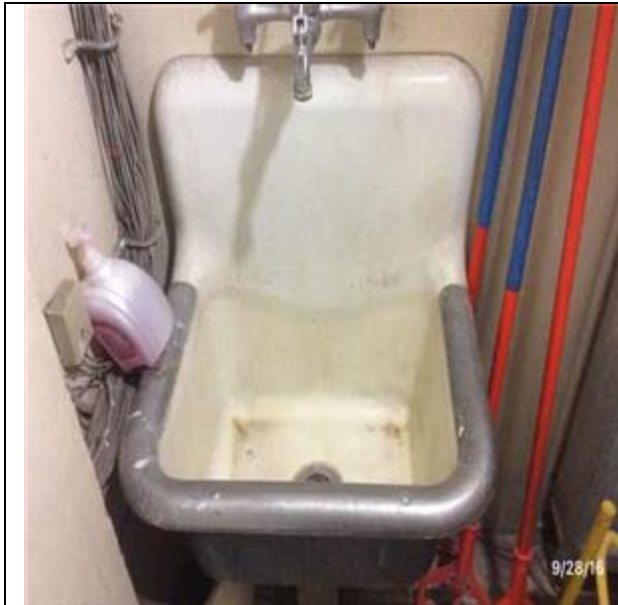
The service sink was observed to be in fair condition with no serious deficiencies noted. We anticipate that the faucet may fail during the study period and may need to be rebuilt or replaced. This work has not been included in this study as we anticipate it will be carried out on an as-needed basis as part of routine maintenance

D2014 Sinks:- View of Service Sink Wall Mounted

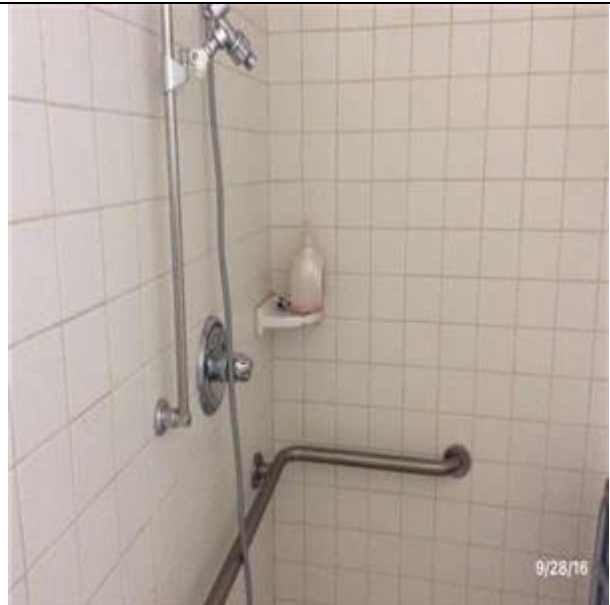
The ceramic tile shower stalls were observed to be in fair to good condition with no noted deficiencies and no actions will be generated within the study period.

D2017 Showers:- View of Shower - Three Wall Ceramic Tile

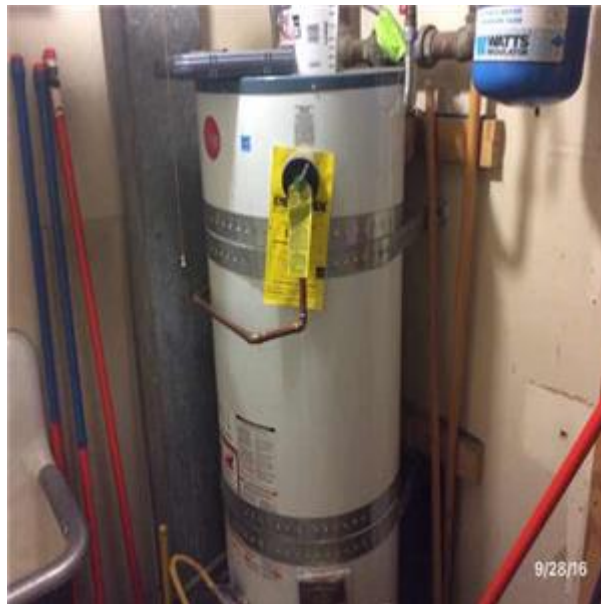
The water heater was observed to be in fair condition and operational. Based on EUL, replacement can be anticipated later in the study period.

D2022 Hot Water Service:- View of Domestic Hot Water Heater - Gas

ID	Type	Recommendation	Priority	Year	Expenditures
153333	D2020	Replace Domestic Hot Water Heater - Gas	Priority 3	2024	\$3,149

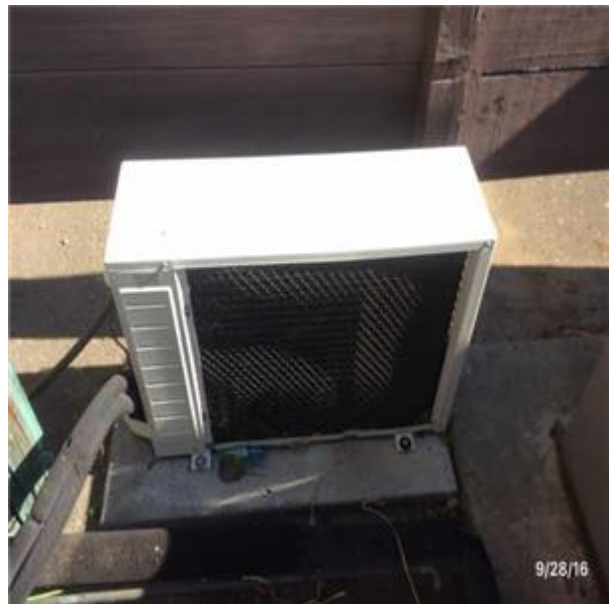
The split system condensing unit was observed to be in fair to good condition and no actions are anticipated during the study period.

D3032 Direct Expansion Systems:- View of Split-System (Outdoor and Indoor Unit)

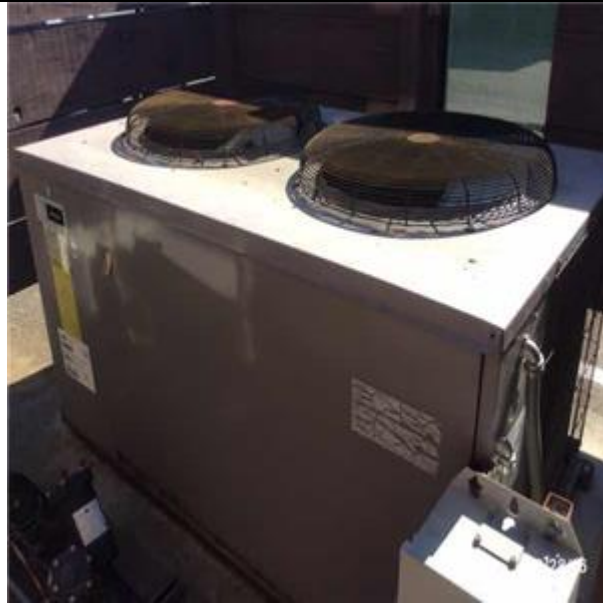
The condensing unit was commissioned in 1995 as part of a remodeling project and was observed to be in fair to good condition. Although the EUL has been exceeded, RUL has been extended to mid-term in the study period based on condition.

D3032 Direct Expansion Systems:- View of Split-System
(Outdoor Unit Only - Compressor and Condenser)

ID	Type	Recommendation	Priority	Year	Expenditures
153334	D3030	Replace Split-System (Indoor Furnace Unit) 151 to 250 BTU	Priority 3	2020	\$5,904
153335	D3030	Replace Split-System (Outdoor Unit Only - Compressor and Condenser)	Priority 3	2020	\$10,434
153336	D3040	Replace Exhaust Fan	Priority 3	2020	\$1,607
153337	D3040	Replace Exhaust Fan	Priority 3	2022	\$989

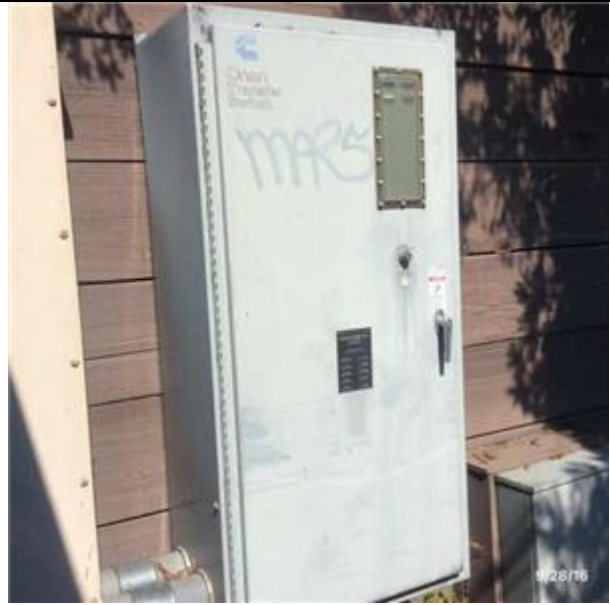
The emergency generator transfer switch was observed to be in fair condition and replacement is anticipated mid-term in the study period.

D5012 Low Tension Service & Dist:- View of Emergency
Generator Transfer Switch

ID	Type	Recommendation	Priority	Year	Expenditures
153338	D5010	Replace Emergency Generator Transfer Switch	Priority 3	2020	\$8,610

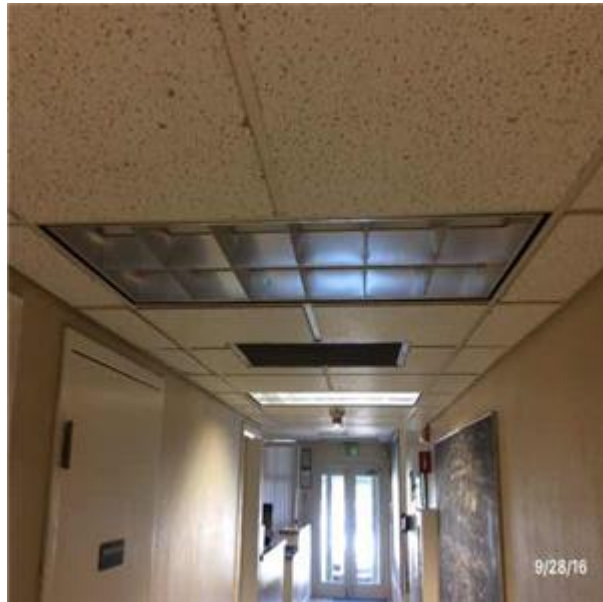
Light fixtures were observed to be in fair to good condition with no reported issues. No actions are anticipated within the study period.

D5022 Lighting Equipment:- View of Interior Light Fixtures -
Fluorescent

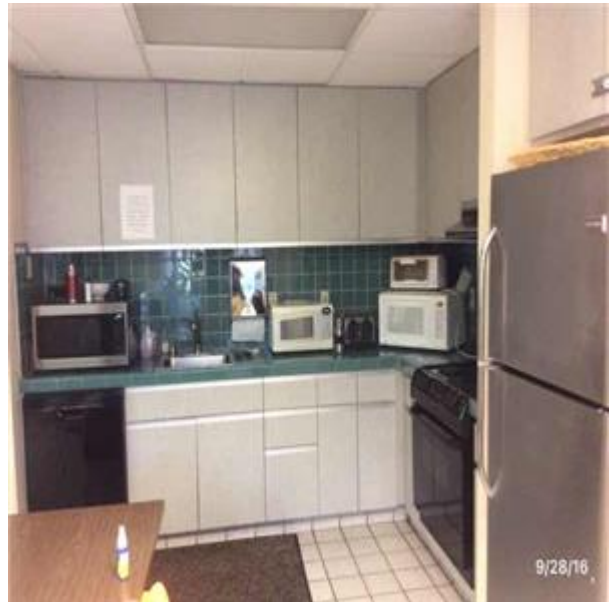
E2012 Fixed Casework:- View of Fixed Casework - Wall
Mounted Cabinets - Standard
