**Tier 1 Report of**

**Facility Condition Assessment**

**Municipal Service Center - Garage**

**Date of Report: October 10, 2016**

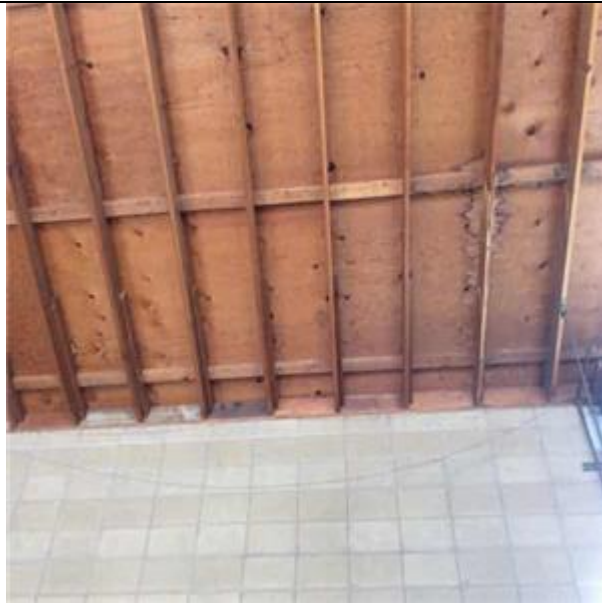
The roof structure was visible from inside the building and no deterioration or deflection was observed. There was minor water infiltration evident that likely occurred prior to the 2001 roof replacement. No actions are anticipated within the study period.

B1022 Pitched Roof Construction:- View of Traditional Wood Beams and Rafters

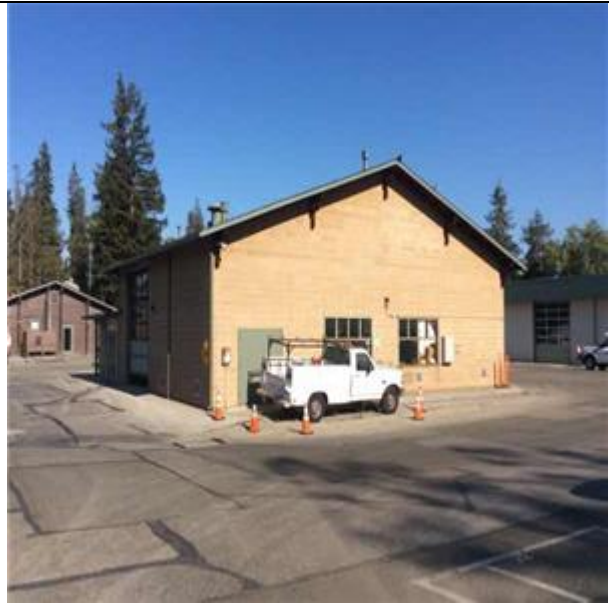
The exterior wall construction was observed to be in fair to good condition and no actions are anticipated during the study period aside from paint as part of routine maintenance.

B2011 Exterior Wall Construction:- View of Exposed CMU Walls

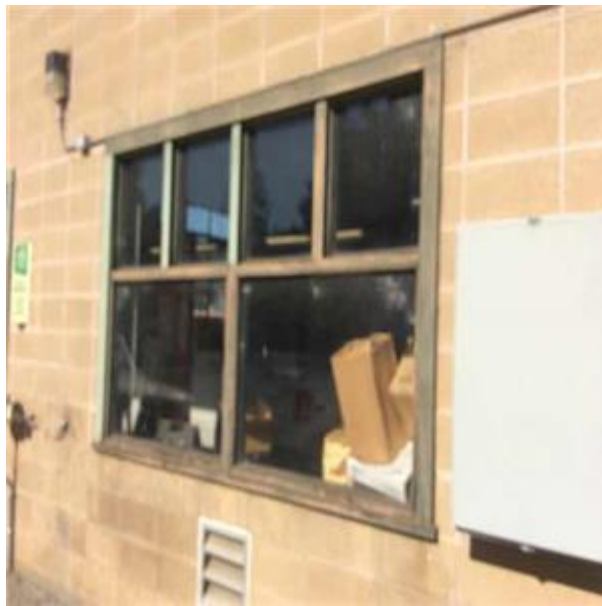
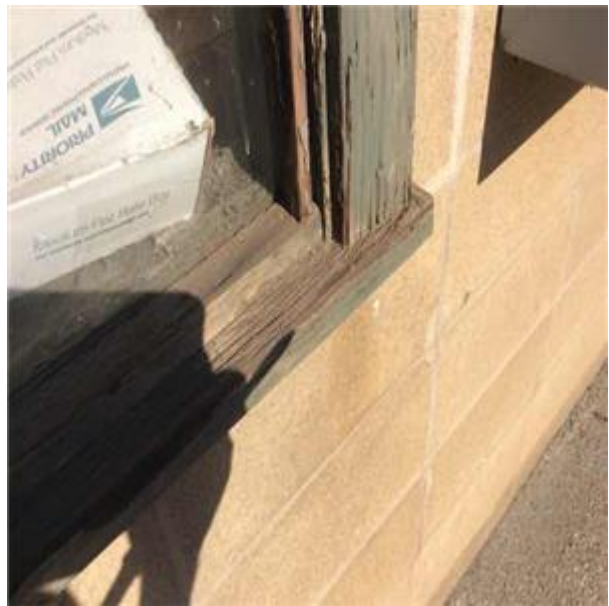
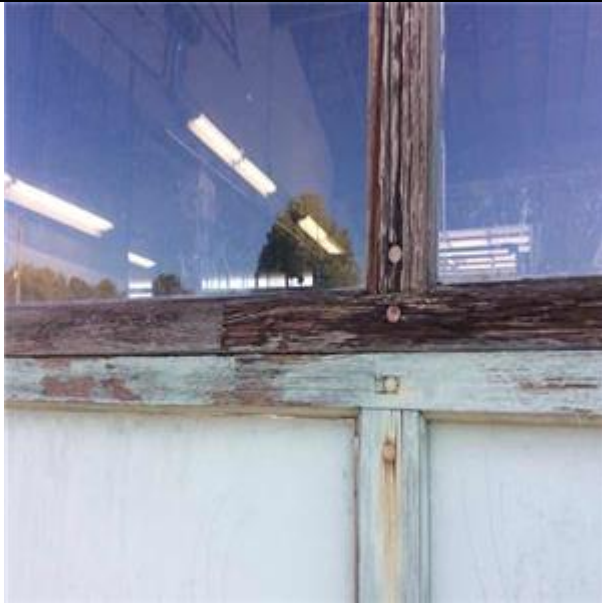
The wood framing at the exterior windows was deteriorated and observed to be in poor condition. Replacement is recommended at the beginning of the study period as part of deferred maintenance.

B2021 Windows:- View of Wood Window Units - Fixed or Single Hung

ID	Type	Recommendation	Priority	Year	Expenditures
153313	B2020	Replace Wood Window Units - Fixed or Single Hung	Priority 2	2016	\$4,771

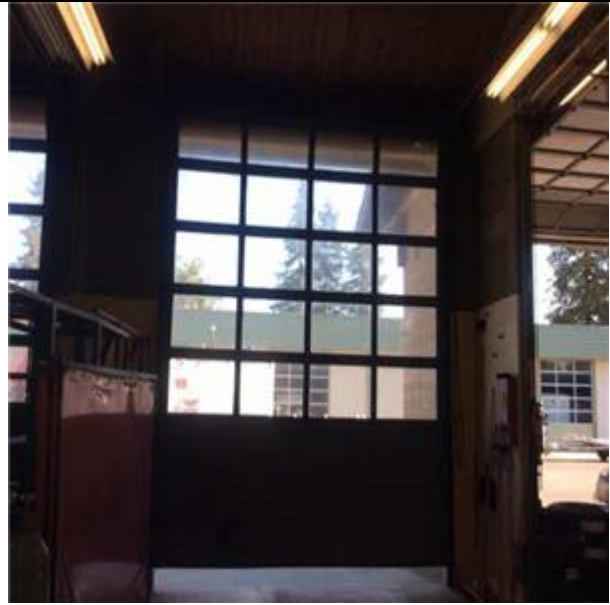
The overhead doors were observed to be in fair condition. With regular maintenance, no actions are anticipated during the study period.

B2034 Overhead Doors:- View of Rolling Overhead Doors, Manual

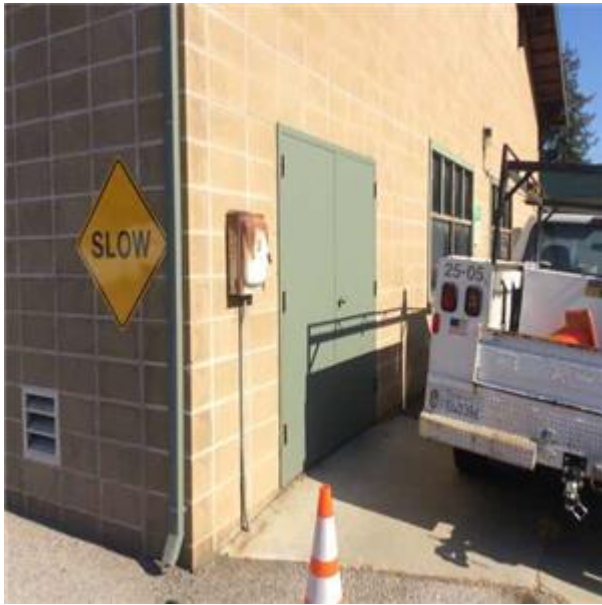
B2039 Other Doors & Entrances:- View of Double HM Doors

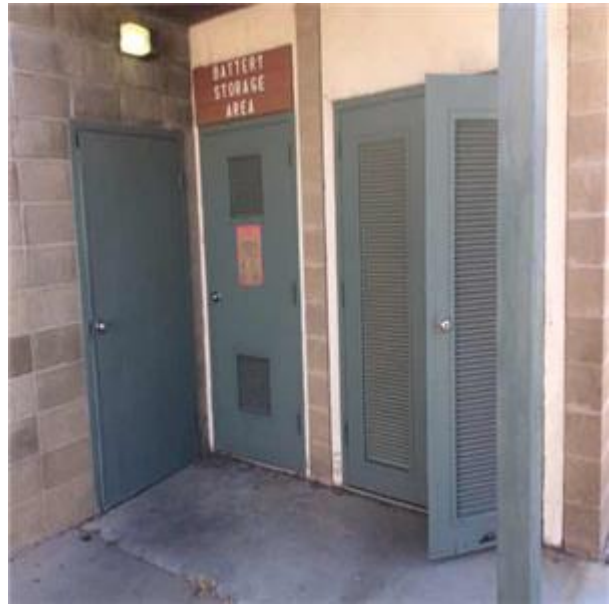
B2039 Other Doors & Entrances:- View of Double HM Louvered Doors

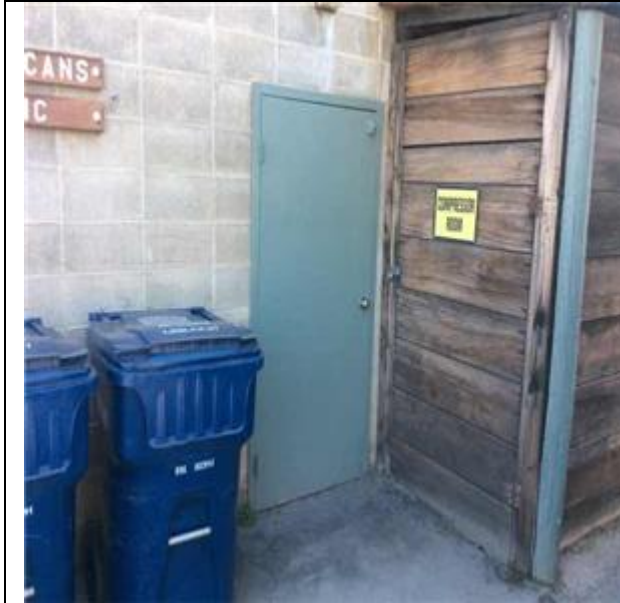
B2039 Other Doors & Entrances:- View of Single HM Doors

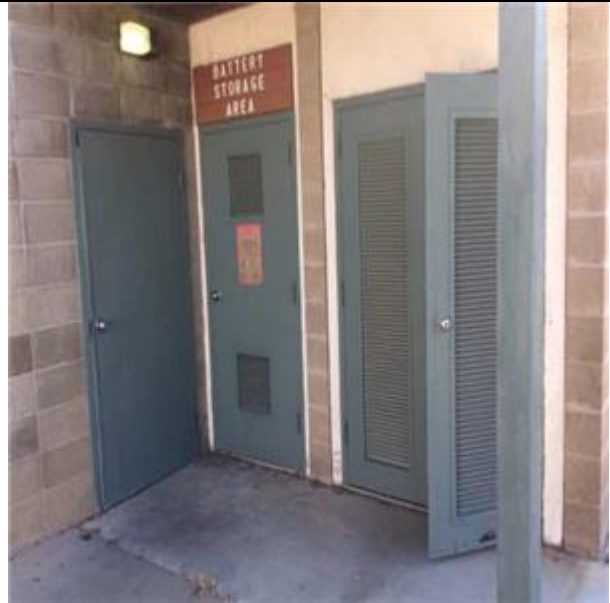
B2039 Other Doors & Entrances:- View of Single HM Louvered Doors

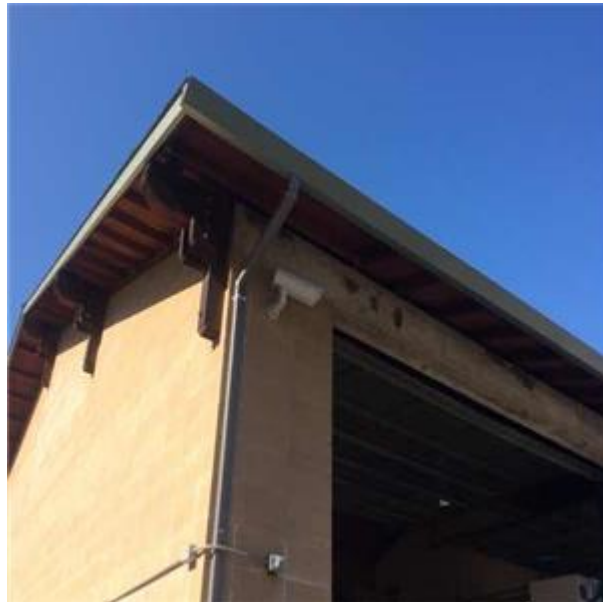
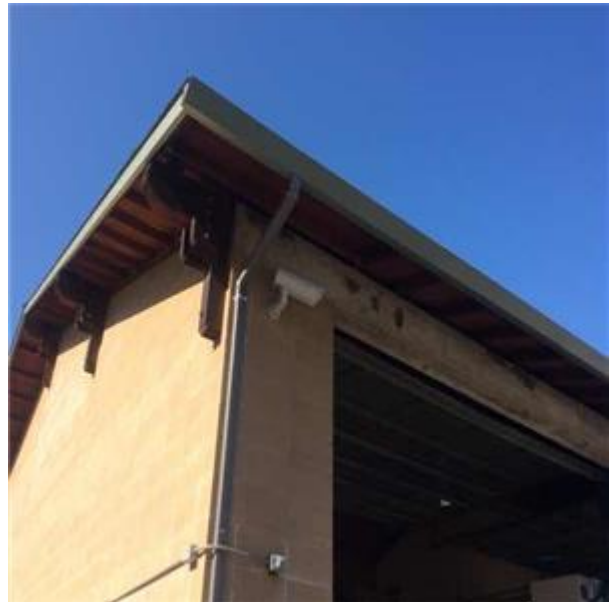
The gutters and downspouts were observed to be in fair to good condition and no actions are anticipated during the study period.

B3016 Gutters and Downspouts:- View of Galvanized Steel Perimeter Gutters & Downspout

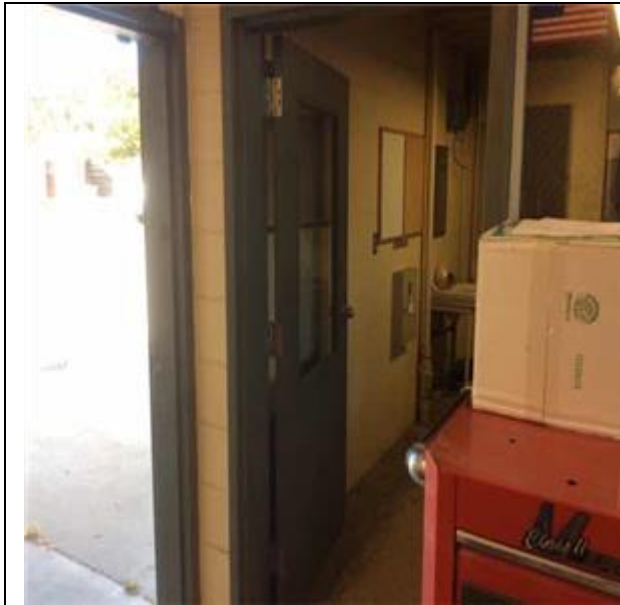
The hollow metal doors were observed to be in fair to good condition and no actions are anticipated aside from painting as part of routine maintenance.

C1021 Interior Doors:- View of Interior Single Hollow Metal Door(s)

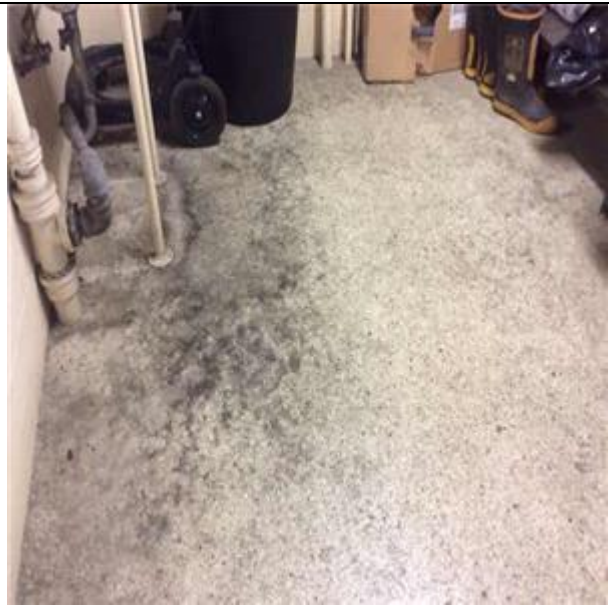
The epoxy floor coating is beginning to show signs of degradation and failure. Recoating of the floor is anticipated early in the study period.

C3023 Hardeners and Sealers:- View of Epoxy Floor Coating

ID	Type	Recommendation	Priority	Year	Expenditures
153314	C3010	Replace Painted Finish - Standard	Priority 3	2020	\$6,034
153315	C3020	Replace Epoxy Floor Coating	Priority 3	2018	\$55,689

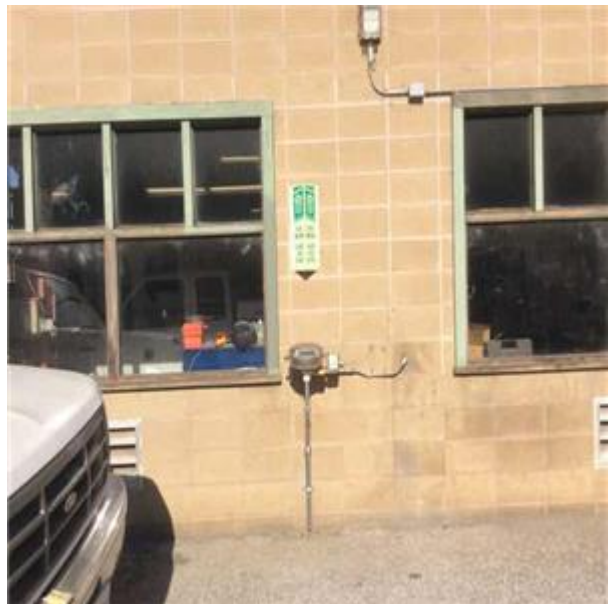
The eye wash stations were observed to be in fair condition and replacement is anticipated mid-term in the study period to keep pace with emerging safety technology.

D2016 Wash Fountains:- View of Emergency Eye Wash

ID	Type	Recommendation	Priority	Year	Expenditures
153316	D2010	Replace Wall Hung Lavatories	Priority 3	2020	\$2,643
153317	D2010	Replace Emergency Eye Wash	Priority 3	2020	\$3,599

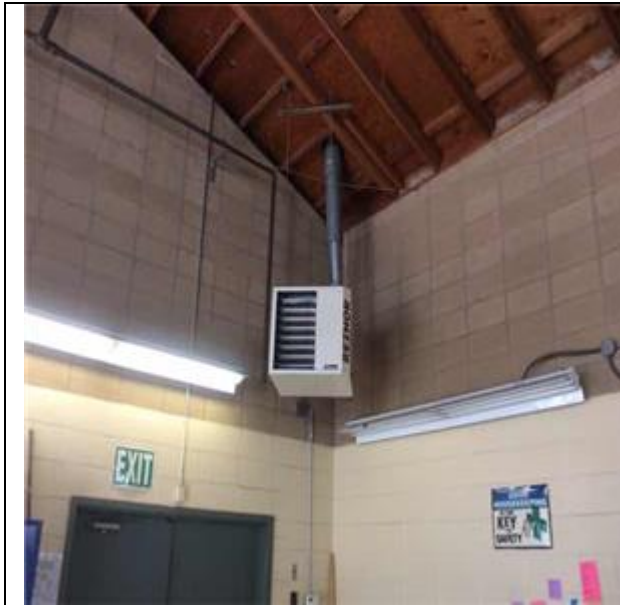
The unit heaters appear to have been recently replaced and no actions are anticipated within the study period.

D3051 Terminal Self-Contained Units:- View of Unit Heater - Gas Fired Suspended - 100 MBH

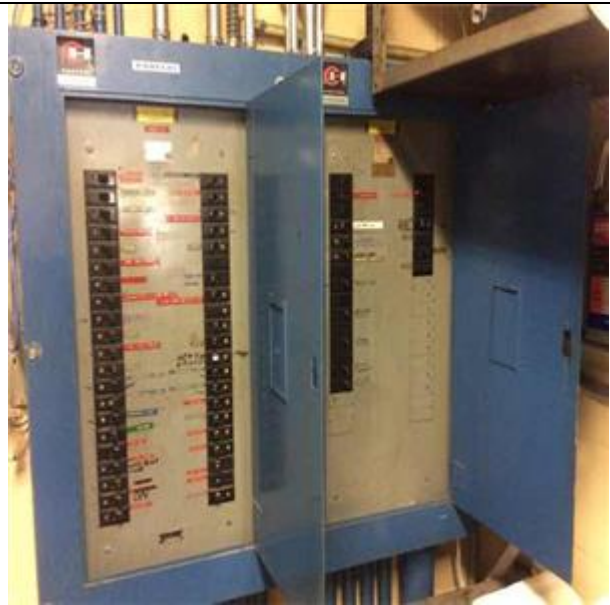
The panelboards were observed to be in poor to fair condition and replacement is anticipated early in the study period.

D5012 Low Tension Service & Dist:- View of Panelboard - 120/240volts, 60 to 2000amp

ID	Type	Recommendation	Priority	Year	Expenditures
153318	D5010	Replace Panelboard - 120/240volts, 60 to 2000amp	Priority 3	2018	\$7,334
153319	D5010	Replace Panelboard - 120/240volts, 60 to 2000amp	Priority 3	2018	\$7,334
153320	D5020	Replace Interior Light Fixtures - Fluorescent	Priority 3	2020	\$29,118

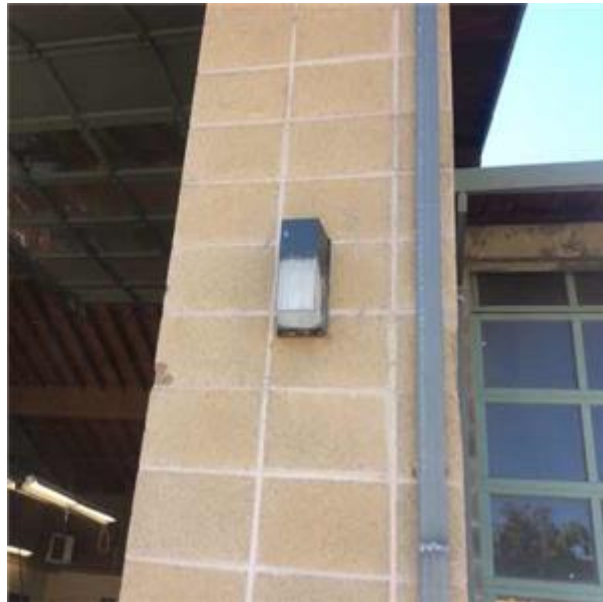
Wall Packs were observed to be in fair to good condition with no reported issues. No actions are anticipated within the study period.

D5022 Lighting Equipment:- View of Exterior Wall Pack Light Fixtures

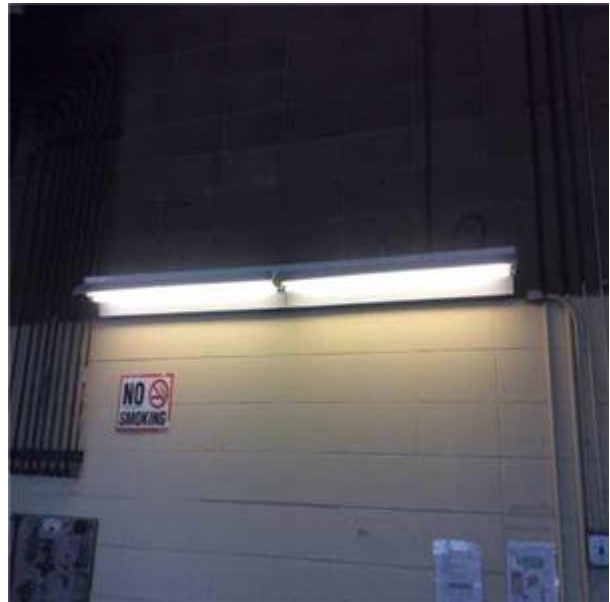
Light fixtures were observed to be in fair condition with no reported issues. Based on the EUL and the observed condition, replacement is recommended towards the mid-term of the study period.

D5022 Lighting Equipment:- View of Interior Light Fixtures - Fluorescent
