**Tier 1 Report of**

**Facility Condition Assessment**

**For  
City of Los Altos  
Municipal Service Center - Warehouse  
707 Fremont Ave  
Los Altos,  
California 94024-5408**

**Date of Report: October 12, 2016**

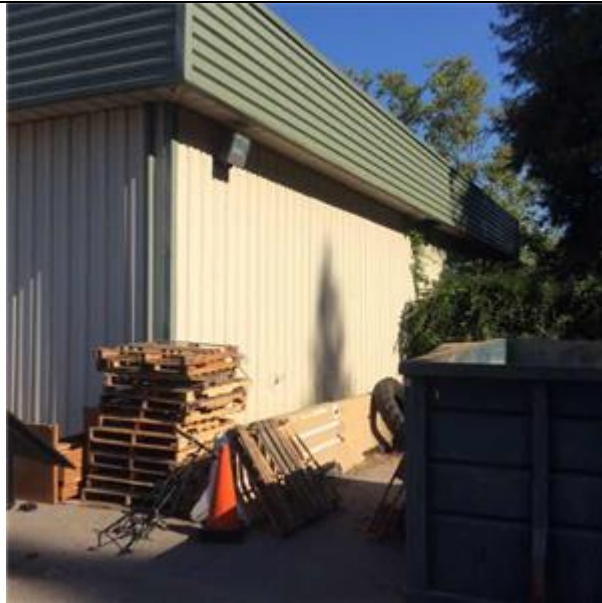
The exterior walls were observed to be in fair to good condition and no actions are anticipated during the study period.

B2011 Exterior Wall Construction:- View of Cladding -  
Prefomed Corrugated Metal Wall Panels

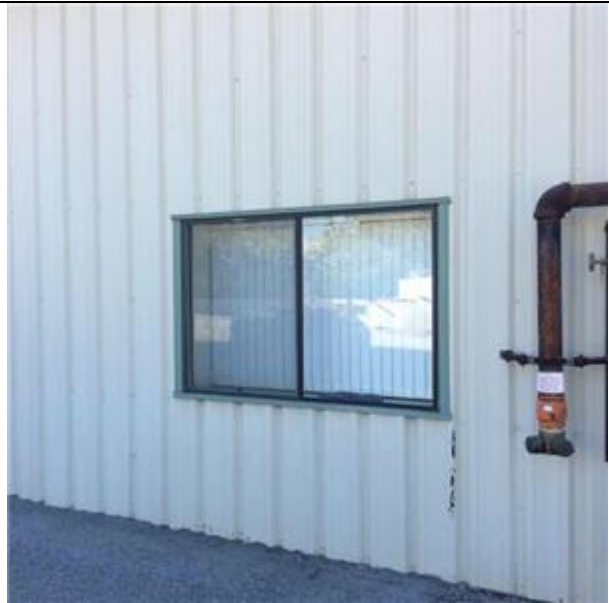
The window units were observed to be in fair to good condition and no actions are anticipated within the study period.

B2021 Windows:- View of Steel Window Units - Casement,  
Double Hung, Vent or Sliding

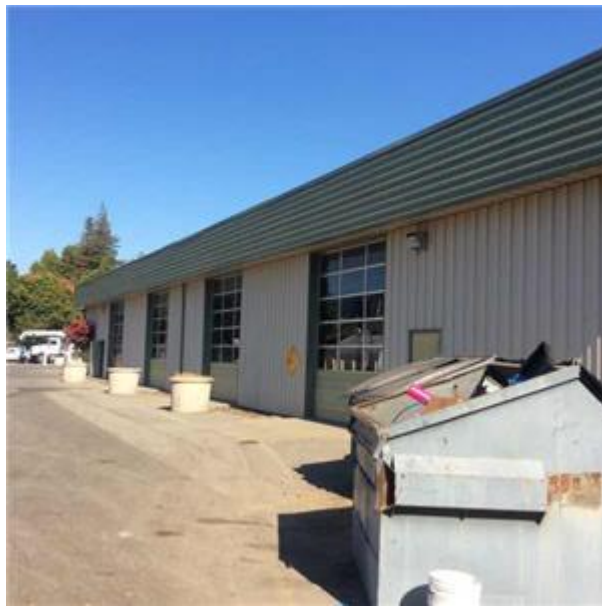
The overhead doors were observed to be in fair to good condition. With regular maintenance, no actions are anticipated during the study period.

B2034 Overhead Doors:- View of Rolling Overhead Doors,  
Electric

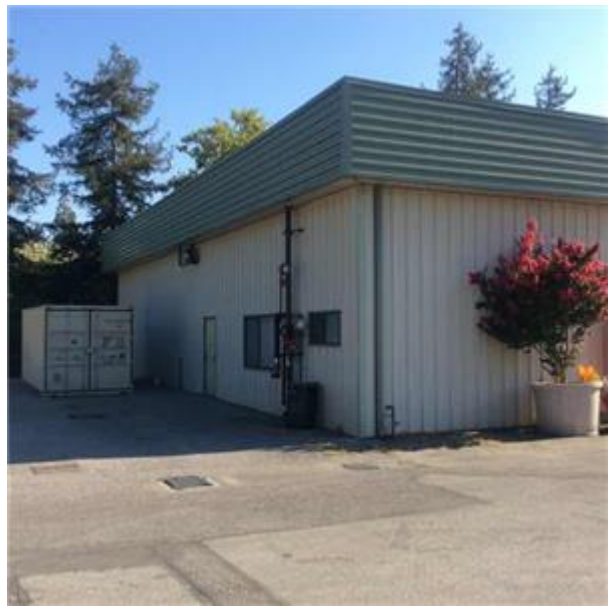
The gutters and downspouts were observed to be in fair to good condition and no actions are anticipated during the study period.

B3016 Gutters and Downspouts:- View of Galvanized Steel  
Perimeter Gutters & Downspout

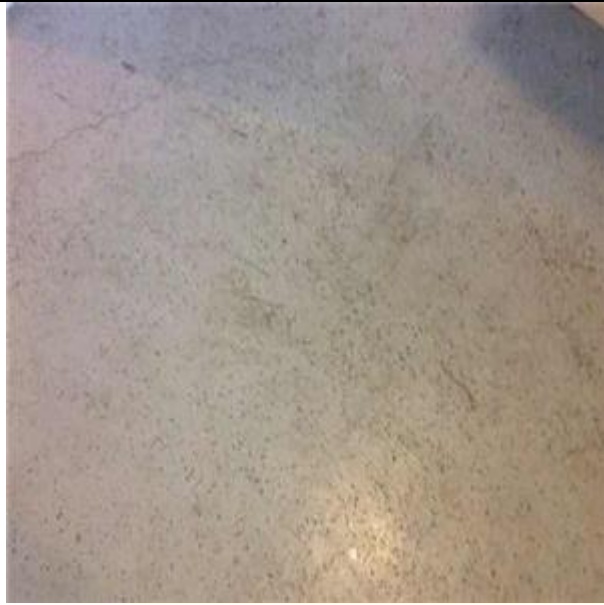
The epoxy coating was observed to be in fair condition and replacement is anticipated early in the study period.

C3023 Hardeners and Sealers:- View of Epoxy Floor Coating

ID	Type	Recommendation	Priority	Year	Expenditures
153831	C3010	Replace Painted Finish - Standard	Priority 3	2020	\$1,939
153832	C3020	Replace Epoxy Floor Coating	Priority 3	2018	\$964
153833	C3020	Replace Broadloom Standard without Padding	Priority 3	2020	\$1,060

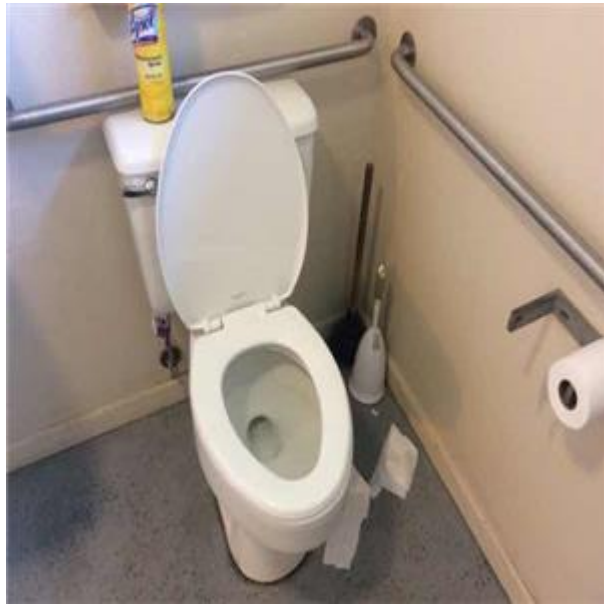
The water closet was observed to be in fair to good condition. The water closet flushed properly and did not have any cracks in the china and no actions are anticipated during the study period. It is expected that the flush valve may fail during the study period and may need to be rebuilt or in some cases replaced. This work has not been included in this study as we anticipate it will be carried out on an as-needed basis as part of routine maintenance.

D2011 Water Closets:- View of Floor Mounted Water Closets

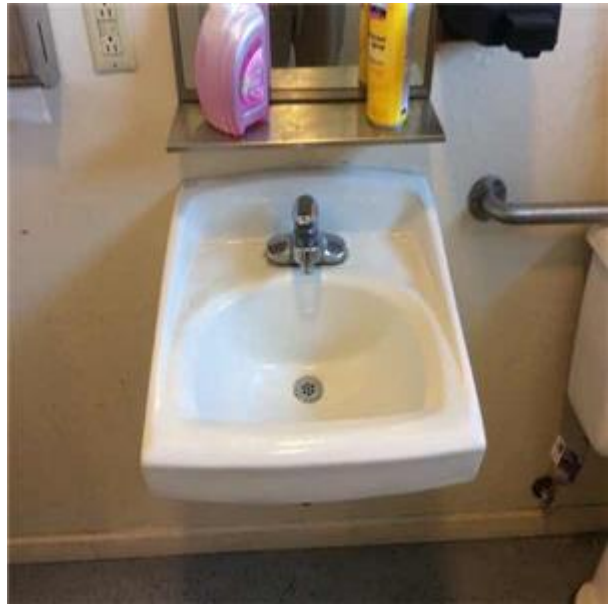
The lavatory was observed to be in fair to good condition. The lavatory drained properly with no deficiencies noted and no actions are anticipated during the study period.

D2013 Lavatories:- View of Wall Hung Lavatories

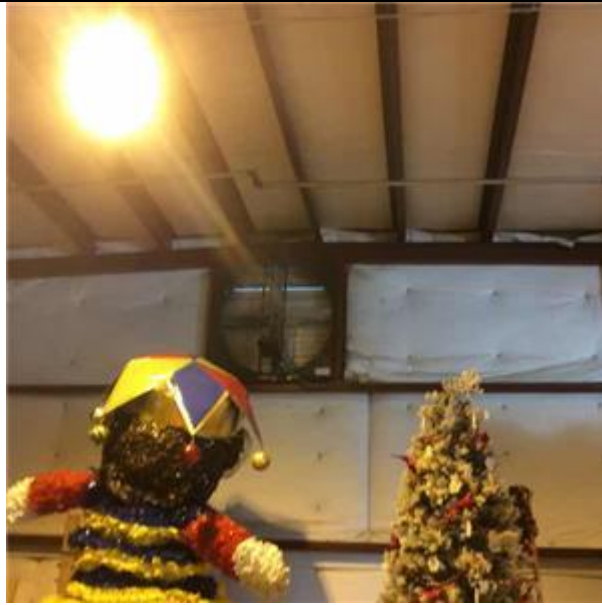
The exhaust fans are presumed to be original to the structure. Based on appearance and EUL, replacement is anticipated mid-term in the study period

D3042 Exhaust Ventilation Systems:- View of Exhaust Fan - Wall Mounted

ID	Type	Recommendation	Priority	Year	Expenditures
153834	D3040	Replace Exhaust Fan - Wall Mounted	Priority 3	2021	\$1,408
153835	D3040	Replace Exhaust Fan - Wall Mounted	Priority 3	2021	\$1,145

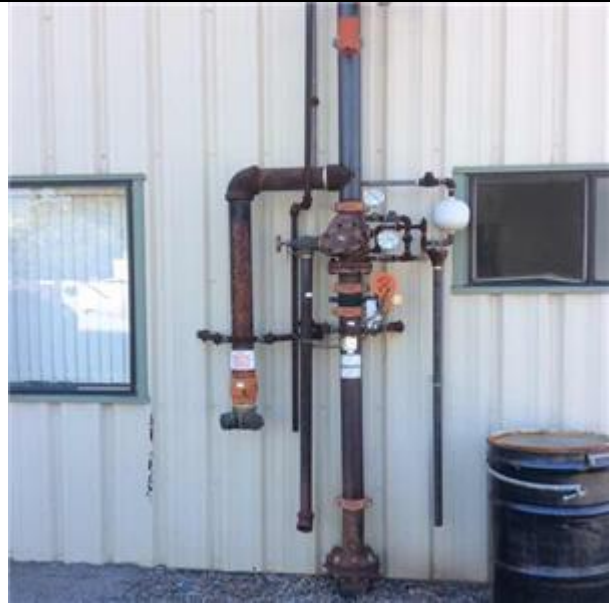
The fire protection system was observed to be in fair to good condition and no actions are anticipated within the study period.

D4011 Sprinkler Water Supply:- View of Wet-Pipe Sprinkler System

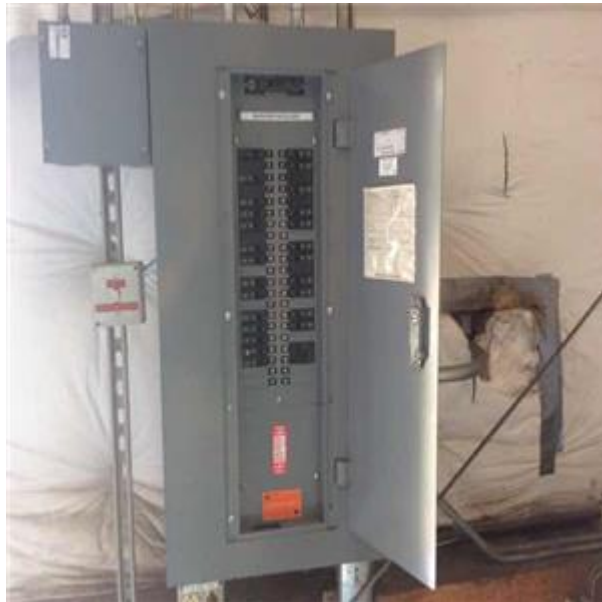
The panelboard was observed to be in fair to good condition and no actions are anticipated within the study period.

D5012 Low Tension Service & Dist:- View of Panelboard - 120/240volts, 60 to 2000amp

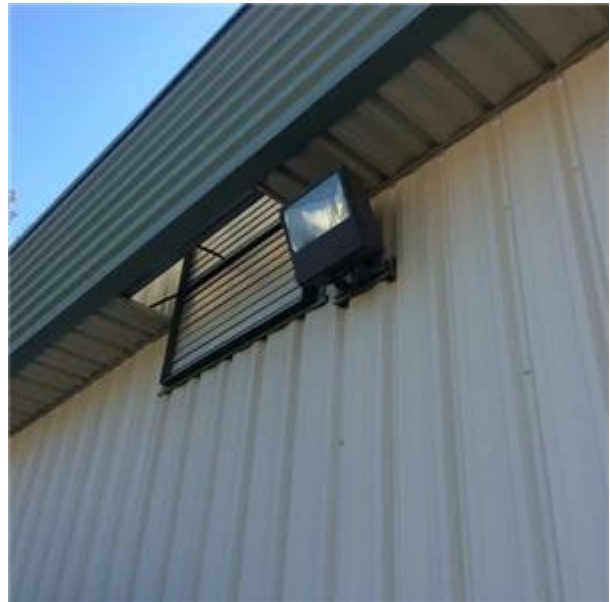
The wall packs were observed to be in fair to good condition and no actions are anticipated during the study period.

D5022 Lighting Equipment:- View of Exterior Wall Pack Light Fixtures

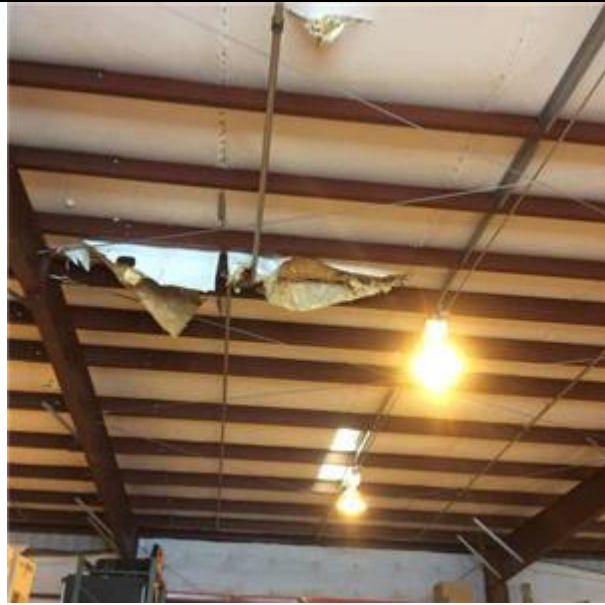
The high bay fixtures were observed to be in fair condition. Based on EUL, replacement is anticipated mid-term in the study period.

D5022 Lighting Equipment:- View of H.I.D High Bay Fixture(s)

ID	Type	Recommendation	Priority	Year	Expenditures
153836	D5020	Replace H.I.D High Bay Fixture(s)	Priority 3	2022	\$17,601
