**Tier 1 Report of
Facility Condition Assessment**

**For
City of Los Altos
Rosita Park - Restroom
401 Rosita Ave
Los Altos,
California 94024-4148**

Date of Report: October 11, 2016

Faithful+Gould, Inc.

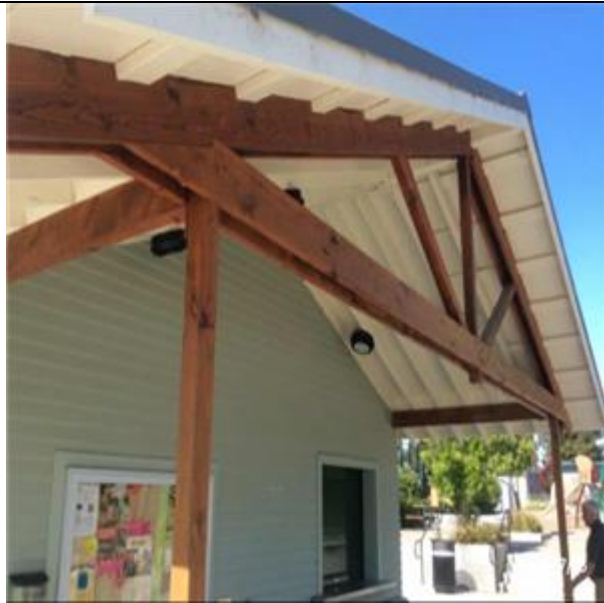
The roof construction and deck are visible due to the open construction and there are no signs of roof leaks or roof deflection therefore, no action for repair or replacement is required within the study period.

B1022 Pitched Roof Construction:- View of Traditional Wood Beams and Rafters

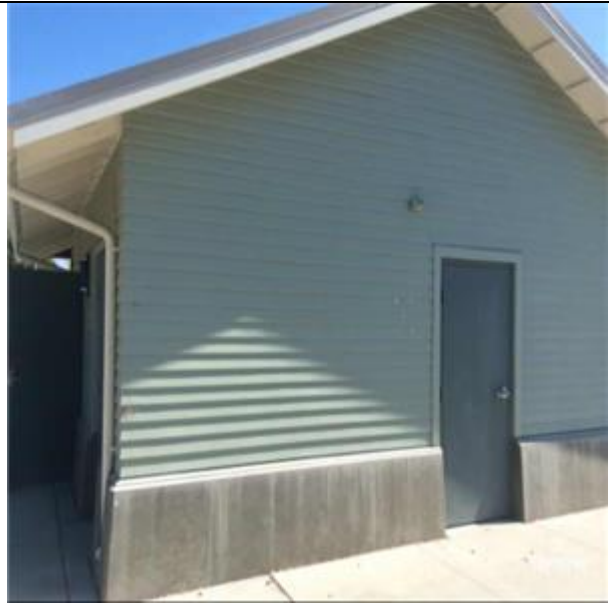
The reinforced concrete wall was observed to be in good condition. We do not anticipate replacement during the study period.

B2011 Exterior Wall Construction:- View of Cast-in-Place Concrete Walls

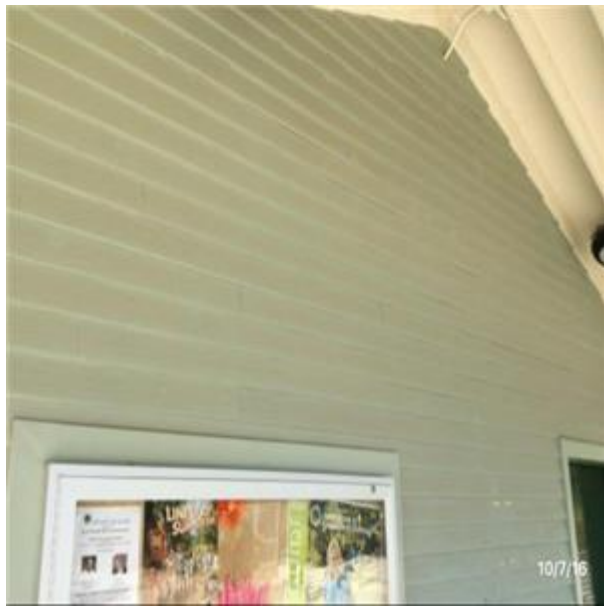
The exterior wall construction was observed to be in fair condition. The fiber cement siding has been painted. We recommend repainting of the surface during the term in the study period to maintain the appearance of the building.

B2011 Exterior Wall Construction:- View of Cementitious Siding

ID	Type	Recommendation	Priority	Year	Expenditures
153532	B2010	Paint	Priority 3	2019	\$1,381

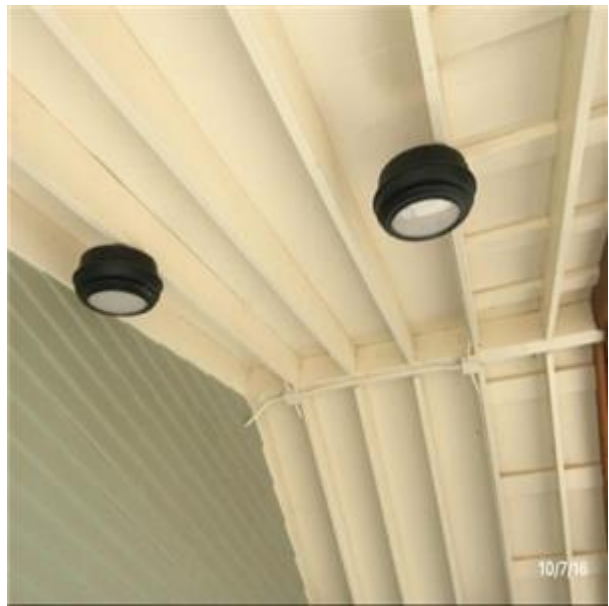
The exterior soffits appeared to be in fair to good condition; therefore we do not anticipate any actions during the study period. We do however recommend repainting of these surfaces later in the study period to maintain the appearance of the building and also protect the asset.

B2016 Exterior Soffits:- View of Exterior Soffits

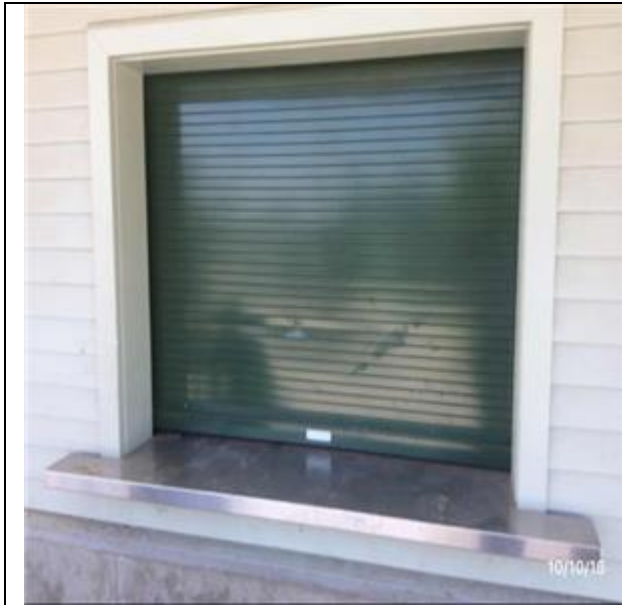
The overhead roller shutter appeared to be in fair condition and operated properly. No replacement actions are anticipated during the study period

B2034 Overhead Doors:- View of Rolling Overhead Door to Counter

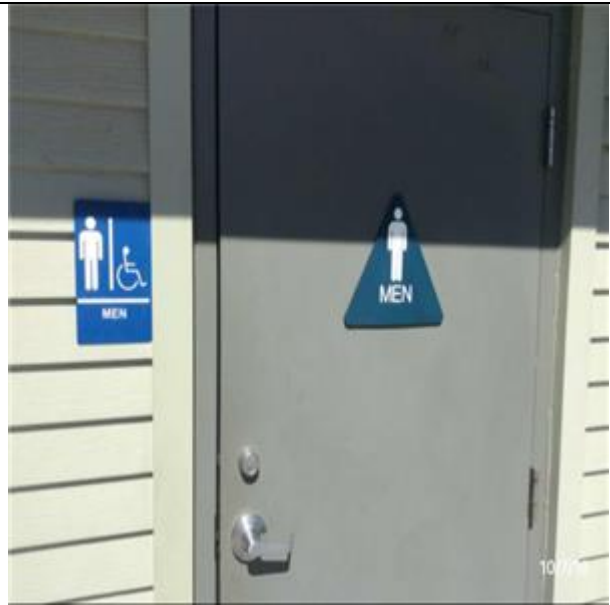
The hollow metal doors appeared to be in fair condition with no major signs of damage or deterioration. There were no issues with these doors therefore no actions will be generated during the study period. The new door surface finish and door frames will require repainting later in the study period. The cost of this work has been included within the amount to undertake the repainting of the exterior walls.

B2039 Other Doors & Entrances:- View of Exterior Single HM Doors

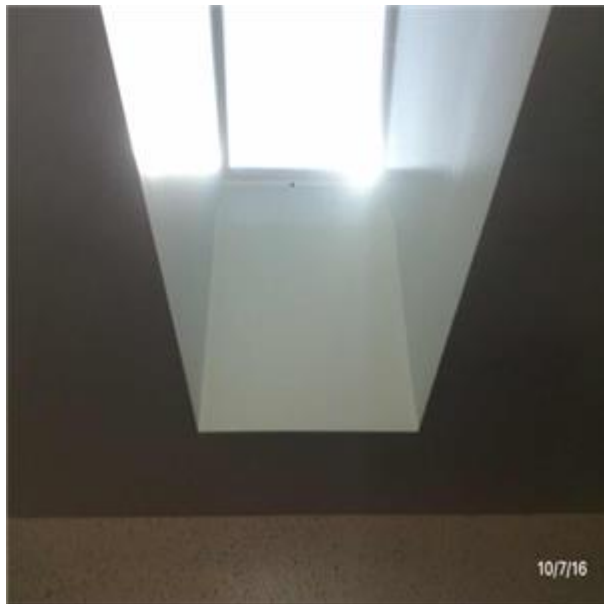
The skylights appeared to be in fair condition. The skylights had no reported or observed moisture ingress present, given the age of the property, we do not anticipate replacement during the study period.

B3021 Glazed Roof Openings:- View of Skylight – Plastic

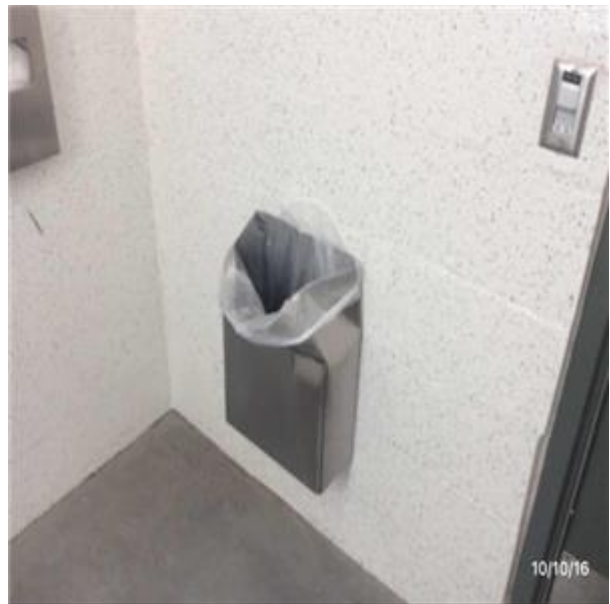
The interior masonry construction was observed to be in fair condition with no obvious bulging or cracking present, therefore no replacement actions will be generated during the study period. The CMU wall will require repainting later in the study period.

C1011 Fixed Partitions:- View of CMU Walls

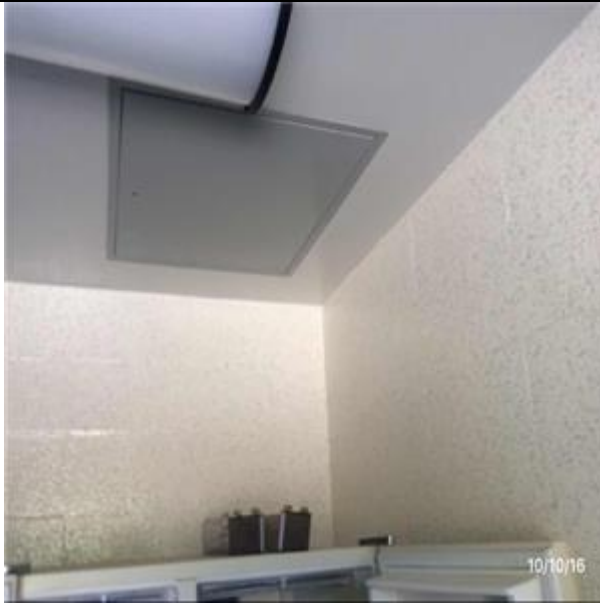
The interior wall finishes were observed to be in fair condition. We anticipate the repainting of the interior surfaces during the study period to maintain appearances.

C3012 Wall Finishes to Interior Walls:- View of Painted Finish - Standard

ID	Type	Recommendation	Priority	Year	Expenditures
153533	C3010	Replace Painted Finish - Standard	Priority 3	2019	\$4,954
153534	C3020	Replace Epoxy Floor Finish	Priority 3	2021	\$3,771

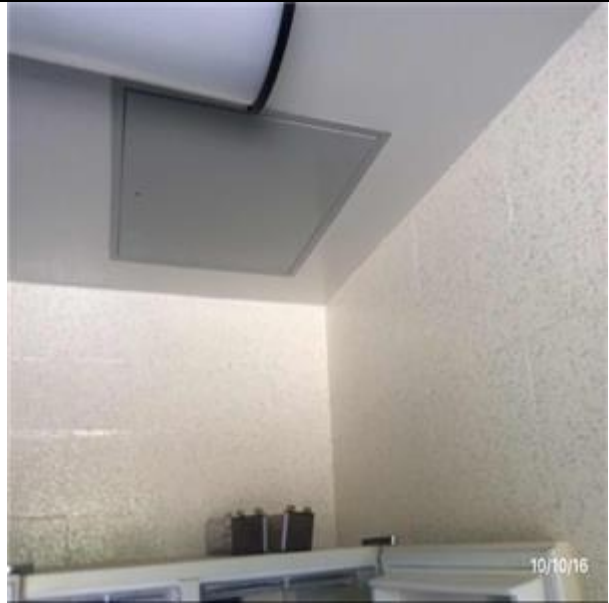
The interior GWB ceilings were observed to be in fair condition. We anticipate the repainting of the interior surfaces during the study period to maintain appearances, at the same time as the interior wall finishes.

C3031 Ceiling Finishes:- View of GWB Ceiling

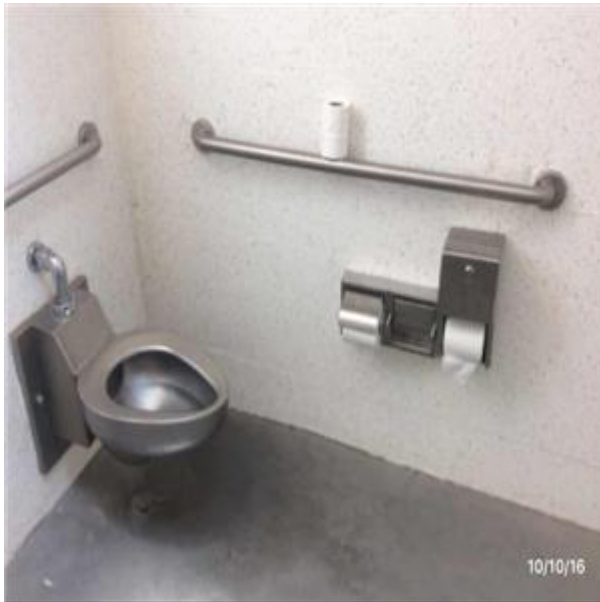
There are two wall mounted stainless steel water closets located in each of the restrooms. They are both tank-less type units with automatic flush valves.

The water closets were observed to be in fair to good condition. They are assumed to be original and installed in 2011, therefore based on a typical EUL of thirty-five years we do not anticipate replacement during the study period. The flush valves may fail during the study period and therefore to maintain function they may need to be replaced. This work has not been included in this study as we anticipate it will be carried out on an as needed basis as part of routine maintenance.

D2011 Water Closets:- View of Wall Mounted Water Closets - Stainless Steel

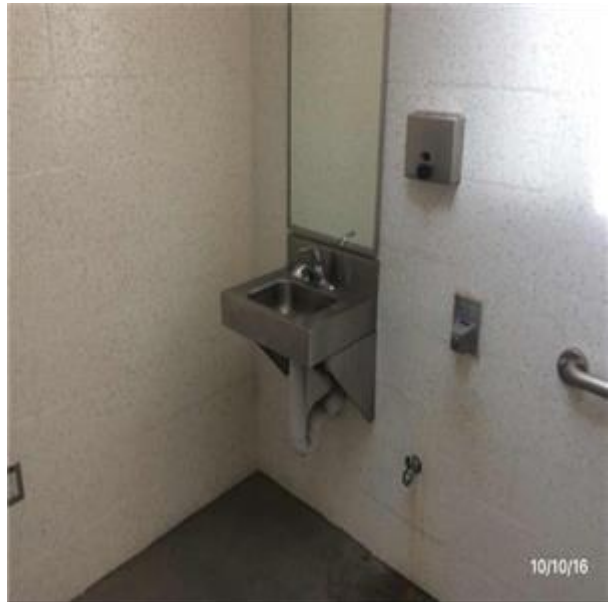
The building contained three wall hung stainless steel lavatories in each of the restrooms and concession. All the lavatories had a single lever metal non-metered faucets. The concession lavatory has an under sink instant water heater. There is no hot water at the restrooms.

The lavatories were observed to be in fair condition. The lavatories drained properly and based on a typical EUL of thirty-five years we do not anticipate replacement during the study period.

D2013 Lavatories:- View of Wall Hung Lavatories

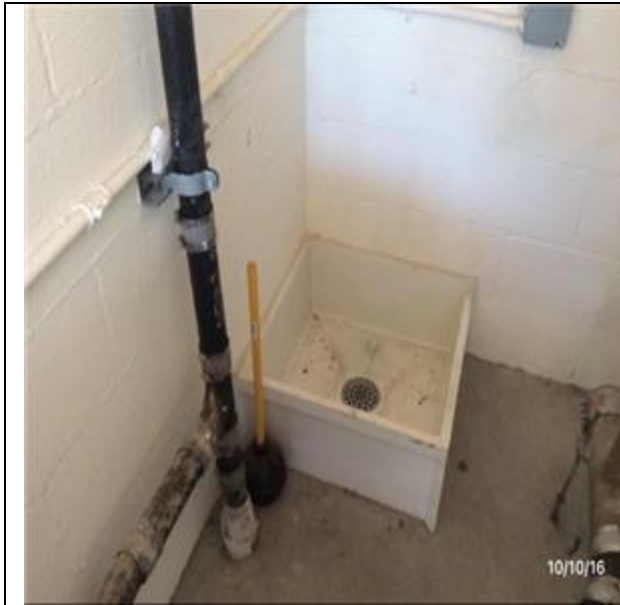
The sink appeared to be in a fair condition. We do not anticipate replacement during the study period.

D2014 Sinks:- View of Service Sink Floor Mounted

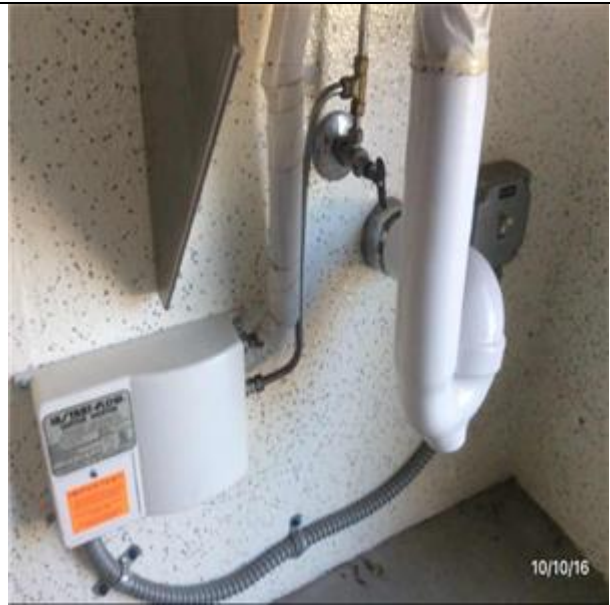
The water heater appeared to be in fair condition and based on an EUL of twenty years, we do not anticipate replacement during the study period.

D2022 Hot Water Service:- View of Insta-Hot under Counter Water Heater

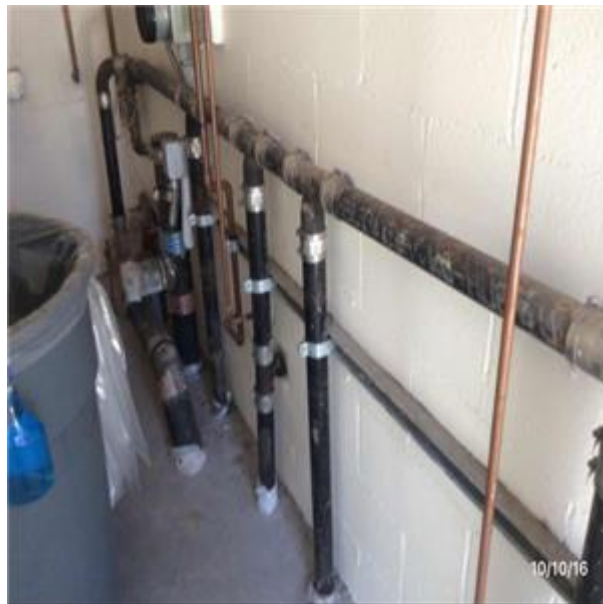
Waste piping was observed to be a combination of both PVC and cast iron piping throughout the building.

The waste piping appears in fair condition. The typical EUL for this type of waste piping is fifty years; therefore it is not included in the study period.

D2031 Waste Piping:- View of Sanitary Water Gravity Discharge

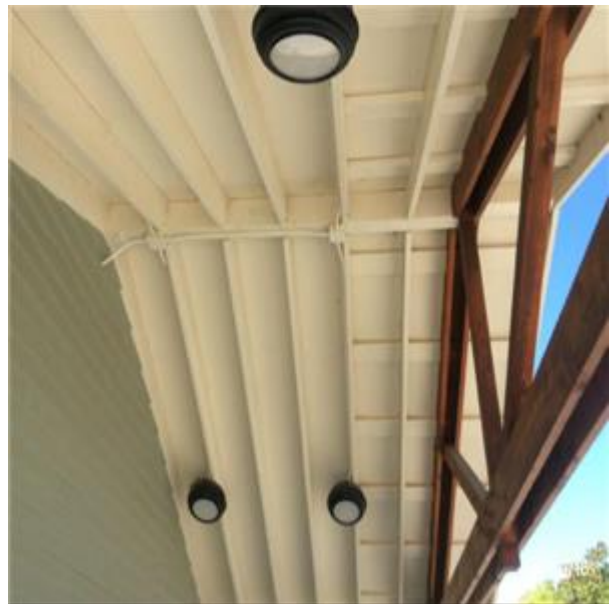
The exterior lighting was observed to be in fair to good condition. Based on a EUL of twenty years we do not anticipate replacement during the study period.

D5022 Lighting Equipment:- View of Exterior Wall Pack Light Fixtures

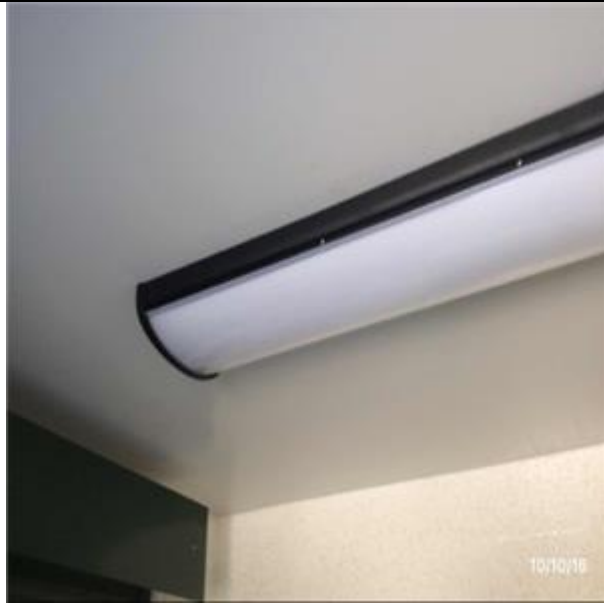
The interior lighting was observed to be in fair to good condition. Based on a EUL of twenty years we do not anticipate replacement during the study period.

D5022 Lighting Equipment:- View of Interior Light Fixtures -
Fluorescent

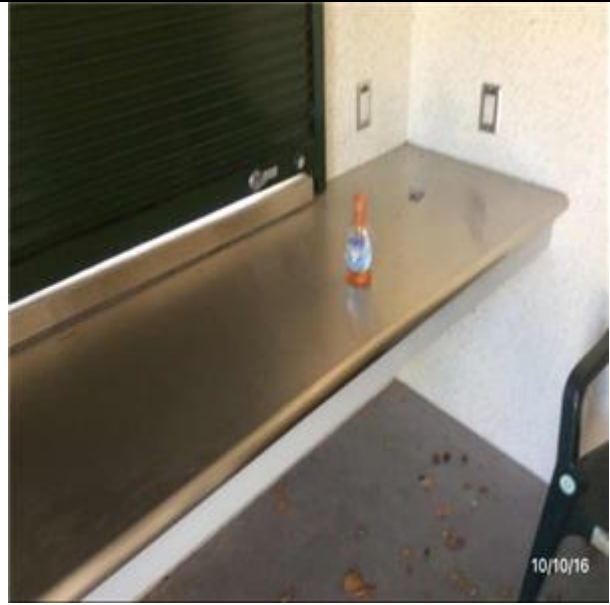
The building contained a stainless steel counter at the concession.

The stainless steel counter was observed to be in fair to good condition, we do not anticipate replacement during the study period.

E2012 Fixed Casework:- View of Concession Counter Stainless
Steel
