Facility Condition Assessment Services

Facility Condition Assessment

**For
City of Los Altos
San Antonio Club
647 S. San Antonio Road
Los Altos,
California 94022-3000**

Date of Report: October 10, 2016

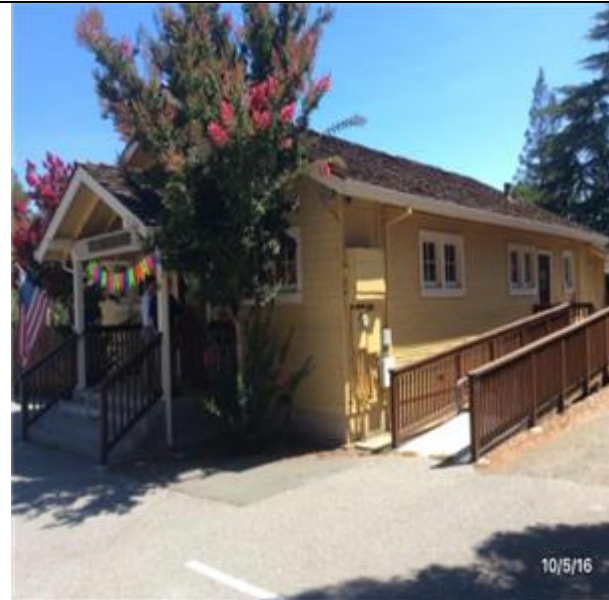
The ramp was constructed in 2011 and appeared to be in good condition, we do not anticipate replacement during the study period.

B1014 Ramp(s):- View of Ramp - Wood Construction

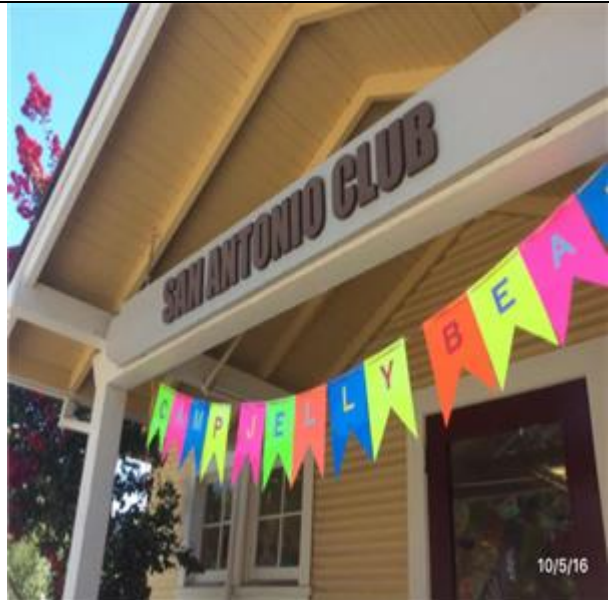
The canopy appeared in fair condition. No signs of weathering were noted; therefore, no actions are anticipated during the study period outside of routine maintenance.

B1023 Canopies:- View of Canopies - Wood Joists Supporting Exterior Grade Plywood

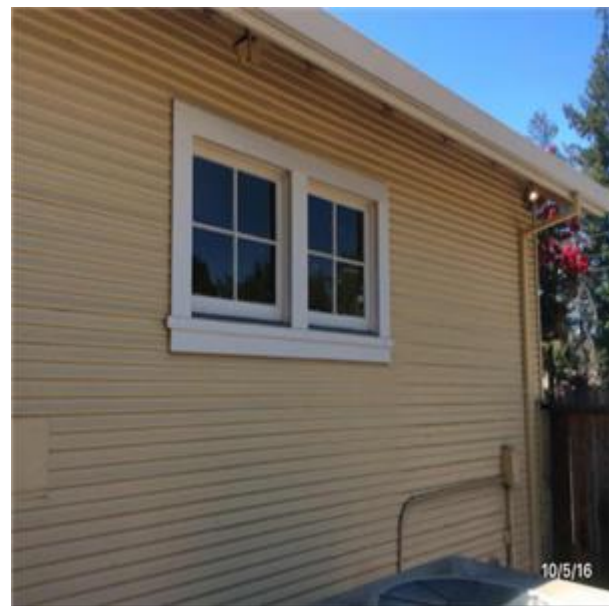
The exterior wall construction was observed to be in fair condition. The wood siding has been regularly painted. We recommend repainting of the surface of the wood panels during study period as a routine maintenance to maintain the appearance of the building and also the wood itself.

B2011 Exterior Wall Construction:- View of Wood Clapperboard Siding

ID	Type	Recommendation	Priority	Year	Expenditures
153372	B2010	Repaint Exterior Wall Surfaces	Priority 3	2019	\$2,813
153373	B2030	ADA Replace or Modify Threshold, Enlarge Door Opening, Increase or Provide Maneuvering or clear Floor Space	Priority 1	2016	\$17,192

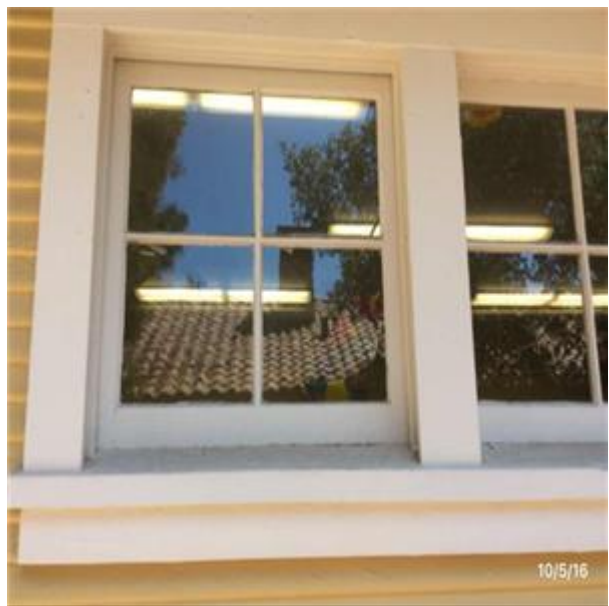
The wood windows appeared to be in good condition despite their age. We do not anticipate replacement during the study period.

B2021 Windows:- View of Wood Window Units - Casement, Double Hung, Vent or Sliding

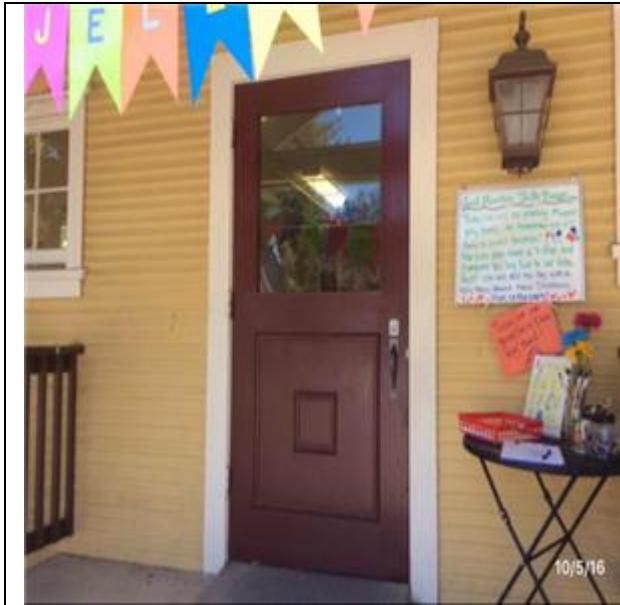
The doors appeared to be in a poor to fair condition with no major signs of damage or deterioration, however, based on a EUL of thirty years we do not anticipate replacement during the study period. The new door surface finish and door frames will require repainting later in the study period. The cost of this work has been included within the amount to undertake the repainting of the exterior walls.

B2039 Other Doors & Entrances:- View of Exterior Single Wood Door

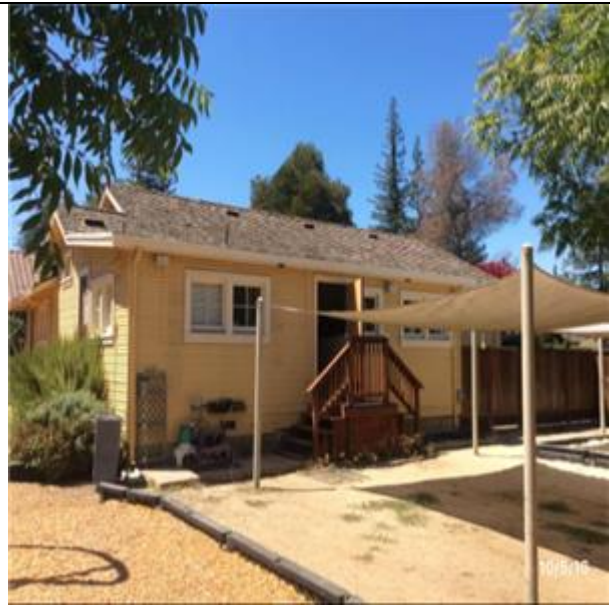
The asphalt shingle covering and TPO roof to the side extension appeared to be in fair to good condition, with no roof leaks reported. We are unaware of when the roof coverings were installed, we assume them to be installed at the time of the refurbishment in 2011, along with the rainwater gutters and downspouts, therefore we do not anticipate replacement during the study period.

B3011 Roof Finishes:- View of Asphalt Shingle Roof

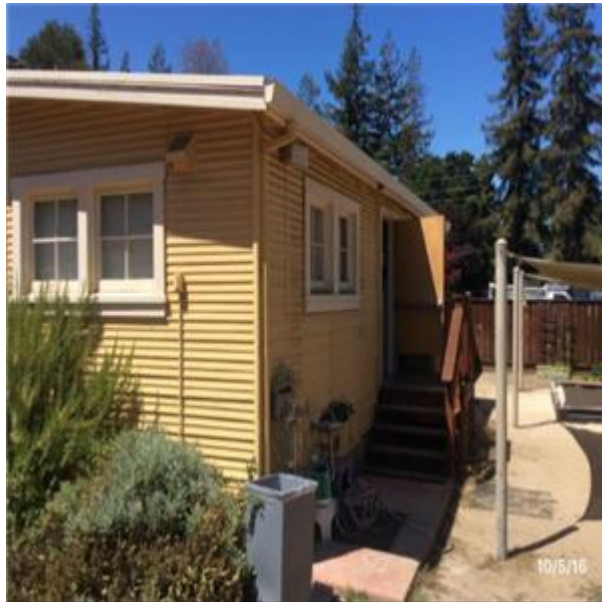
B3016 Gutters and Downspouts:- View of Galvanized Steel Perimeter Gutters & Downspout

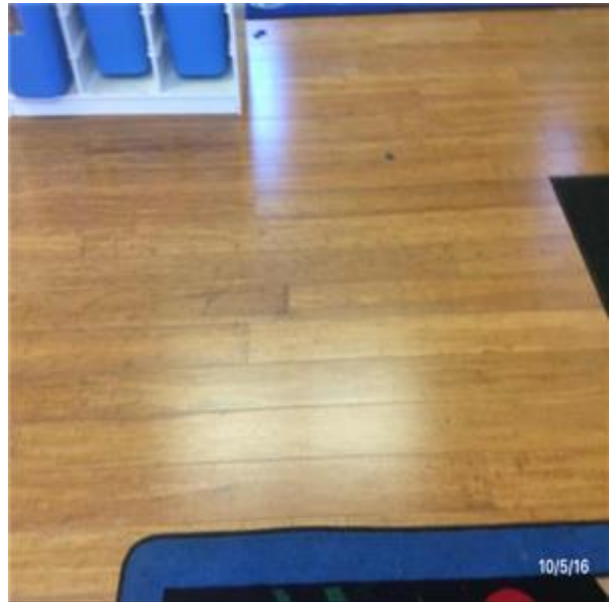
The floor finishes appeared in good condition throughout the building. There is redwood floor throughout which is in good condition having been refurbished in 2011. We do not anticipate replacement during the study period. The vinyl sheet at the restroom is in a fair to good condition so we do not anticipate replacement during the study period.

C3024 Flooring:- View of Wood Flooring – Redwood

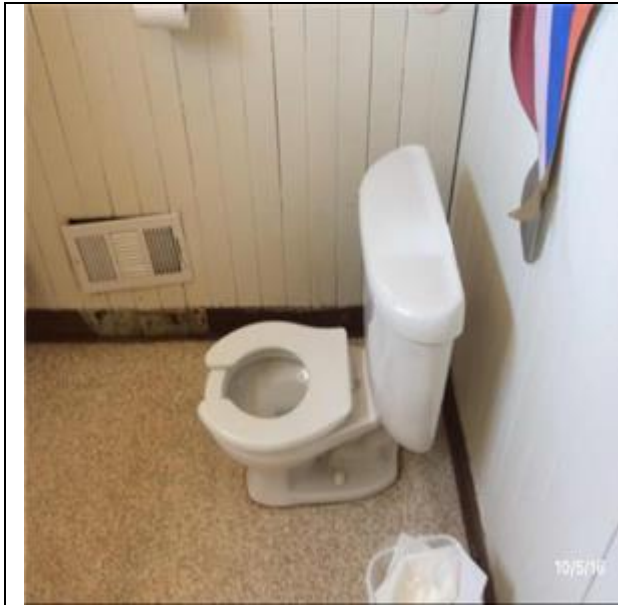
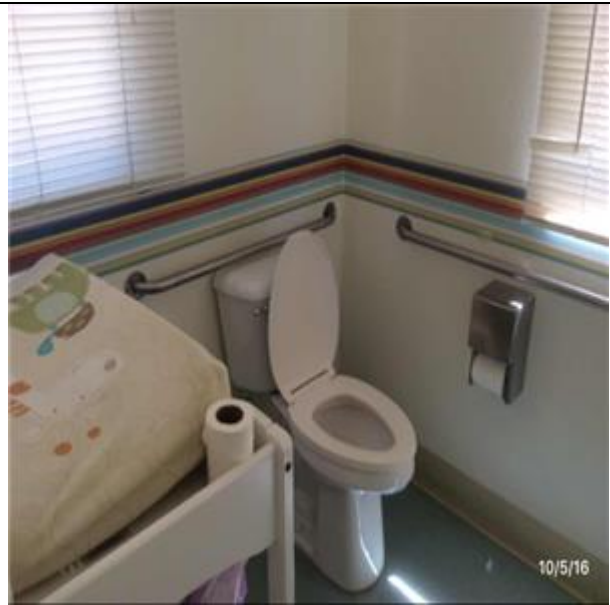
The water closets and lavatories were observed to be in fair to good condition. Based on a EUL of thirty five years we assume these fixtures will not need replacing during the study period.

D2011 Water Closets:- View of Floor Mounted Water Closets

ID	Type	Recommendation	Priority	Year	Expenditures
153377	D2010	ADA Increase or Provide Maneuvering or Clear Floor Area	Priority 1	2016	\$2,240
153378	D2010	ADA - Replace or modify Grab Bars, fixtures and mirrors	Priority 1	2016	\$2,968
153379	D2020	Replace Domestic Hot Water Heater - Gas	Priority 3	2021	\$3,149

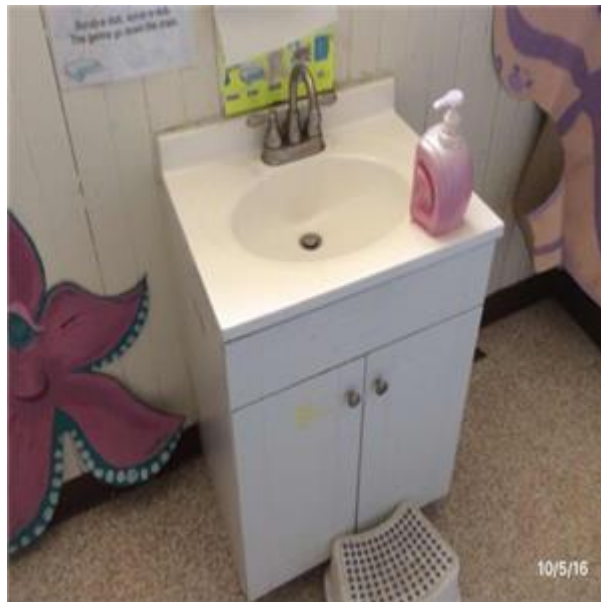
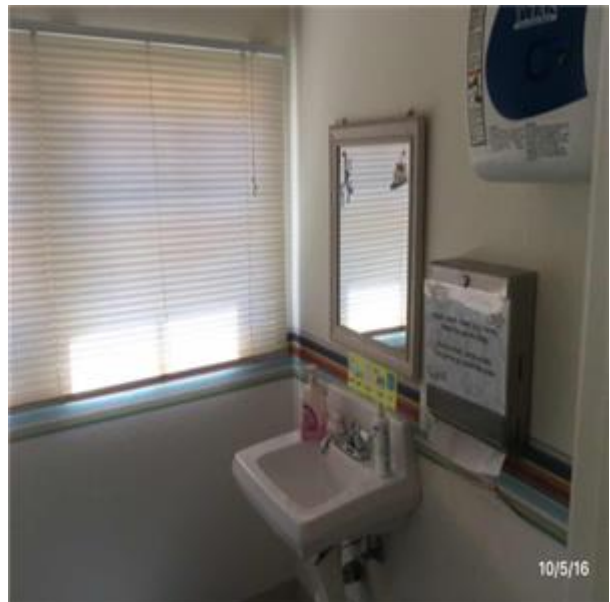
D2013 Lavatories:- View of Vanity Top Lavatories

D2013 Lavatories:- View of Wall Hung Lavatories

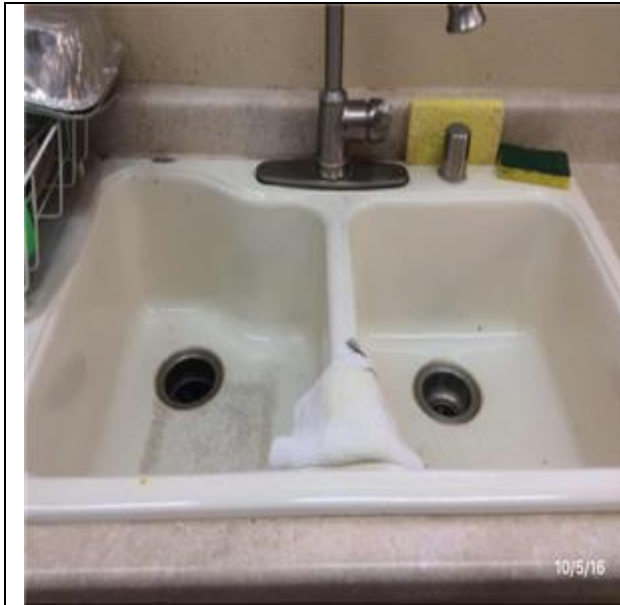
The counter top metal sink was observed to be in fair condition. The sink drained properly and appeared not to have any damage in the enameled steel finish. We assumed it was installed in 2011 and based on a typical EUL of twenty years we do not anticipate replacement during the study period.

We anticipate that the faucet may fail during the study period and therefore to maintain function they may need to be replaced. This work has not been included in this study as we anticipate it will be carried out on an as-needed basis as part of routine maintenance.

D2014 Sinks:- View of Countertop Double Bowl Kitchen Sink

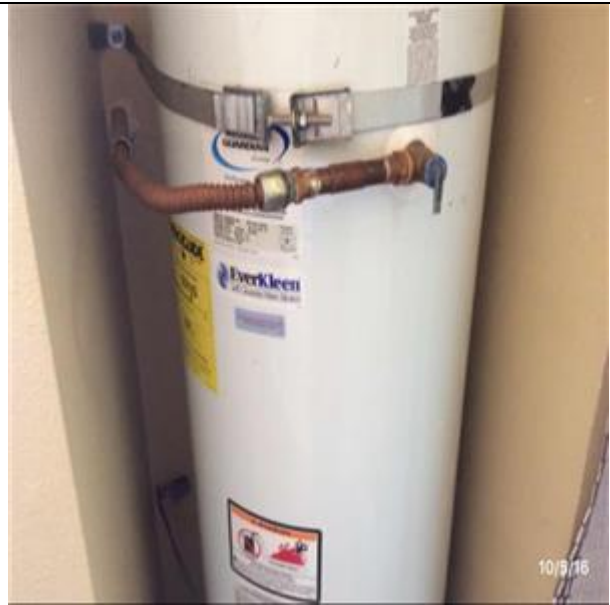
The domestic water heater appeared in fair condition and functioned without issue. The EUL for this equipment is fifteen years which puts the RUL during the study period; therefore, we anticipate replacement.

D2022 Hot Water Service:- View of Domestic Hot Water Heater
- Gas

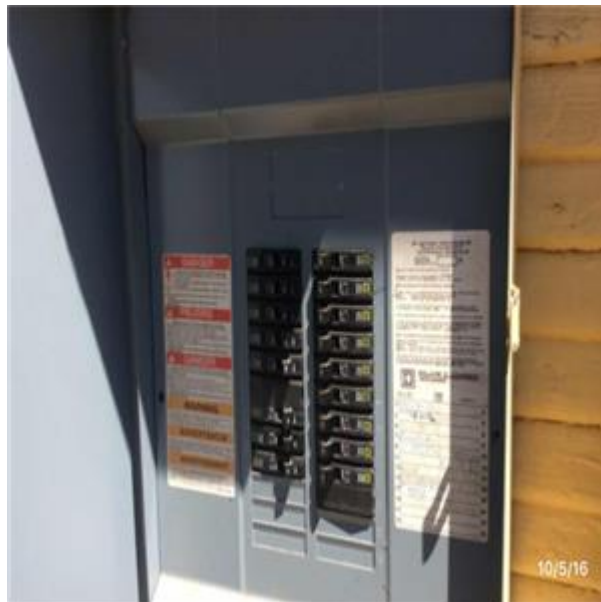
The panel appeared to be in a good condition due to its age. There was no sign of deterioration at the panels. The typical EUL for electrical switchboard such as this is thirty years; therefore replacement will not be necessary during the study period. We do recommend further evaluation of the branch panels via an infrared electrical inspection which will highlight if high temperatures, excessive electrical resistance, failing components, ground faults and short circuiting issues exist.

D5012 Low Tension Service & Dist:- View of Panelboard -
120/208volts, 60 to 2000amp

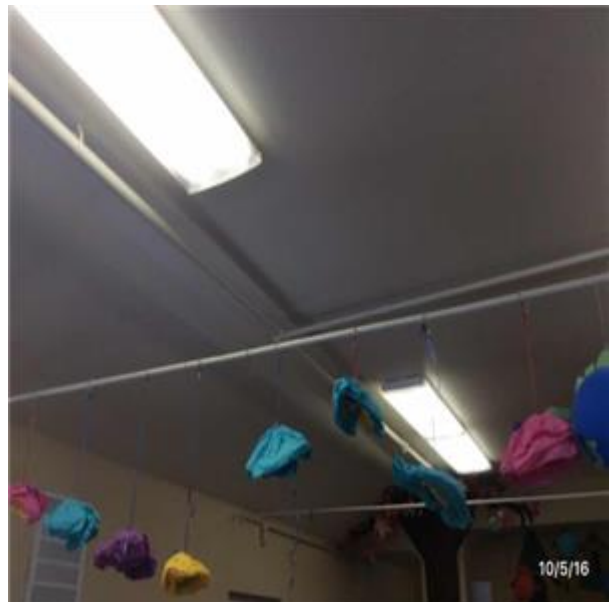
The interior lighting was observed to be in good condition. We do not anticipate the lighting will need to be replaced during the study period based on EUL of twenty years.

D5022 Lighting Equipment:- View of Fluorescent Light Fixtures

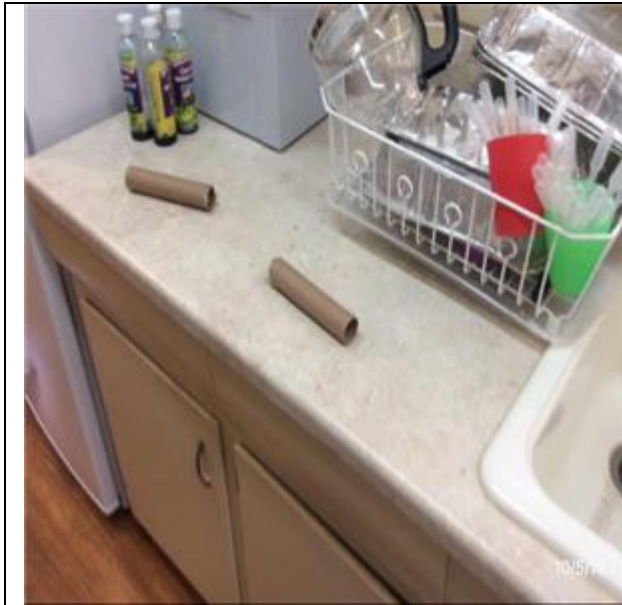
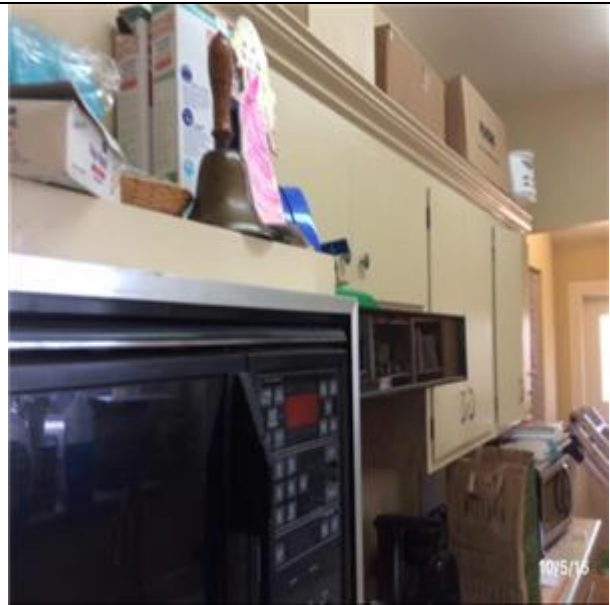
We have assumed the cabinets and countertop were installed as part of the refurbishment, and based on a EUL of twenty years, we do not anticipate replacement during the study period.

E2012 Fixed Casework:- View of Counter Top

E2012 Fixed Casework:- View of Wall Mounted Cabinets

ID	Type	Recommendation	Priority	Year	Expenditures
153380	E2010	ADA Provide an Accessible Counter, Modify Counter Clearances, Increase or provide Maneuvering or Clear Floor Area	Priority 1	2016	\$10,808
