Tier 1 Report of

Facility Condition Assessment

For
City of Los Altos
Shoup Park - Restroom
400 University Ave
Los Altos,
California 94022-3518

Date of Report: September 27, 2016

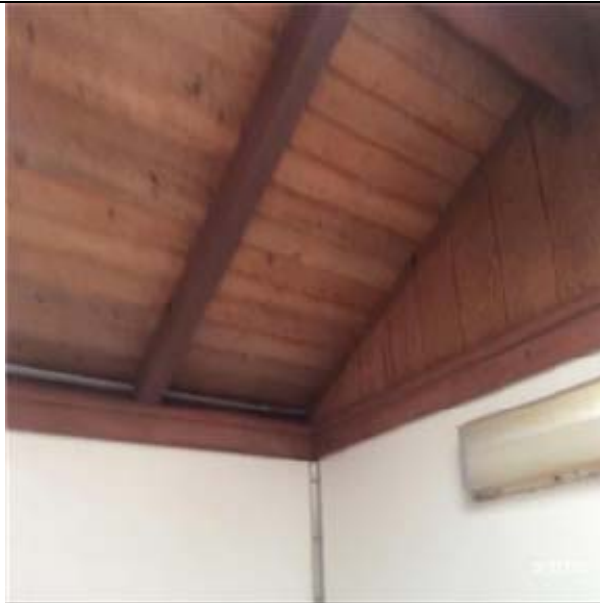
The roof construction and deck are visible due to the open construction and there are no signs of roof leaks or roof deflection therefore, no action for repair or replacement is required within the study period.

B1022 Pitched Roof Construction:- View of Traditional Wood Beams and Rafters

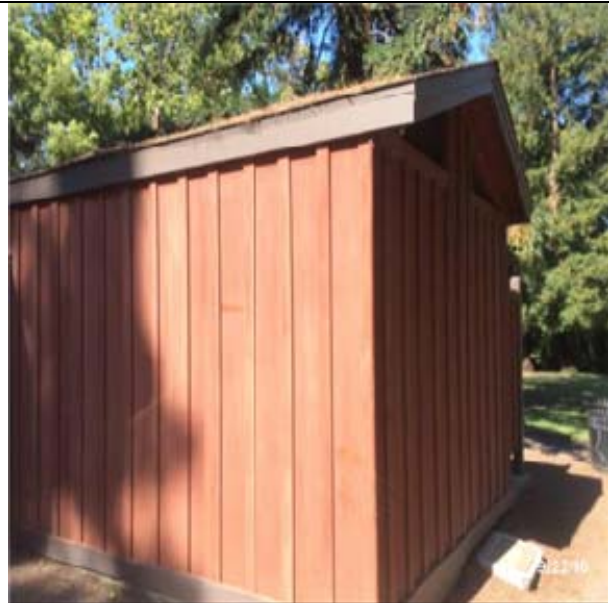
The exterior walls are constructed of stained vertical wood board and battens which are supported by wood studs.

The exterior wall construction was observed to be in fair condition. The wood siding has been regularly painted. We recommend repainting of the surface of the wood panels during the term in the study period to maintain the appearance of the building and also the wood itself.

B2011 Exterior Wall Construction:- View of Wood Board and Batten Cladding

ID	Type	Recommendation	Priority	Year	Expenditures
150596	B2010	Repaint Exterior Wall Surfaces	Priority 3	2018	\$957
150597	B2030	Replace Exterior Single Wood Door	Priority 3	2021	\$5,784

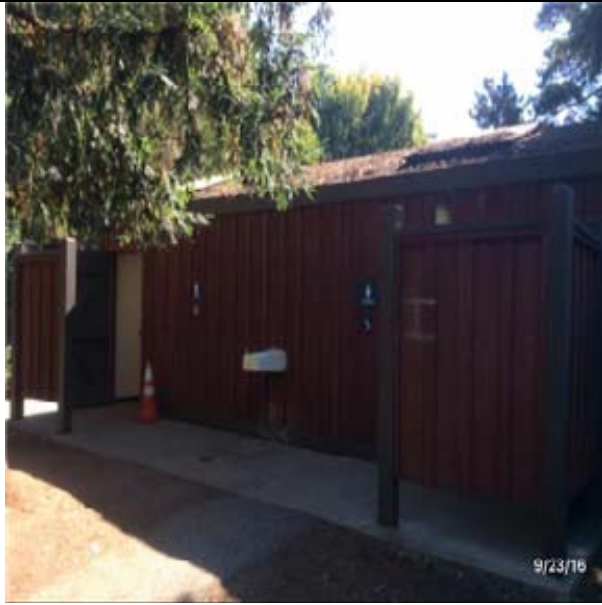
The wood shake shingle coverings appeared to be in a poor condition based on their ages. The wood shake covering is showing signs of cracking and curing, therefore based on the typical EUL of twenty years and observed condition it is recommend that the replacement of the wood shake shingles will be necessary early in the study period. There was a large amount of debris on the roof, due to close proximity to many large trees. We suggest the roof area is cleaned regularly to prevent accelerated degradation, as part of routine maintenance.

B3011 Roof Finishes:- View of Wood Shingle Roof

ID	Type	Recommendation	Priority	Year	Expenditures
150598	B3010	Replace Wood Shingle Roof	Priority 3	2018	\$7,306
150599	B3020	Replace Skylight - Plastic	Priority 3	2018	\$4,859

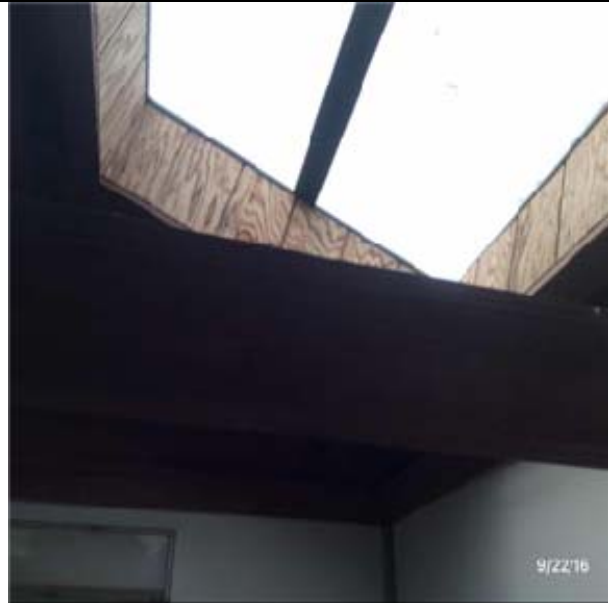
The skylights appeared to be in fair condition. The skylights had no reported or observed moisture ingress present; However, The typical EUL for this type of skylight is thirty years. We recommend replacing the skylights at the same time as the replacement roof covering during the study period. As before regular cleaning of tree debris is recommended.

B3021 Glazed Roof Openings:- View of Skylight – Plastic

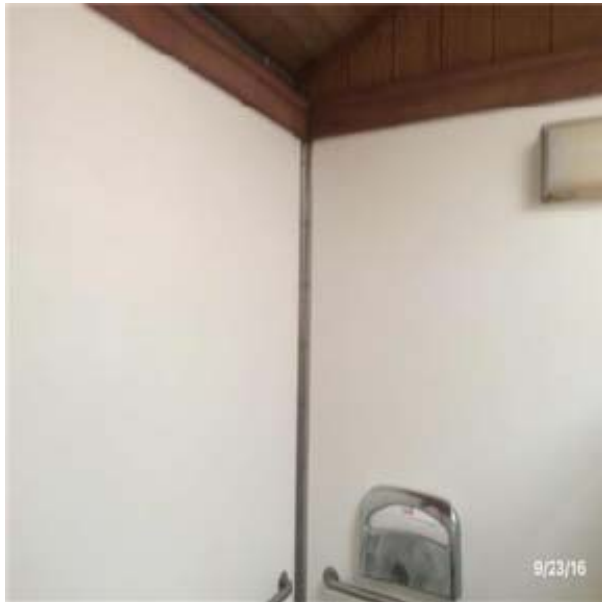
The FRP wall panels were observed to be in a fair condition, we do not anticipate replacement during the study period.

C3012 Wall Finishes to Interior Walls:- View of FRP
Finish to Wall

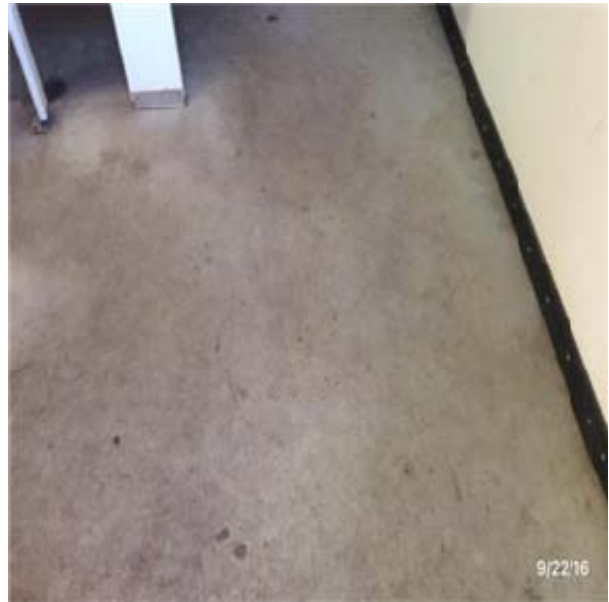
The floor finishes appeared in poor condition throughout the building. We are unaware of the paint finish, however the maintenance personnel confirmed that it was not an epoxy finish. We are unaware of the age of the floor paint, however we assume it to be more than fifteen years of age, therefore based on the typical EUL of five years for this type of finish and current observed condition, we anticipate repainting both early and later in the study period.

C3023 Hardeners and Sealers:- View of Floor Paint - Non Slip

ID	Type	Recommendation	Priority	Year	Expenditures
150602	C3020	Replace Floor Paint - Non Slip	Priority 2	2016	\$2,107
150603	C3020	Replace Floor Paint - Non Slip	Priority 2	2021	\$2,107
150604	C3030	Refinish Wood Ceiling (Stained)	Priority 3	2018	\$16,843

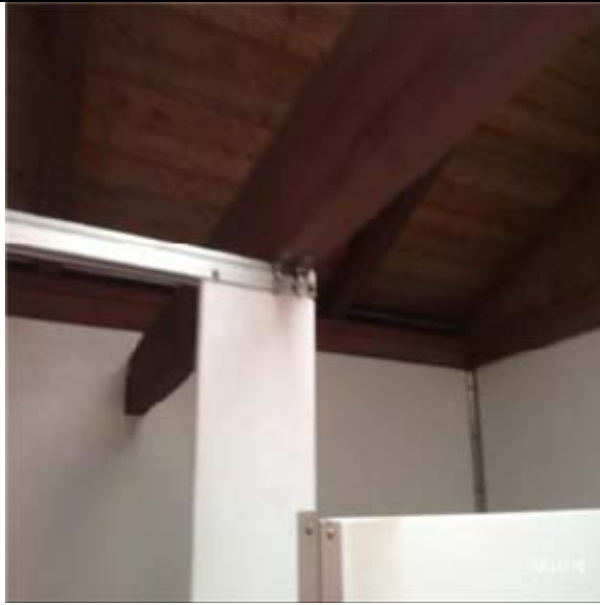
The interior wood ceilings were observed to be in fair condition. We anticipate the repainting of the interior surfaces early in the study period to maintain appearances, at the same time as the interior wall finishes.

C3031 Ceiling Finishes:- View of Wood Ceiling (Stained)

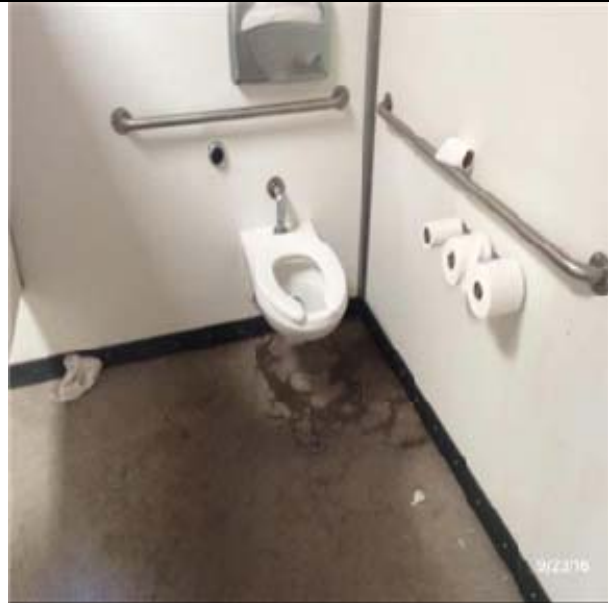
The water closets were observed to be in fair condition. They are assumed to be upgraded in the 1990's and based on a typical EUL of thirty-five years we recommend that they are considered for replacement during the study period. The flush valves may fail during the study period and therefore to maintain function they may need to be replaced. This work has not been included in this study as we anticipate it will be carried out on an as needed basis as part of routine maintenance.

D2011 Water Closets:- View of Wall Mounted Water Closets

ID	Type	Recommendation	Priority	Year	Expenditures
150605	D2010	Replace Wall Hung Lavatories	Priority 3	2025	\$5,286
150606	D2010	ADA Adaptions to Lavatories	Priority 1	2016	\$5,600
150607	D2010	Replace Drinking Fountain	Priority 2	2016	\$1,799
150608	D2010	ADA Replace or Reposition Drinking Fountain	Priority 1	2016	\$5,600
150609	D2010	Replace Wall Mounted Water Closets	Priority 3	2025	\$10,332
150610	D2010	ADA Adaptions to Water Closets	Priority 1	2016	\$11,760

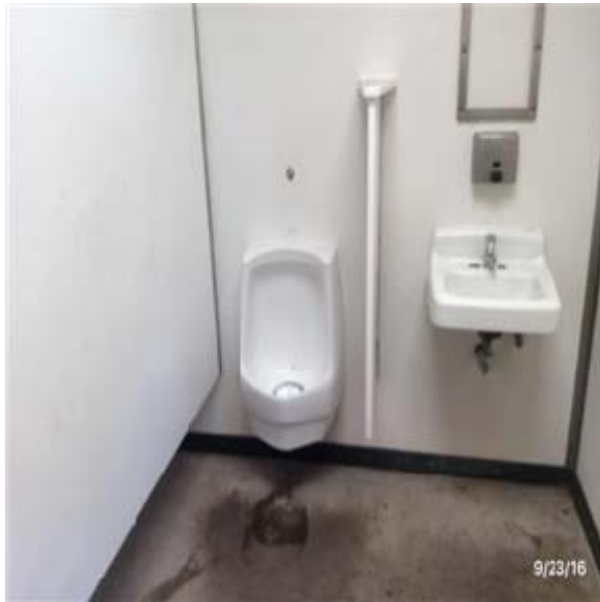
The urinal was observed to be in fair to fair condition. The urinal drained properly and appeared to not have any cracks in the china; based on a typical EUL of thirty years no action for replacement is anticipated during the study period.

D2012 Urinals:- View of Wall Hung Urinal

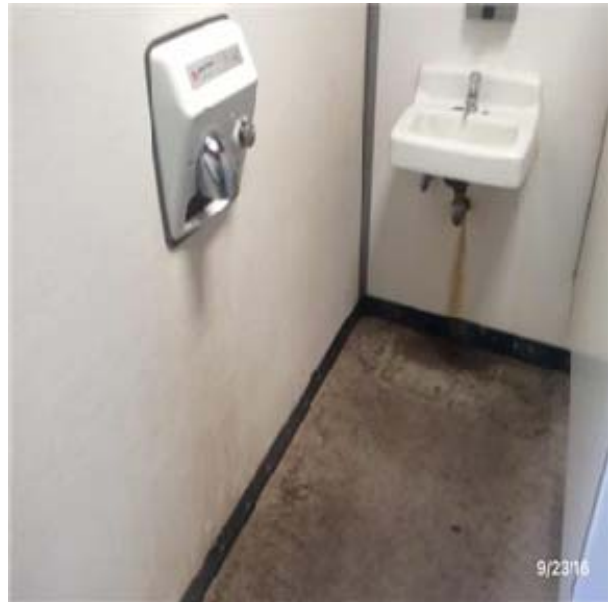
The lavatories were observed to be in poor condition. The lavatory drained properly and appeared to not have any cracks in the china; however, they are assumed to be upgraded in the 90's and based on a typical EUL of thirty-five years we recommend that they are considered for replacement during the study period.

D2013 Lavatories:- View of Wall Hung Lavatories

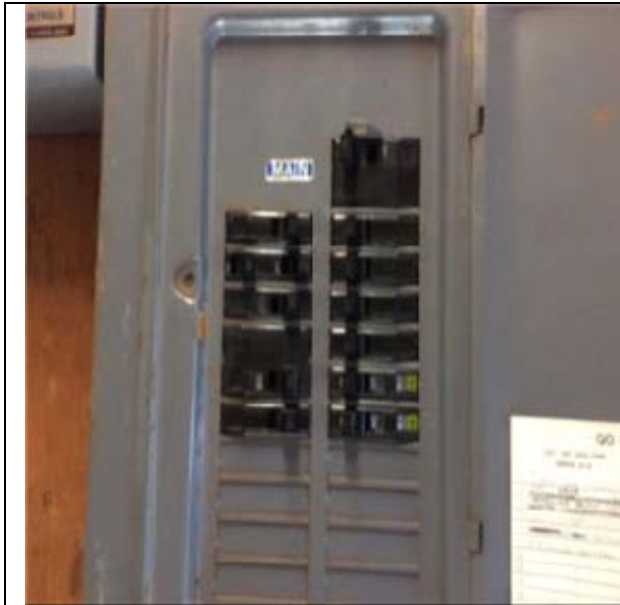
The building contains two Main Distribution Panels (MDP). One is rated at 120/240 volts at 200amps, the other at 120/240 volts at 100 amps . They both manufactured by Square D. It was observed that the panels not only service the building but also the parking lot lighting and walkway lights via time clocks.

The panels appeared to be in fair condition due to their age. There were no signs of deterioration at the panels. The typical EUL for electrical switchboard such as this is thirty years; therefore replacement will be necessary during the study period. We do recommend further evaluation of the branch panels via an infrared electrical inspection which will highlight if high temperatures, excessive electrical resistance, failing components, ground faults and short circuiting issues exist.

D5012 Low Tension Service & Dist:- View of Panelboard -
120/240volts, 60 to 2000amp

ID	Type	Recommendation	Priority	Year	Expenditures
150611	D5010	Replace Panelboard - 120/240volts, 60 to 2000amp	Priority 3	2020	\$3,260
150612	D5010	Replace Panelboard - 120/240volts, 60 to 2000amp	Priority 3	2020	\$6,519
150613	D5020	Replace Fluorescent Light Fixtures	Priority 3	2020	\$2,809
150614	D5020	Replace Wiring Systems (Inc. Receptacles & Switches)	Priority 3	2020	\$3,024
150615	D5030	Replace Time Clock	Priority 3	2020	\$1,350

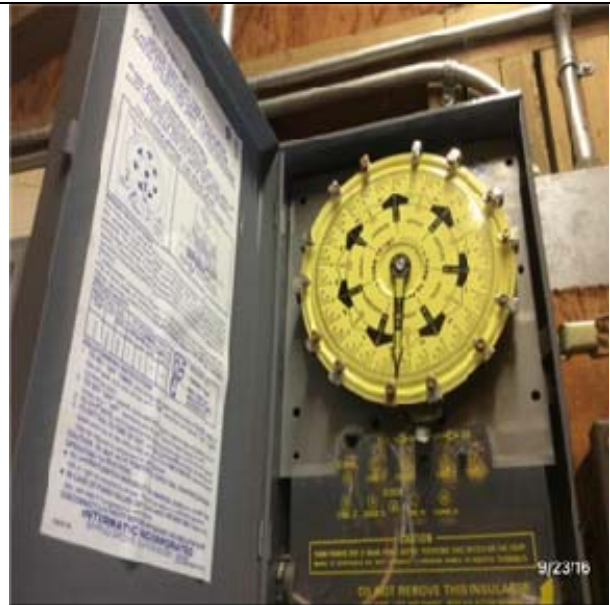
D5036 Clock and Program Systems:- View of Time Clock
