Facility Condition Assessment

**For
City of Los Altos
Woodland Library
1975 Grant Road
Los Altos,
California 94024-6912**

Date of Report: October 12, 2016

Faithful+Gould, Inc.

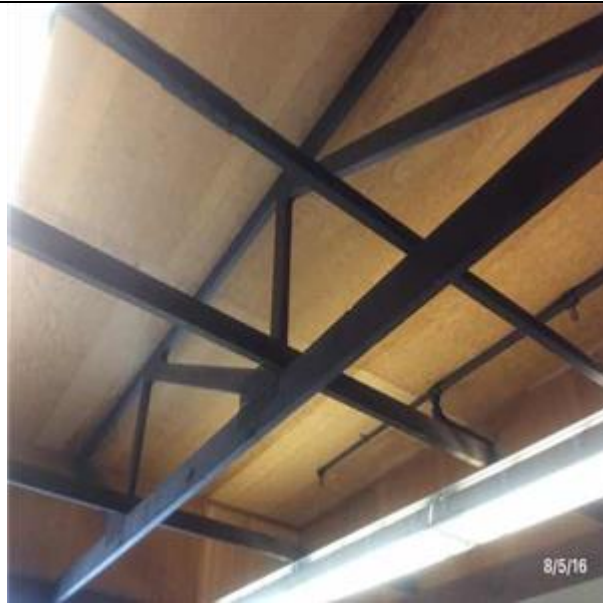
B1022 Pitched Roof Construction:- View of Manufactured Wood Trusses

The roof structure was observed to be in good condition free from visible structural defects or deflection and no actions are anticipated during the study period.

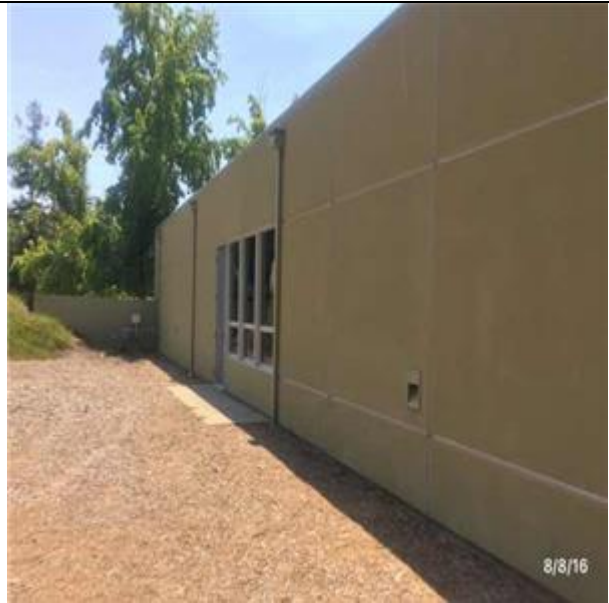
B2011 Exterior Wall Construction:- View of EIFS (Synthetic Stucco) Wall Panels - Standard

The exterior wall construction was observed to be in fair to good condition with no appreciable deterioration present and no actions are anticipated during the study period.

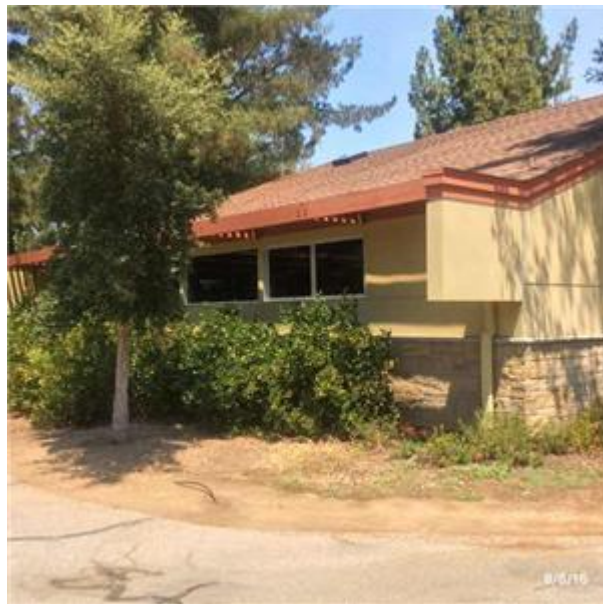
B2012 Parapets:- View of Metal Capping

The metal capping was observed to be in fair to good condition and no actions are anticipated within the study period.

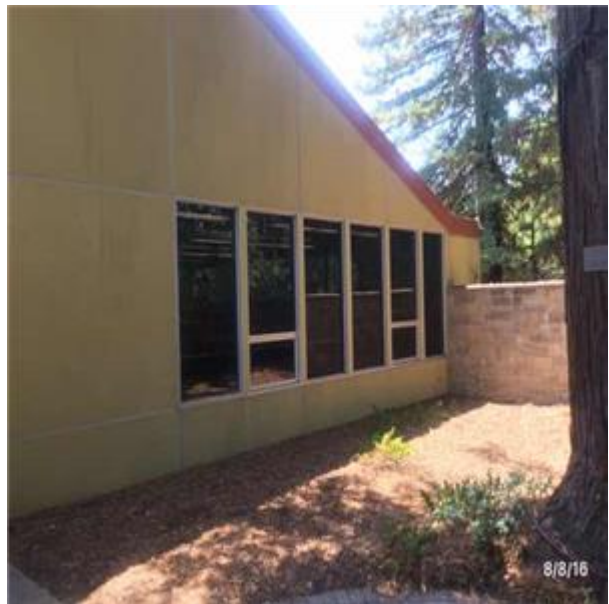
B2021 Windows:- View of Aluminum Window Units - Fixed or Single Hung

The exterior windows were observed to be well maintained in fair to good condition and no repair or replacement actions are anticipated during the study period.

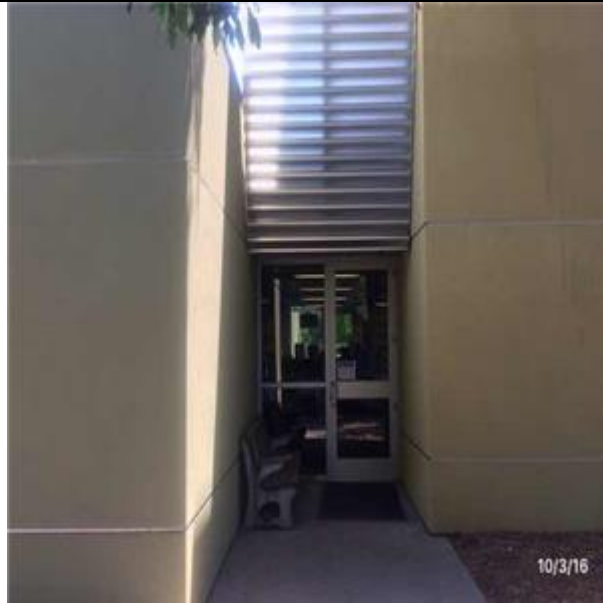
B2031 Glazed Doors & Entrances:- View of Single Aluminum Glazed Doors

The doors were observed to be in fair to good condition and no actions are anticipated within the study period.

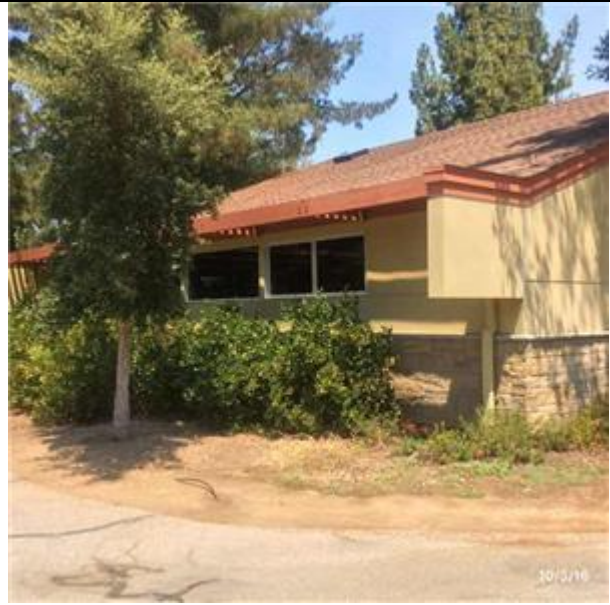
B3011 Roof Finishes:- View of Standing Seam Metal Roof Panels

The standing seam metal roof was observed to be in good condition and no actions are anticipated within the study period.

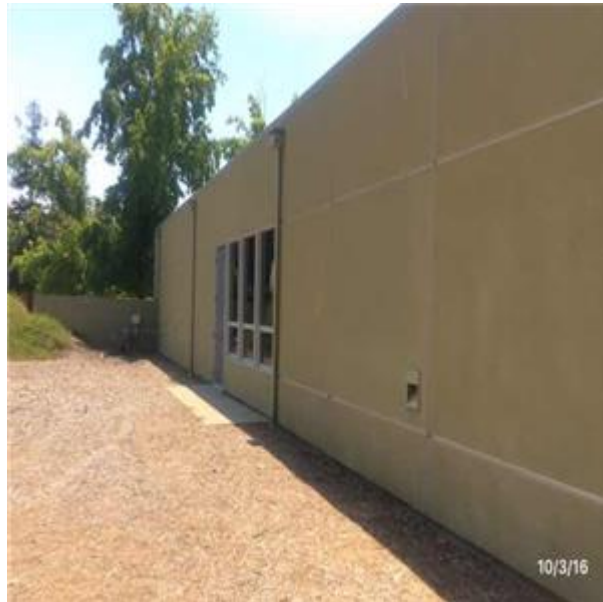
B3016 Gutters and Downspouts:- View of Galvanized Steel Perimeter Gutters & Downspout

The steel downspouts were observed to be in fair to good condition and no actions are anticipated during the study period.

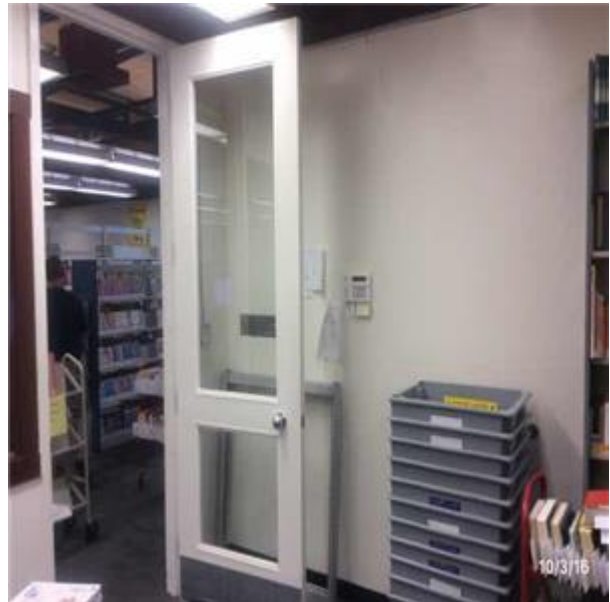
C1021 Interior Doors:- View of Interior Single Wood Door(s)

The wood doors were observed to be in fair to good condition with no signs of significant damage or deterioration and no actions are anticipated within the study period aside from painting as part of routine maintenance.

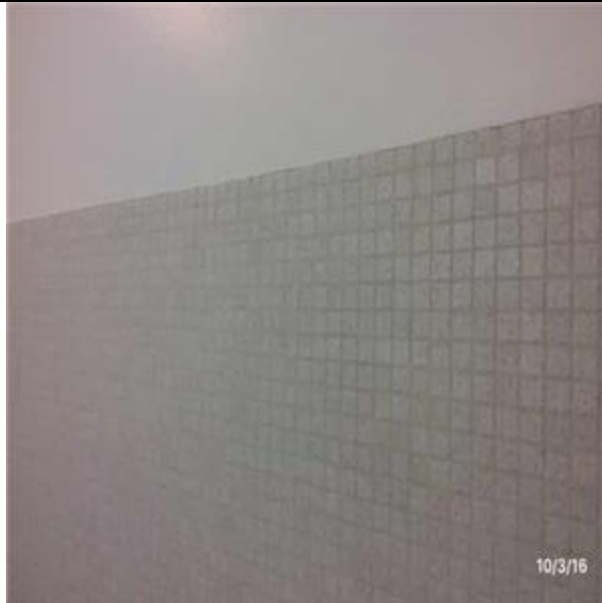
C3012 Wall Finishes to Interior Walls:- View of Ceramic Wall Tiles

The ceramic wall tile was observed to be in good condition and no actions are anticipated within the study period.

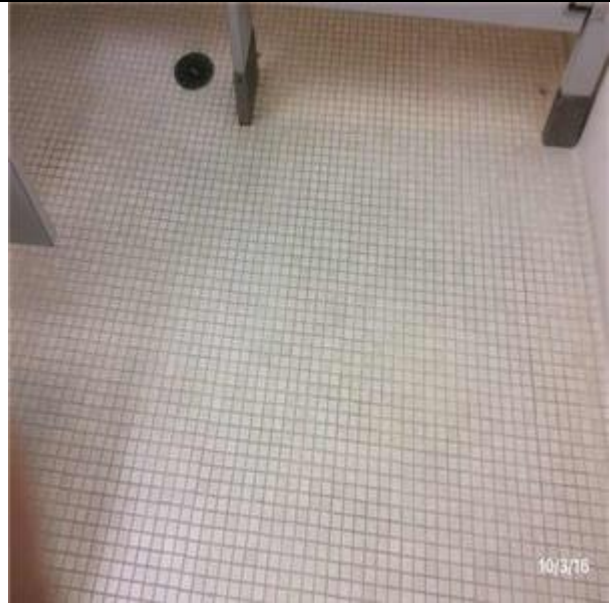
C3024 Flooring:- View of Ceramic Tile

The ceramic floor tile was generally found to be in fair to good condition and no actions are anticipated within the study period.

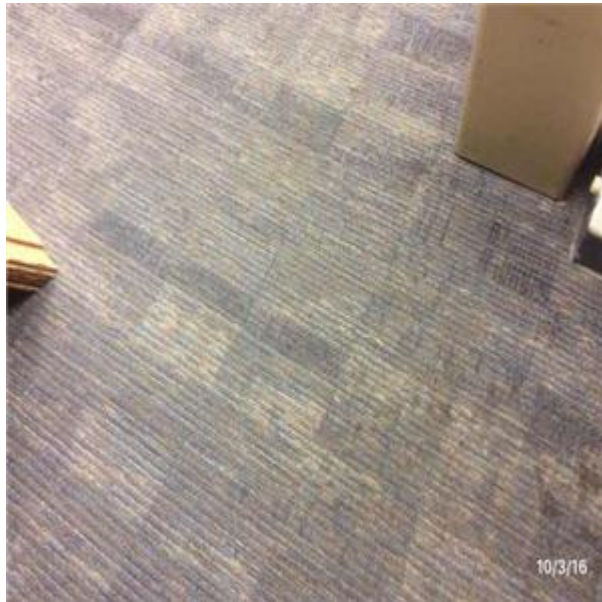
C3025 Carpeting:- View of Carpet Tiles – Standard

The carpet tiles appeared to be in fair to good condition. Based on EUL and observed condition, replacement can be anticipated later in the study period.

ID	Type	Recommendation	Priority	Year	Expenditures
153873	C3010	Replace Painted Finish - Standard	Priority 3	2020	\$13,334
153874	C3020	Replace Carpet Tiles - Standard	Priority 3	2024	\$378,973

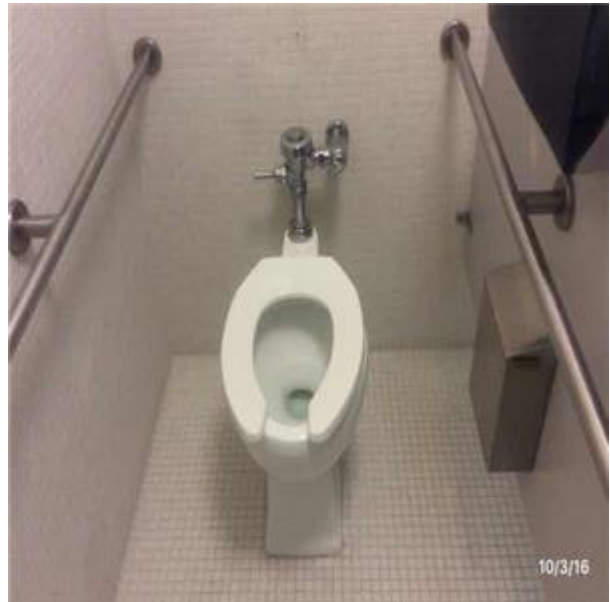
D2011 Water Closets:- View of Floor Mounted Water Closets

The water closets were observed to be in fair to good condition. The water closets flushed properly and did not have any cracks in the china and no actions are anticipated during the study period. It is expected that the flush valves may fail during the study period and may need to be rebuilt or in some cases replaced. This work has not been included in this study as we anticipate it will be carried out on an as-needed basis as part of routine maintenance.

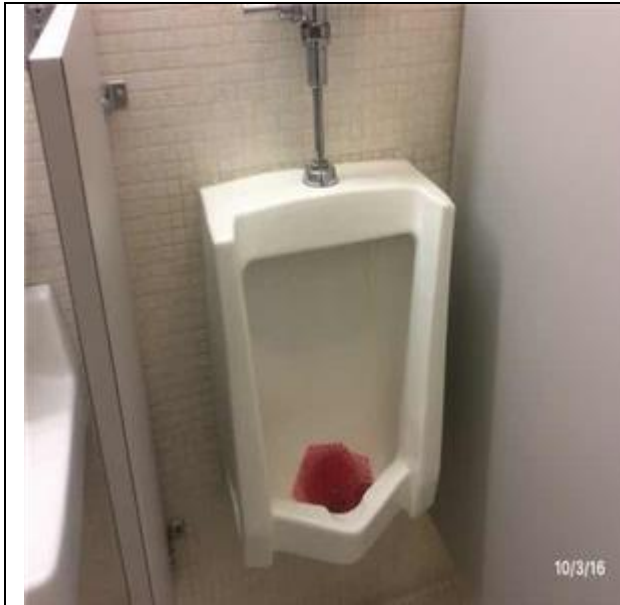
D2012 Urinals:- View of Wall Hung Urinals

The urinal was observed to be in fair to good condition. The urinal flushed properly and did not have any cracks in the china and no actions are anticipated during the study period. It is expected that the flush valves may fail during the study period and may need to be rebuilt or in some cases replaced. This work has not been included in this study as we anticipate it will be carried out on an as-needed basis as part of routine maintenance.

ID	Type	Recommendation	Priority	Year	Expenditures
153875	D2010	ADA Modifications to Lavatories	Priority 1	2016	\$2,500
153876	D2010	ADA Modification to Urinals	Priority 1	2016	\$3,000

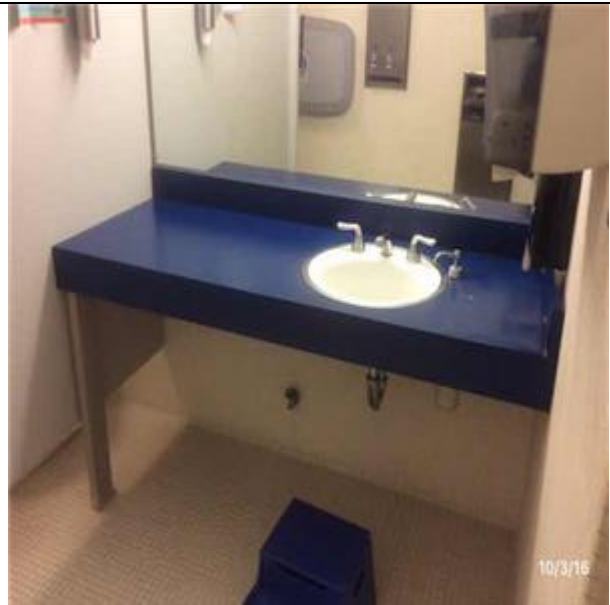
D2013 Lavatories:- View of Vanity Top Lavatories

The lavatory drained properly with no noted deficiencies to the china or faucet. No actions are anticipated during the study period.

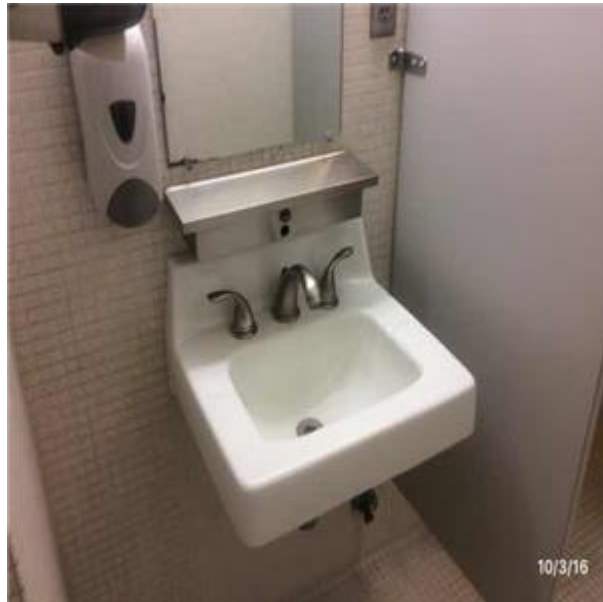
D2013 Lavatories:- View of Wall Hung Lavatories

The lavatory drained properly with no noted deficiencies to the china or faucet. No actions are anticipated during the study period aside from ADA modifications.

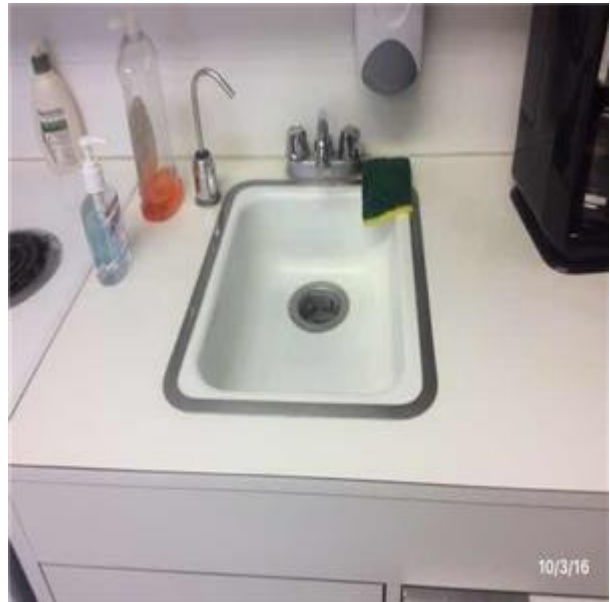
D2014 Sinks:- View of Countertop Single Bowl Kitchen Sink

The counter top sink was observed to be in fair to good condition and no deficiencies were noted to the sink or the faucet. No repair or replacement actions are anticipated within the study period.

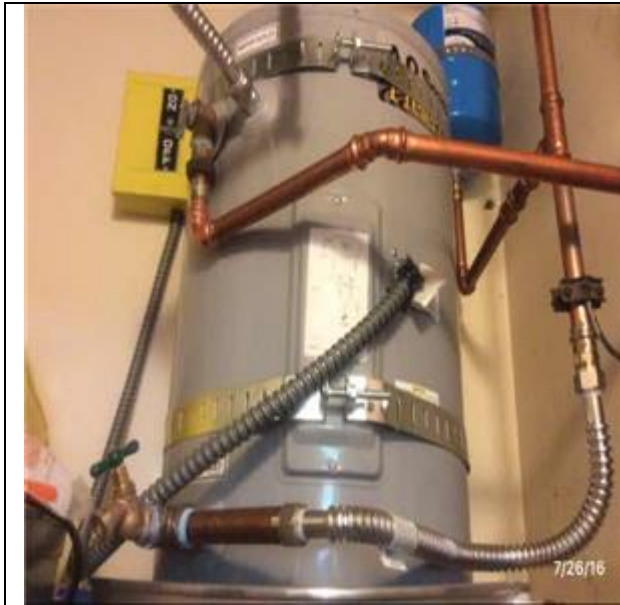
D2022 Hot Water Service:- View of Domestic Hot Water Heater - Electric

The domestic water heater was observed to be in good condition and no actions are anticipated within the study period.

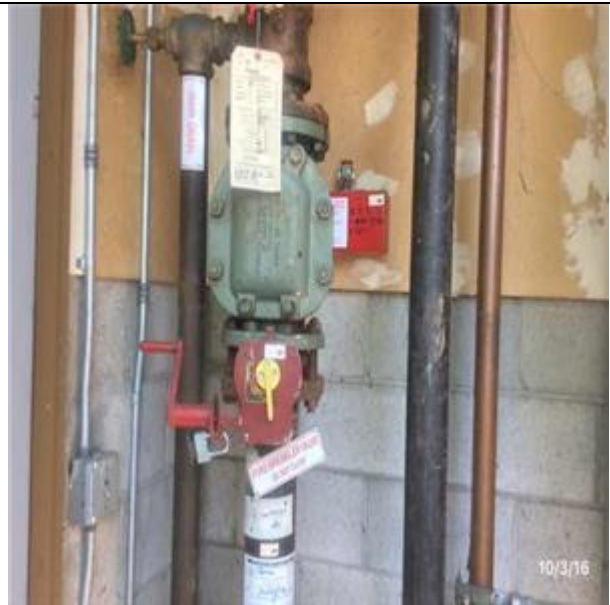
D4011 Sprinkler Water Supply:- View of Wet-Pipe Sprinkler System

The wet pipe fire protection system was observed to be in fair to good condition and no actions are anticipated within the study period.

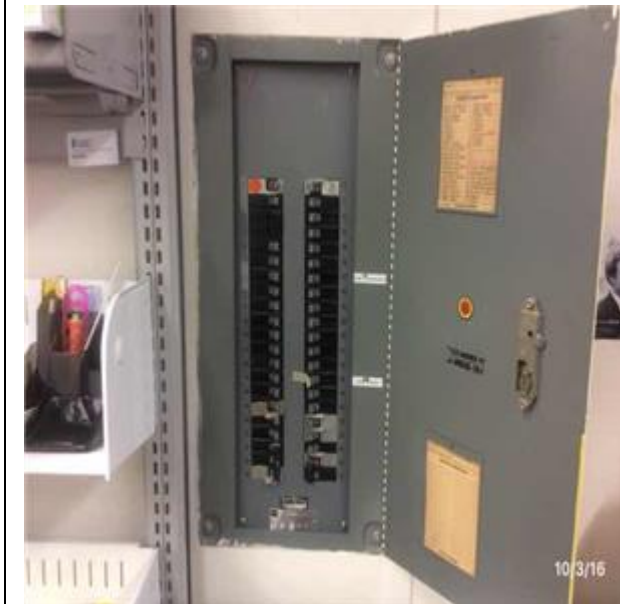
D5012 Low Tension Service & Dist:- View of Panelboard - 120/240volts, 60 to 2000amp

The panelboard was observed to be in good condition and no actions are anticipated within the study period.

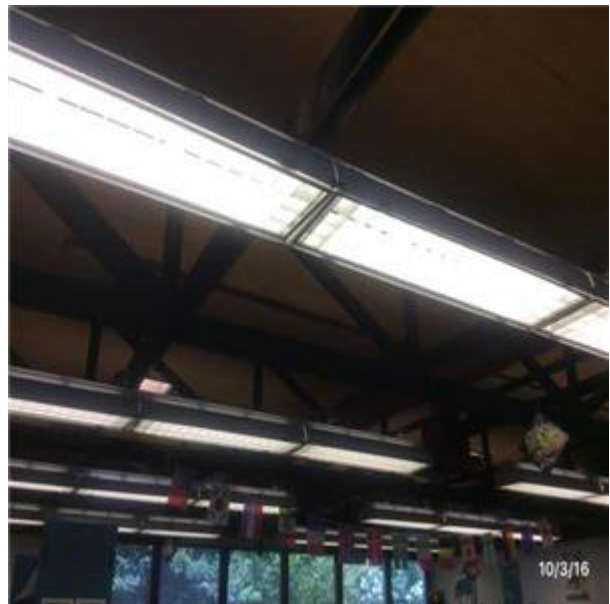
D5022 Lighting Equipment:- View of Interior Light Fixtures - Fluorescent

Light fixtures were observed to be in fair to good condition with no reported issues. No actions are anticipated within the study period.

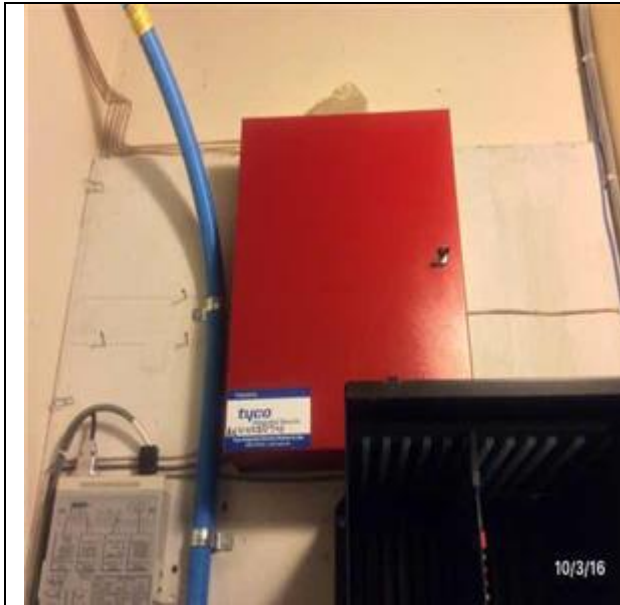
D5037 Fire Alarm Systems:- View of Fire Alarm System (Full System Inc. Panel)

The fire alarm panel was observed to be in fair to good condition and no actions are anticipated within the study period aside from ADA modifications.

ID	Type	Recommendation	Priority	Year	Expenditures
153879	D5030	ADA Modifications to Fire Alarm System	Priority 2	2016	\$1,500

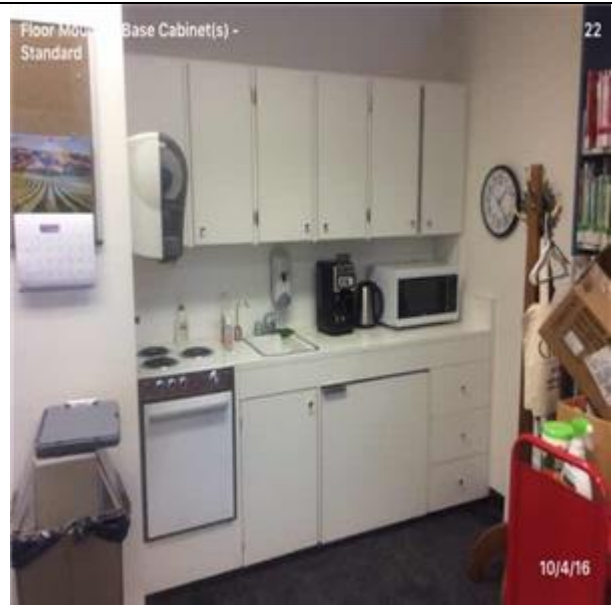
E2012 Fixed Casework:- View of Floor Mounted Base Cabinet(s) - Standard

The base cabinets were observed to be in fair to good condition and no actions are anticipated within the study period.
