Tier 1 Report of
Facility Condition Assessment

For
City of Los Altos
Youth Center
2 N. San Antonio Road
Los Altos,
California 94022-3000

Date of Report: September 16, 2016

Faithful+Gould, Inc.

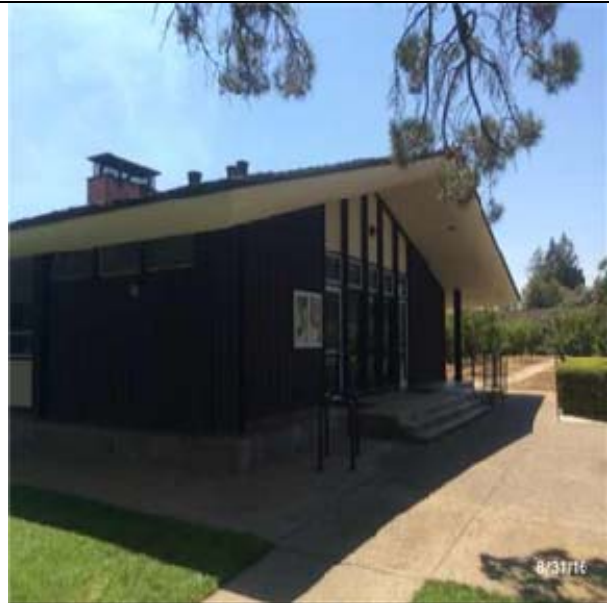
The window systems appeared to be in poor to fair condition. We noted some deterioration of frame and/or glass which would require actions. The frames are over their EUL of thirty years and replacement is anticipated in the mid-term of the study period.

B2021 Windows:- View of Aluminum Window Units - Fixed or Single Hung

ID	Type	Recommendation	Priority	Year	Expenditures
149990	B2020	Replace Aluminum Window Units - Fixed or Single Hung	Priority 3	2022	\$60,965
149991	B2030	ADA Modifications to Exterior Doors	Priority 1	2016	\$4,500

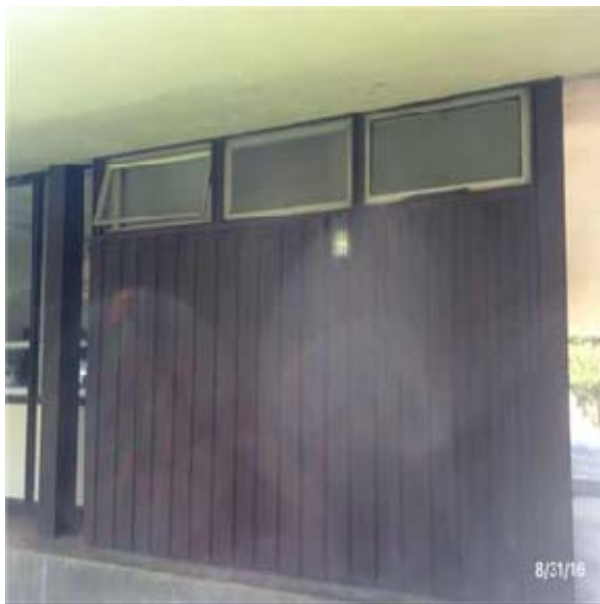
The aluminum hopper windows were operable and observed to be in fair condition and no actions are anticipated during the study period.

B2021 Windows:- View of Awning or Hopper Style Window

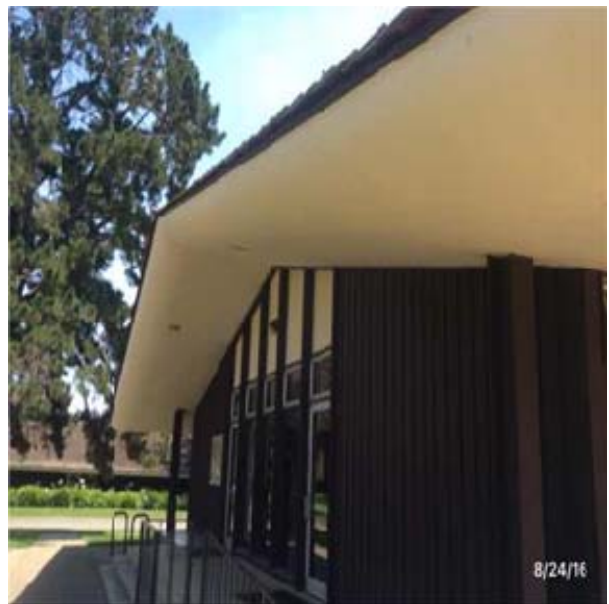
The wood framed window units were observed to be in fair condition and based on their visual appearance and estimated useful life no replacement actions are anticipated during the study period.

B2021 Windows:- View of Wood Window Units - Fixed or Single Hung

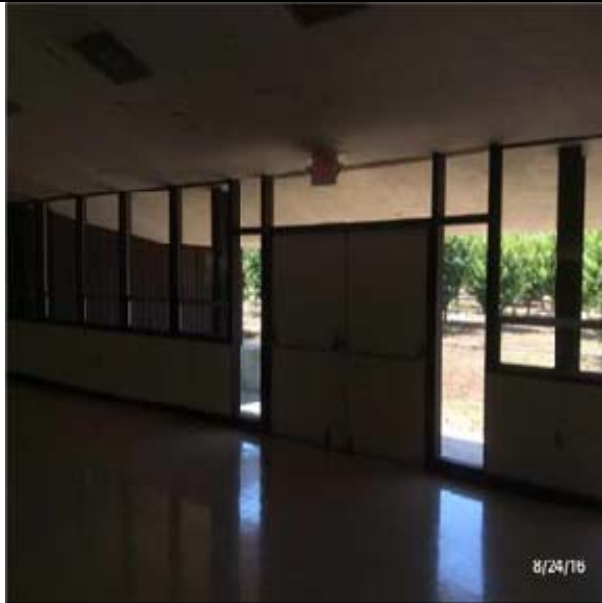
The single solid core wood doors appeared in fair condition and are assumed to be original construction to the building. The typical EUL for this type of equipment is thirty years and no actions are anticipated during the study period aside from painting and ADA modifications.

B2032 Solid Exterior Doors:- View of Double Solid Core Wood Doors

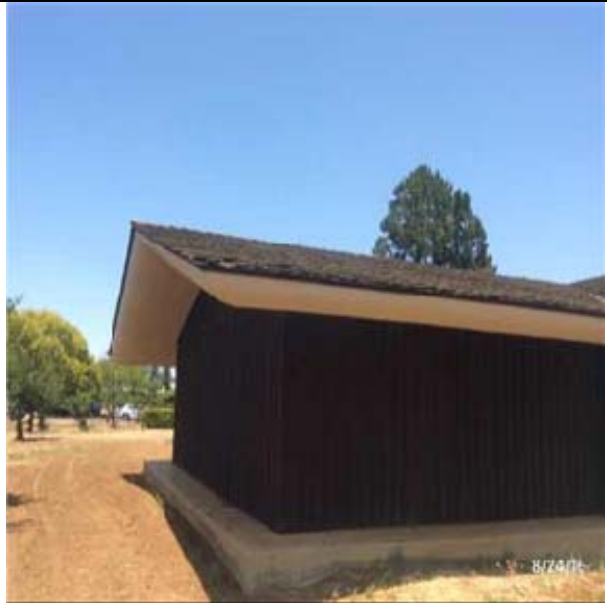
The wood shake roof was observed to be in fair condition with no issues reported by maintenance. Based on the EUL of twenty years and observed condition, replacement can be anticipated towards the mid-term of the study period.

B3011 Roof Finishes:- View of Wood Shake Roof

ID	Type	Recommendation	Priority	Year	Expenditures
149992	B3010	Replace Wood Shake Roof	Priority 3	2020	\$167,976

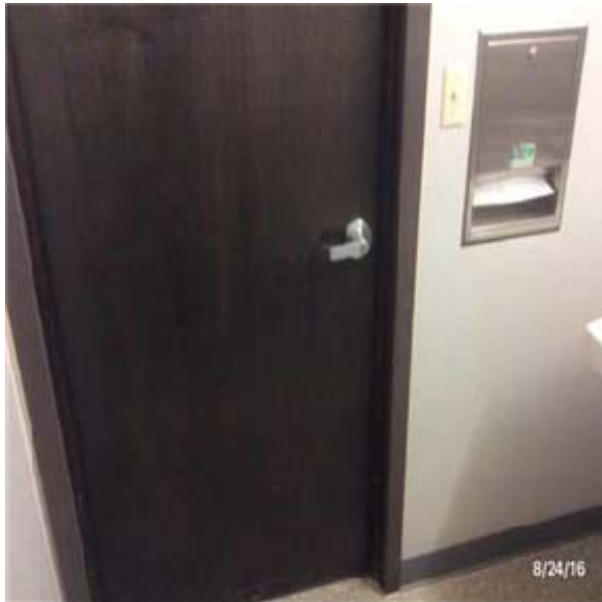
The single interior solid core wood doors appeared in fair to good condition and no actions are anticipated during the study period aside from painting and ADA modifications.

C1021 Interior Doors:- View of Interior Single Wood Door(s)

ID	Type	Recommendation	Priority	Year	Expenditures
149993	C1010	Modifications to Wall Mounted Defibrillator	Priority 1	2016	\$1,000
149994	C1010	ADA Modifications to Toilet Partitions	Priority 1	2016	\$1,650
149995	C1020	ADA Modifications to Interior Doors	Priority 1	2016	\$4,500

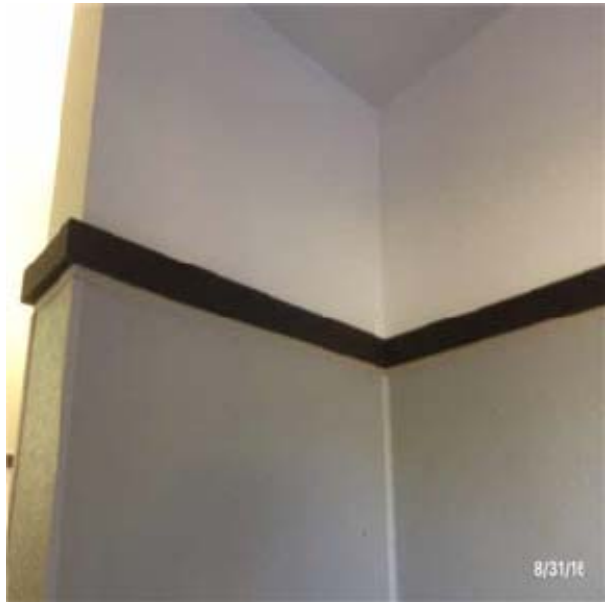
The wainscoting was observed to be in fair to good condition and no actions are anticipated during the study period.

C3012 Wall Finishes to Interior Walls:- View of Wainscot

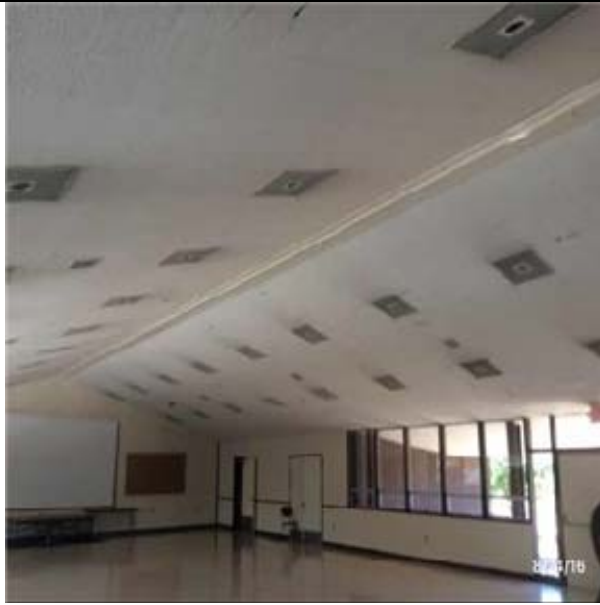
The interior walls were observed to be fair condition. Interior repainting is generally recommended to be performed every eight years and is recommended for the mid-term of the study period.

C3012 Wall Finishes to Interior Walls:- View of Painted Finish - Standard

ID	Type	Recommendation	Priority	Year	Expenditures
149997	C3010	Replace Painted Finish - Standard	Priority 3	2022	\$6,150
149998	C3020	Replace Carpet Tiles - Standard	Priority 3	2022	\$18,491

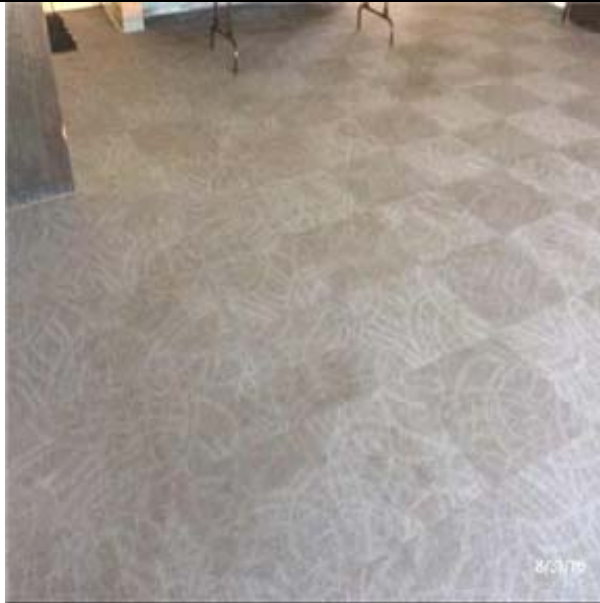
The carpet tile does not appear to be original to the building, although the installation date is unknown. The carpet is in fair to good condition but with an EUL of ten years, replacement actions can be anticipated after mid-term of the study period.

C3025 Carpeting:- View of Carpet Tiles – Standard

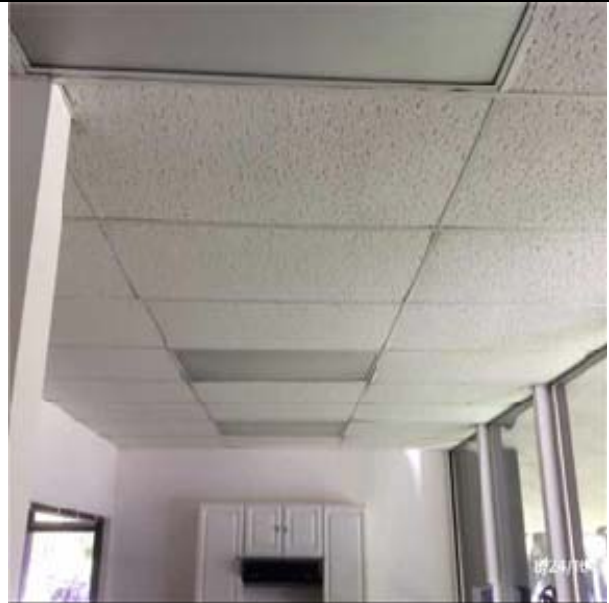
The suspended acoustical ceiling and direct adhered ceiling tiles was observed to be in fair condition and no actions are anticipated over the study period.

C3032 Suspended Ceilings:- View of Acoustical Tile

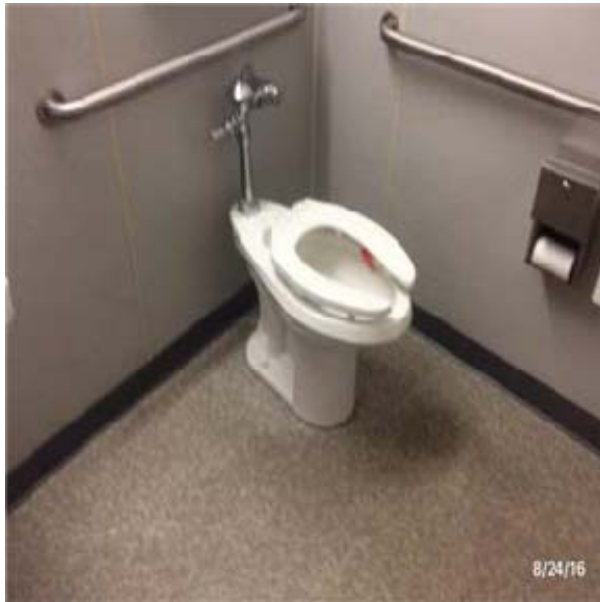
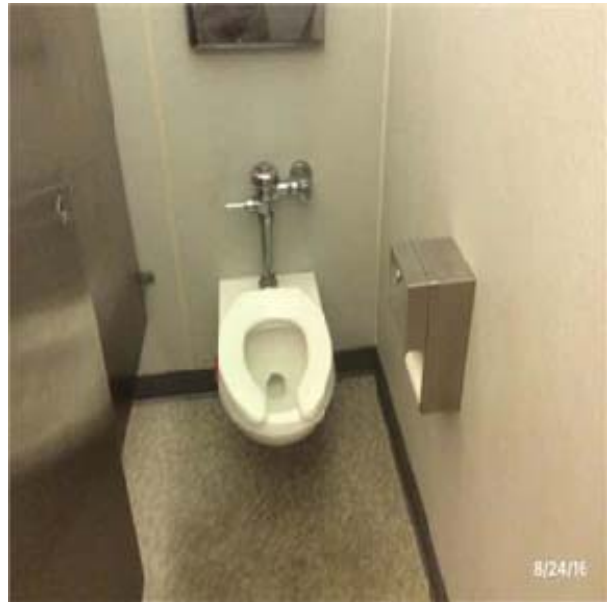
The water closets were observed to be in fair to good condition. The water closets flushed properly and appeared not to have any cracks in the china. Replacement is not anticipated during the study period.

D2011 Water Closets:- View of Floor Mounted Water Closets

D2011 Water Closets:- View of Wall Mounted Water Closets

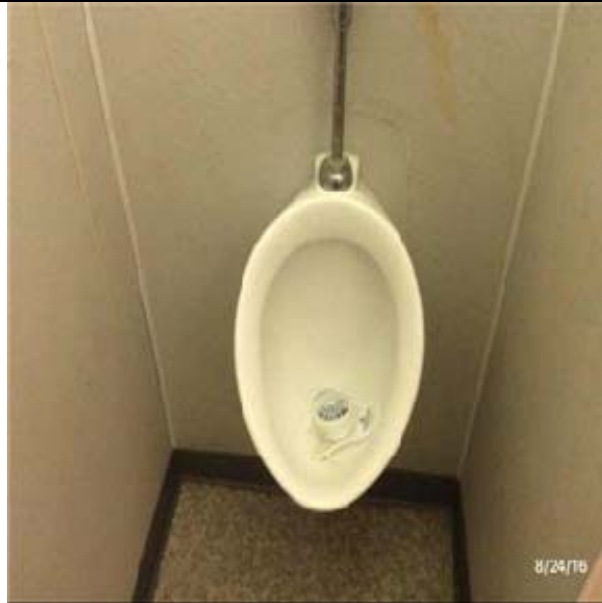
The wall mounted urinal was observed to be in fair condition with no apparent cracks in the china. No actions are anticipated over the study period.

D2012 Urinals:- View of Wall Hung Urinals

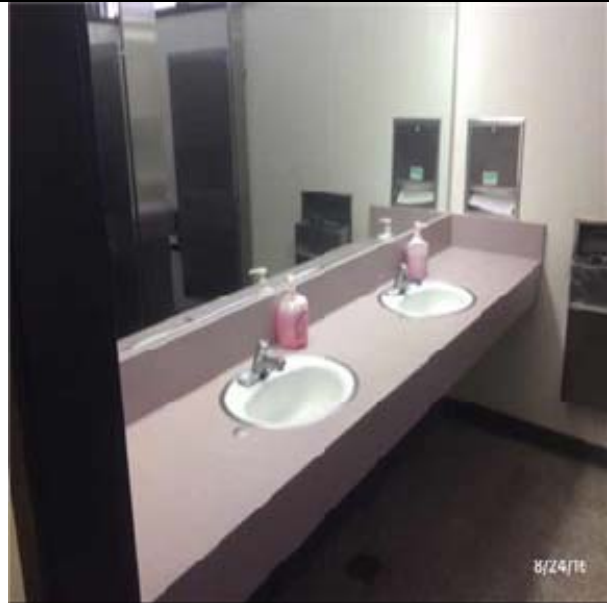
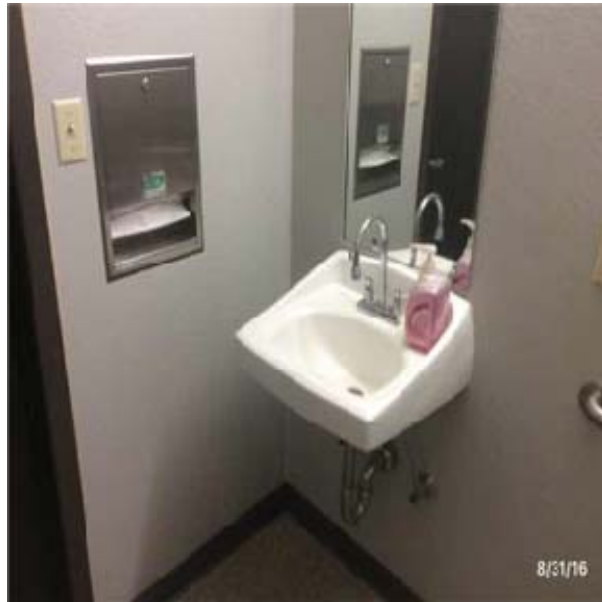
The lavatories were observed to be in fair to good condition and no actions are anticipated over the study period aside from ADA modifications.

D2013 Lavatories:- View of Vanity Top Lavatories

D2013 Lavatories:- View of Wall Hung Lavatories

ID	Type	Recommendation	Priority	Year	Expenditures
149999	D2010	ADA Modifications to Drinking Fountain	Priority 1	2016	\$6,000
150000	D2010	ADA Modifications to Lavatories	Priority 1	2016	\$2,500

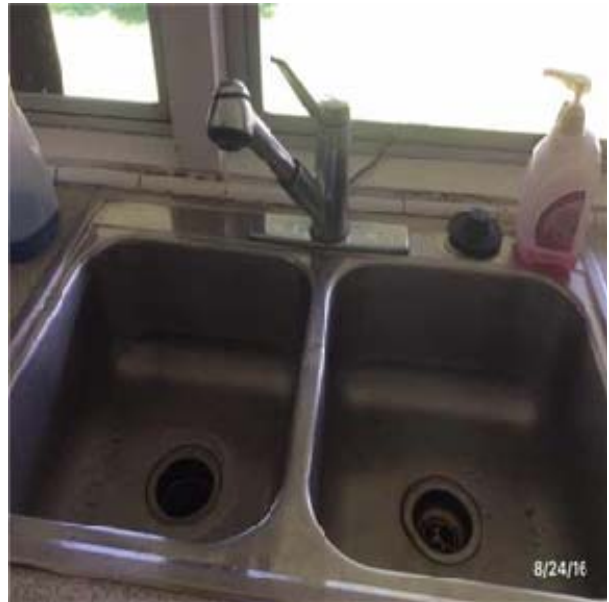
The kitchen countertop double bowl kitchen sinks were observed to be in fair condition and with no issues reported; therefore, based on the RUL, we extended the RUL; no action is necessary during the study period.

D2014 Sinks:- View of Countertop Double Bowl Kitchen Sinks

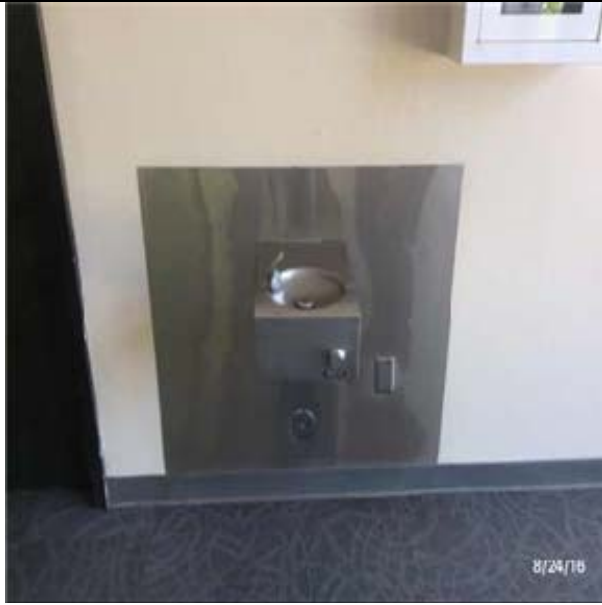
The facility contains one stainless steel wall mounted single level drinking fountain that is believed to have been installed as part of the original construction.

The drinking fountain was observed to be operational and in fair condition. No actions are anticipated over the study period aside from ADA modifications.

D2018 Drinking Fountains and Coolers:- View of Wall Mounted Standard Drinking Fountain (Single)

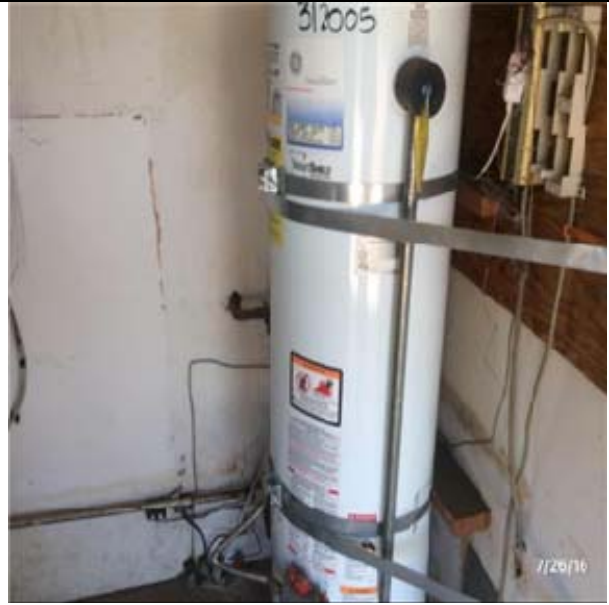
The gas hot water heater were observed to be in fair condition; the typical EUL for hot water heater is fifteen-years; therefore replacement is not anticipated within the study period.

D2022 Hot Water Service:- View of Domestic Hot Water Heater - Gas

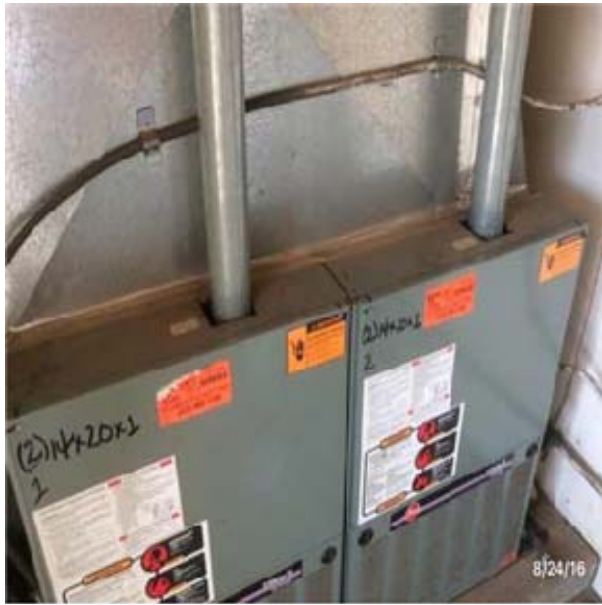
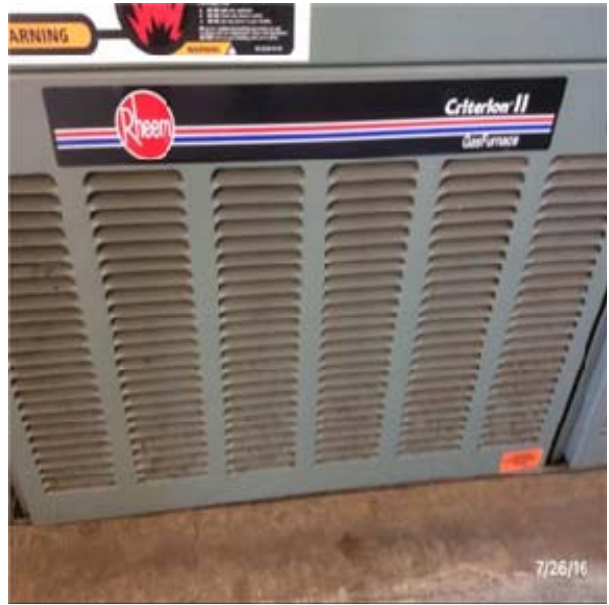
The building contains two Rheem gas fired boilers for the building heating system with estimated capacities of 199 MBH each and installed in 1998. Based on EUL and observed condition, no actions are anticipated over the study period.

The gas fired boilers were observed to be in fair condition the typical EUL thirty five -years; therefore replacement is not anticipated within the study period.

D3021 Boilers:- View of Furnace - Gas #1

D3021 Boilers:- View of Furnace - Gas #2

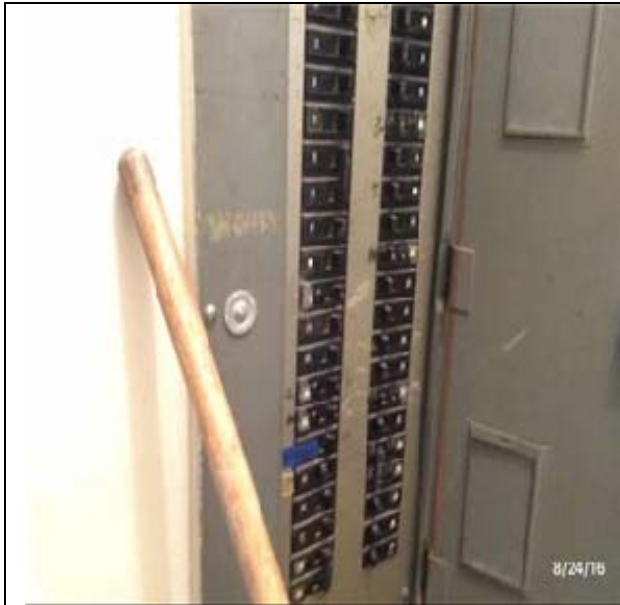
The Main Distribution Panelboards (MDPs) were observed to be in fair condition with no reported issues. Based on EUL, replacement is recommended early in the study period.

D5012 Low Tension Service & Dist:- View of Panelboard -
120/240volts, 200 to 1200amp

- + D Services: Replace Panelboard - 120/240volts, 200 to 1200amp at an estimated cost of \$7,334 in year 2016
- + D Services: Replace Panelboard - 120/240volts, 60 to 2000amp at an estimated cost of \$13,038 in year 2016

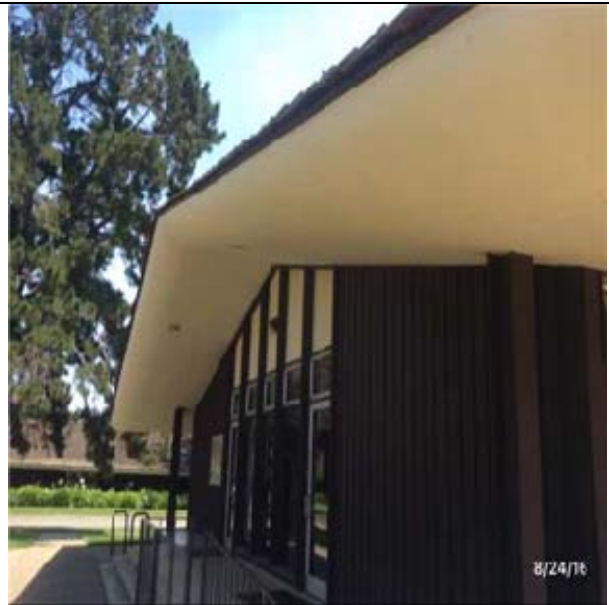
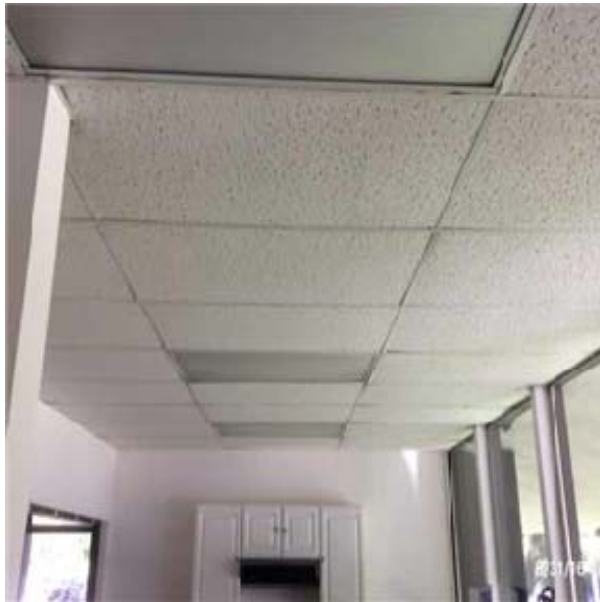
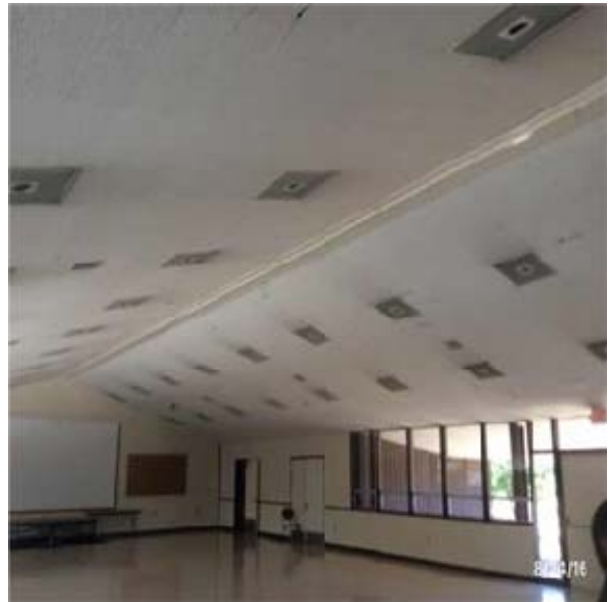
The interior and exterior lighting was observed to be in fair condition and no actions are anticipated over the study aside from re-lamping.

D5022 Lighting Equipment:- View of Exterior Wall Pack
Light Fixtures

D5022 Lighting Equipment:- View of Interior Light
Fixtures - Fluorescent

D5022 Lighting Equipment:- View of Recessed Can
Light Fixtures

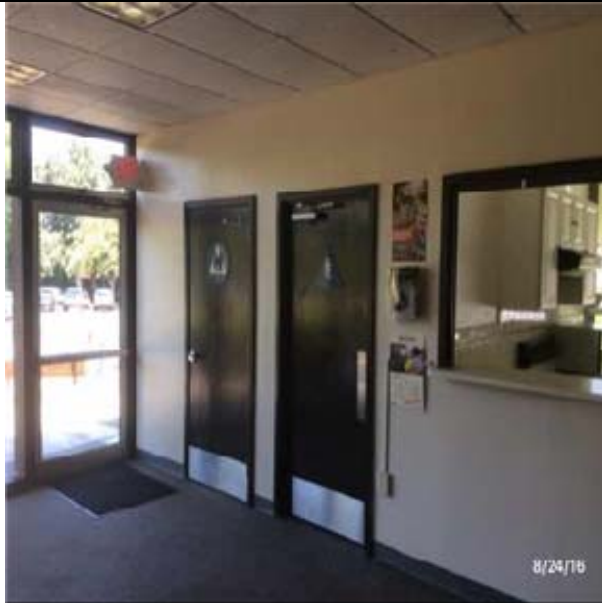
The exit signs were properly illuminated observed to be in fair condition. No actions are anticipated over the study period.

D5092 Emergency Light & Power Systems:- View of Exit
Lights
