Tier 1 Report of

Facility Condition Assessment

For  
City of Los Altos  
Grant Park - Classroom building  
1575 Holt Ave  
Los Altos,  
California 94024

Date of Report: August 31, 2016

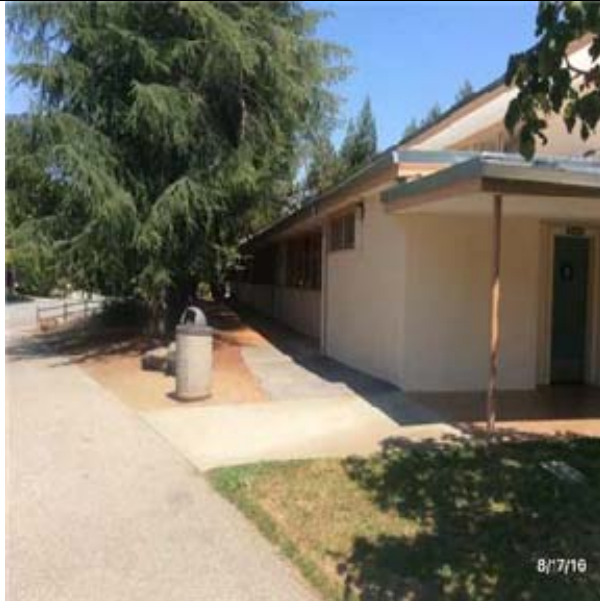
The canopy was observed to be in fair to good condition showing no signs of structural distress. No actions are anticipated during the study period.

B1023 Canopies:- View of Canopies - Wood Joists Supporting Exterior Grade Plywood

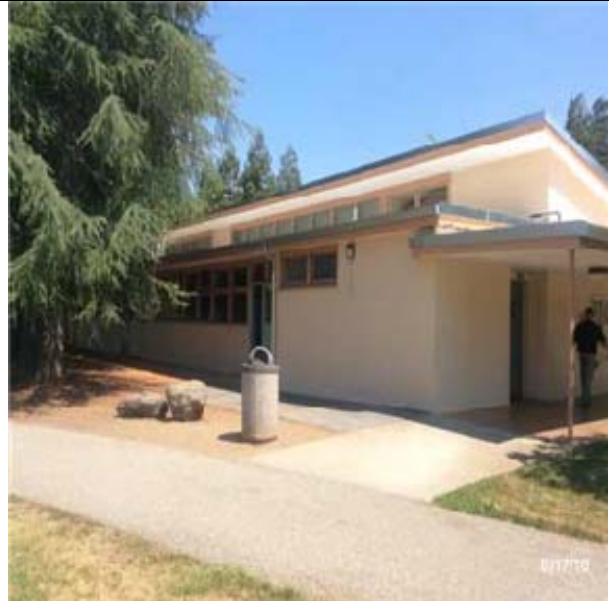
The stucco appeared to be in fair condition with no instances of deterioration observed. We do however recommend repainting of exterior surfaces later in the study period to maintain the appearance of the building and protect the asset.

B2011 Exterior Wall Construction:- View of Stucco over Stud Walls

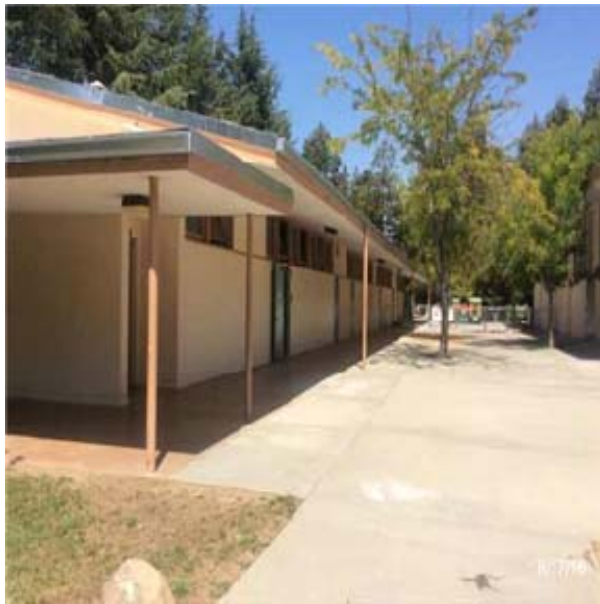
The wood framed glazing appeared to be in fair to good condition, however based on age we anticipate replacement of the building's windows in the mid-term of the study period.

B2021 Windows:- View of Wood Window Units - Fixed or Single Hung

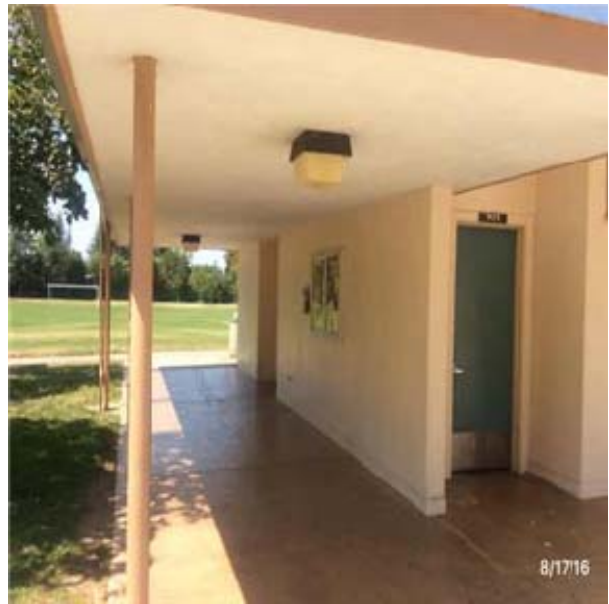
The building contains seven exterior solid core wood doors equipped with lever locksets, automatic closures and a painted finish. Various doors contain half glazing and stainless steel kick plates.

The solid core wood exterior doors were observed to be in fair to good serviceable condition although all require modifications to comply with ADA standards. Repainting of exterior doors early in the study period should be anticipated as part of routine maintenance.

B2032 Solid Exterior Doors:- View of Single Solid Core Wood Doors

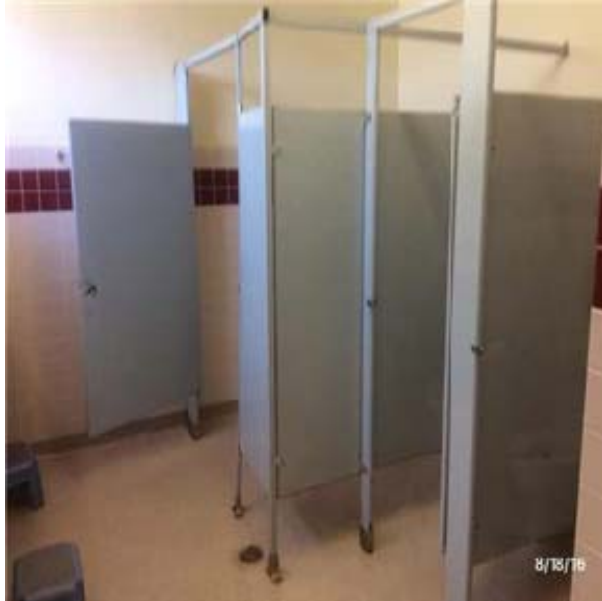
Toilet partitions in the restrooms were observed to be damaged and corroded. Replacement is recommended as part of deferred maintenance in order to maintain appearance, privacy, and sanitary conditions.

C1014 Site Built Toilet Partitions:- View of Toilet Partition

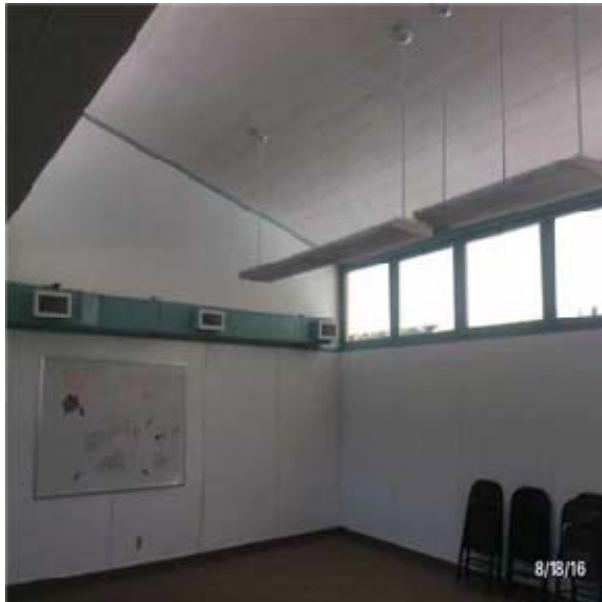
C3012 Wall Finishes to Interior Walls:- View of Wainscot

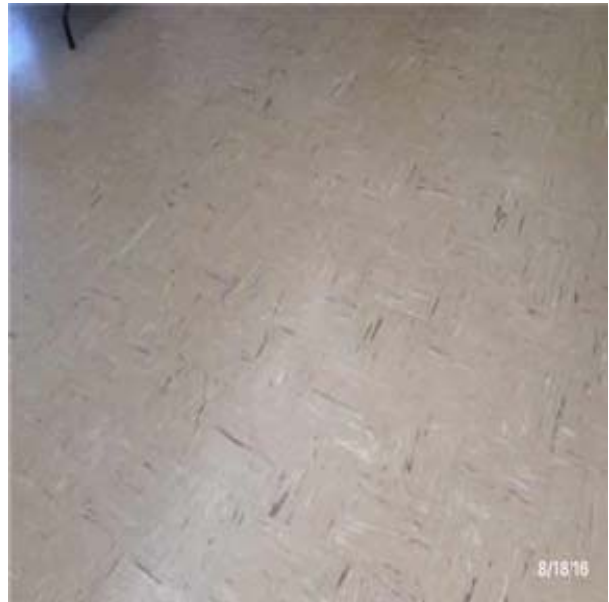
The VCT was observed to be in fair to good condition and no actions are anticipated during the study period.

C3024 Flooring:- View of Vinyl Composite Tile (VCT)

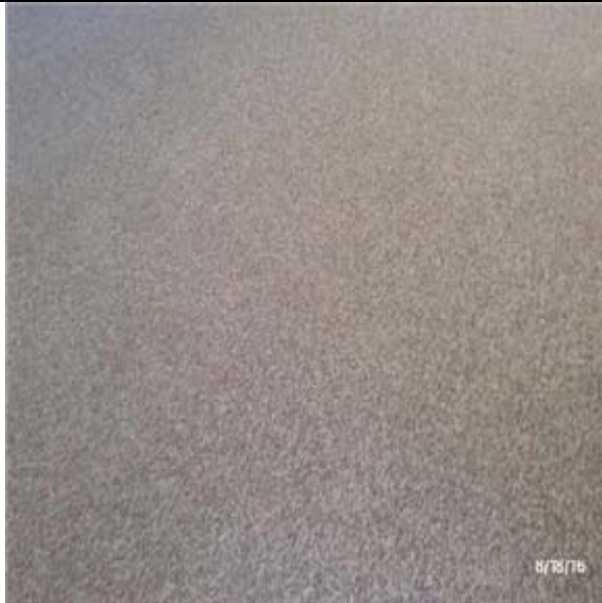
The date of the last carpet replacement is unknown but based on observation and evaluation, replacement should be anticipated mid-term in the study period.

C3025 Carpeting:- View of Broadloom Standard without Padding

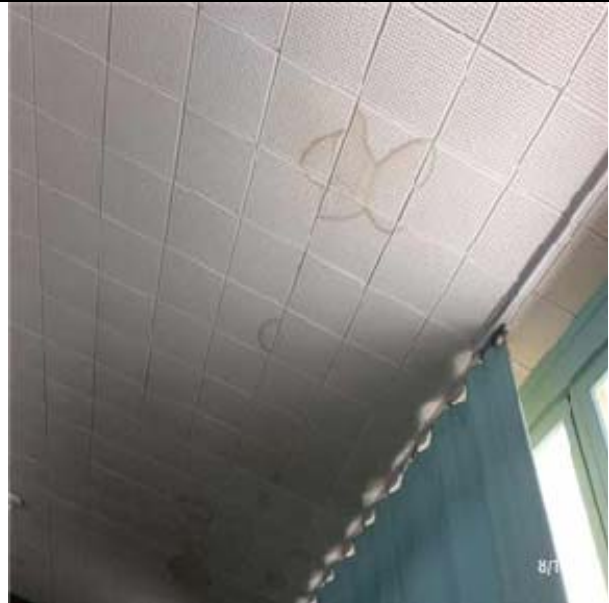
The acoustic tiles were observed to be in fair condition and no actions are anticipated during the study period.

C3032 Suspended Ceilings:- View of Acoustic Ceiling System - Standard

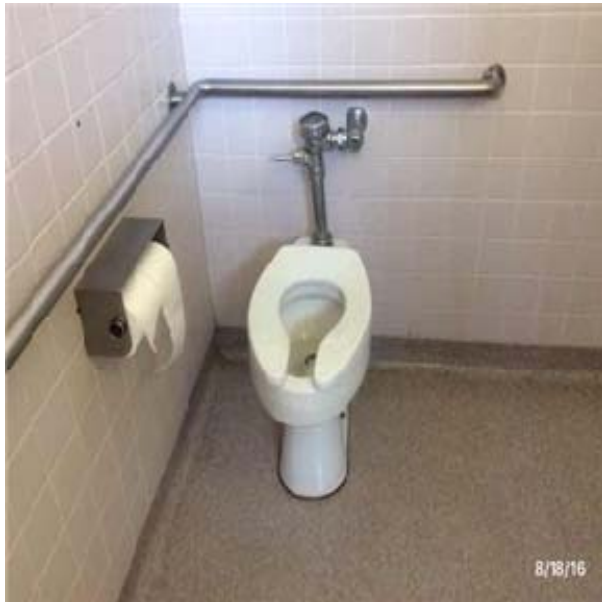
The water closets appeared to be in fair condition. The water closets flushed properly and did not have any cracks in the china and no actions will be generated as it is anticipated that they are suitable to last beyond the study period. ADA modification actions to the water closets have been generated for the beginning of the study period.

D2011 Water Closets:- View of Floor Mounted Water Closets

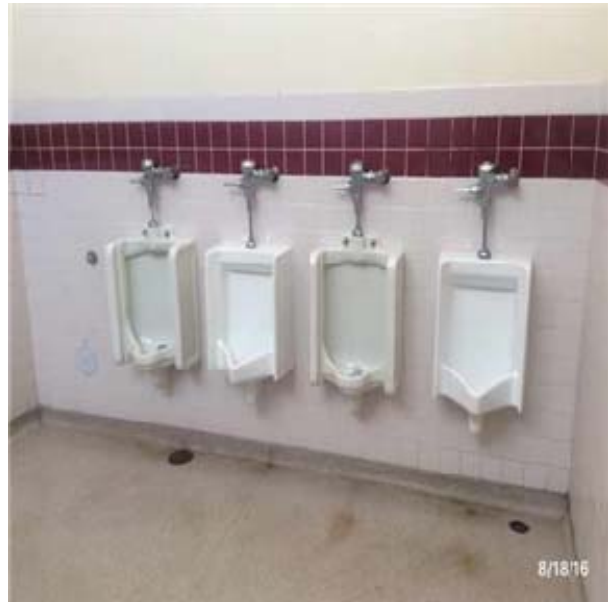
The urinals were observed to be in fair condition. The urinals flushed properly and did not have any cracks in the china and no actions will be generated during the study period. ADA modification actions to the urinal have been generated for the beginning of the study period.

D2012 Urinals:- View of Wall Hung Urinals

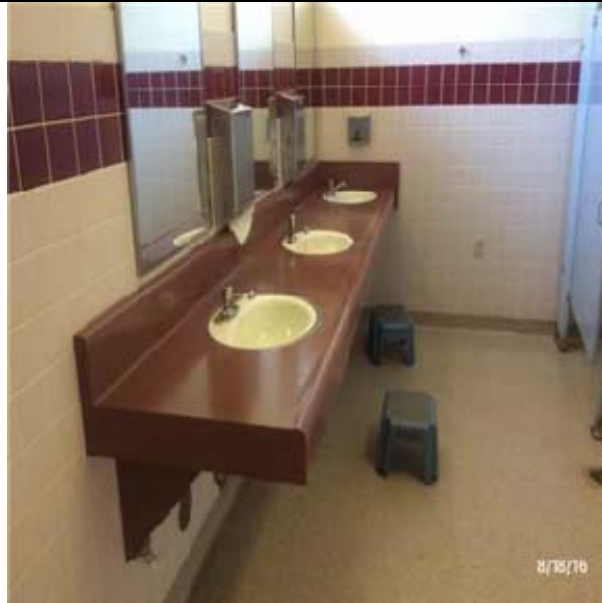
The lavatories appeared to be in fair to good condition. As a whole the lavatories drained properly and did not have any cracks in the china therefore no actions will be generated as we anticipate that they are suitable to last beyond the study period. ADA modification actions on the faucets have been generated at the beginning of the study period.

D2013 Lavatories:- View of Vanity Top Lavatories

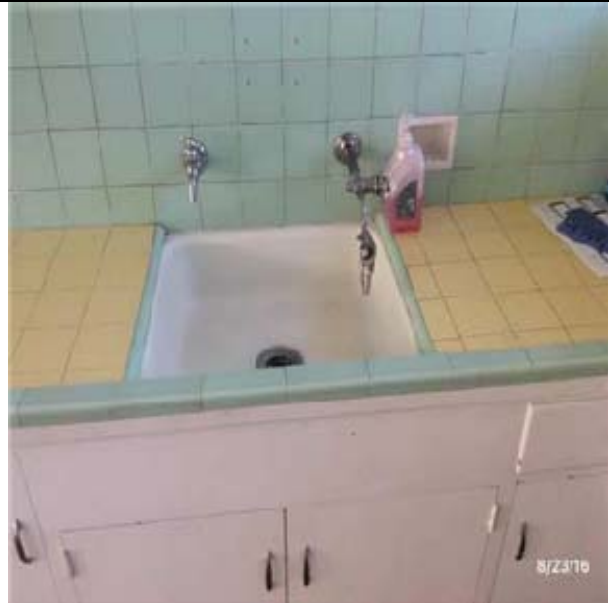
The kitchen sinks were observed to be in fair to good condition showing no damage or cracking. No actions are anticipated during the study period. ADA modifications to the kitchen sinks have been generated for the beginning of the study period.

D2014 Sinks:- View of Countertop Single Bowl Kitchen Sink

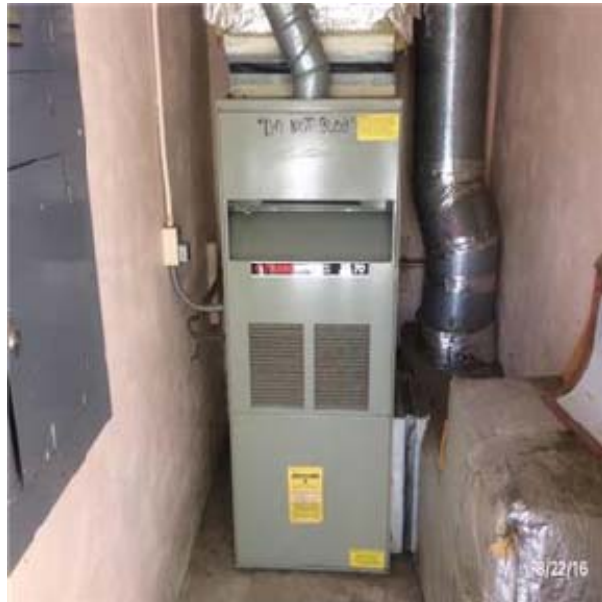
The furnaces were originally installed in 1988. With an EUL of twenty years, the units are due for replacement at the beginning of the study period as part of Deferred Maintenance.

D3032 Direct Expansion Systems:- View of Split-System  
(Indoor Furnace Unit) 101 to 150 BTU

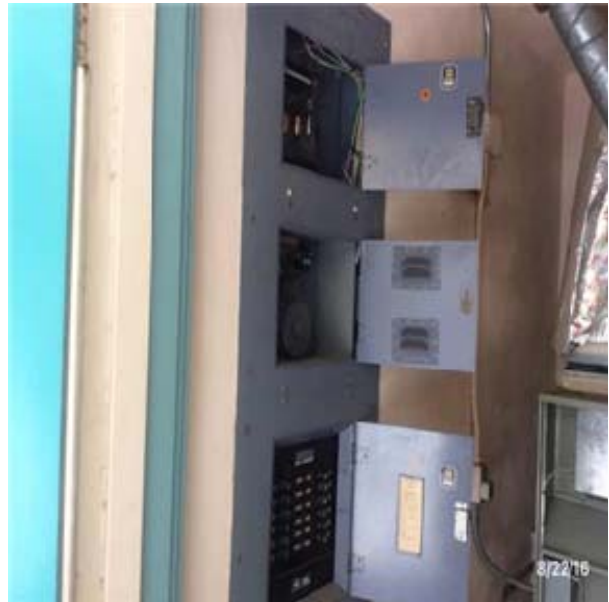
The distribution panels appear to be original to the building and have exceeded EUL. Replacement should be anticipated at the beginning of the study period.

D5012 Low Tension Service & Dist:- View of Panelboard -  
120/240volts, 60 to 2000amp

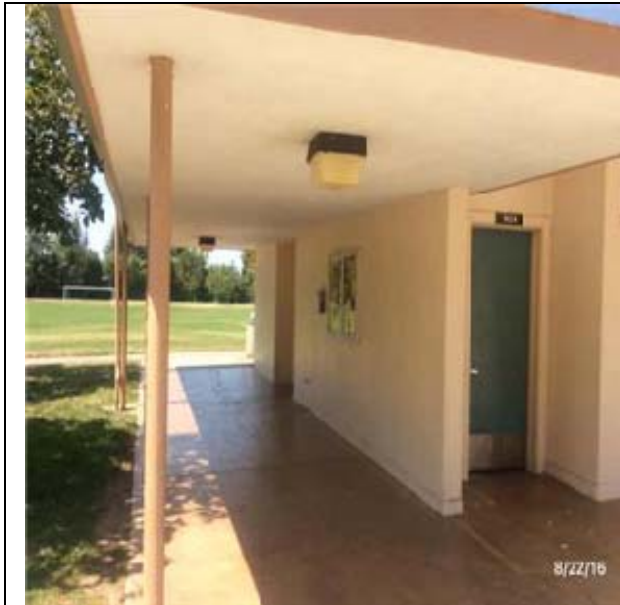
The wall pack fixtures are oxidized and the lenses are clouded. Replacement with LED is recommended at the beginning of the study period. The interior fluorescent fixtures were observed to be in fair condition and no actions are generated during the study period.

D5022 Lighting Equipment:- View of Exterior Wall Pack Light Fixtures

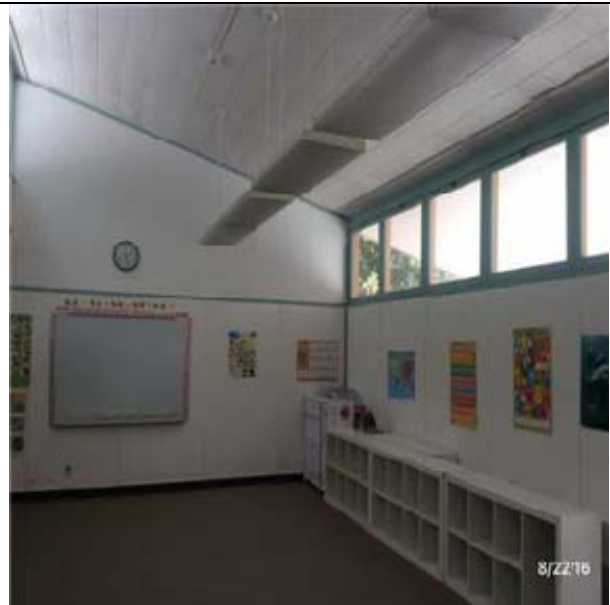
D5022 Lighting Equipment:- View of Interior Light Fixtures - Fluorescent

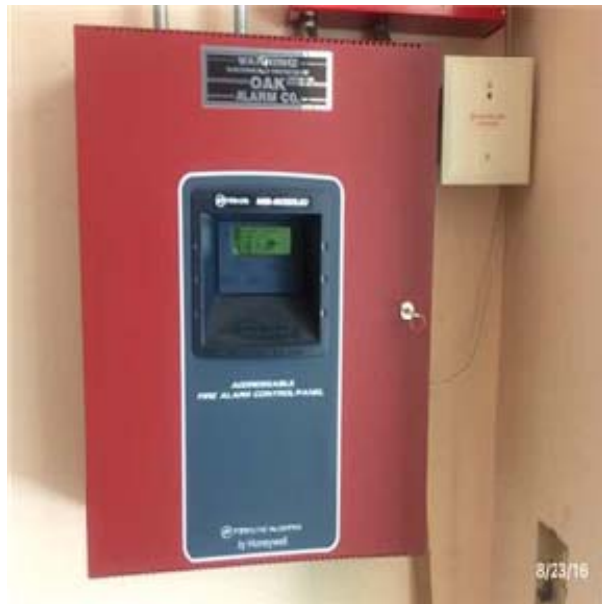
The FACP was observed to be in fair condition and no actions are anticipated during the study period.

D5037 Fire Alarm Systems:- View of Fire Alarm Control Panel (FACP) - Up to 10 Zone
