Tier 1 Report of

Facility Condition Assessment

For
City of Los Altos
Grant Park - Multi-Purpose Building
1575 Holt Ave
Los Altos,
California 94024

Date of Report: August 31, 2016

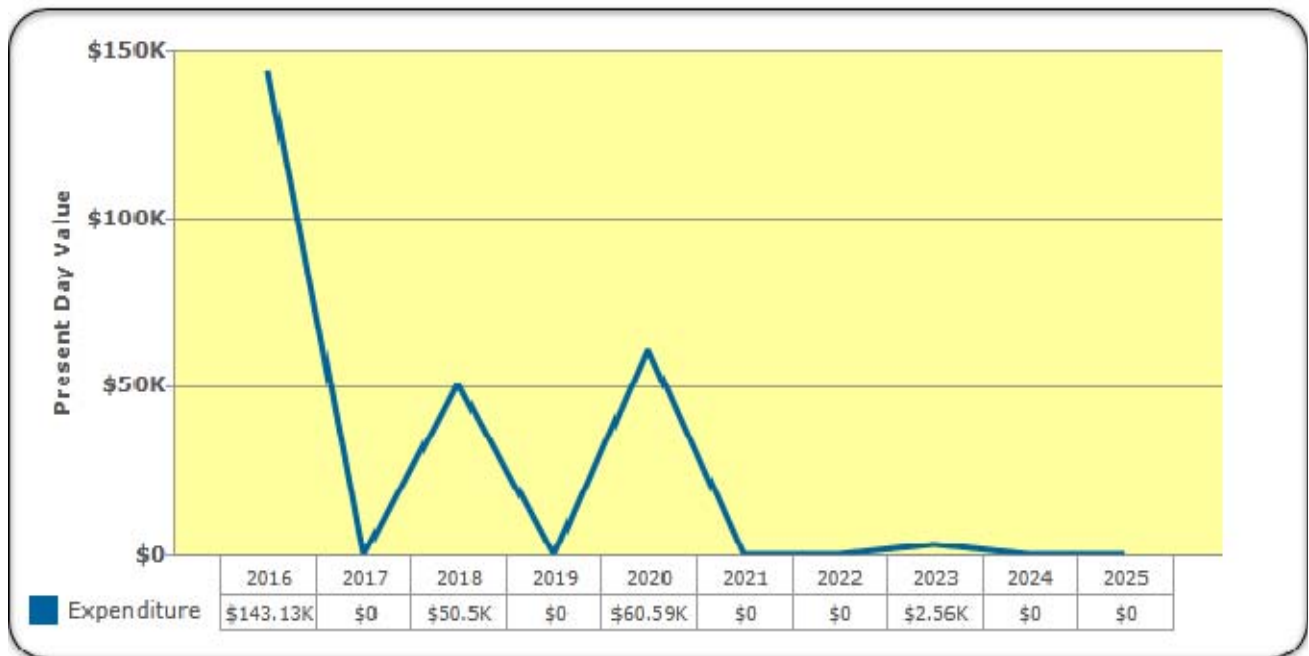
Expenditure Forecast Over Study Period

The building expenditure summary section provides an executive overview of the findings from the assessment. The chart below provides a summary of yearly anticipated expenditures over the study period for the Grant Park - Multi-Purpose Building. In addition, we have scheduled key findings highlighting items greater than \$5,000 and their anticipated failure year. Further details of these expenditures are included within each respective report section and within the expenditure forecast, in Appendix A of this report. The results illustrate a total anticipated expenditure over the study period of approximately \$256,793.

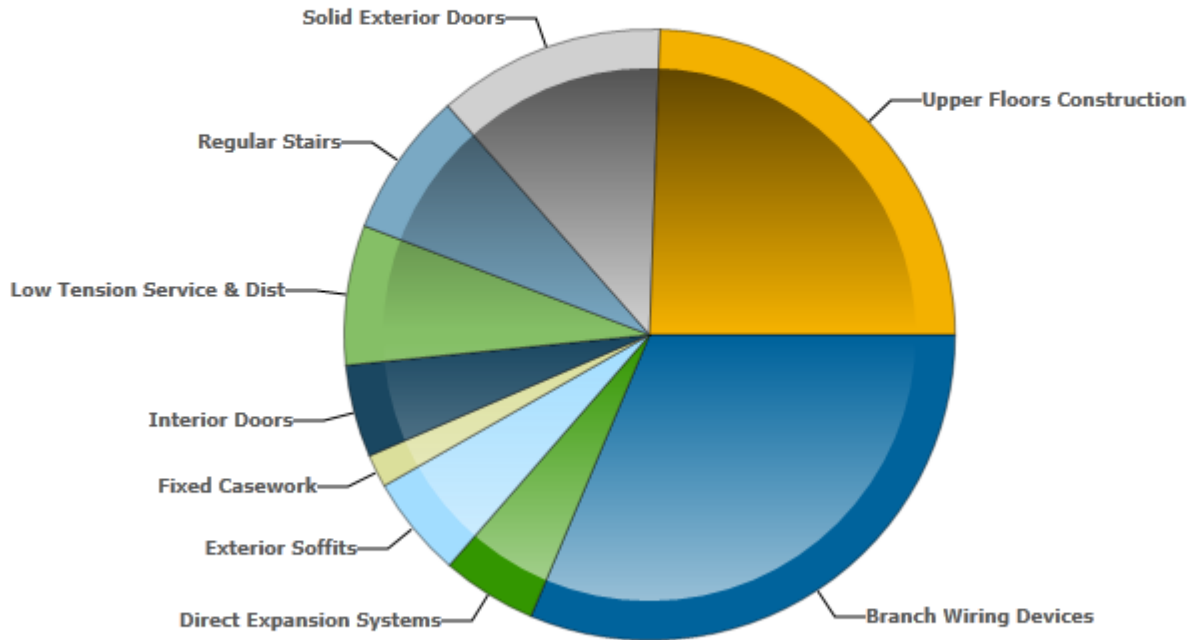
Distribution of Immediate Needs by Building System

Building System	Estimated Cost	Percentage of Total Cost
Branch Wiring Devices	\$44,884	31.4%
Direct Expansion Systems	\$7,200	5.0%
Exterior Soffits	\$7,700	5.4%
Fixed Casework	\$2,500	1.8%
Interior Doors	\$7,000	4.9%
Low Tension Service & Dist	\$10,600	7.4%
Regular Stairs	\$11,000	7.7%
Solid Exterior Doors	\$17,250	12.1%
Upper Floors Construction	\$35,000	24.5%
Total	\$143,134	100%

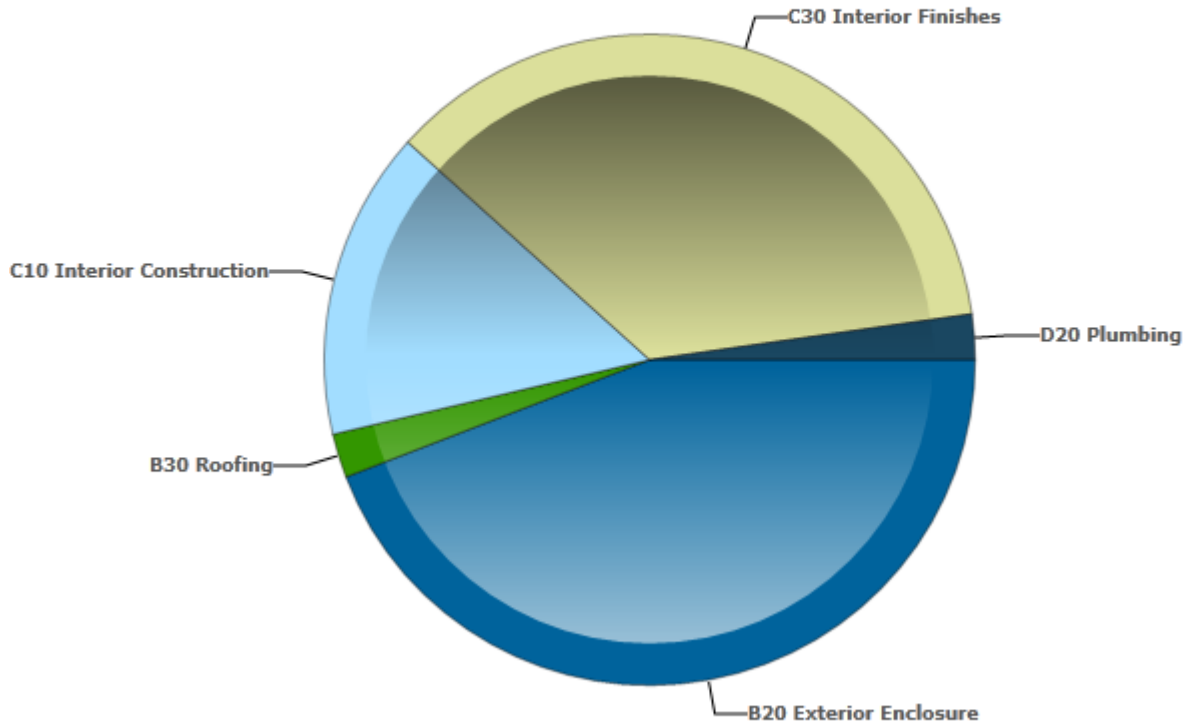
Distribution of Capital Needs by Building System

Building System	Estimated Cost	Percentage of Total Cost
B20 Exterior Enclosure	\$50,168	44.1%
B30 Roofing	\$2,483	2.2%
C10 Interior Construction	\$17,436	15.3%
C30 Interior Finishes	\$41,011	36.1%
D20 Plumbing	\$2,560	2.3%
Total	\$113,659	100%

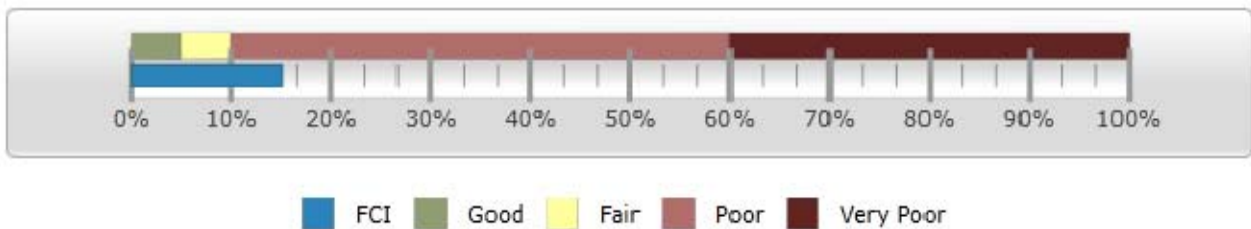
The chart below indicates the current FCNI ratio of the Grant Park - Multi-purpose building building.

Grant Park - Multi-purpose building, FCNI: 15.20%

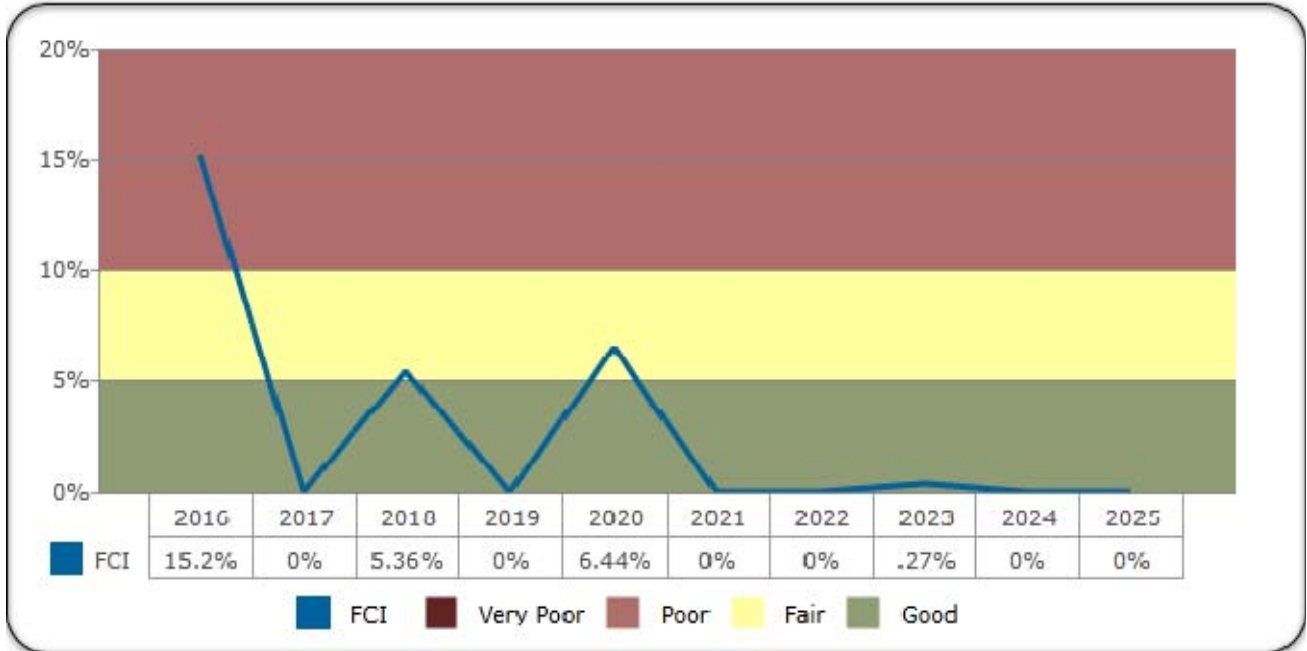
Year by Year Effects of FCI Over the Study Period

The chart below indicates the effects of the FCNI ratio per year, assuming the required funds and expenditures ARE made to address the identified actions each year.

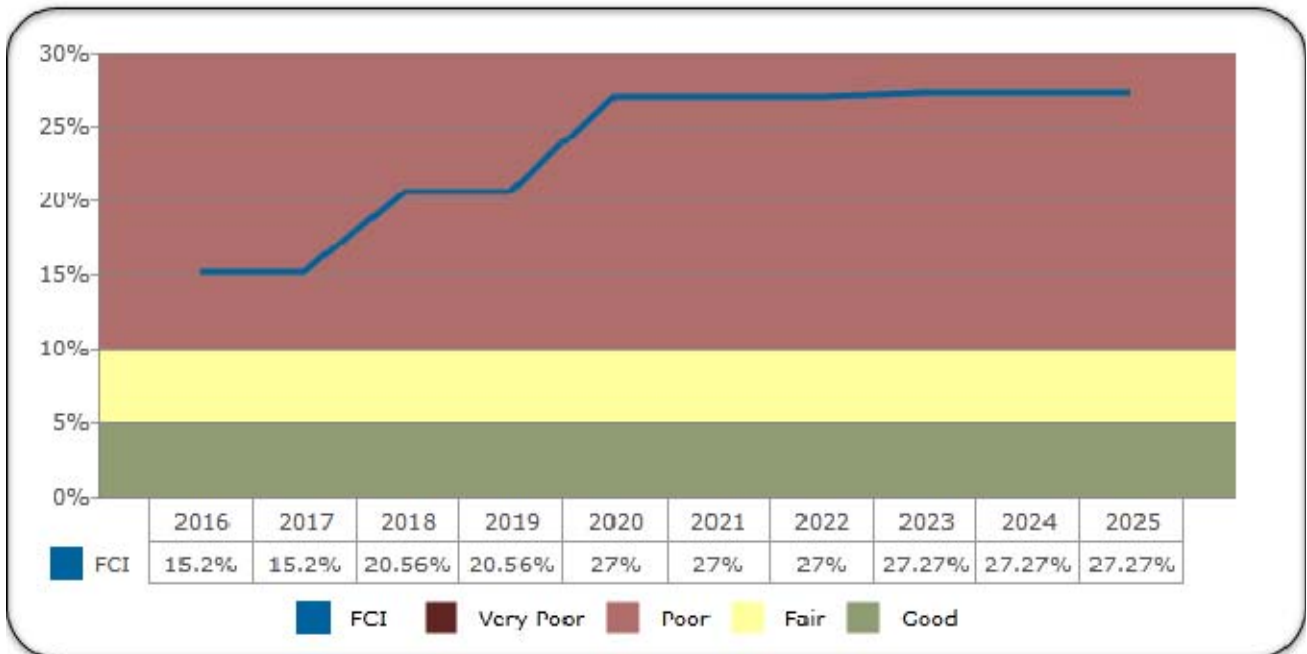
Cumulative Effects of FCI over the Study Period

The Chart below indicates the cumulative effects of the FCNI ratio over the study period assuming the required funds and expenditures are NOT provided to address the identified works and deferred maintenance each year.

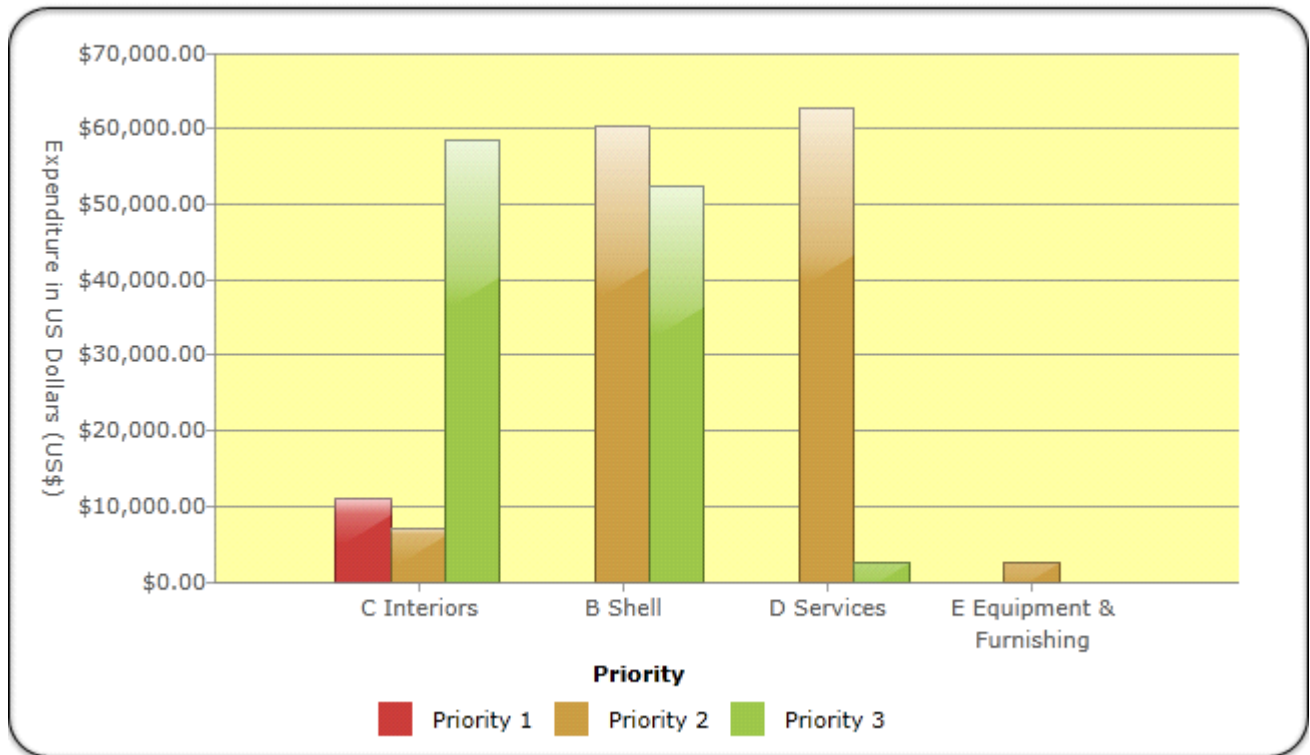
Planning Horizon Needs by System and Priority

The chart below illustrates the breakdown of expenditure according the priority coding providing an opportunity to strategically plan and effectively direct funding to the highest priority.

Building System	Priority 1	Priority 2	Priority 3	Total
B Shell	\$0	\$60,286	\$52,315	\$112,601
C Interiors	\$11,000	\$7,000	\$58,447	\$76,447
D Services	\$0	\$62,684	\$2,560	\$65,245
E Equipment & Furnishing	\$0	\$2,500	\$0	\$2,500
Totals	\$11,000	\$132,470	\$113,323	\$256,793

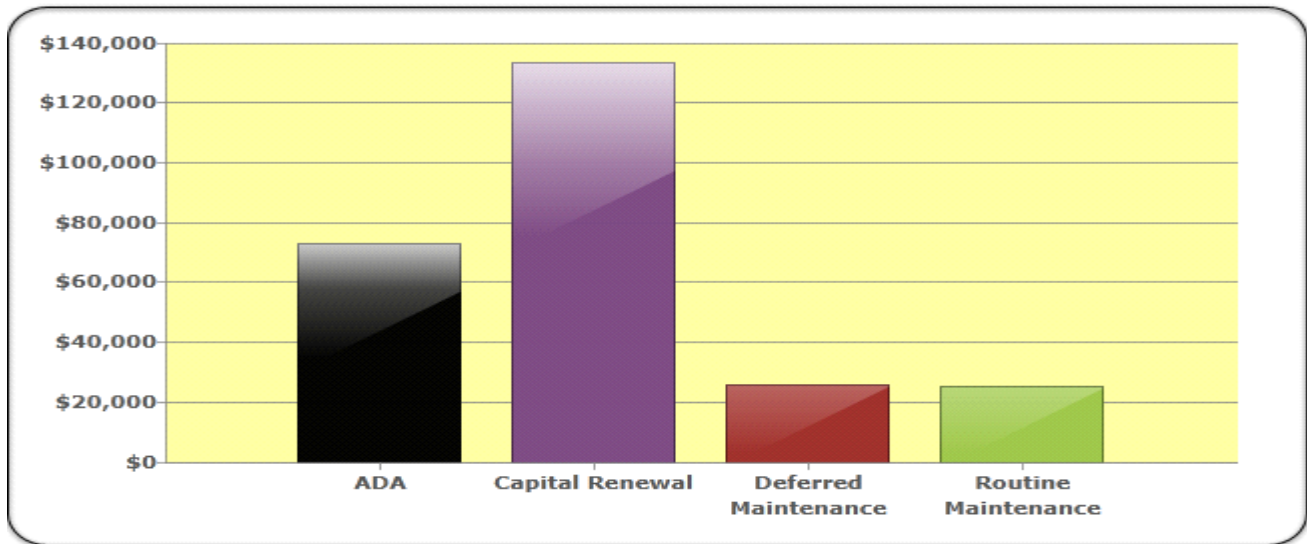
Planning Horizon Needs by Category

The chart below illustrates the breakdown of expenditure according to the Plan Type or deficiency categories providing an opportunity to strategically plan and effectively direct funding.

Building System	Total Cost
Deferred Maintenance	\$25,500
Capital Renewal	\$133,124
Routine Maintenance	\$25,420
ADA	\$72,750
Total	\$256,793

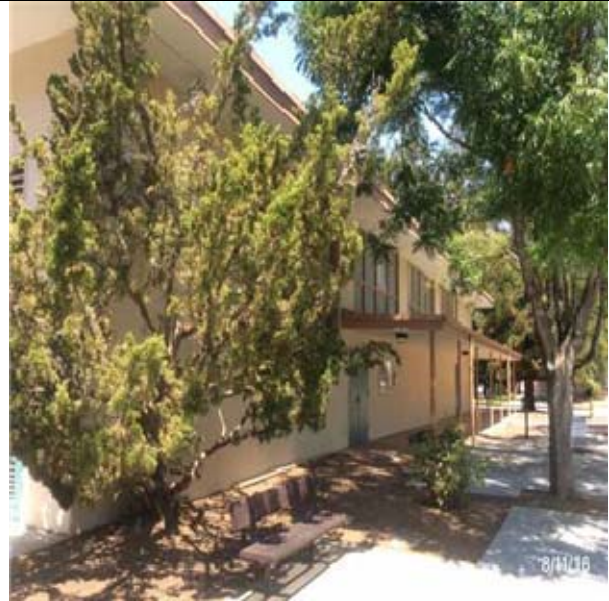
The wall construction was observed to be in fair condition and well maintained with no instances of deterioration, cracking or damage observed. No actions have been generated during the study period for works associated with the structural wood frame structure aside from painting as routine maintenance.

B2011 Exterior Wall Construction:- View of Stucco over Stud Walls

ID	Type	Recommendation	Priority	Year	Expenditures
144247	B2010	Repaint Exterior Wall Surfaces	Priority 3	2018	\$7,144
144248	B2010	Replace Exterior Soffits	Priority 2	2016	\$7,700
144249	B2020	Replace Wood Window Units - Fixed or Single Hung	Priority 3	2018	\$42,185
144250	B2030	Repaint Exterior Double Wood Doors	Priority 2	2018	\$336
144251	B2030	Repaint Exterior Doors	Priority 3	2018	\$504
144252	B2030	ADA Modifications to Exterior Doors	Priority 2	2016	\$17,250

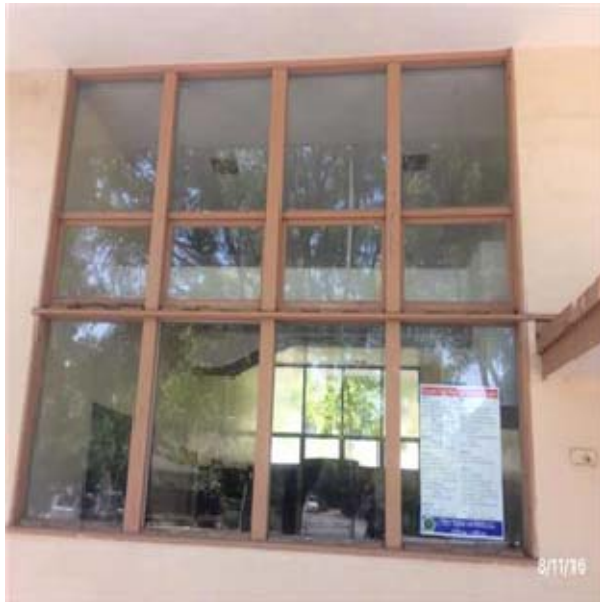
The wood window frames were observed to be showing substantial age related deterioration. Window replacement should be anticipated early in the study period.

B2021 Windows:- View of Wood Window Units - Fixed or Single Hung

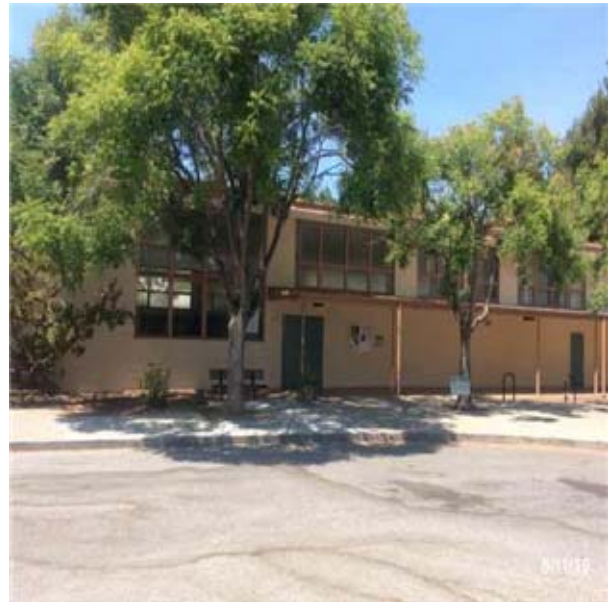
The exterior doors were observed to be in fair to good condition. No actions are anticipated during the study period aside from repainting as part of routine maintenance. ADA modification actions have been generated for the beginning of the study period.

B2032 Solid Exterior Doors:- View of Double Solid Core Wood Doors

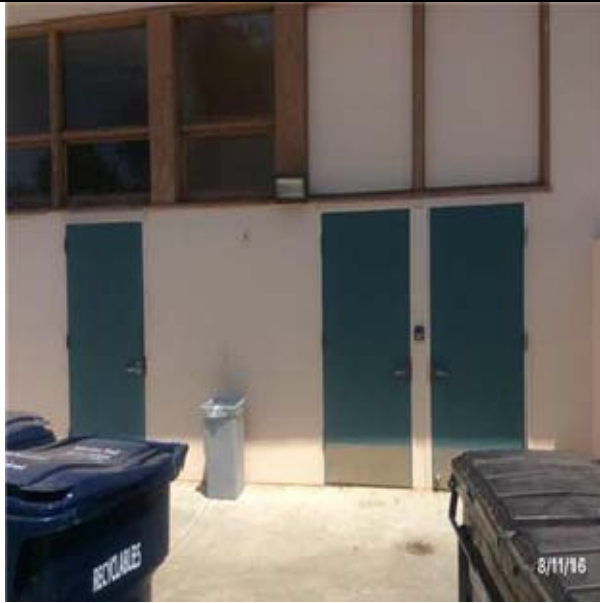
B2032 Solid Exterior Doors:- View of Single Solid Core Wood Doors

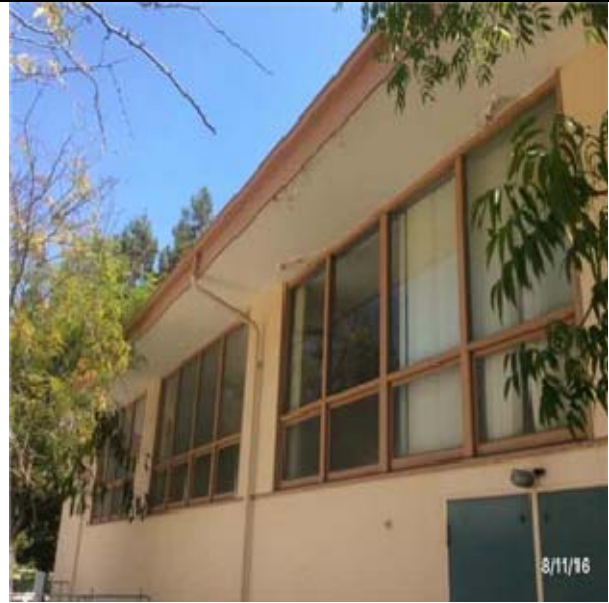
The gutters and downspouts were observed to be in fair condition. Based on EUL, replacement can be anticipated mid-term in the study period.

B3016 Gutters and Downspouts:- View of Galvanized Steel Perimeter Gutters & Downspout

ID	Type	Recommendation	Priority	Year	Expenditures
144253	B3010	Replace Galvanized Steel Perimeter Gutters & Downspout	Priority 3	2020	\$2,483

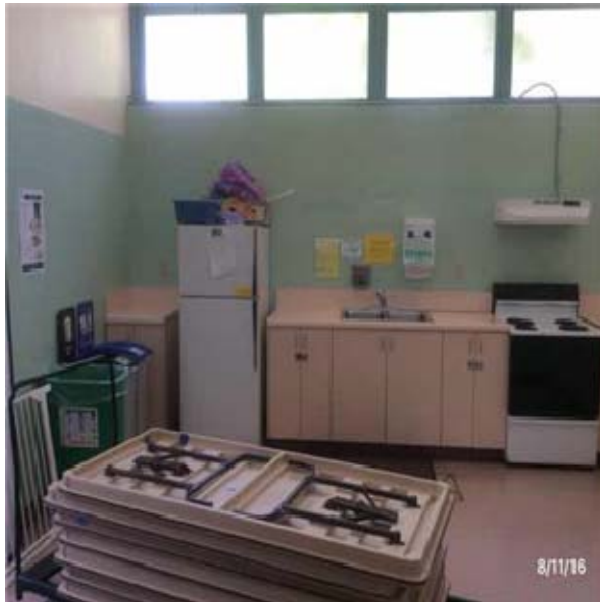
Ceramic wall tile in the kitchen area was observed to be in fair to good condition. No actions are anticipated during the study period.

C3012 Wall Finishes to Interior Walls:- View of Ceramic Wall Tiles

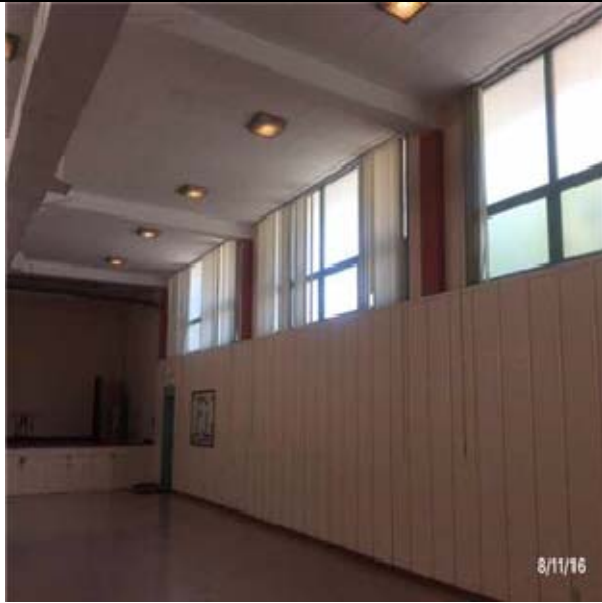
The acoustic tile ceiling system was observed to be in fair condition. Based on estimated RUL, no actions are anticipated during the study period.

C3032 Suspended Ceilings:- View of Acoustic Ceiling System with Concealed Grid

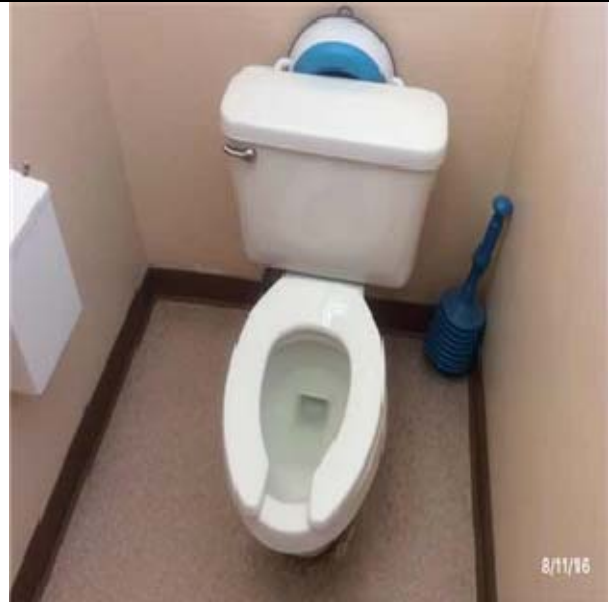
The water closet was observed to be in fair to good condition. The water closet flushed properly and did not have any cracks in the china and no actions will be generated during the study period. We anticipate that the flush valves may fail during the study period and therefore to maintain function they may need to be rebuilt or in some cases replaced. This work has not been included in this study as we anticipate it will be carried out on an as-needed basis as part of routine maintenance.

D2011 Water Closets:- View of Floor Mounted Water Closets

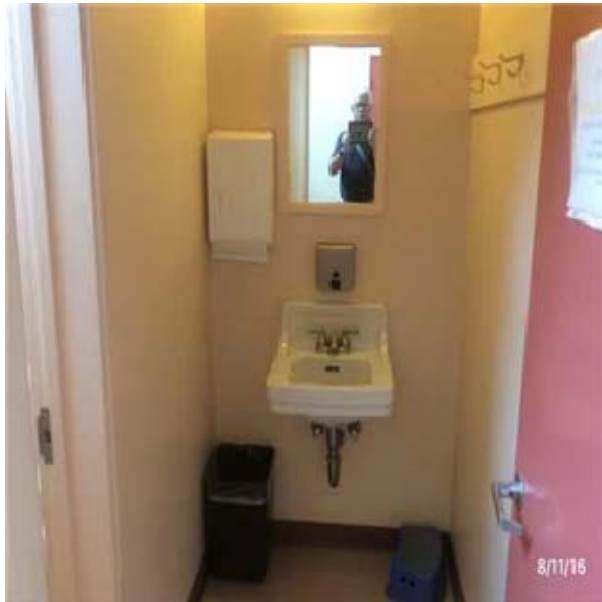
The lavatory was observed to be in fair to good condition. The lavatory drained properly and did not appear to have any cracks in the china. Based on observed condition, no actions are anticipated during the study period.

D2013 Lavatories:- View of Wall Hung Lavatories

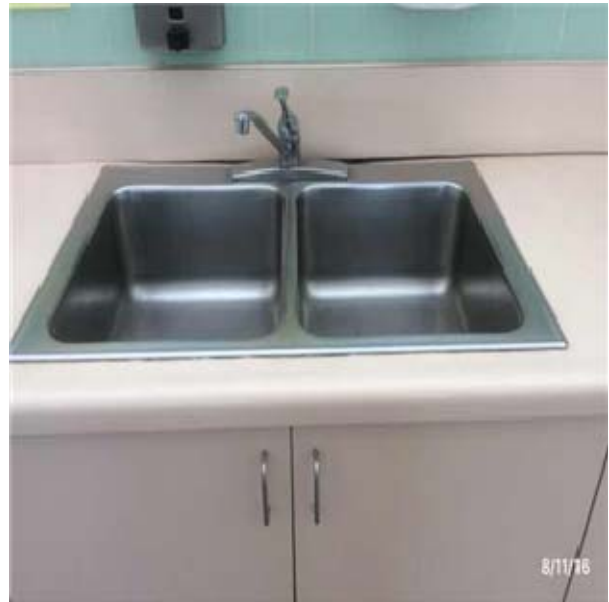
The countertop stainless sink was observed to be in fair to good condition. The sink drained properly and appeared not to have any damage in the stainless steel finish so no replacement action is anticipated.

D2014 Sinks:- View of Countertop Double Bowl Kitchen Sinks

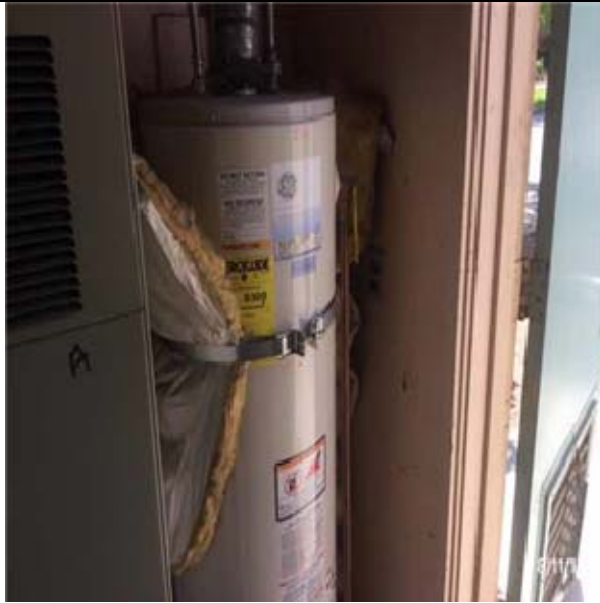
The water heater was observed to be in fair to good condition. Based on EUL, replacement can be anticipated later in the study period.

D2022 Hot Water Service:- View of Domestic Hot Water Heater - Gas

ID	Type	Recommendation	Priority	Year	Expenditures
144259	D2020	Replace Domestic Hot Water Heater - Gas	Priority 3	2023	\$2,560

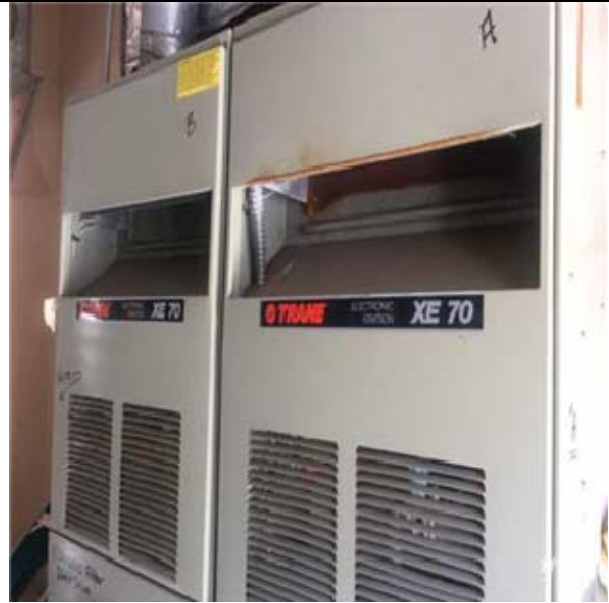
The furnace units were put in service circa 1987. With an EUL of twenty years, the units are due for replacement now as part of deferred maintenance.

D3032 Direct Expansion Systems:- View of Split-System (Indoor Furnace Unit) 101 to 150 BTU

ID	Type	Recommendation	Priority	Year	Expenditures
144260	D3030	Replace Split-System (Indoor Furnace Unit) 101 to 150 BTU	Priority 2	2016	\$3,600
144261	D3030	Replace Split-System (Indoor Furnace Unit) 101 to 150 BTU	Priority 2	2016	\$3,600

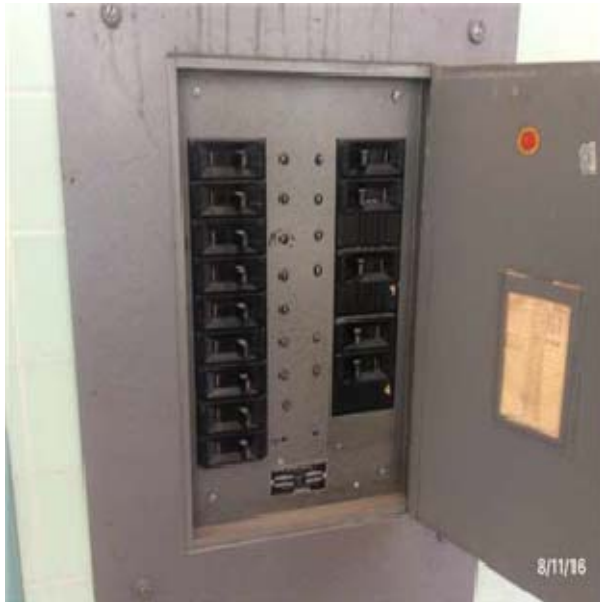
The MDPs are assumed to be original to the building. Based on a typical EUL of thirty years, replacement is recommended now as part of deferred maintenance.

D5012 Low Tension Service & Dist:- View of Panelboard - 120/240volts, 60 to 2000amp

ID	Type	Recommendation	Priority	Year	Expenditures
144262	D5010	Replace Panelboard - 120/240volts, 60 to 2000amp	Priority 2	2016	\$5,300
144263	D5010	Replace Panelboard - 120/240volts, 60 to 2000amp	Priority 2	2016	\$5,300
144264	D5020	Replace Wiring Systems (Inc. Receptacles & Switches)	Priority 2	2016	\$44,884

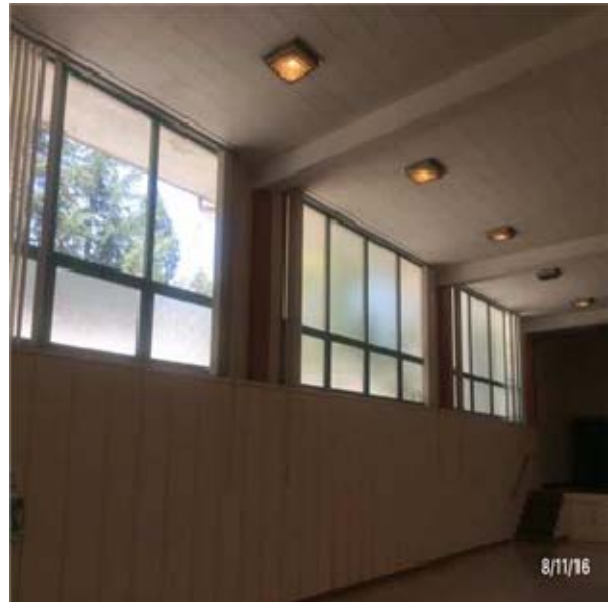
The light fixtures were observed to be functioning properly and no actions are anticipated during the study period.

D5022 Lighting Equipment:- View of H.P. Sodium Fixtures

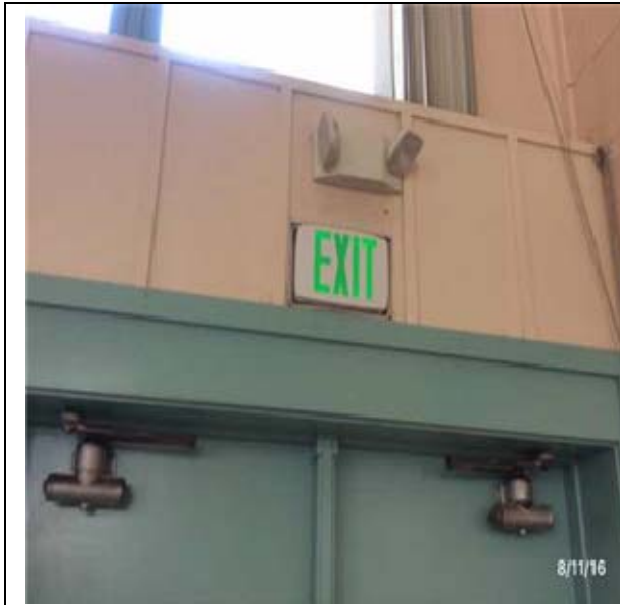
The exit signs were observed to be in good condition and no actions are anticipated during the study period.

D5092 Emergency Light & Power Systems:- View of Exit
Lights L.E.D

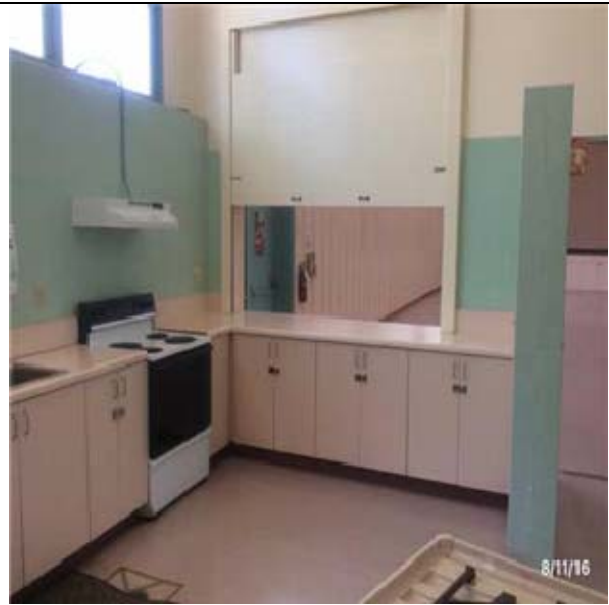
E2012 Fixed Casework:- View of Floor Mounted Base
Cabinet(s) - Standard

ID	Type	Recommendation	Priority	Year	Expenditures
144265	E2010	ADA Modifications to Counter Top	Priority 2	2016	\$2,500
